SOLID WASTE DELINEATION REPORT

Douglas Park
2795 SW 37th Avenue
Miami, Florida

Prepared for
City of Miami
Capital Improvement Programs

URS Corporation
January 2014

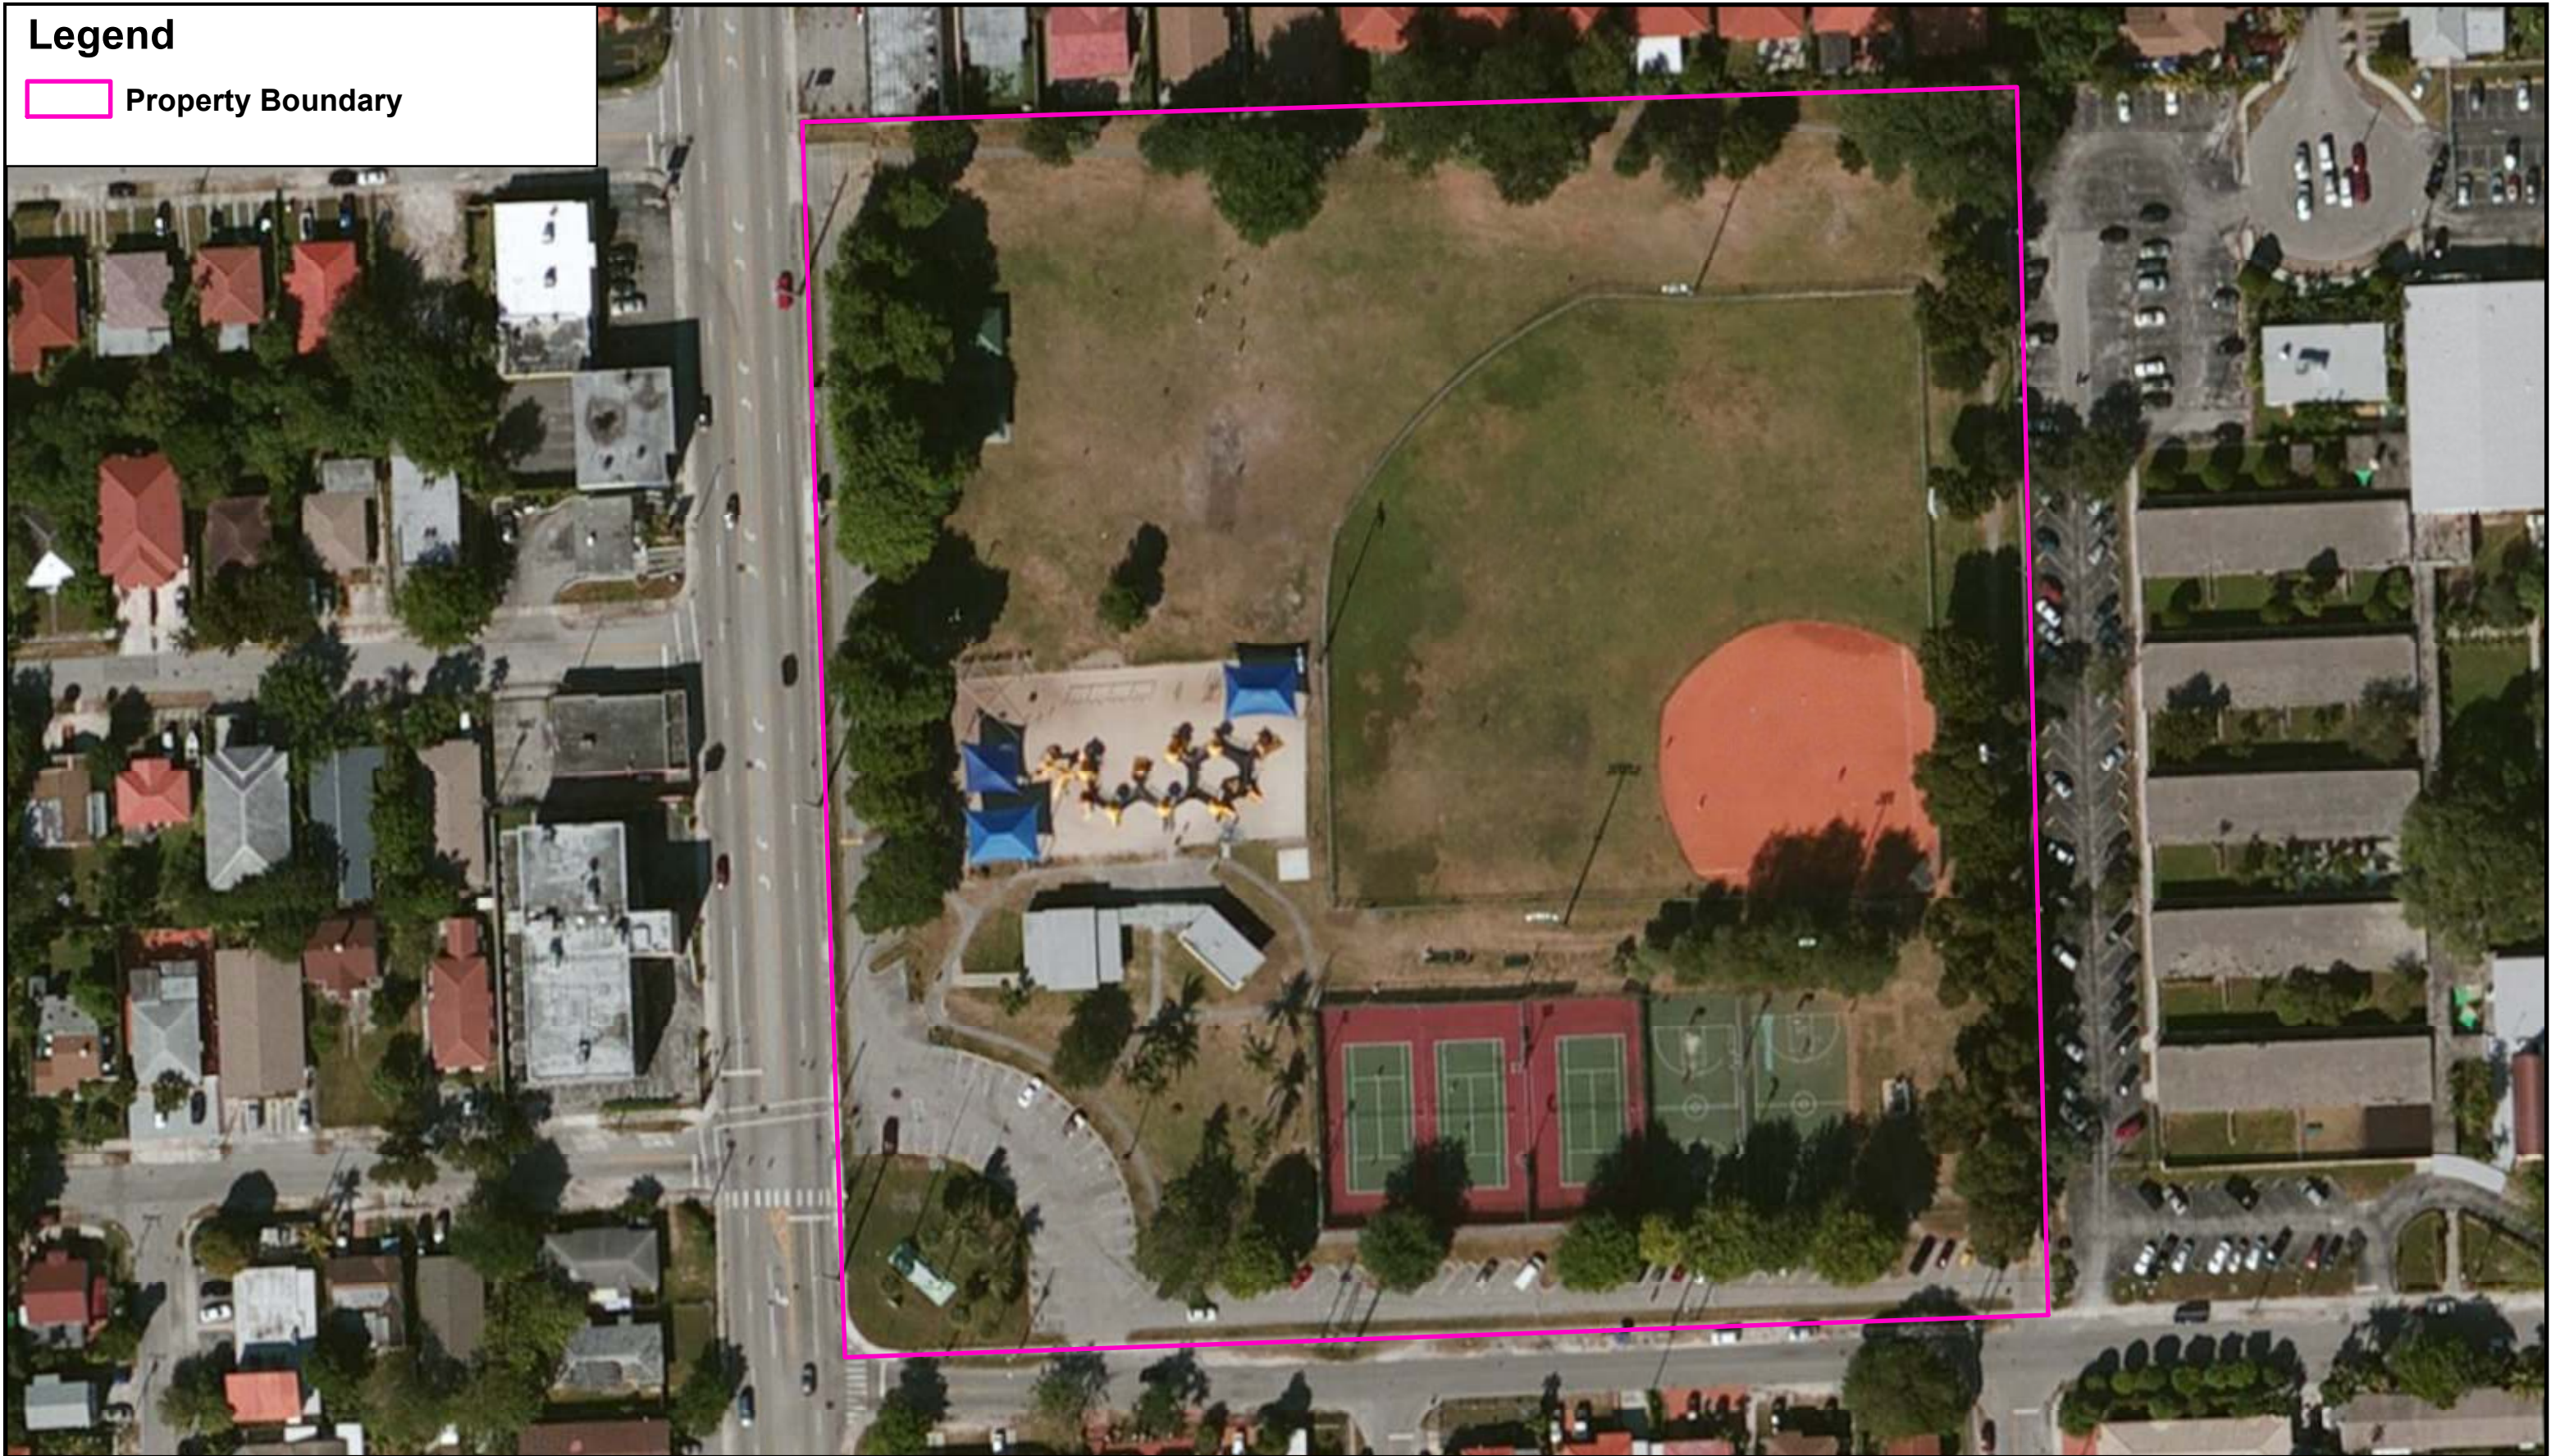
The locations of the test pits and the estimated percentage of solid waste observed in each pit are shown in **Figure 3**. The test pit samples recovered were visually inspected for proper classification and stratification. Information regarding soil classification, type and description of solid waste material, depth, and thickness was properly documented. The test trench logs providing a detailed description of the waste characteristics observed are provided as **Appendix D**.

- Angular or molten pieces of glass or small solid waste debris were observed in the surficial layer immediately below the grass or topsoil in most of the test pits.
- The estimated quantities of solid waste debris in the test pits varied considerably from about less than 5 percent near the northwest corner of the Park to about 70-90 percent near the eastern boundary and the southeastern portion of the Park.

- The test pits showed significant amount of solid waste debris below the surficial soil layers near existing playgrounds, tennis courts and basketball courts.
- The type of solid waste noted during the excavations generally included angular or molten pieces of glass, construction and demolition debris, partially burnt unrecognizable material, incidental amounts of old tires or remnants of tires, rusted metal, plastic bottles, wood from building or structures, and black residues of material that was burnt.

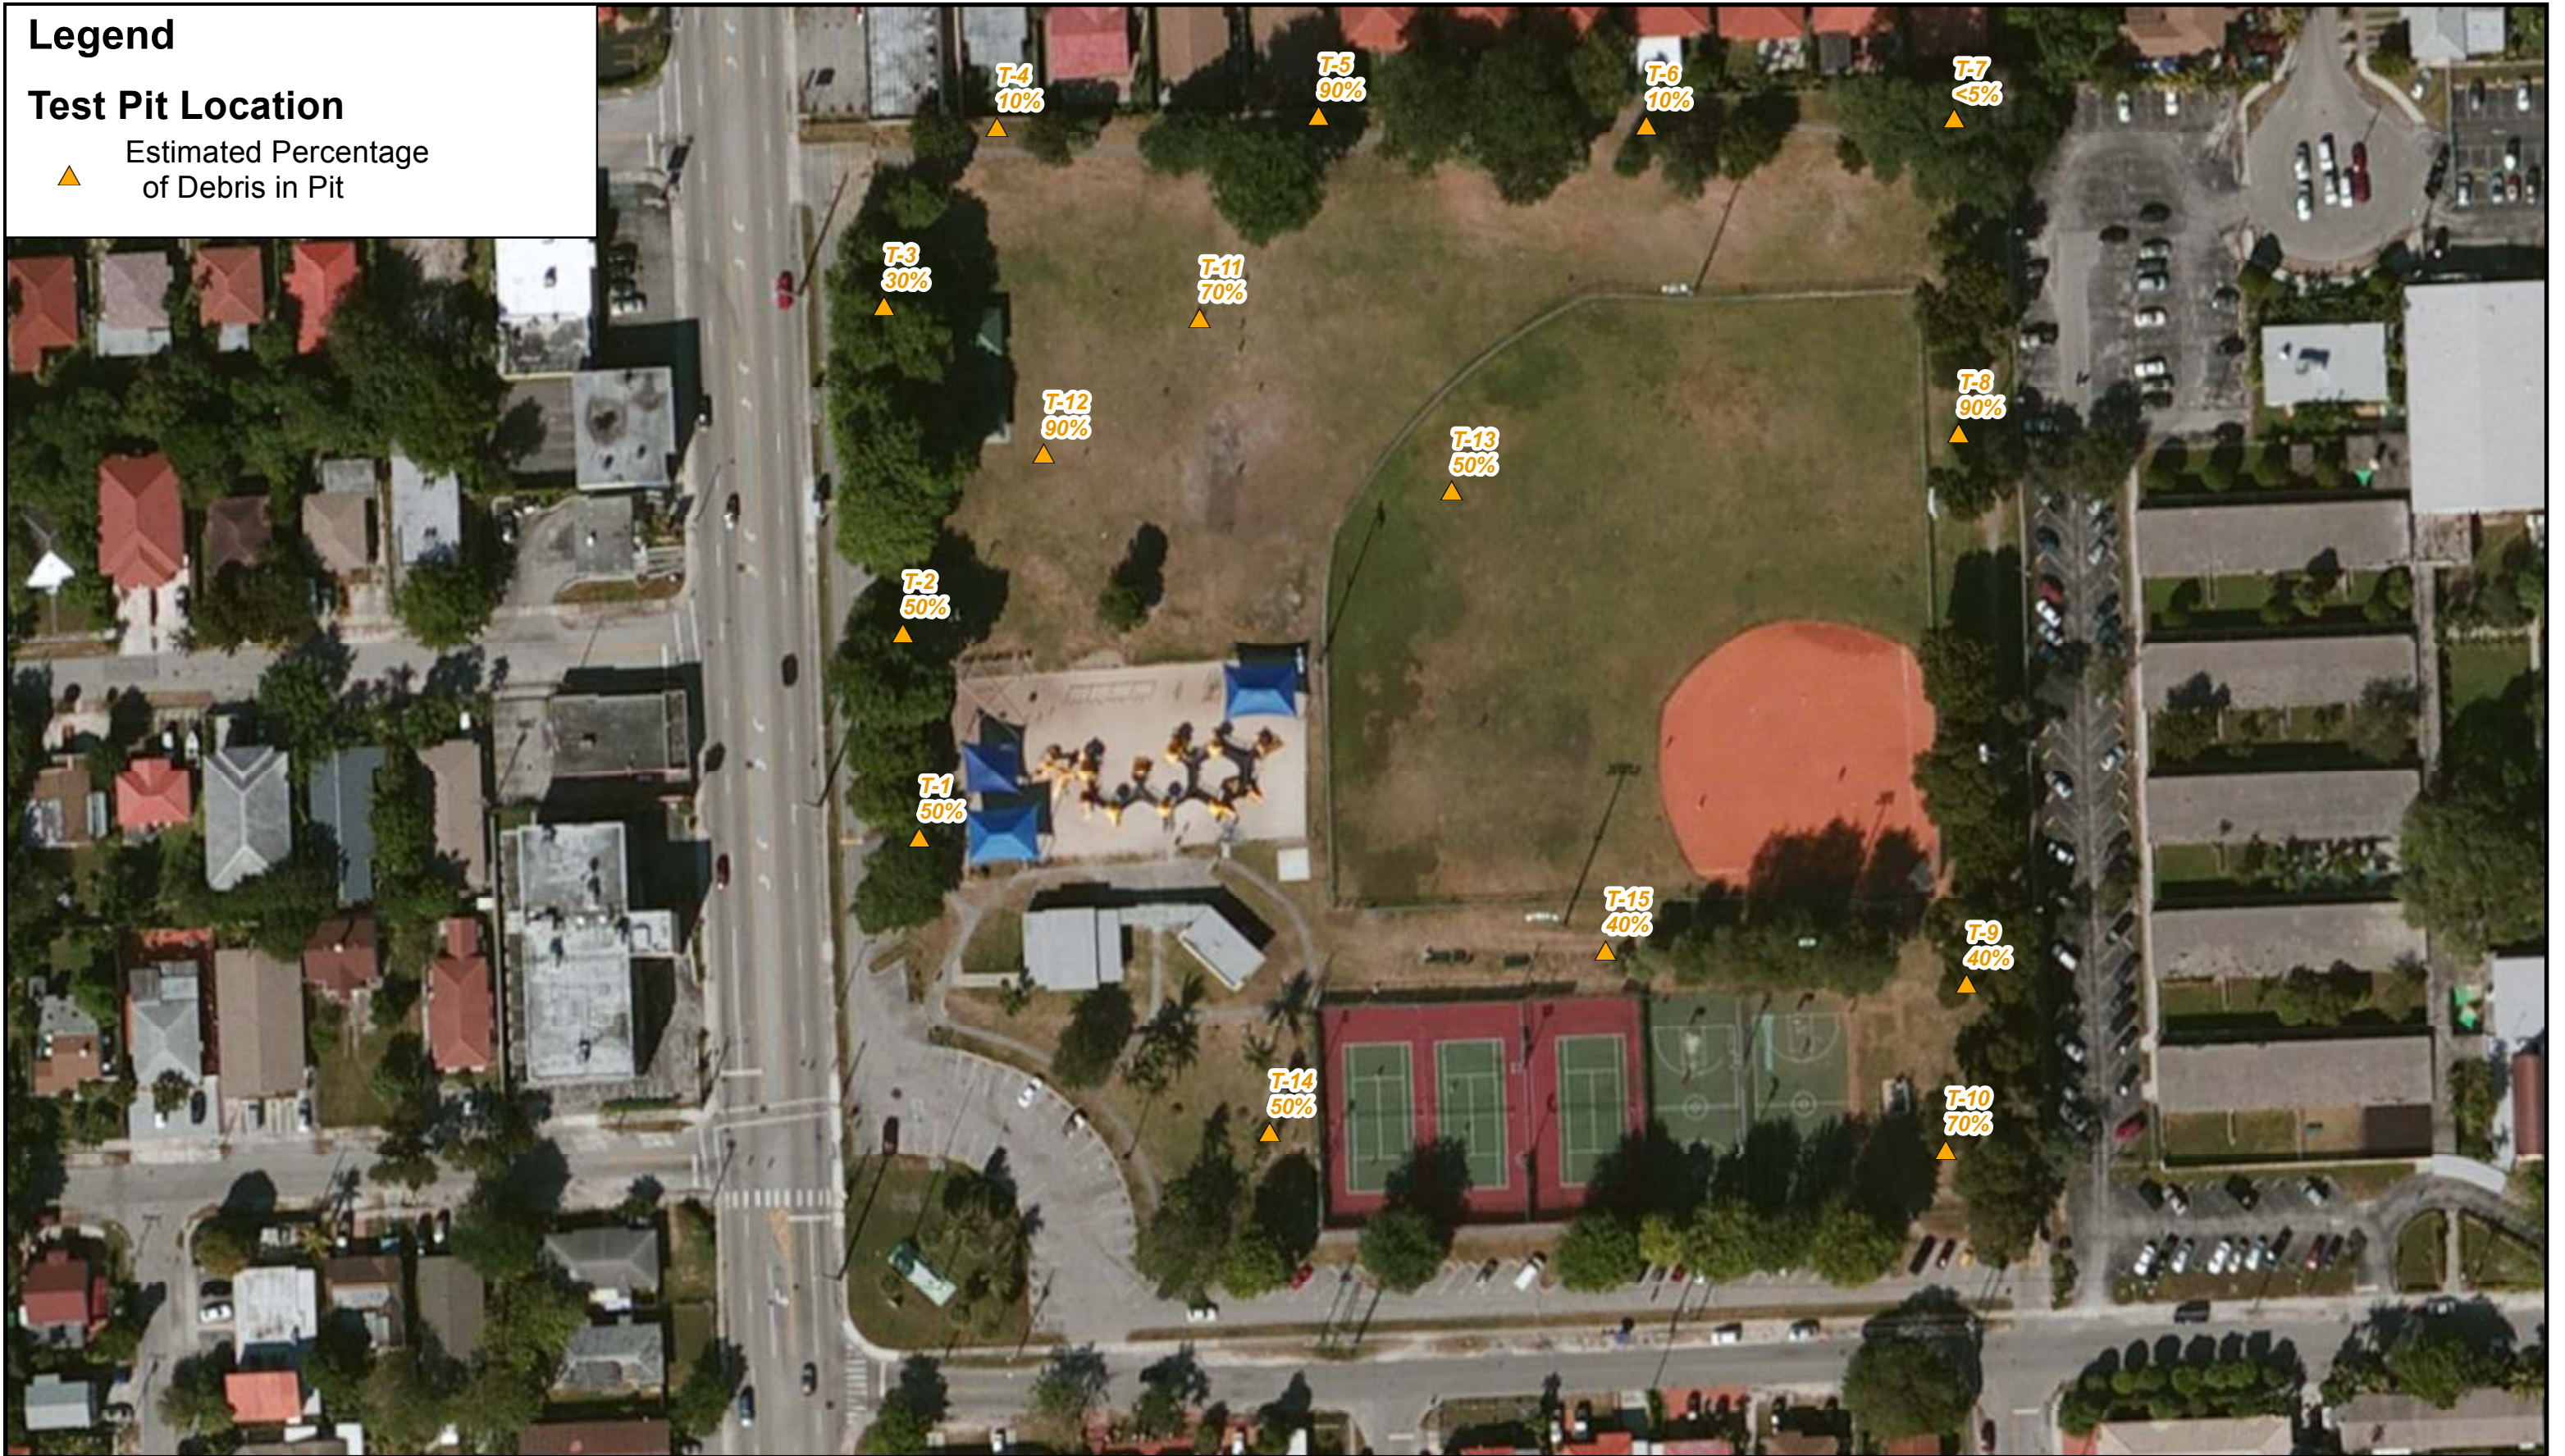
- A surficial layer made up of top soil or vegetative cover, as shown in **Figure 4**;
- An intermediate layer made of soil and limerock to support the surficial layer mixed with small quantities of solid waste debris, as shown in **Figure 5**; and
- A bottom solid waste debris layer consisting of soil, limerock mixed with significant quantities of trash, construction and demolition debris, unrecognizable burnt material or residues, and municipal solid wastes, as shown in **Figure 6**.

- Angular or molten pieces of glass or small solid waste debris were observed in the surficial layer immediately below the grass or topsoil in most of the soil borings. This layer was generally about 6 inches thick.

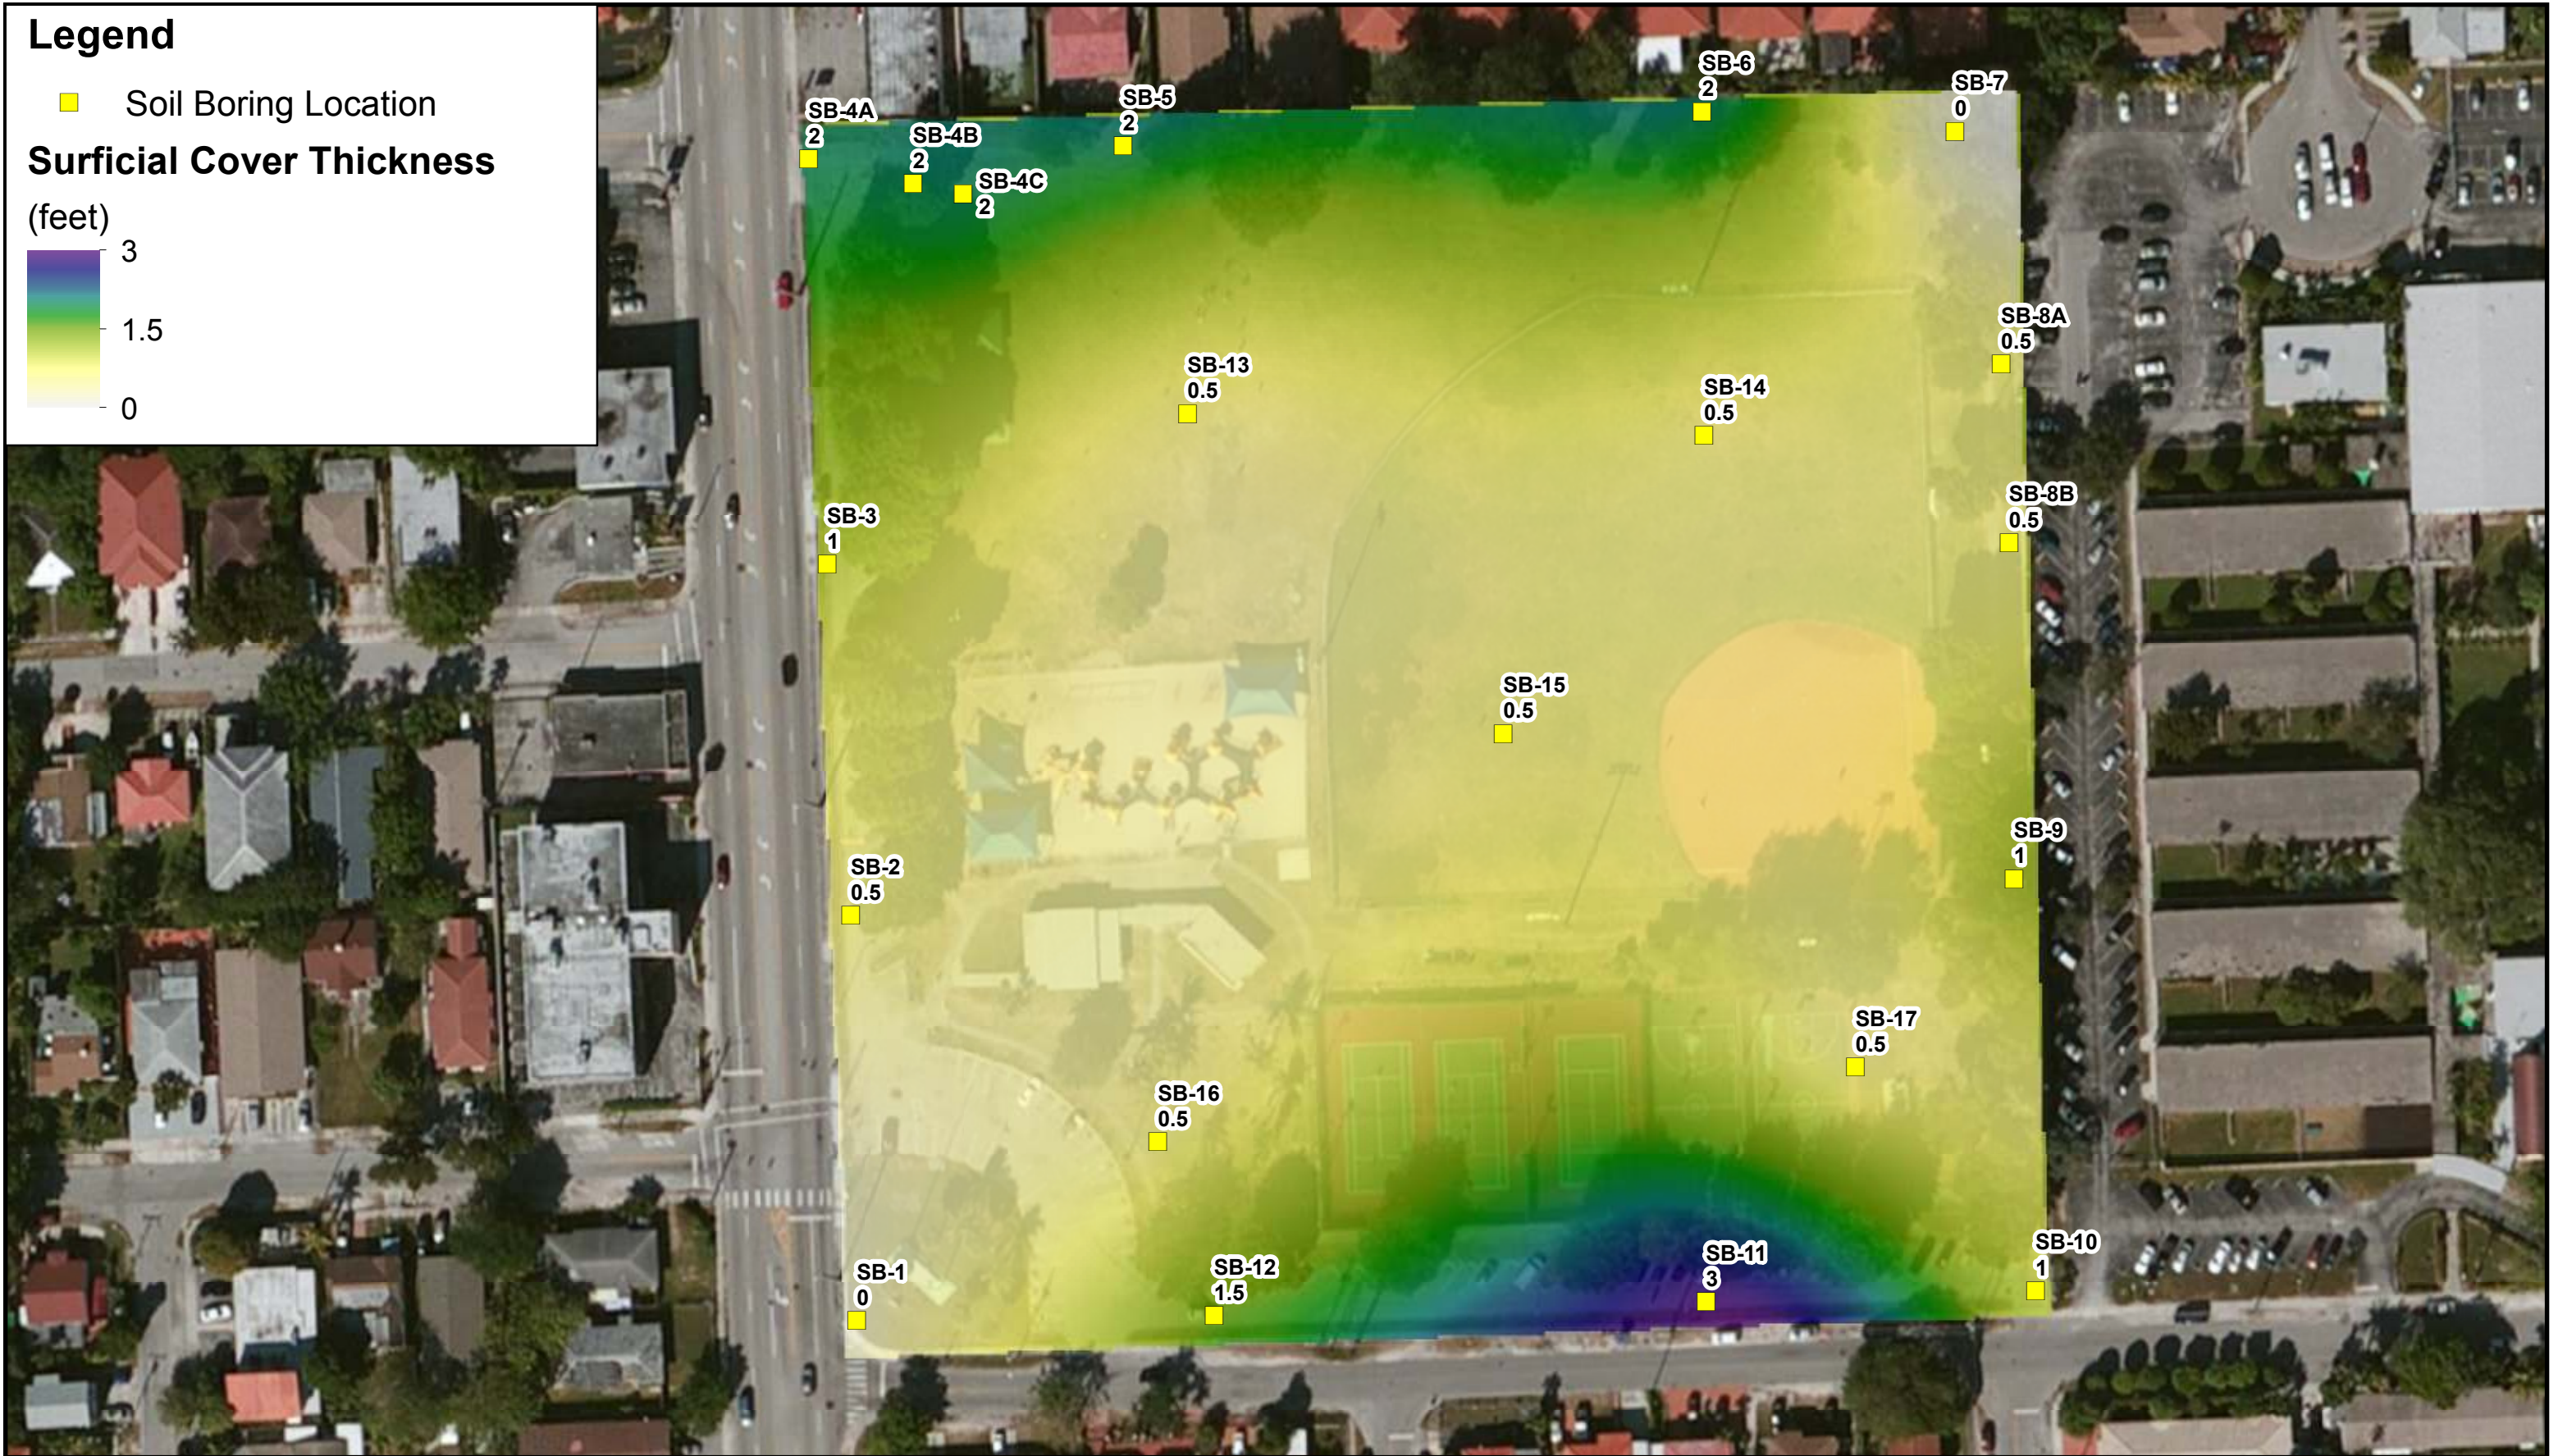
- Immediately below the surficial layer, an intermediate layer of soil and limerock that was mixed with solid waste debris or unrecognizable burnt material was noted. The thickness of the intermediate layer varied considerably across the Park from about 6 inches to 5 feet.

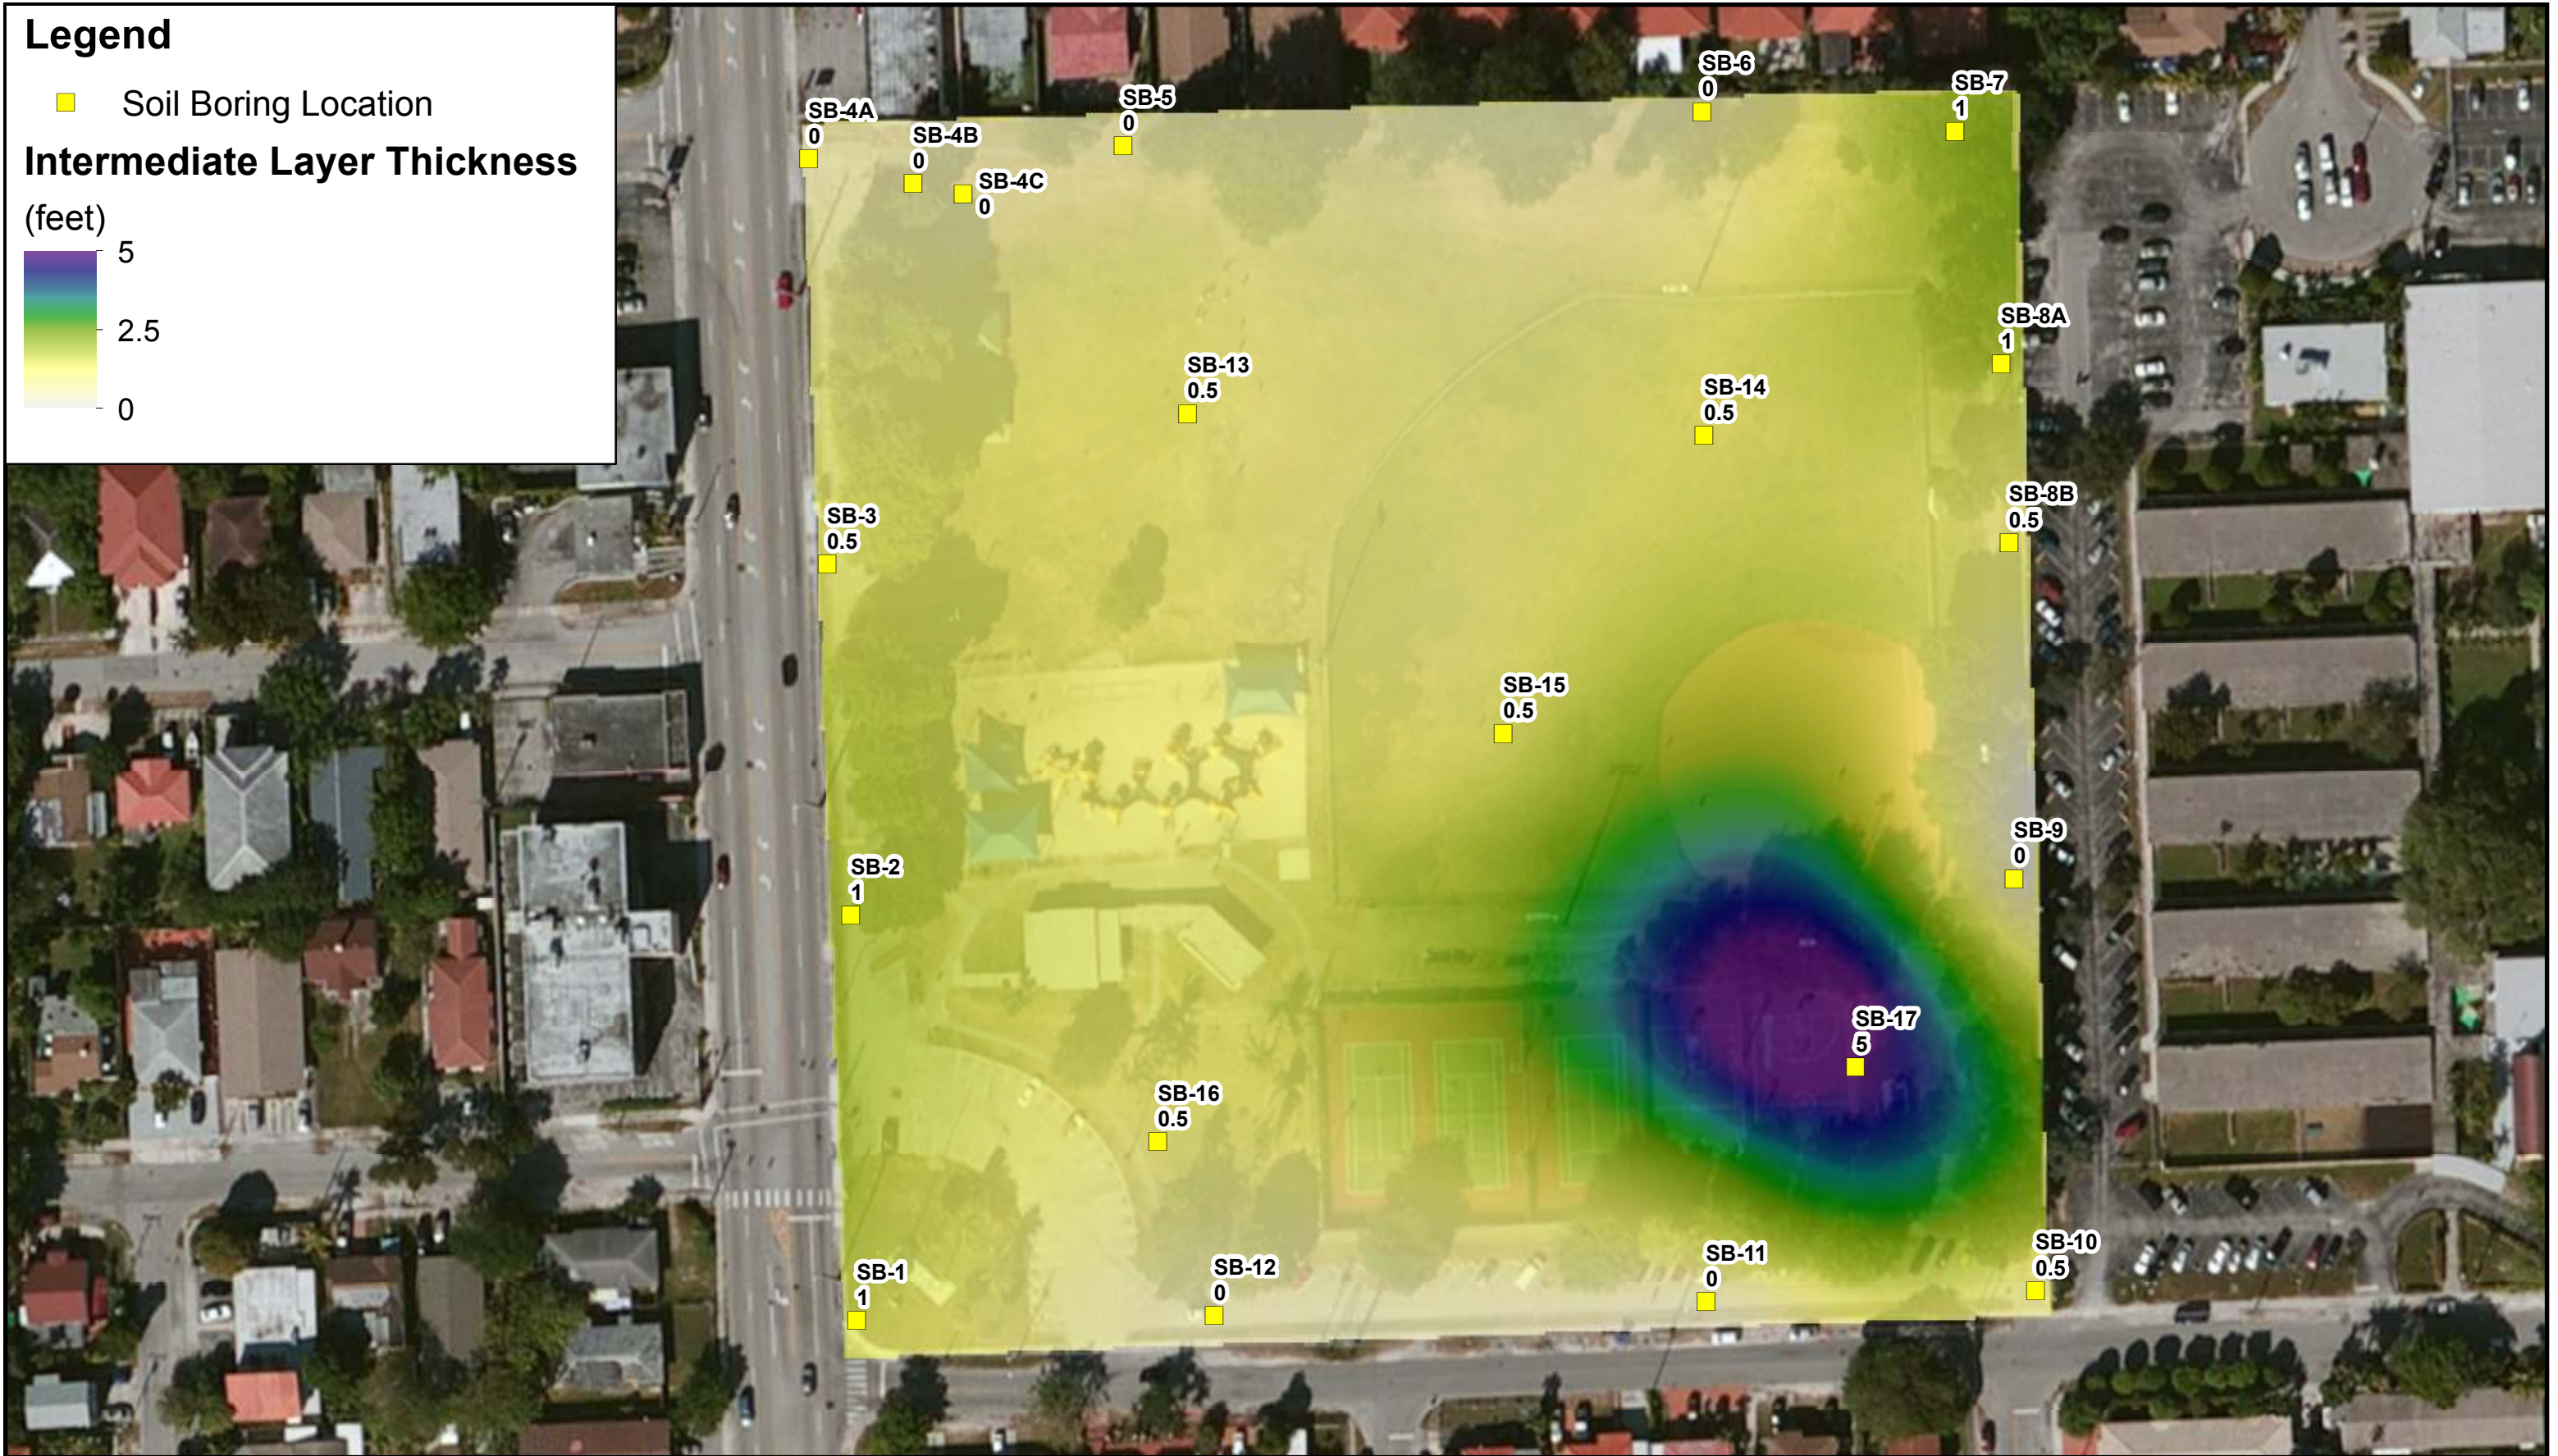
- The bottom layer immediately below the intermediate limerock layer contained trash, half burnt or decomposed tires, construction and demolition debris, and unrecognizable burnt material or residues, and other municipal solid wastes. The thickness of the bottom layer varied considerably across the center portion of the Park. The deepest solid waste layer was observed near the southeastern quadrant of the Park with an estimated thickness of 14.5 feet and a depth of approximately 20.5 feet bgs. It is believed that the main entrance to the former rock pit was near the southeastern corner.

3. The thickest layer of solid waste debris noted from the soil borings was approximately 14.5 feet thick to a depth of 20.5 feet bgs. This was noted in a soil boring in the southeast quadrant immediately to the east of the basketball courts. Significant quantities of solid waste debris were also noted along the eastern boundary and the entrance to the Park to the west of the tennis courts.

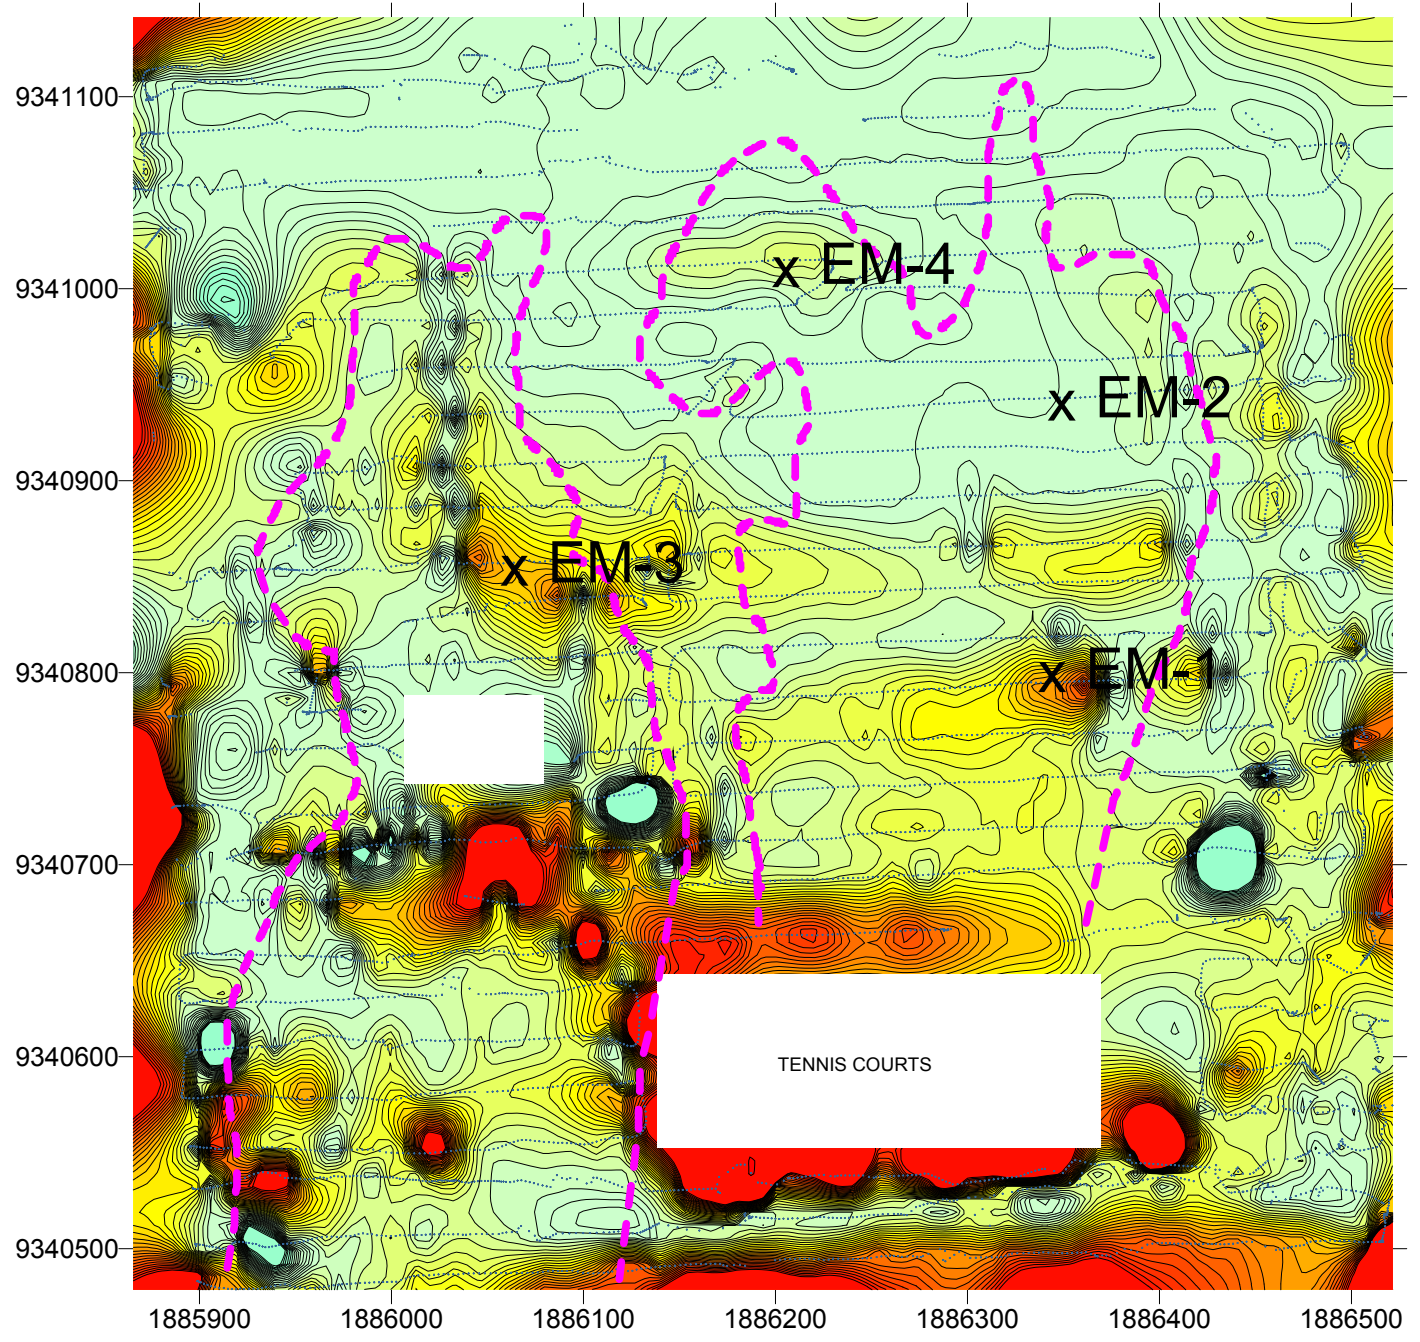
FIGURE 3	DOUGLAS PARK SITE MIAMI, FLORIDA	
	COLOR CONTOUR MAP OF EM-31 CONDUCTIVITY RESPONSE	URS CORPORATION MIAMI, FLORIDA	PROJECT: 24000 DATE: 01/03/14

To aid with future testing activities, six possible locations within the GPR anomalies and four possible locations within the EM anomalies were marked in the field. These locations are also shown on the figures as GPR1 through GPR6 and EM1 through EM4.

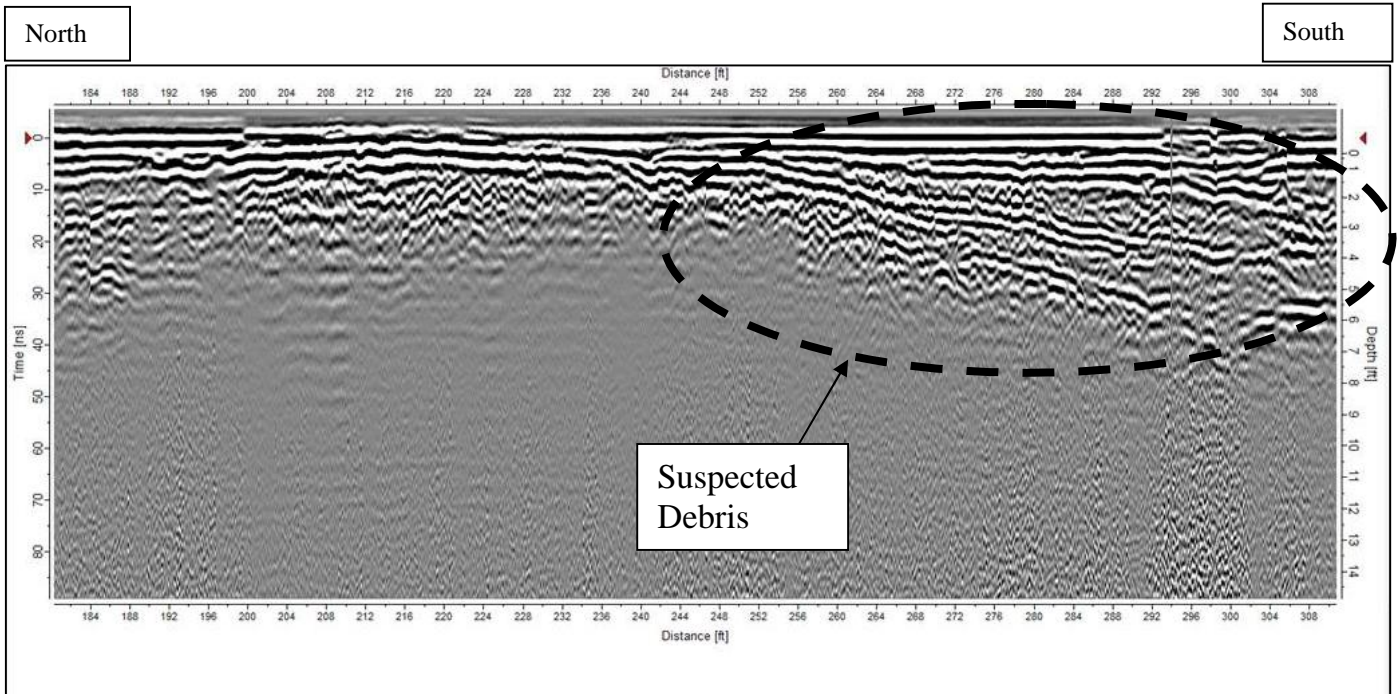
GPR Profile 27 Collected Showing a Suspected Area of Buried Debris

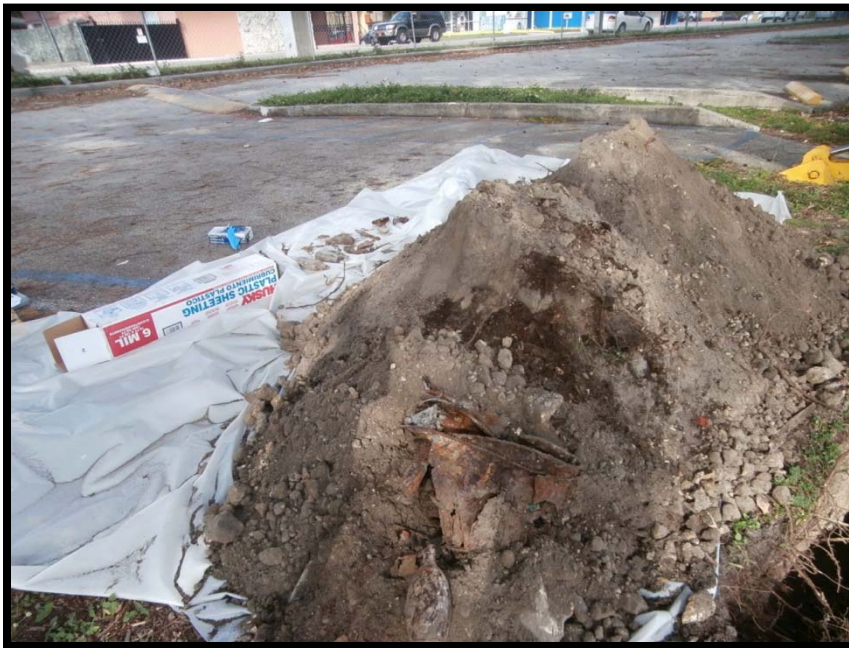
Test Pit 1. Metal debris.

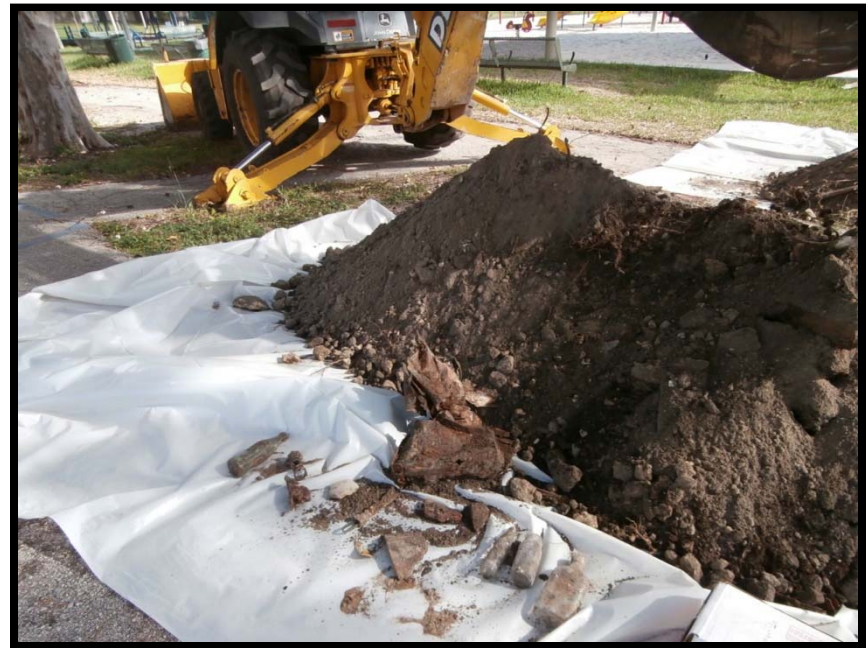
Test Pit 1. Mixed solid waste.

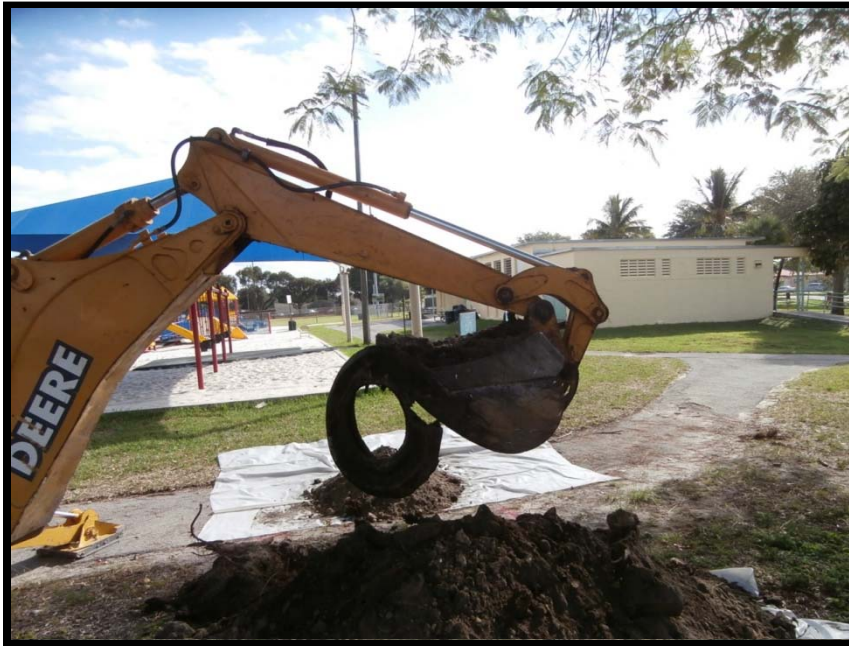
Test Pit 1. Shredded tire.

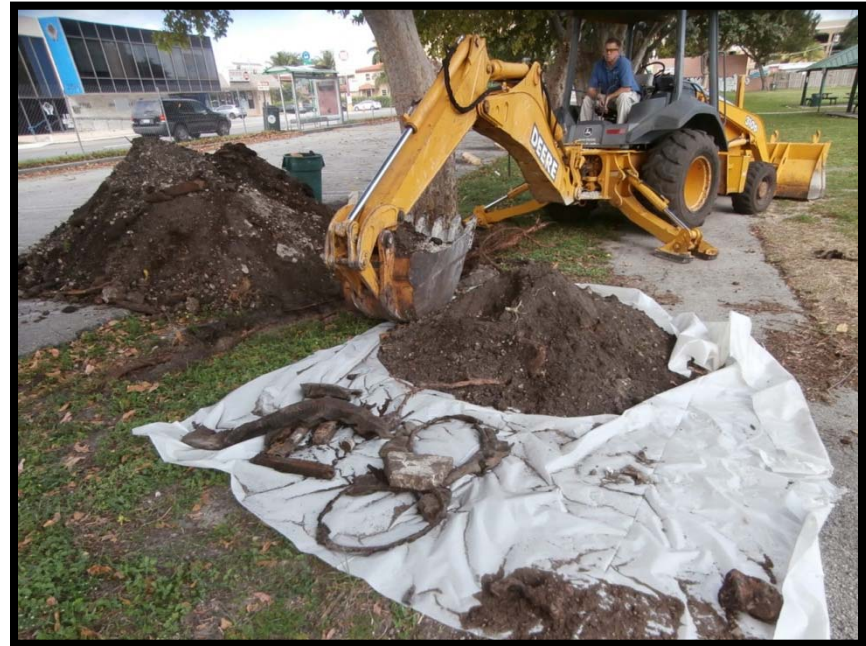
Test Pit 2. Tools and metal debris.

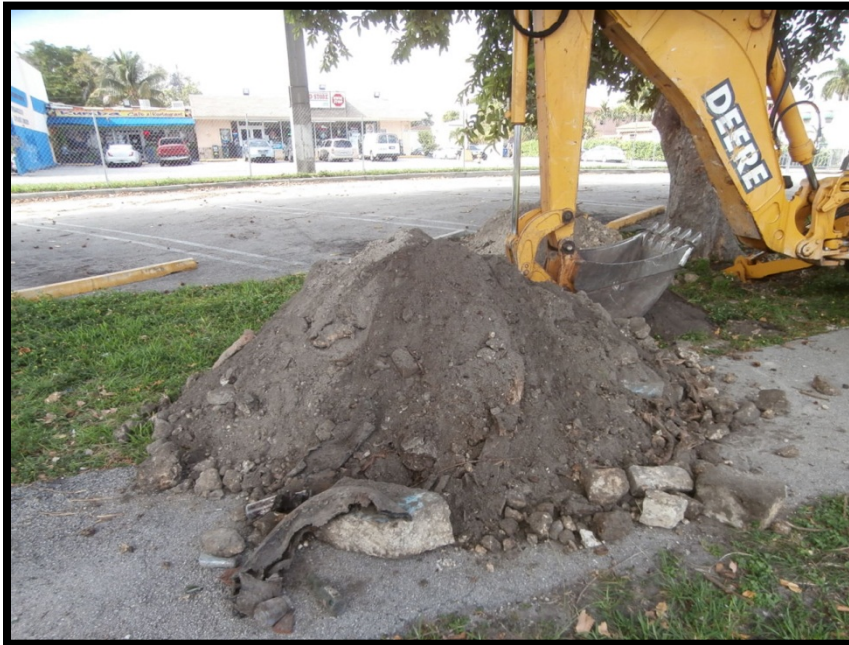
Test Pit 3. Bottles, rubber pieces and C+D debris.

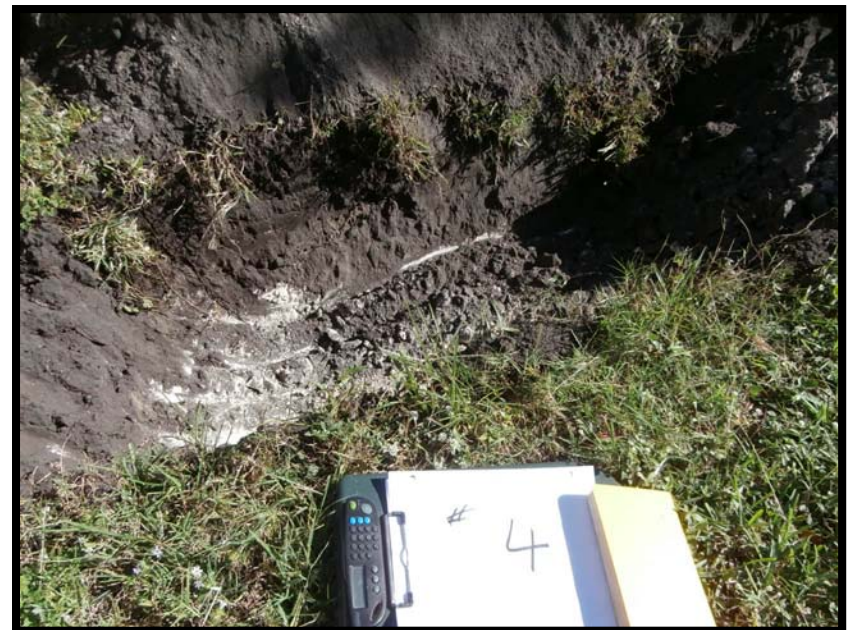
Test Pit 4. No debris.

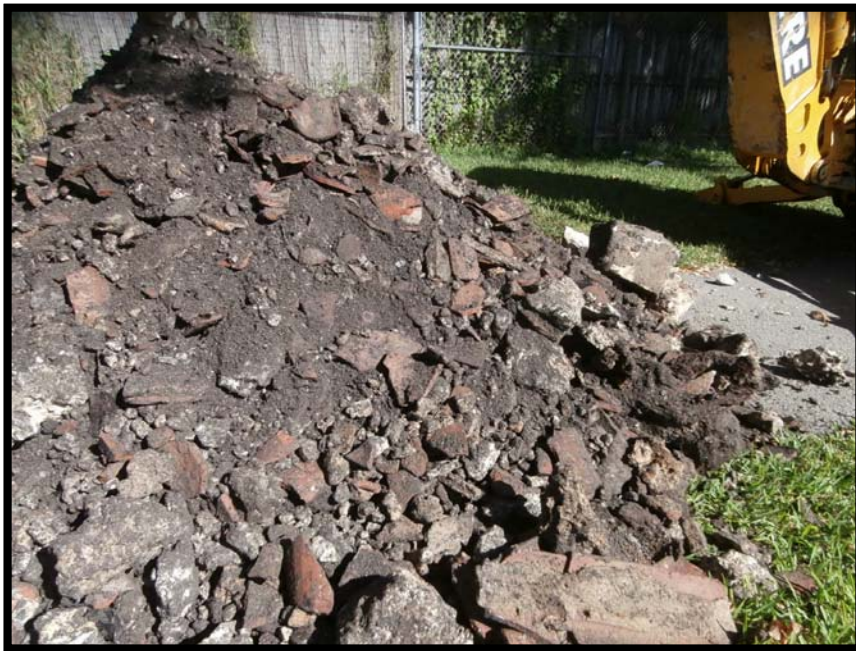
Test Pit 5. C+D debris.
