SOLID WASTE DELINEATION REPORT

Douglas Park
2795 SW 37th Avenue
Miami, Florida

Prepared for
City of Miami
Capital Improvement Programs

URS Corporation
January 2014

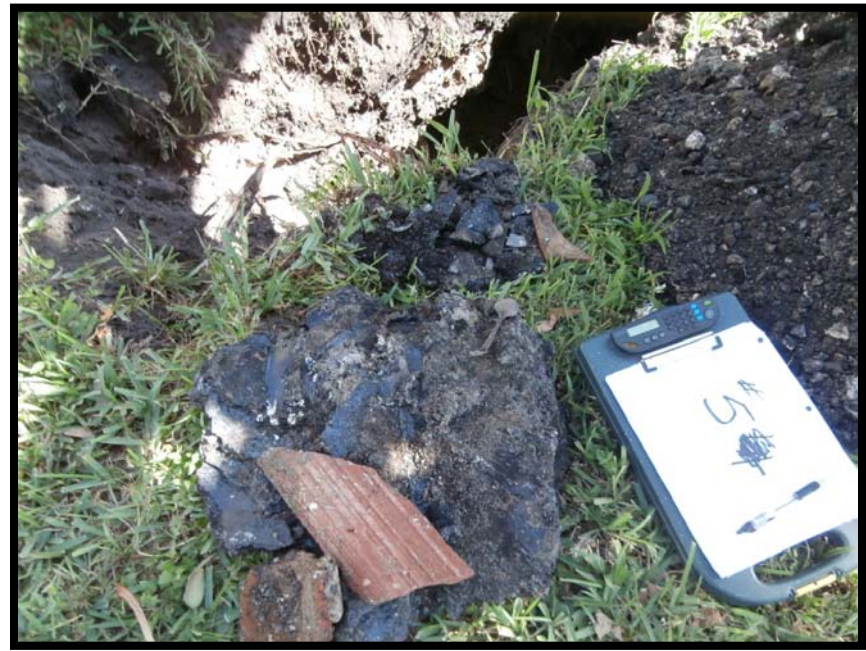
Test Pit 5. Burnt material, clay and dark residue.

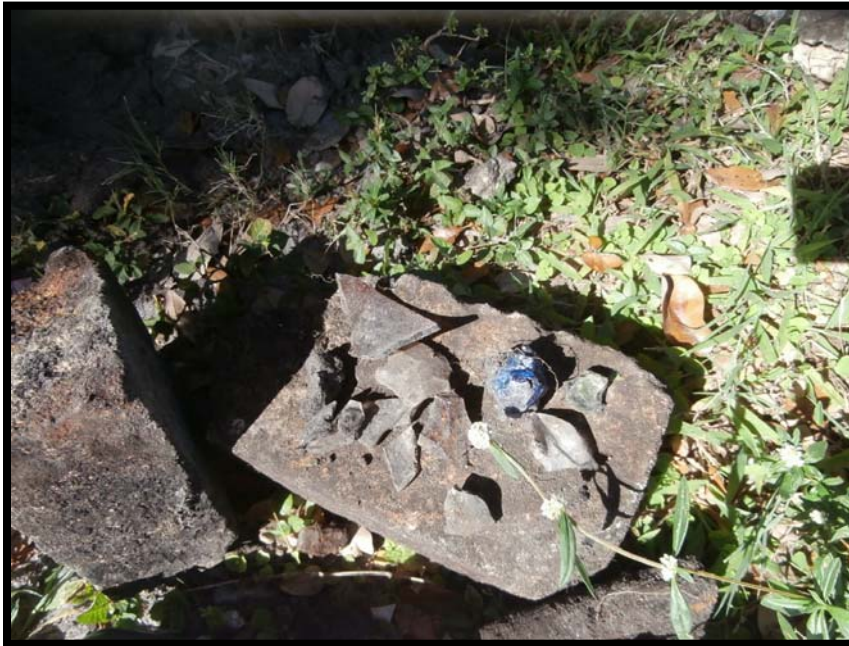
Test Pit 6. Molten and broken glass.

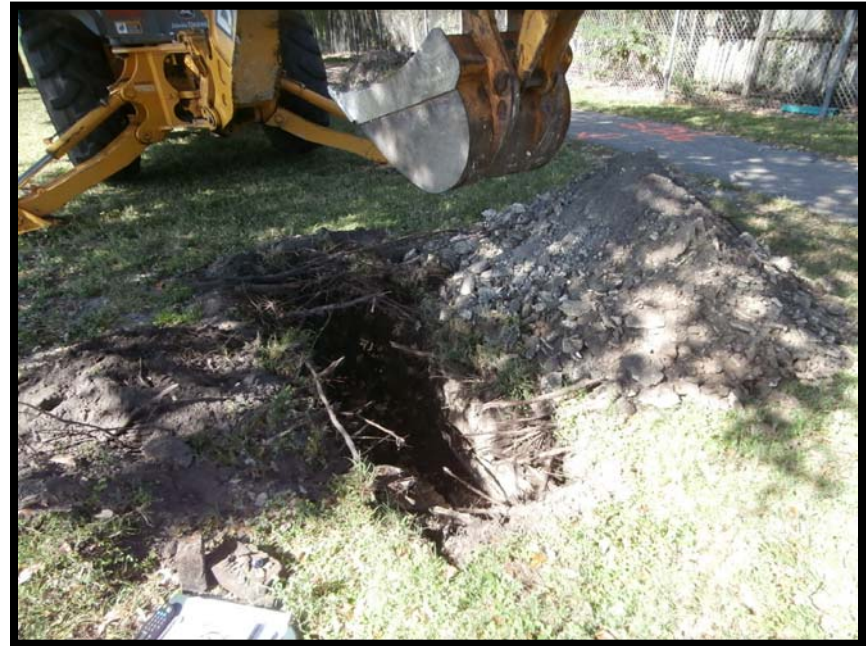
Test Pit 6. C+D debris.

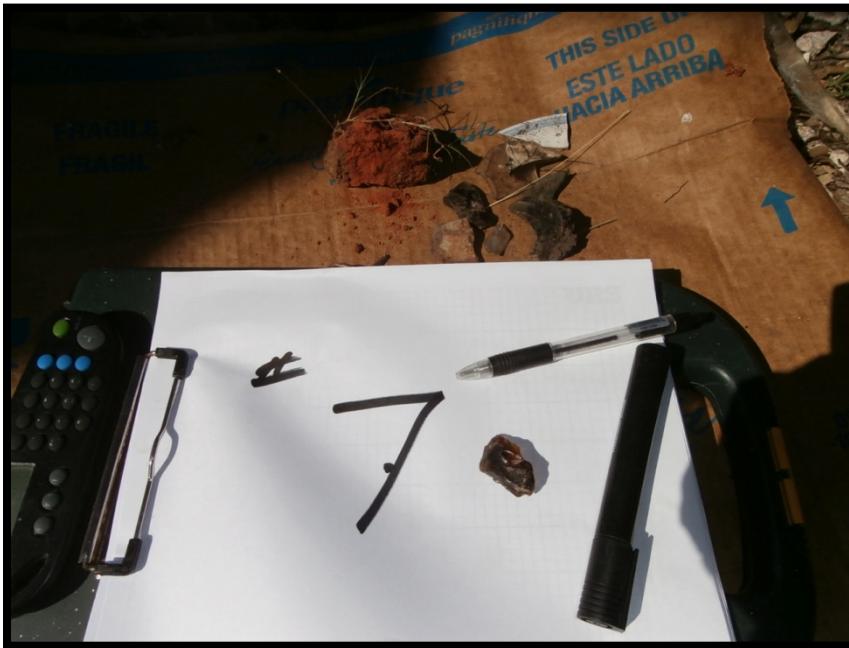
Test Pit 7. Molten glass piece.

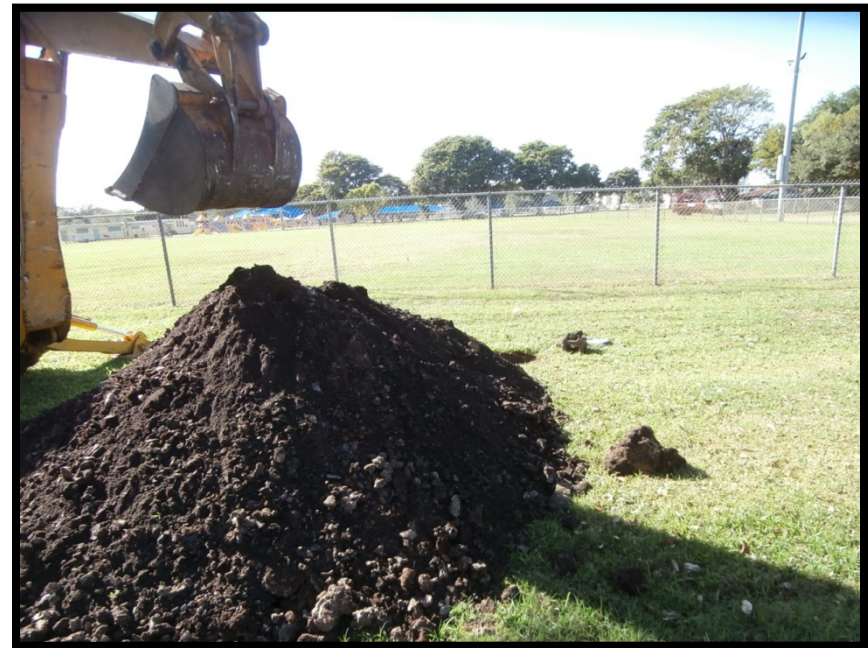
Test Pit 8. Dark colored soil mixed with limerock.

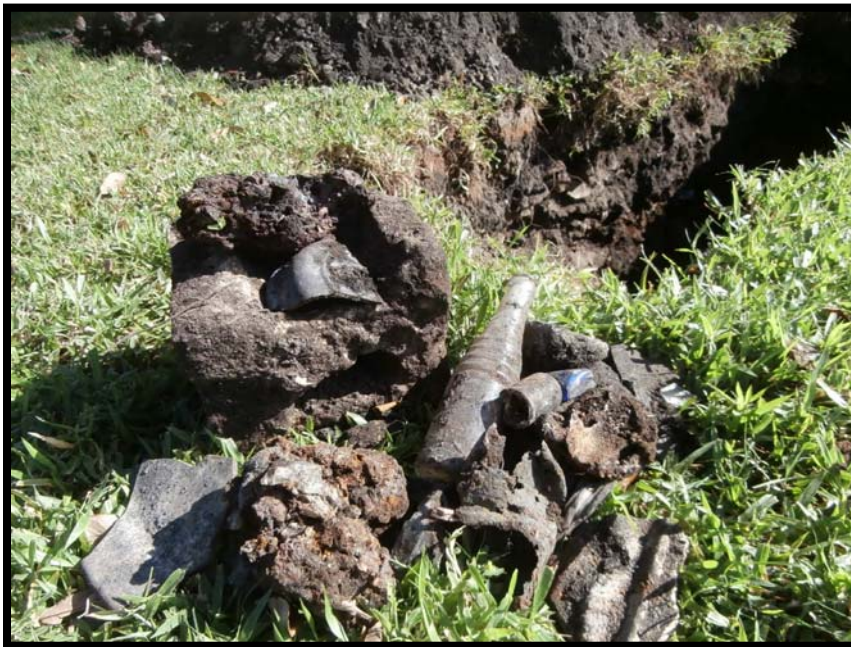
Test Pit 8. Mixed solid waste debris.

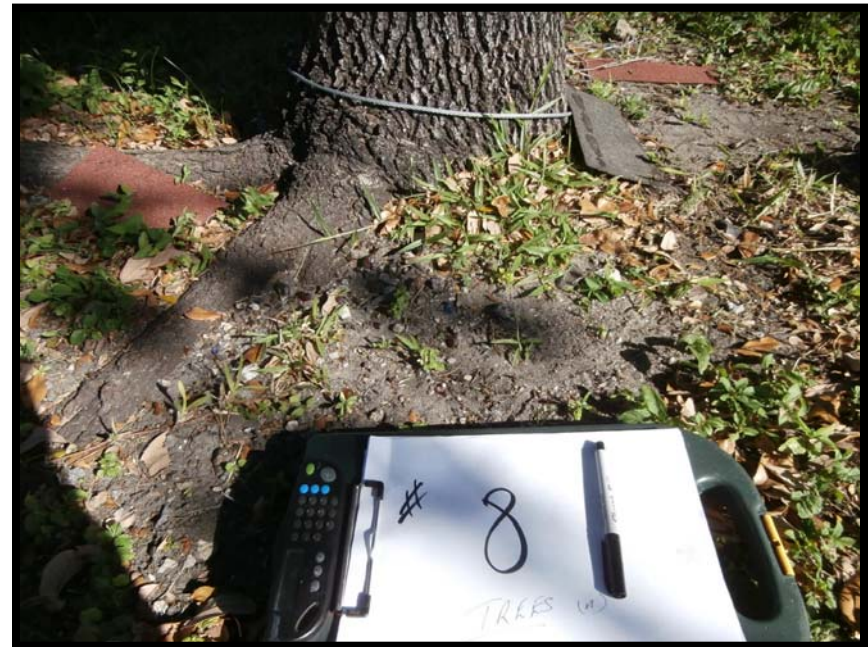
Angular glass pieces around tree near TP 8.

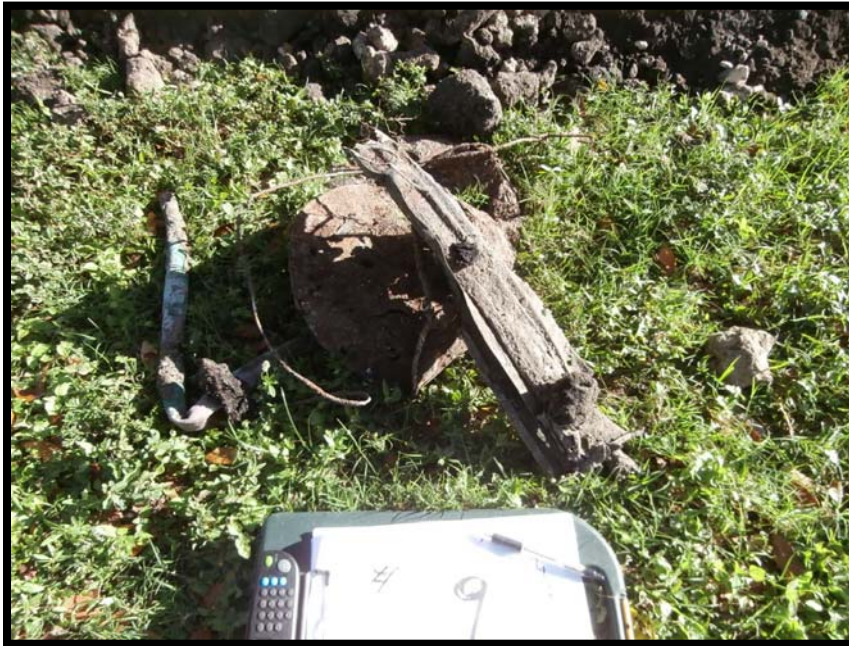
Test Pit 9. Metallic debris.

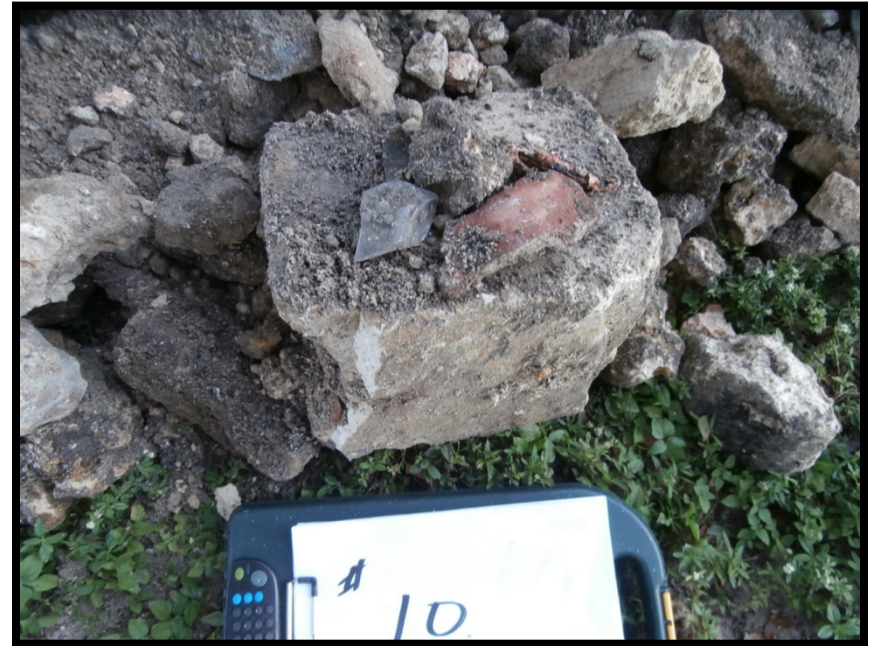
Test Pit 10. Broken glass and C+D debris.

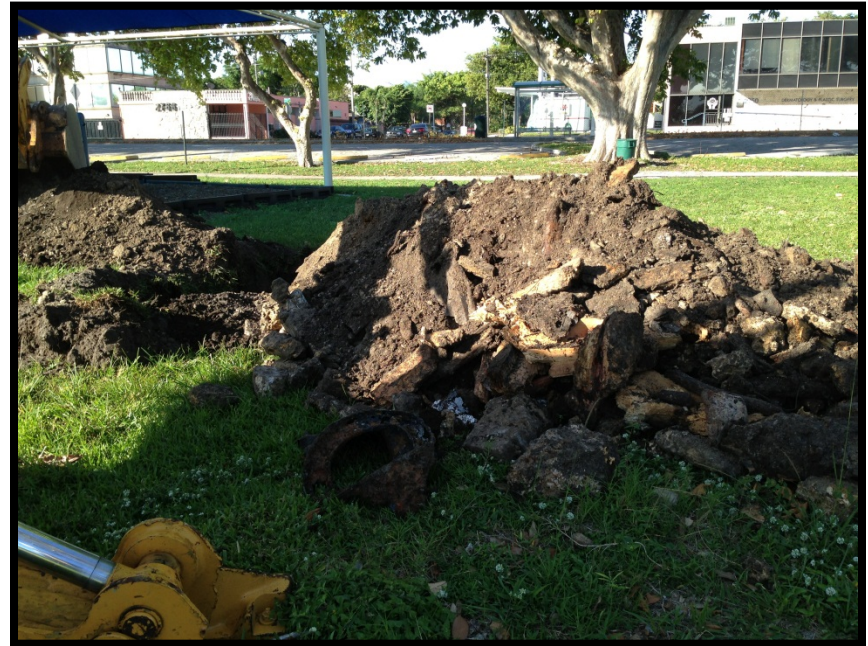
Test Pit 12. C+D debris.

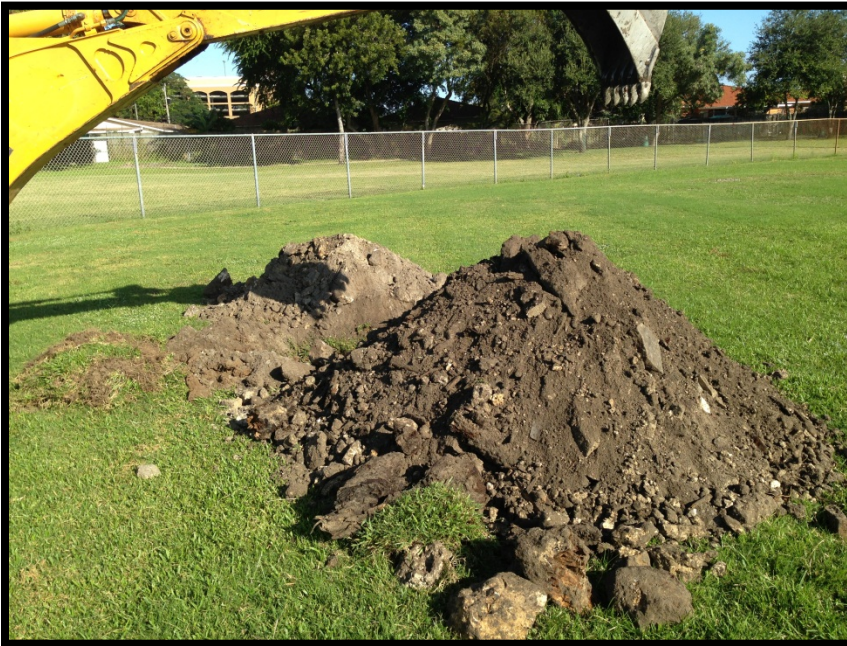
Test Pit 13. C+D debris

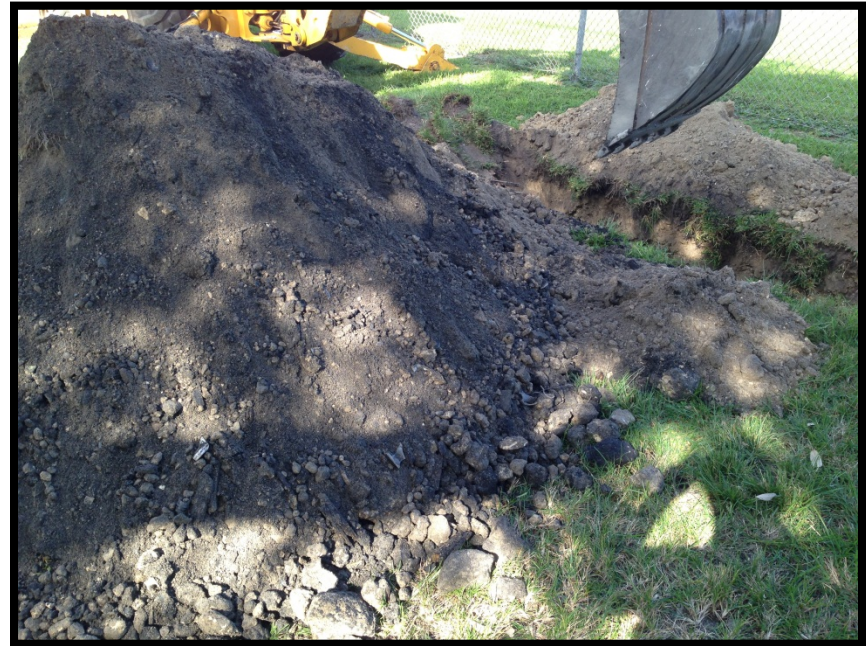
Test Pit 15. C+D debris with black residue

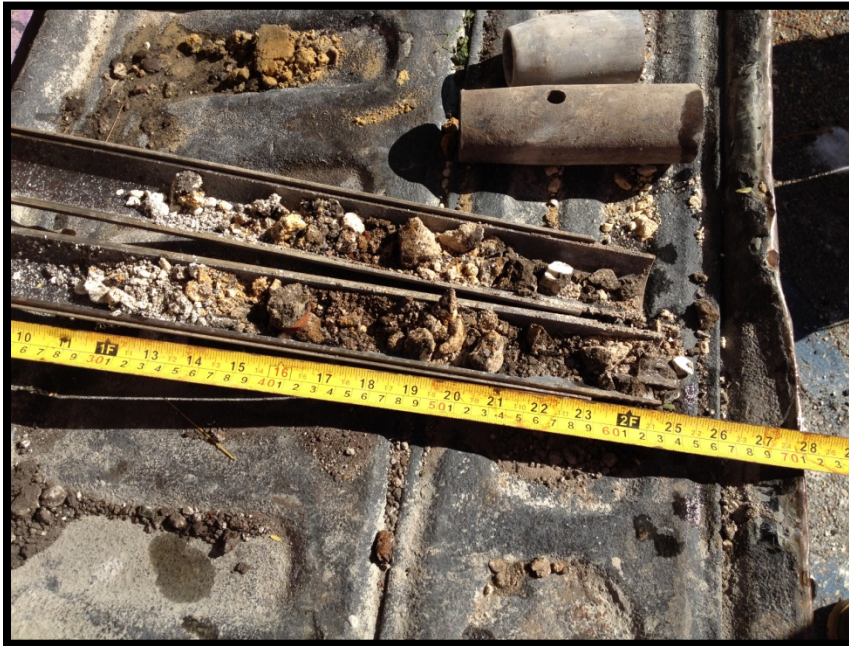
SB 2. Metal fragments.

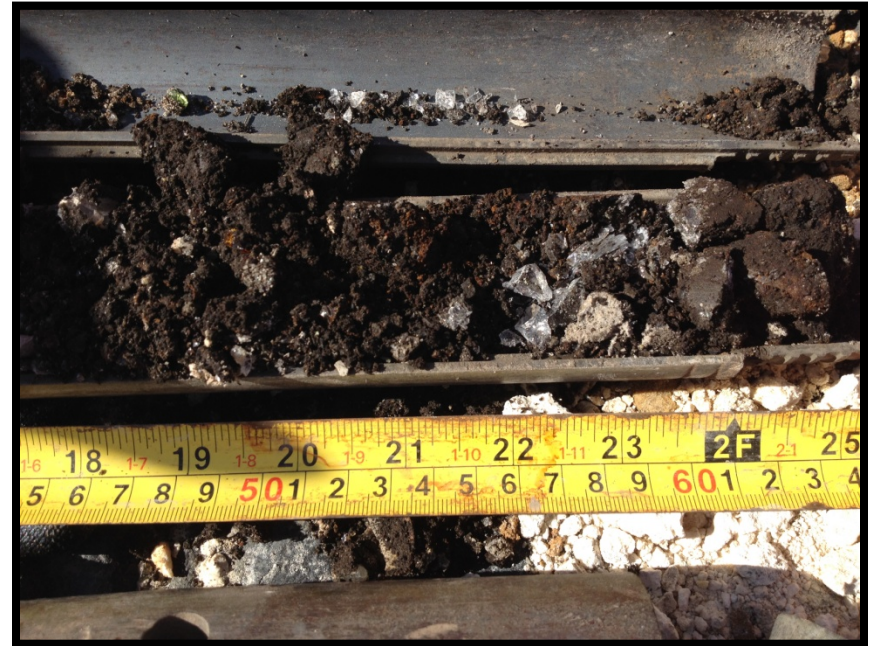
SB 13. Metal and glass fragments.

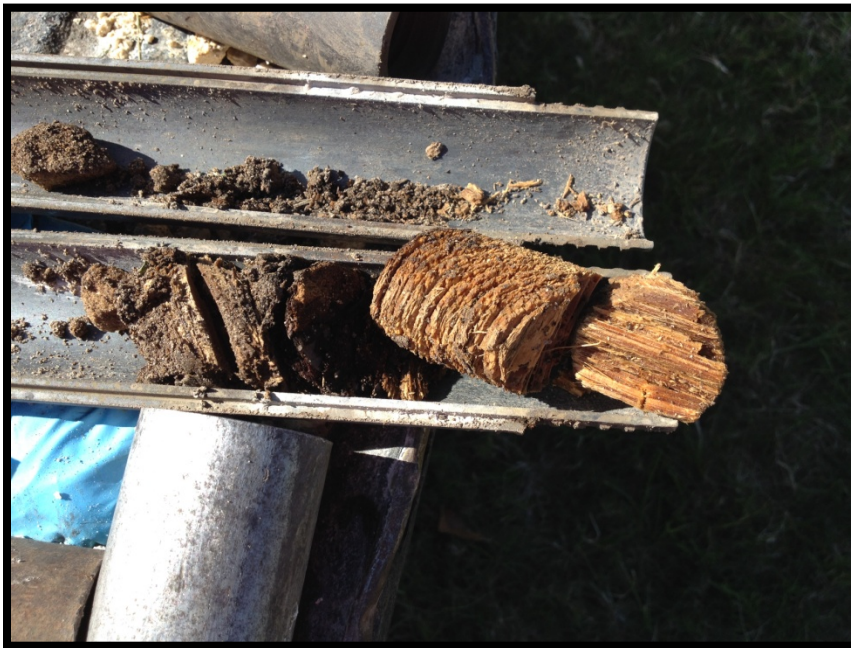
SB 13. Processed wood pieces.

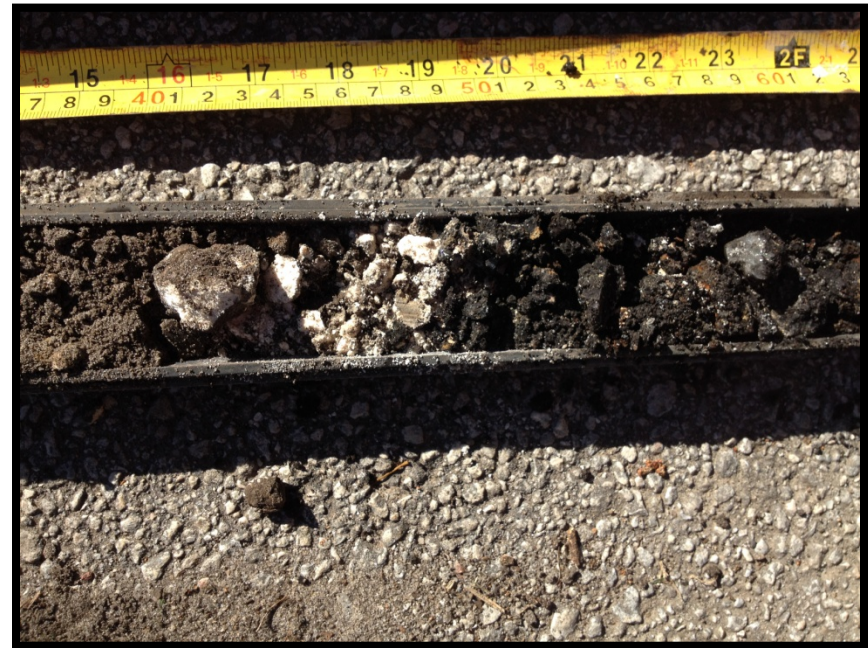
SB 7. Angular glass pieces with black residue.

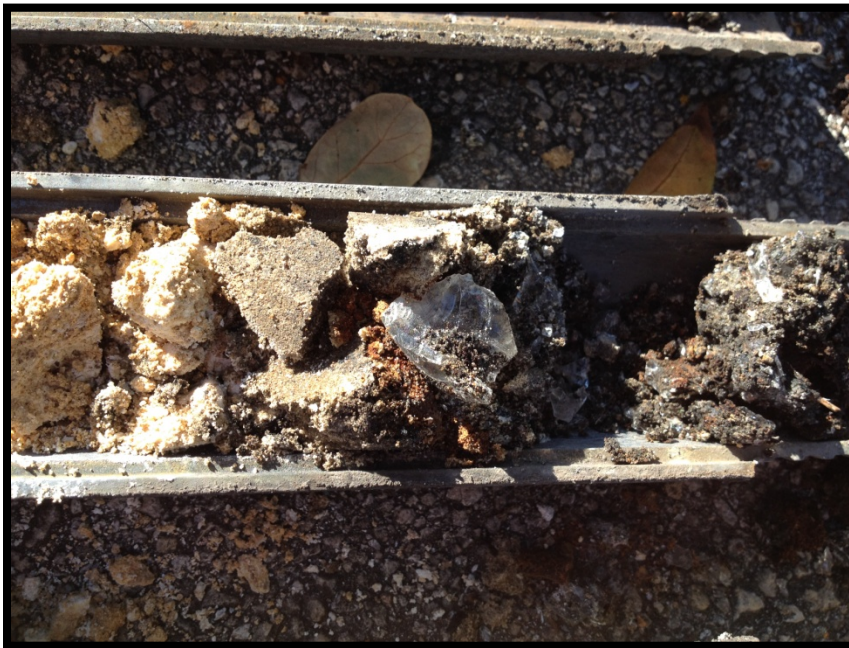
SB 8a. Glass pieces mixed with black residue.

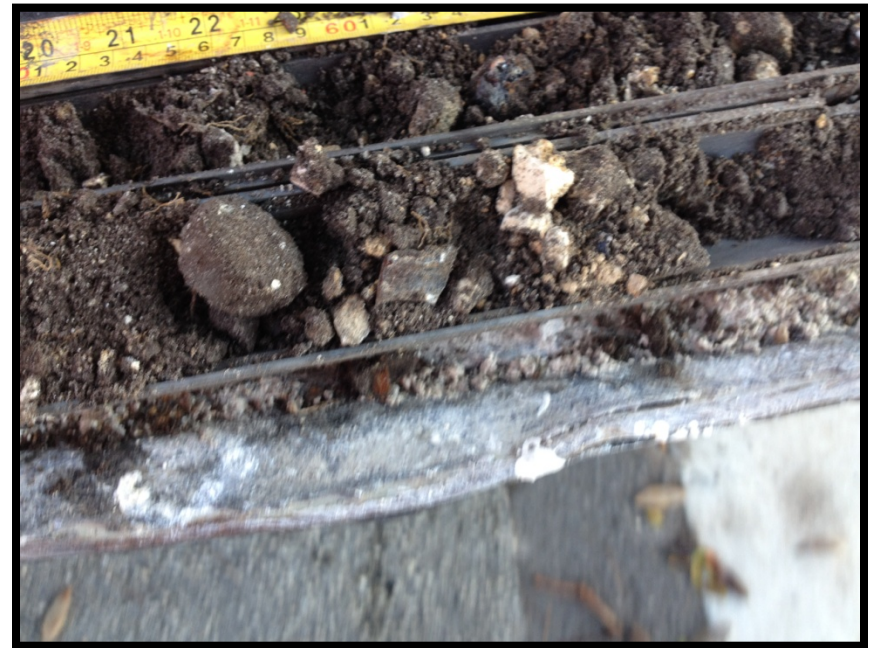
SB 9. Angular glass fragments.

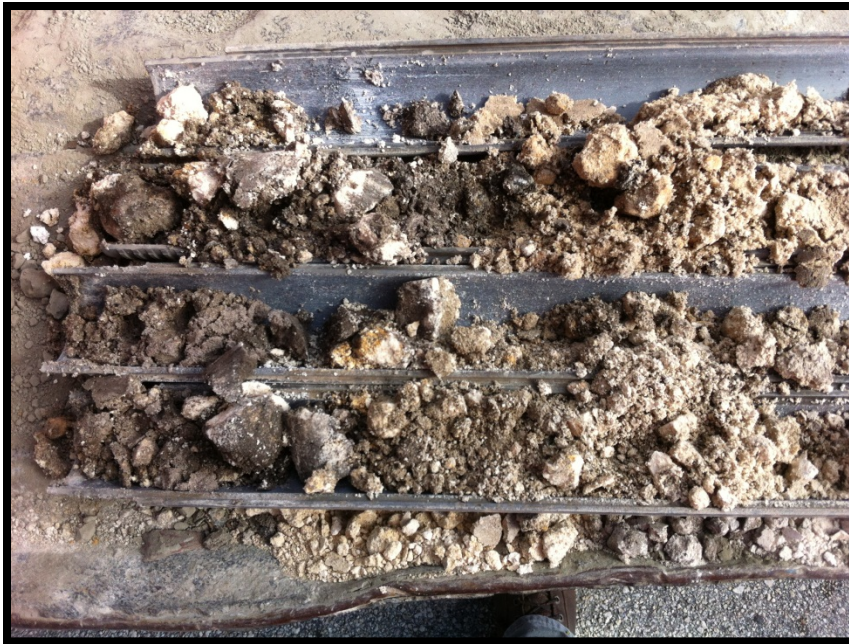
SB 10. Limerock mixed with glass fragments.

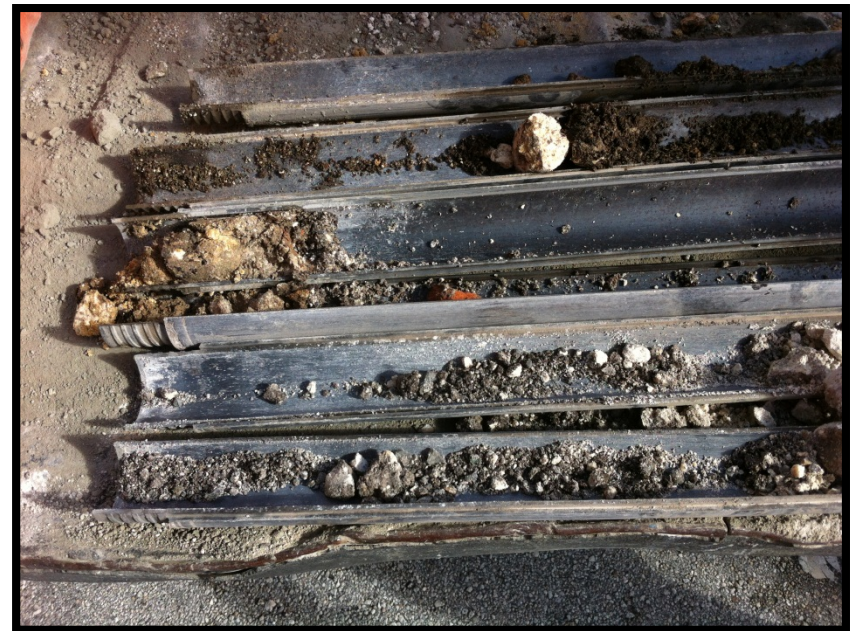
SB 11. Limerock (gray) mixed with glass fragments.

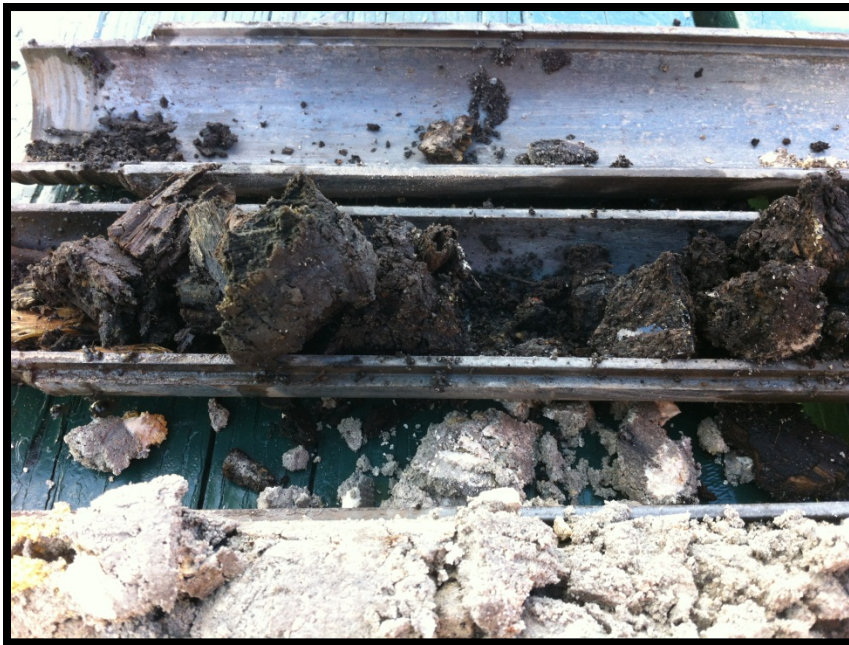
SB 16. Rusted metal pieces mixed with soil (top split spoon).

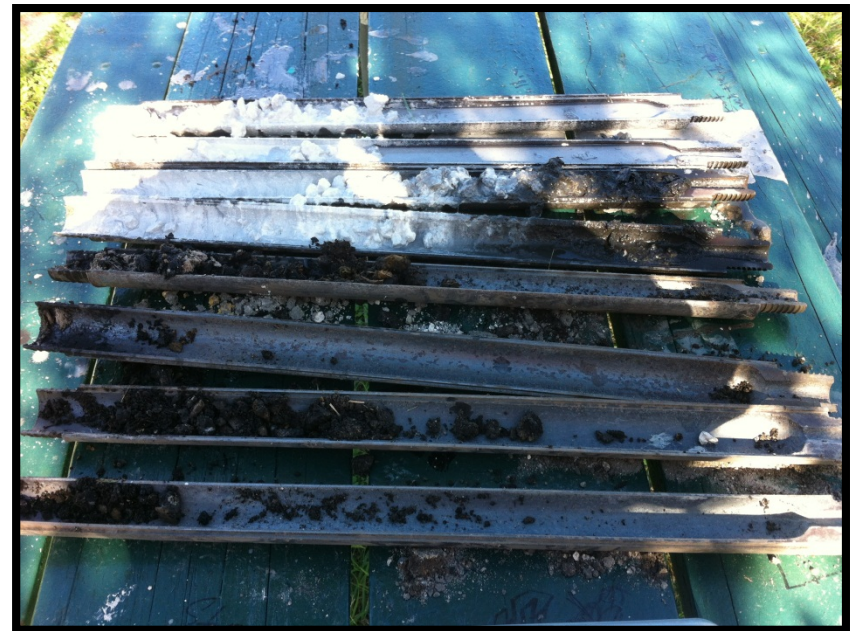
SB 16. Native limestone (stained gray) in contact with possible incinerator residue.
