PRE-DEMOLITION ASBESTOS SURVEY

**Curtis Park Ballpark and Pool
1901 NW 24 Avenue
Miami, FL 33125**

URS Project # 12640409

April 15, 2015

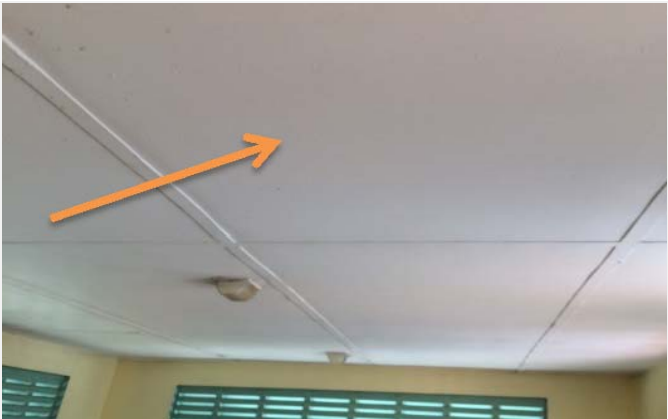
HSA	2: 4’x8’ Cementitious Ceiling Panels
Asbestos Content:	35% Chrysotile Asbestos
Quantity	Approximately 2,080 SF
HSA Location(s)	Pool House Building
NESHAPS Category	NF-2
Physical Assessment	Good
Photo

1. If the building is scheduled for demolition, any Category II Non-friable (NF-II) ACM identified in this report must be removed by a Florida licensed asbestos abatement contractor prior to demolition.
2. If abatement will be performed, URS recommends that an asbestos abatement work plan be developed to describe the appropriate engineering and administrative controls to be used for the safe and proper completion of the work. Additionally, project oversight and air monitoring should be performed by a Florida licensed asbestos consultant during asbestos abatement activities.

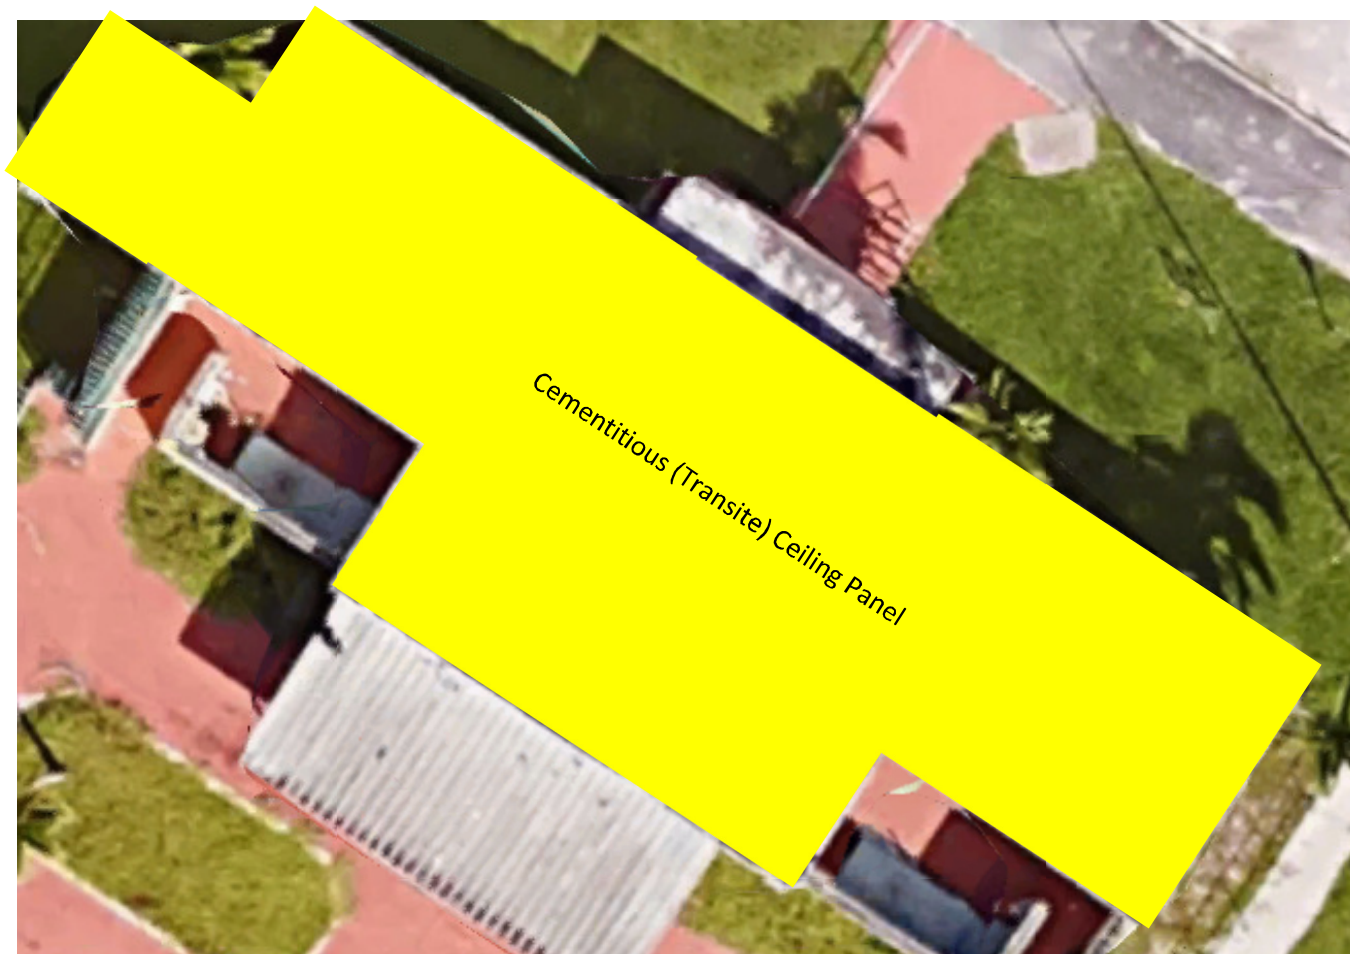
**Figure 1
 POOL HOUSE
 BUILDING**

**HSA 2 - ACM 4'x8'
 CEMENTITIOUS
 CEILING PANEL IN
 POOL HOUSE
 BUILDING**

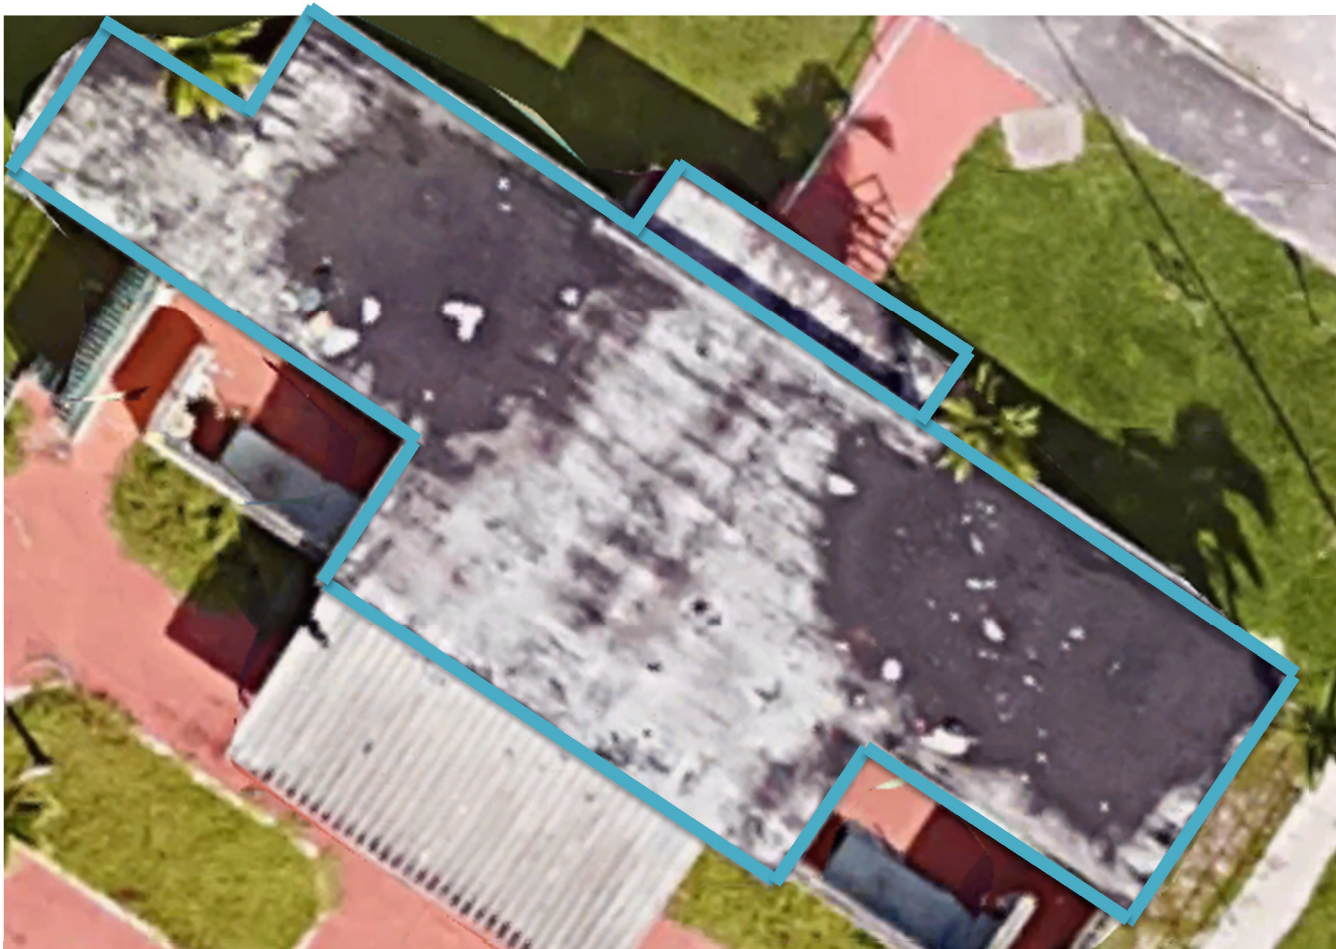
Figure 2

HSA 4 - ACM
ROOF FLASHING
