# **REPORT OF ASBESTOS SURVEY & PAINT CONTAINING LEAD SCREENING**

## **CURTIS PARK POOL FACILITY – DESIGNATED AREAS**

**City of Miami  
1901 N.W. 24<sup>th</sup> Avenue  
Miami, Florida 33125**

MACTEC Project Number 6785-10-2054

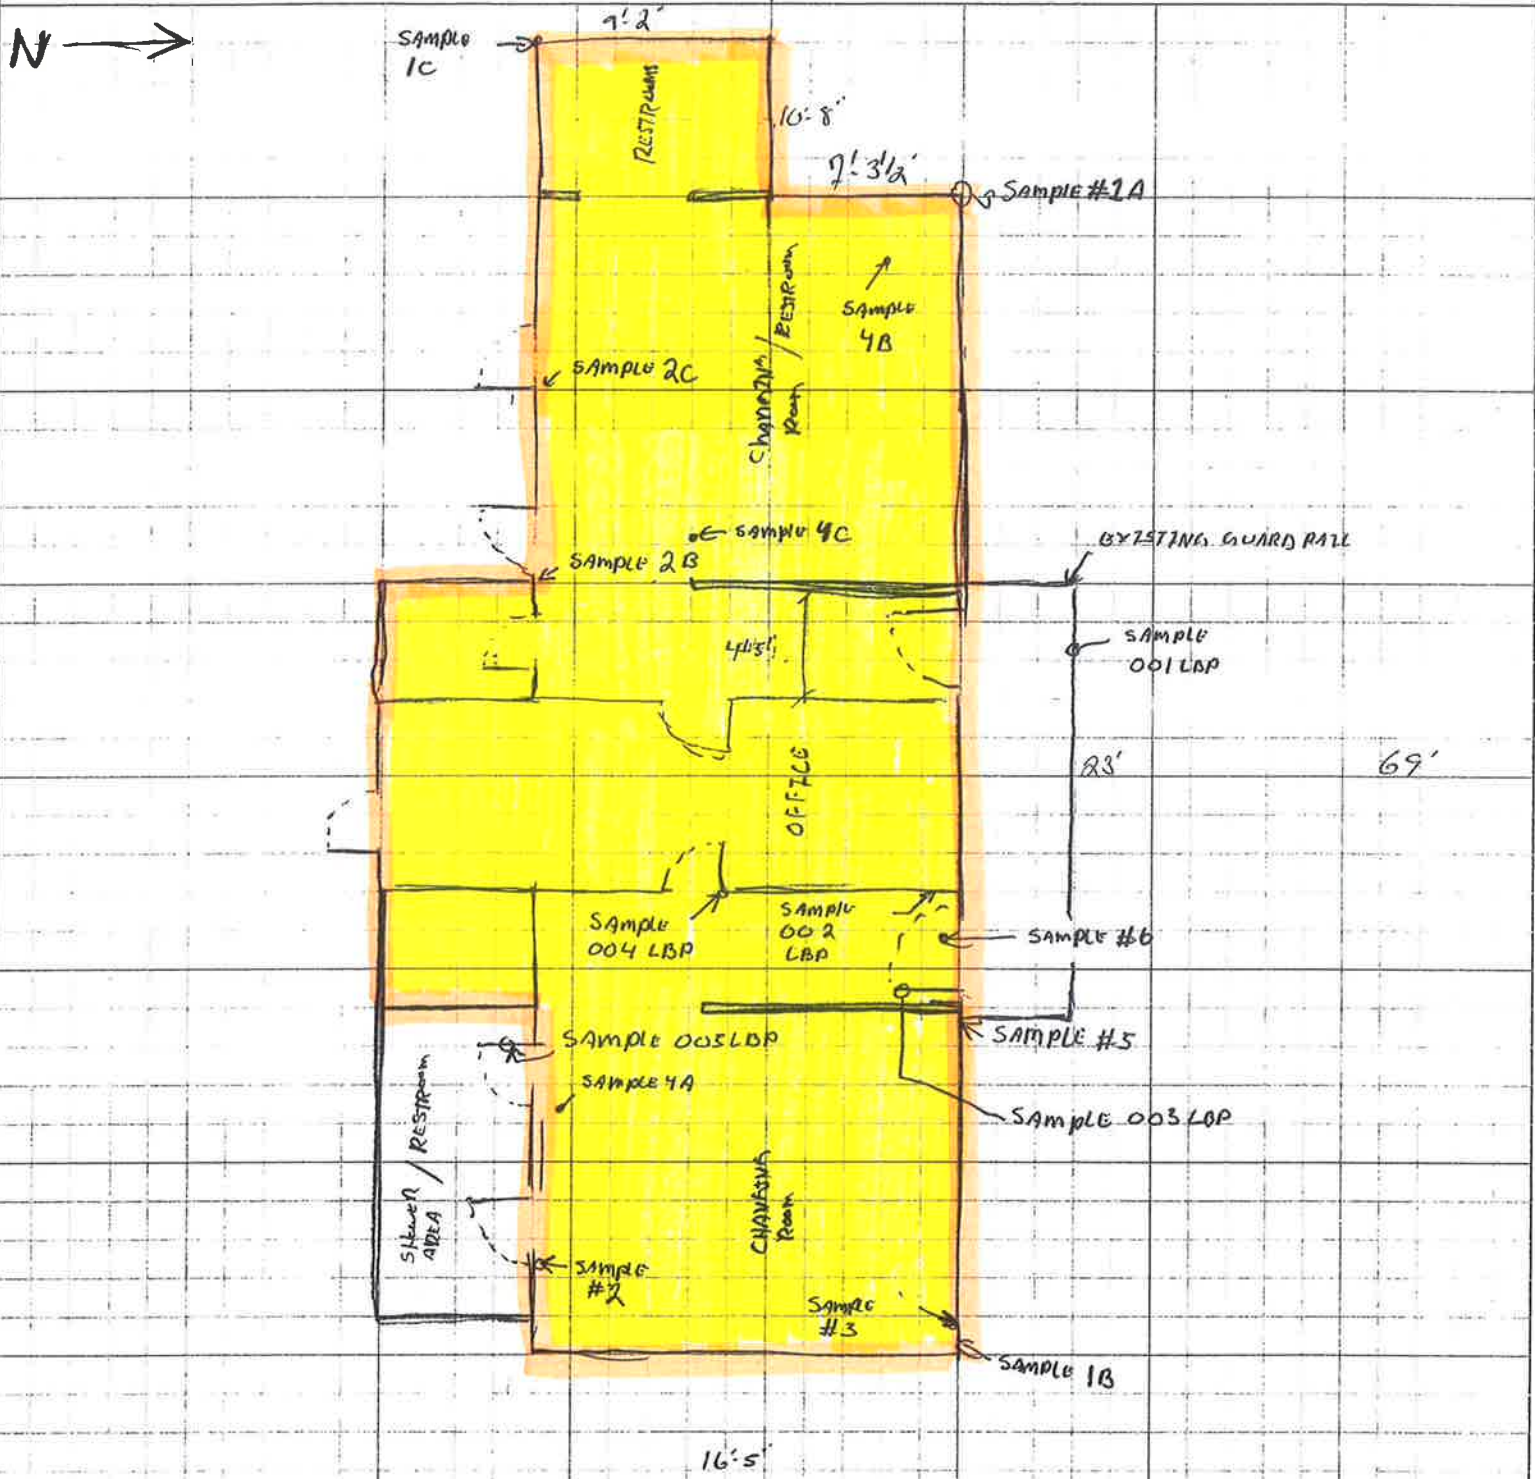
### **SITE PLAN**

- **White interior ceiling material** was found throughout most of the facility. The material was documented to be Friable (RACM) and in fair condition. The quantity of the material is estimated to be approximately 1,105 square feet.

- **Mastic (Black)** was found underneath the roof flashing material throughout the perimeter of the roof. The material was documented to be Non-Friable, Category I and in fair condition. The quantity of the material is estimated to be approximately 200 square feet.

- DENOTES ROOF FLASHING PERIMETER
- WHITE INTERIOR CEILING MATERIAL

We recommend that the ACM be removed prior to any disturbance work that would dislodge or similarly break up the material. If subjected to activities that would cause the materials to become RACM, they should be removed as such. Removal as RACM would also apply if the materials, or the substrates to which they are adhered, were planned to be commingled with normal construction debris and subject to recycling activities which would also break up the materials. Additionally, while these materials remain within the facility, we recommend that they be maintained in an Asbestos Operations and Maintenance (O&M) Program.
