CITY OF MIAMI
CAPITAL IMPROVEMENTS PROGRAM

PROJECT PHOTOS PRIOR TO SHORING & DEMO
DORSEY MEMORIAL LIBRARY RESTORATION

100 NW 17 STREET
MIAMI, FL 33136

G2.0

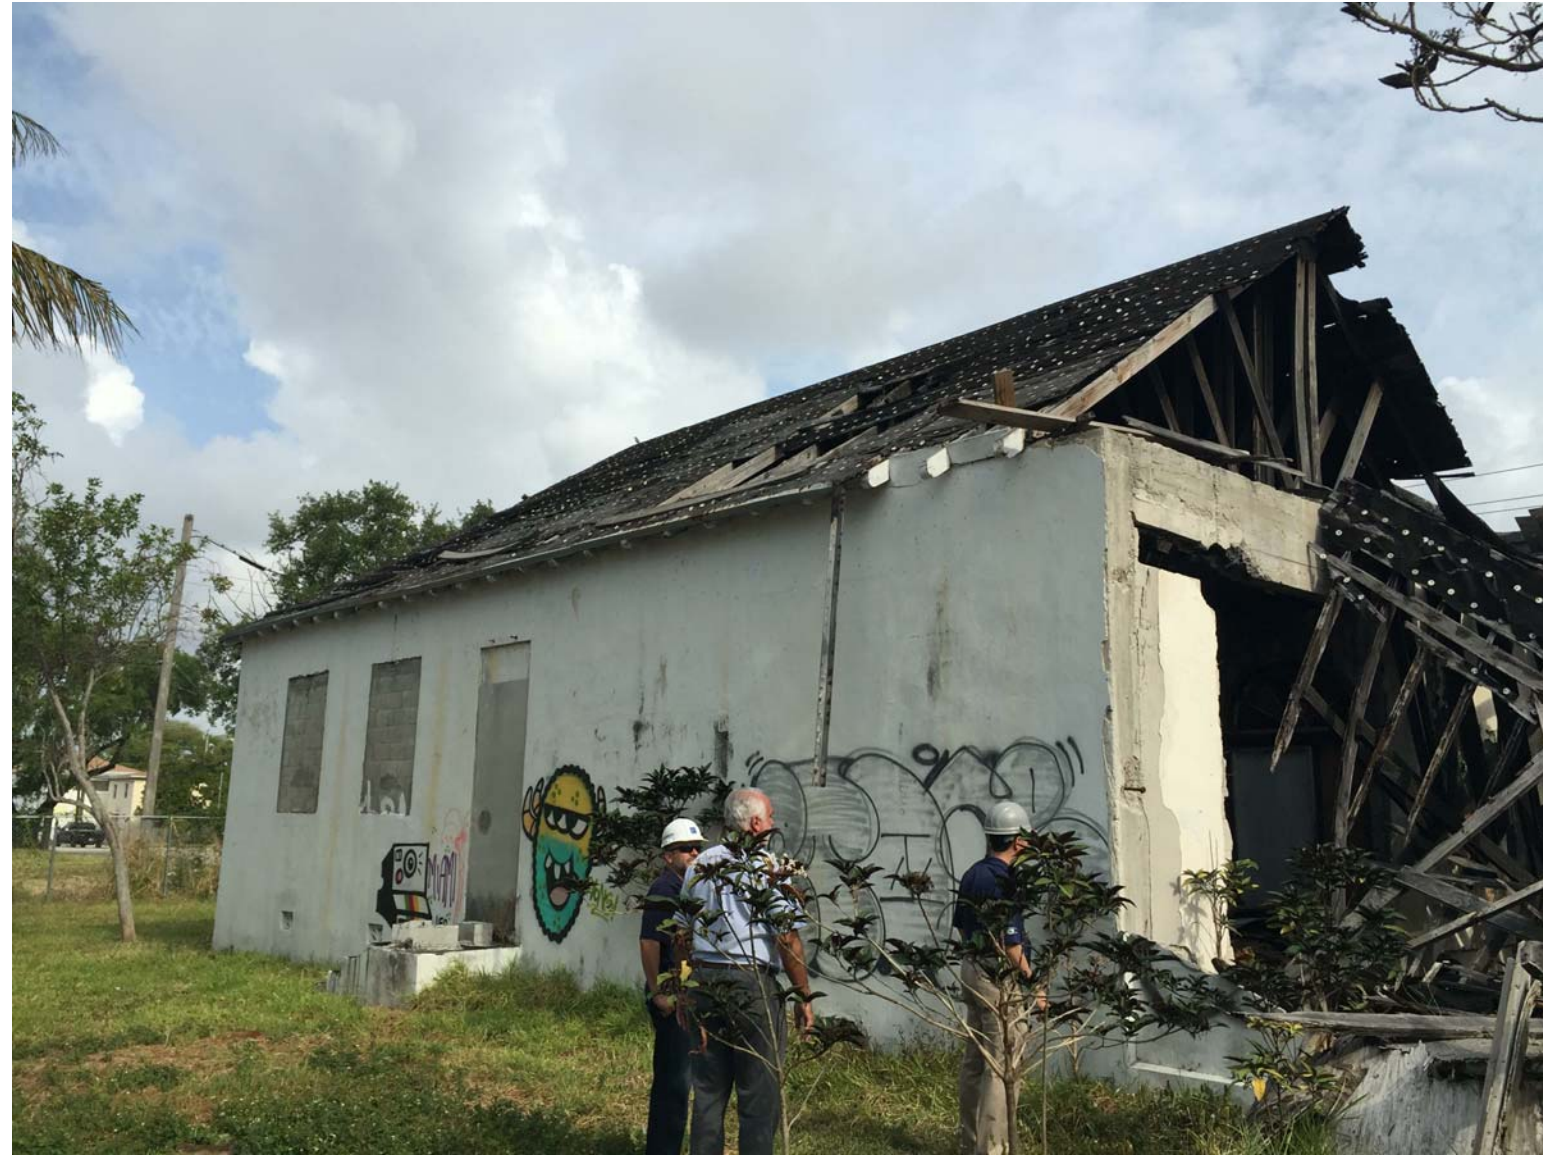
EXISTING CONDITION OF COLLAPSED OF ROOF

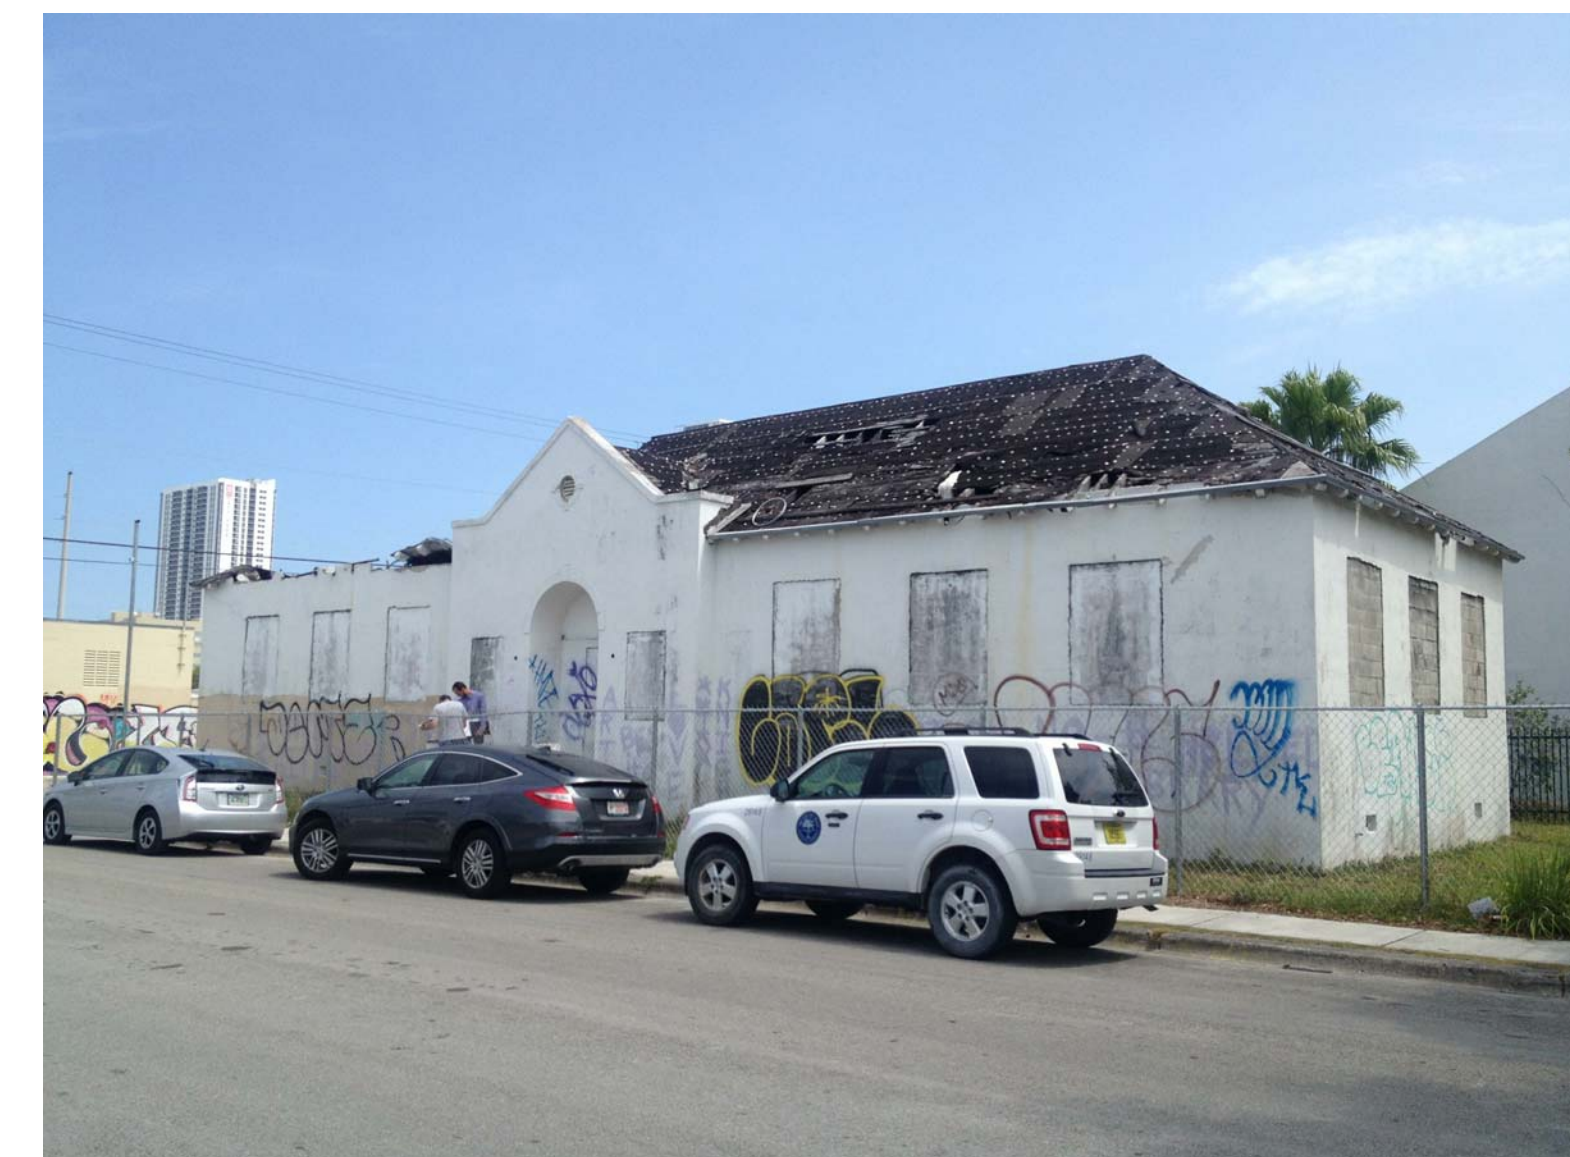
EXISTING CONDITION OF NORTH WEST CORNER (PRIOR TO ROOF REMOVAL)

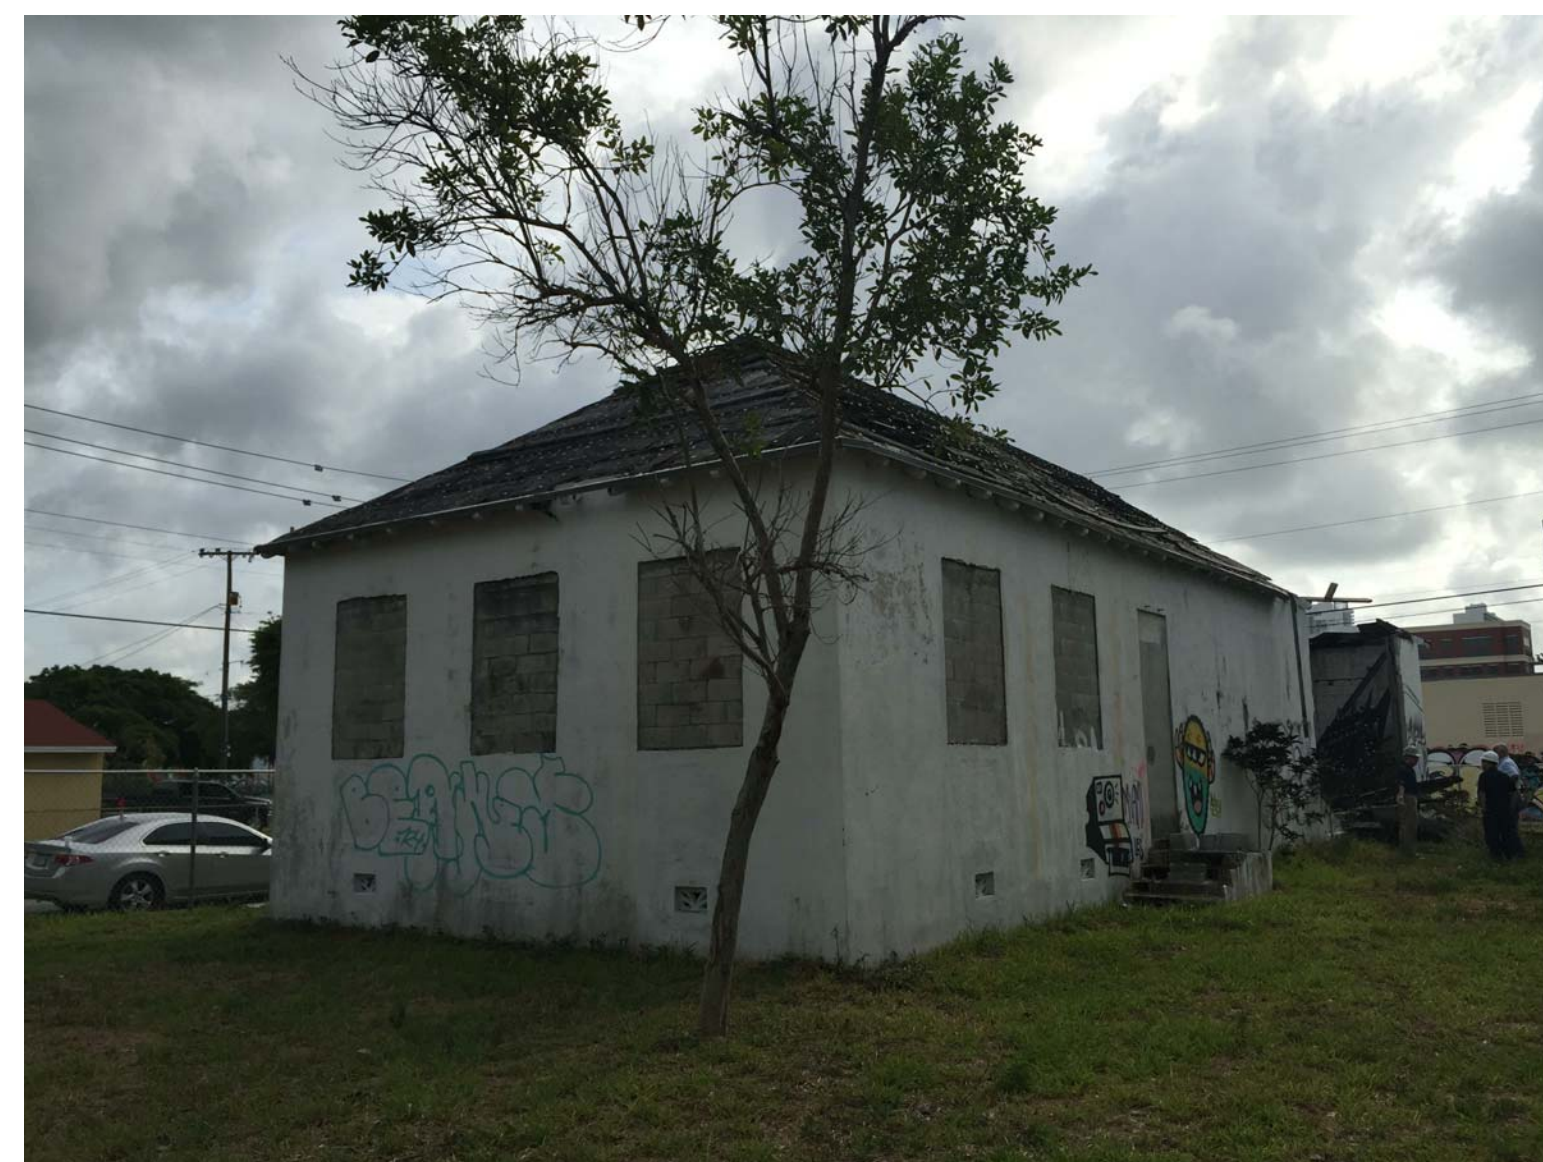
EXISTING CONDITION OF SOUTH WEST CORNER

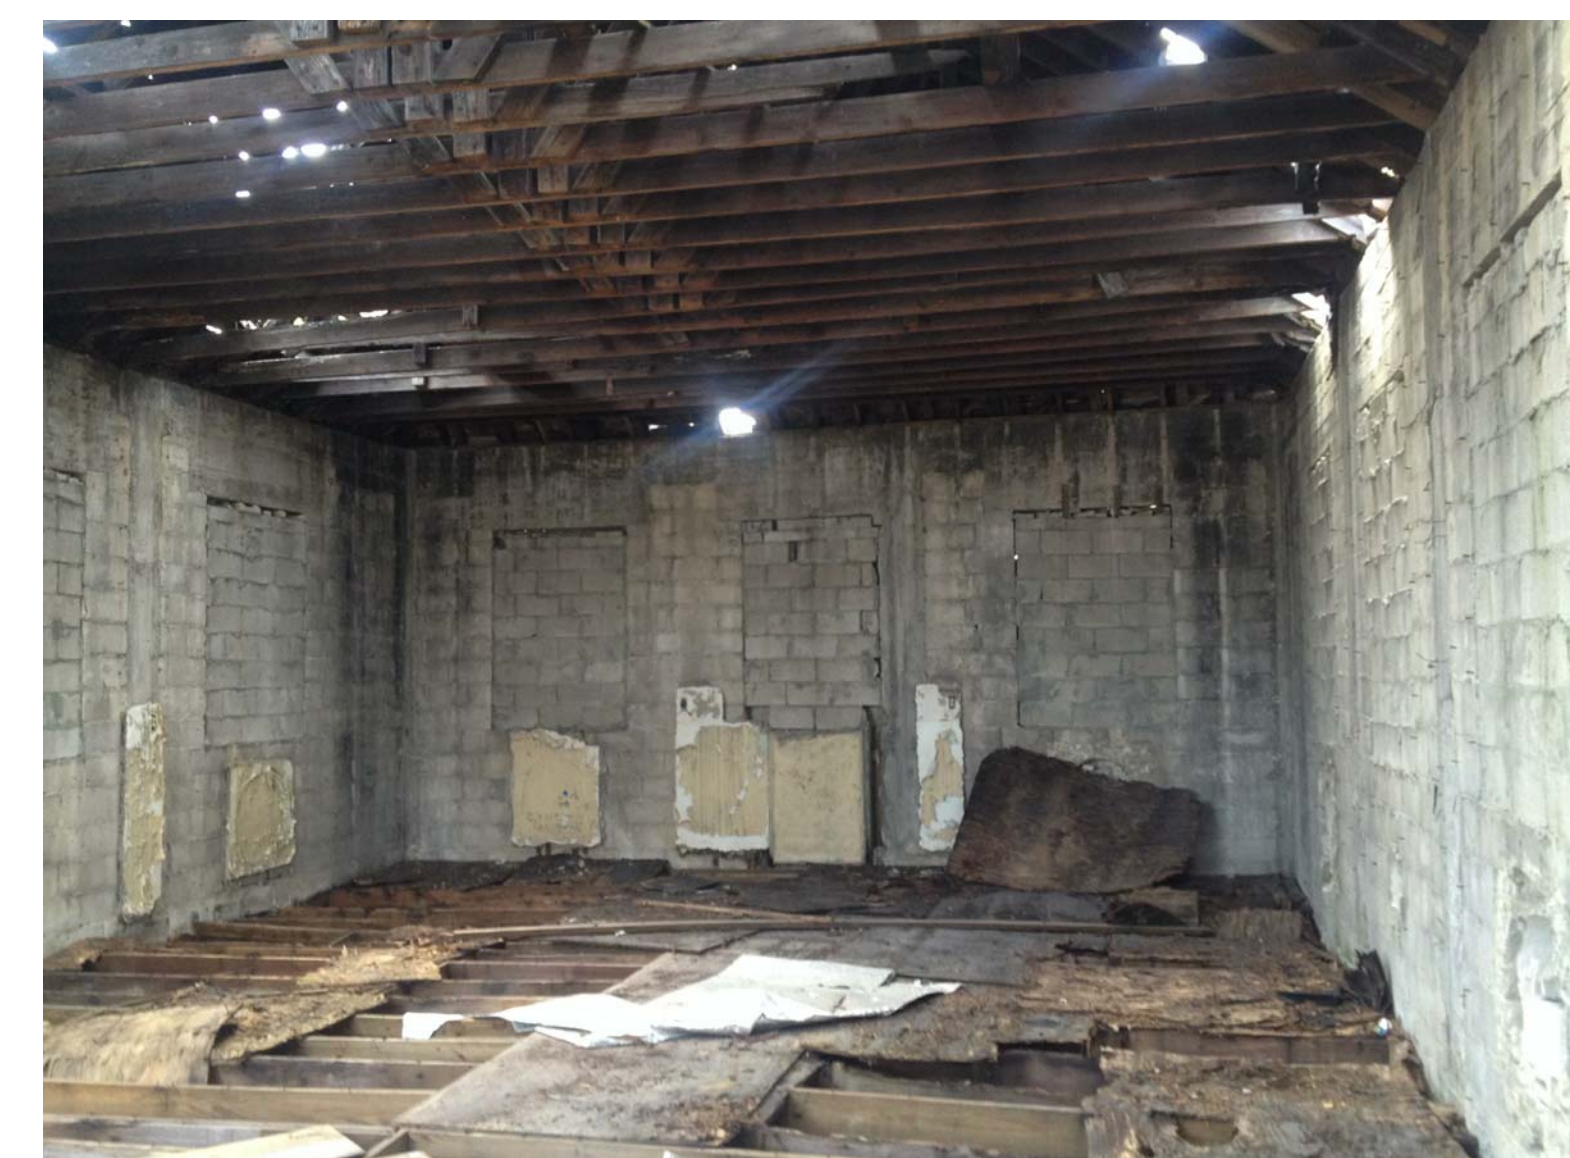
EXISTING INTERIOR CONDITION. WOOD FRAMING TO BE SALVAGED, REMILLED AND REPURPOSED IN RESTORATION

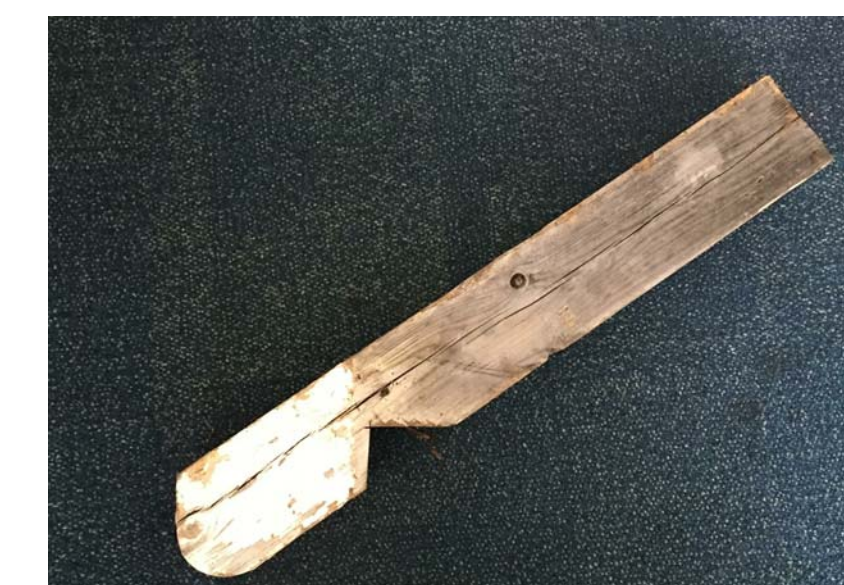
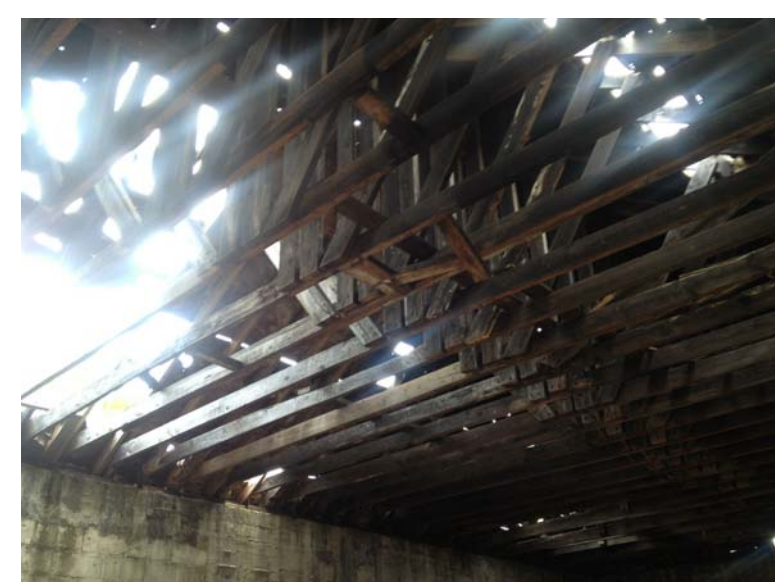
EXISTING WOOD TRUSSES TO BE SALVAGED. REMILLED AND REPURPOSED IN RESTORATION

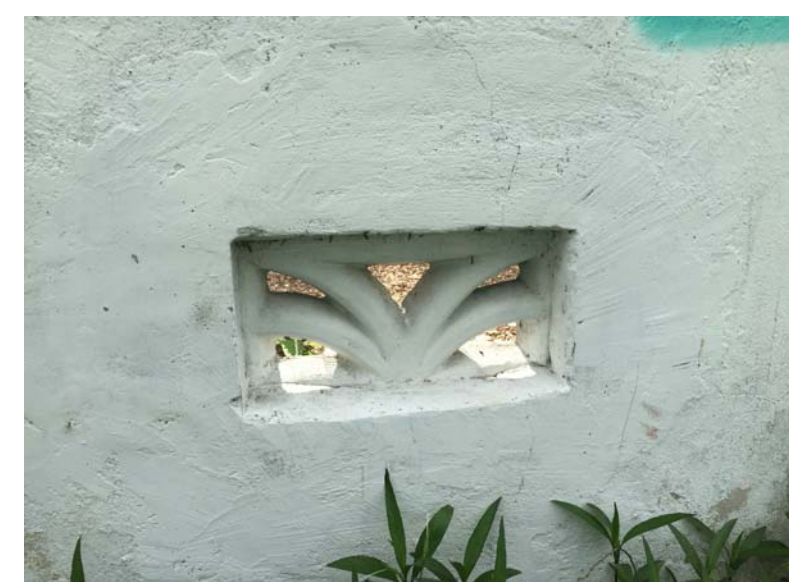
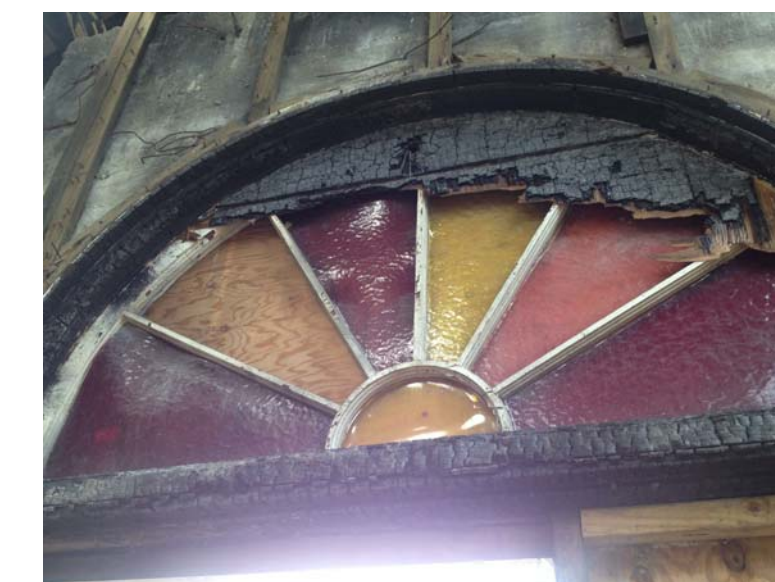
EXISTING CONDITION OF TRANSOM OVER MAIN ENTRY. TRANSOM TO BE REFURBISHED/RESTORED TO HISTORIC CONDITION AND REINSTALLED.
