ADDENDUM No. 2

BAYSIDE WHARF MIAMARINA – PIER 5 (NORTH SECTION)

Pier 5 at Miamarina, Miami Dade County, Florida

Overwater Deck, Bulkhead,
Pile Caps and Piling
Structural Investigation Report

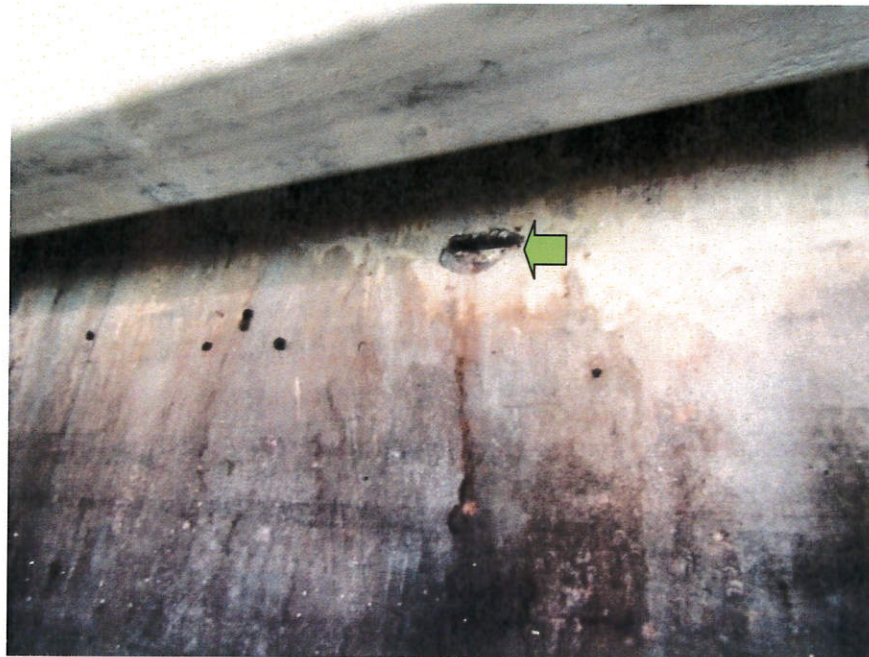
Photo 18: Underside of wood decking; bulkhead above. The waterline, exposed reinforcing noted.

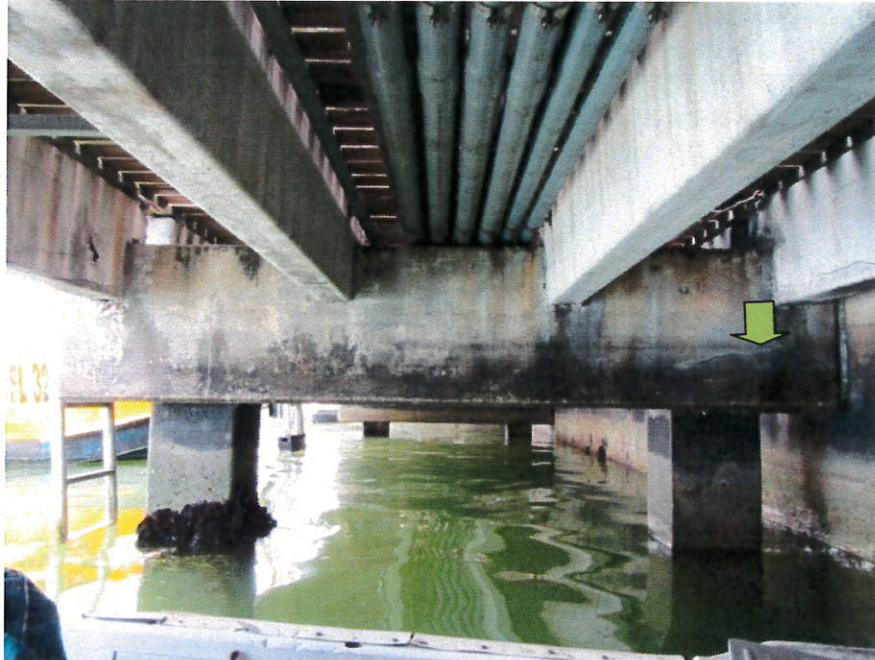
Photo 19: 24x24 concrete pile cap exhibited hairline crack and random honeycombs.

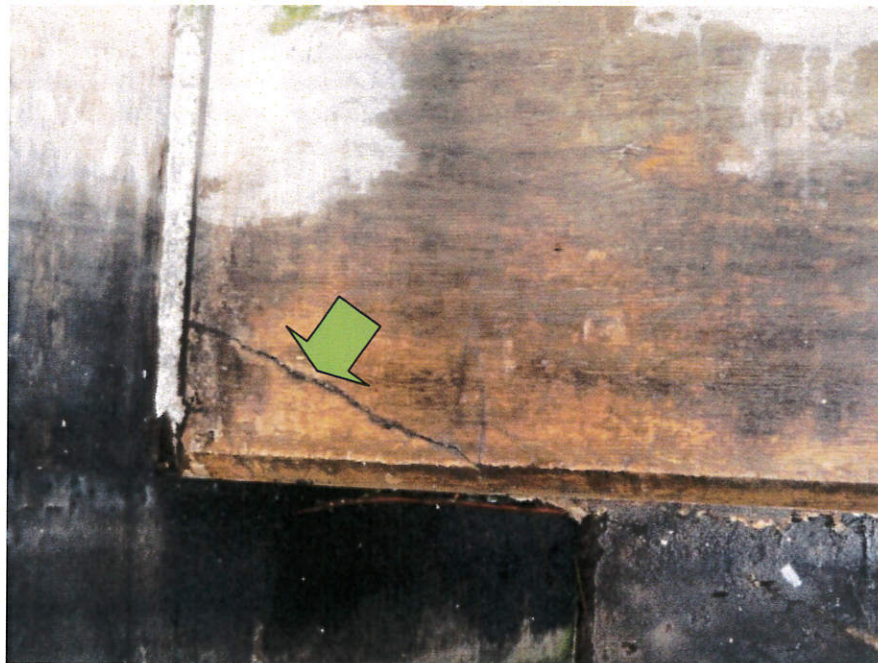
Photo 20: Early signs of deterioration - hairline cracks at Corner of pile caps typical.

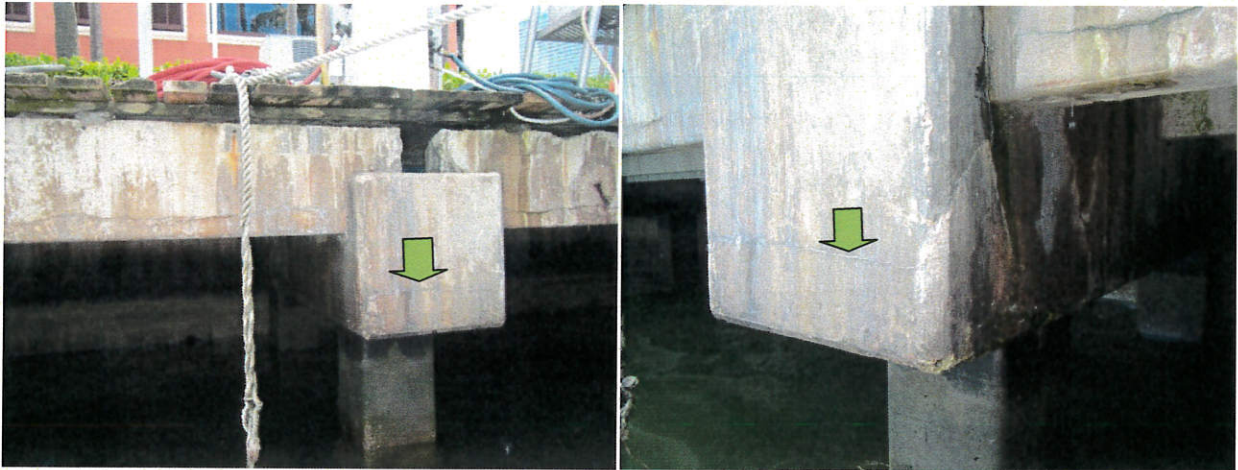
Photo 21: Early signs of deterioration - horizontal hairline crack across face of pile cap.

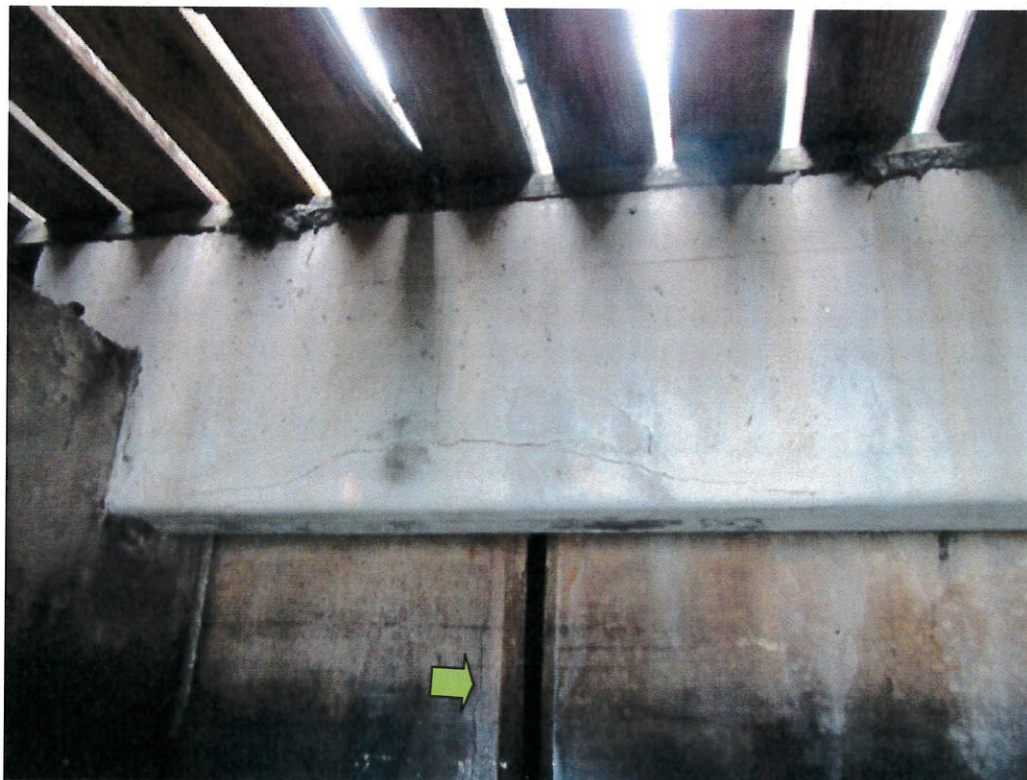
Photo 22: Vertical hairline crack parallel to expansion joint.

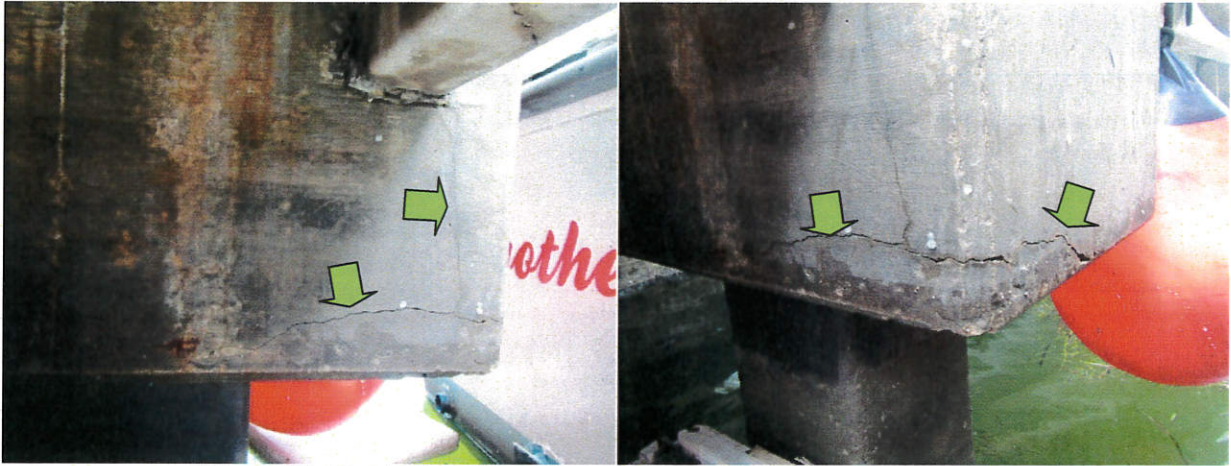
Photo 23: Vertical and hair line cracks at existing pile cap (typical).

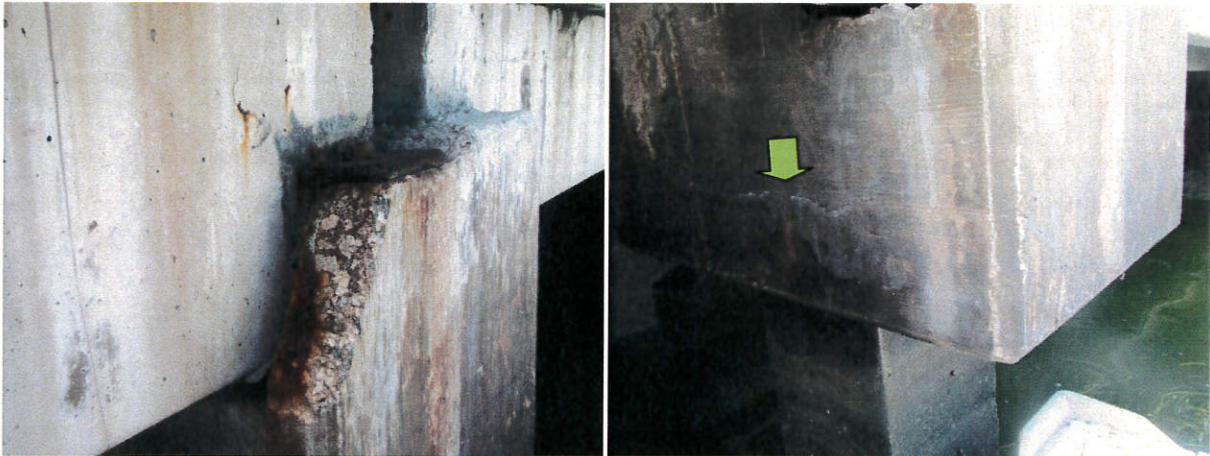
Photo 24: Concrete spall, exposed reinforcing (top of pile cap left).
Hair line crack across the face of pile cap. See photo #23 for side view.

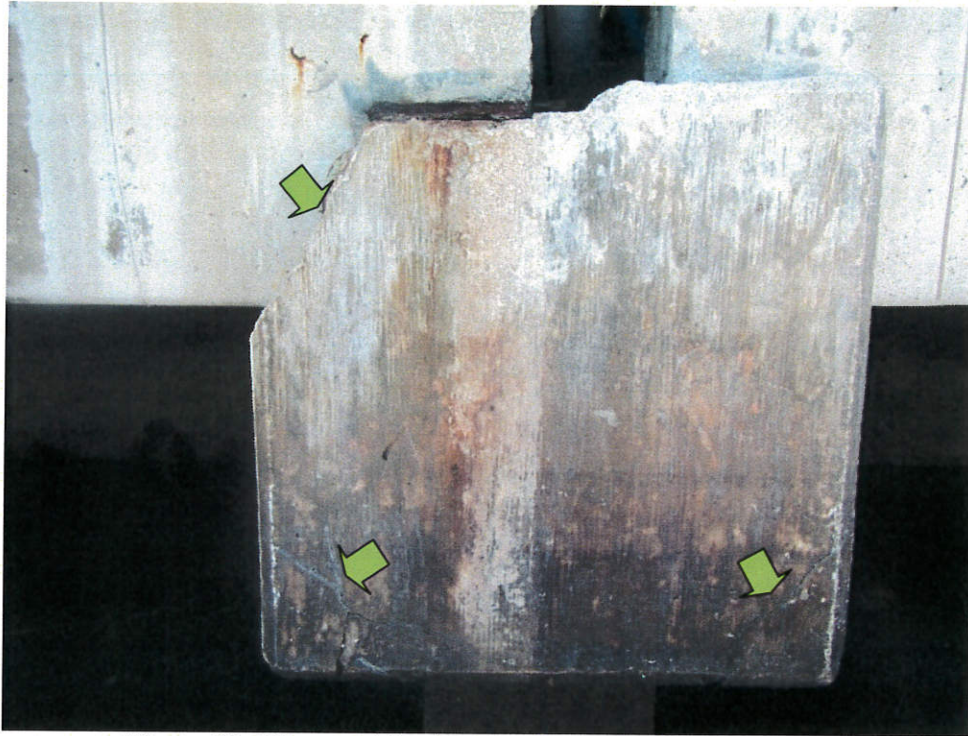
Photo 25: Pile cap side view, concrete spall, exposed steel (top arrow) And hairline cracks (bottom arrows).

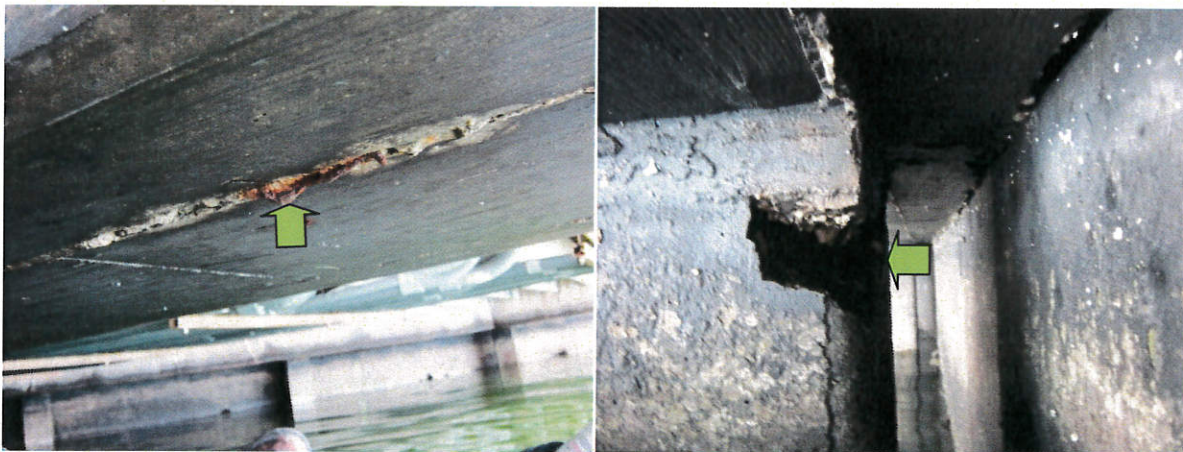
Photo 30: Exposed metal chair at underside of beam (left photo), concrete void and exposed reinforcing at top of concrete pile (right photo - northwest corner area).

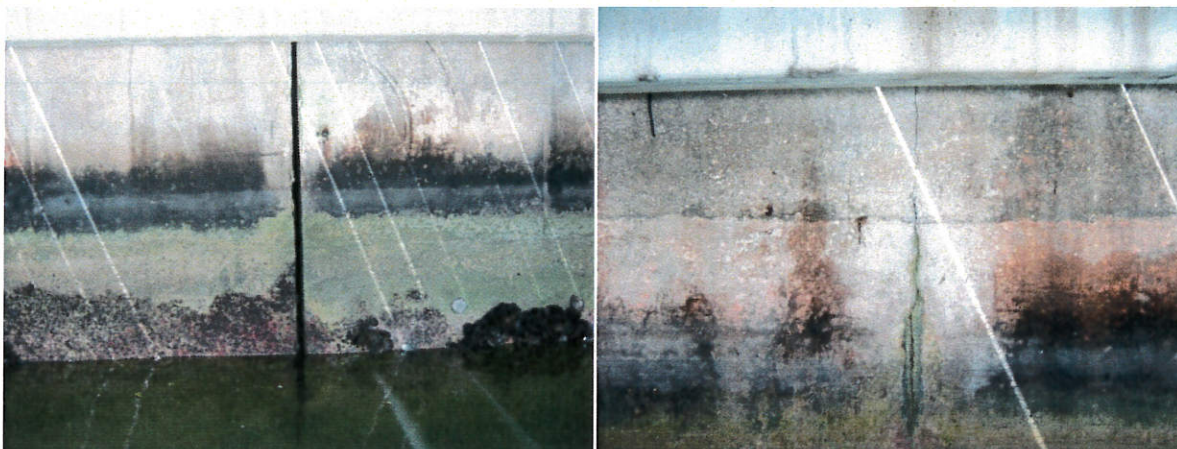
Photo 31: Loss of expansion joint material at expansion joint (left photo) typical. North face of bulkhead exhibited more hairline cracks typical (right photo).

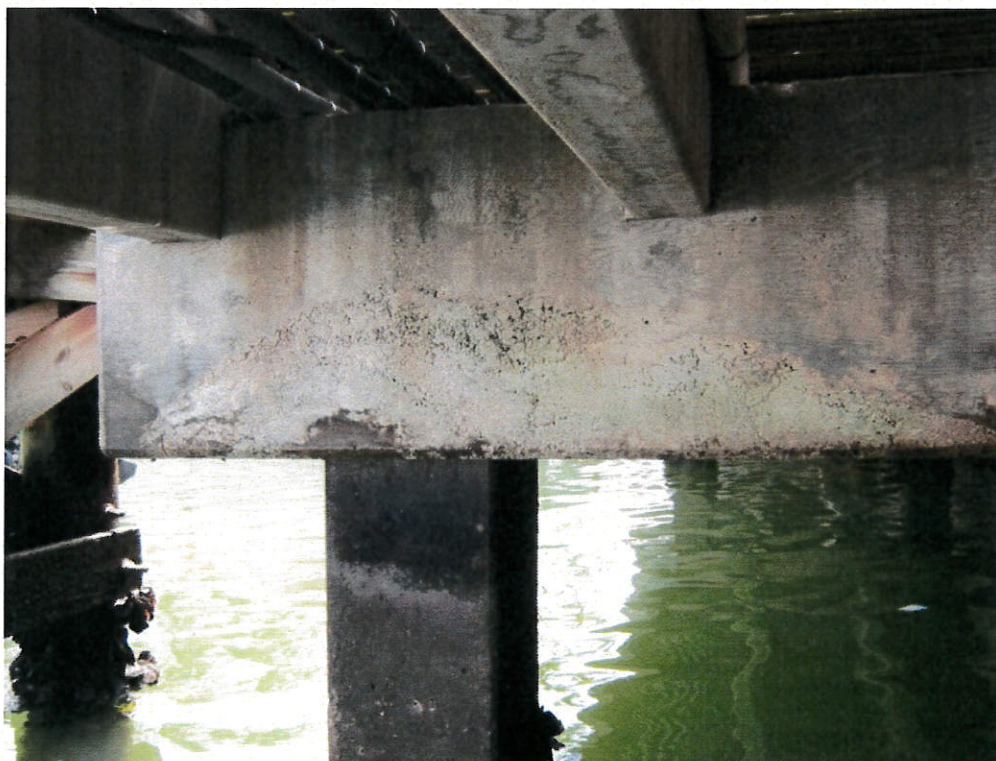
Photo 32: Random honeycombing on pile caps through Entire boardwalk.

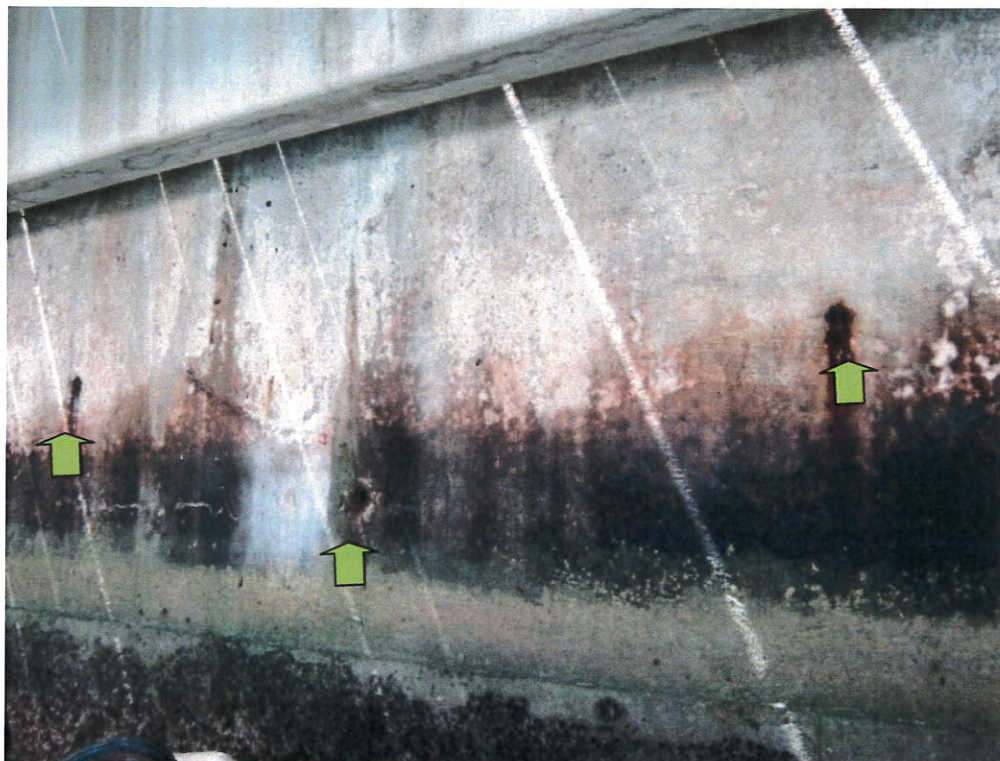
Photo 33: Corroded steel rods noted over the length of wall.

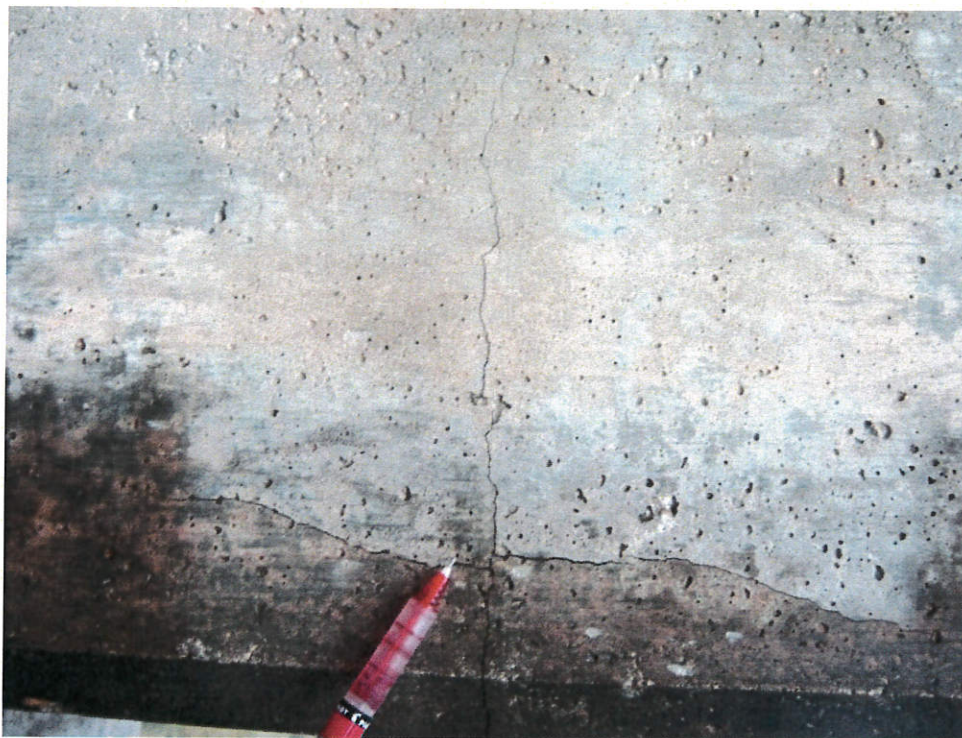
Photo 37: Hairline cracks merging at one location (lower portion of pile cap).

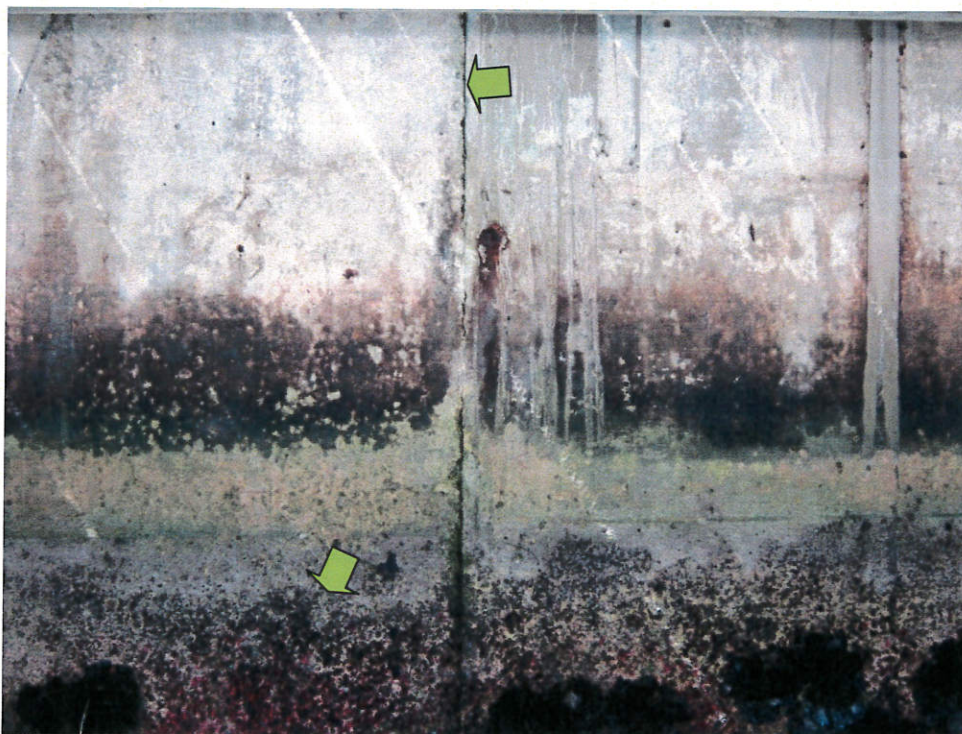
Photo 38: Cold joint throughout entire length of bulkhead (top arrow). Noticed bulkhead surface roughen caused by debris abrasion (lower portion of photo).

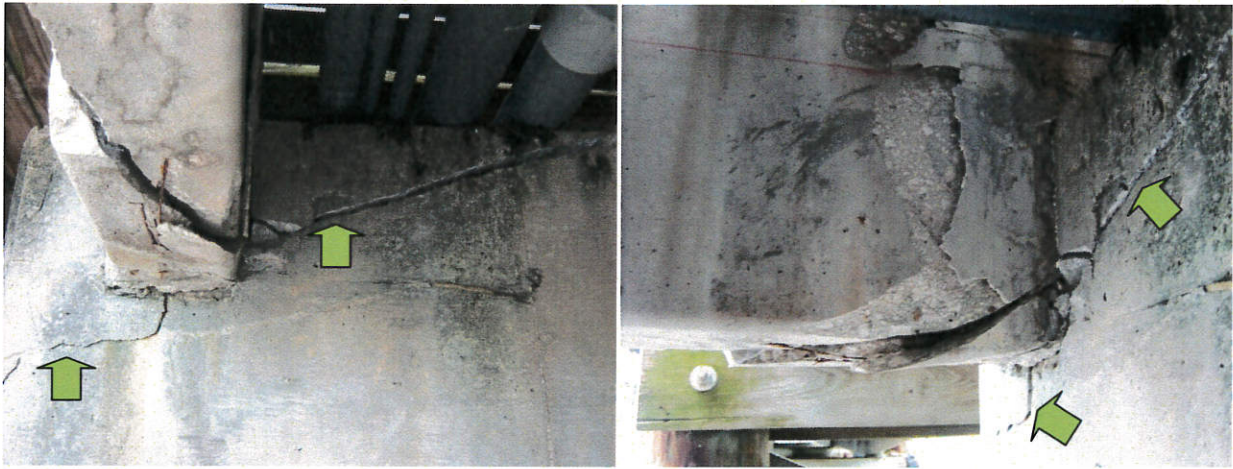
Most of the existing cast in place concrete pile caps exhibited minor deterioration. However, one isolated breakage/overstressing affected the load bearing capacity of the structure. Repairs are planned under this Project and will significantly extend the life of the structure.

Photo 39: Top corner of pile cap failed (left). Precast concrete joist failed (right).

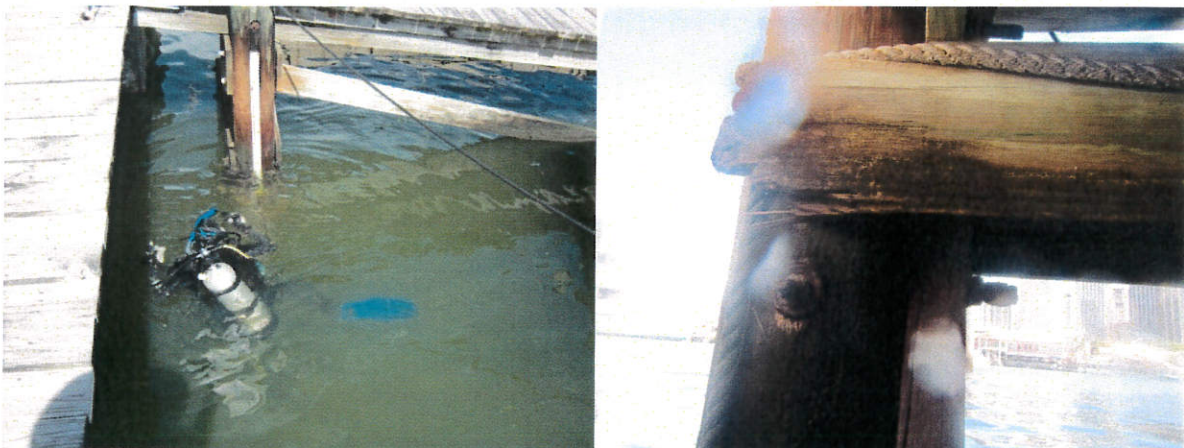
Photo 42: Timber finger pier: fender/mooring pile and Divers performing framing structural assessment (left). Missing diagonal bracing (right).

Several of the timber diagonal bracings, headers, and connection hardware, will need to be replaced.

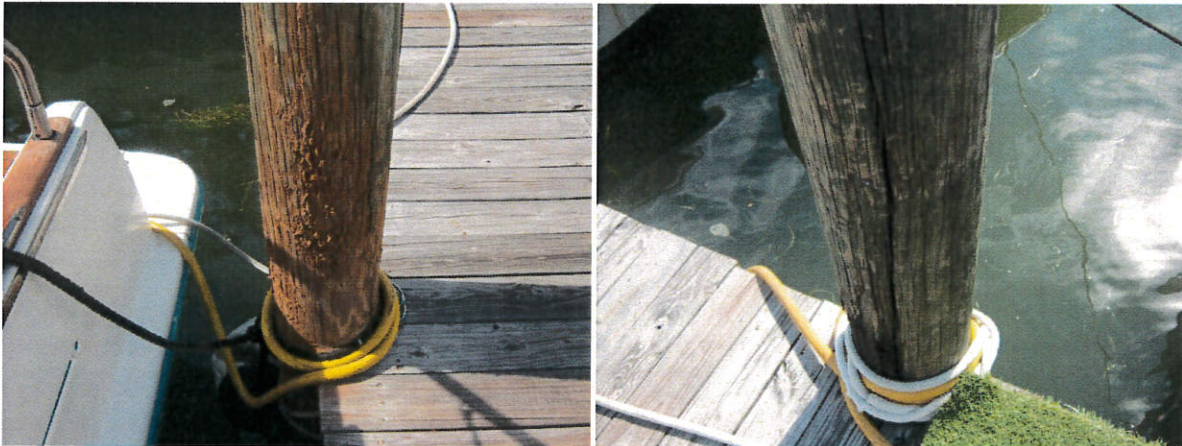
The timber structures were observed to be generally stable; however, the piles presented minor to moderate cracks and splits above the water line. Some piles presented up to 50% cross section loss at the mean water line. Refer to (photo 44 and 45) for a typical view of timber piles. Typical timber mooring pile replacements will be illustrated in the Design Development Plans and more detailed quantities and locations will be illustrated in the Construction set.

Photo 44: Fender pile exhibited heavy load impacts (left), vertical cracks exhibited on surface of fender pile.

Several of the timber mooring piles need to be replaced due to current conditions. The extent of the deterioration of the piles presented vertical cracking, splitting, signs of impact loads, fungal rot (soften of the wood) and reduction of cross section area loss at the splash zone. Therefore, more wide spread of failures are likely to occur. Repairs are planned under this Project and will significantly extend the life of the structure.

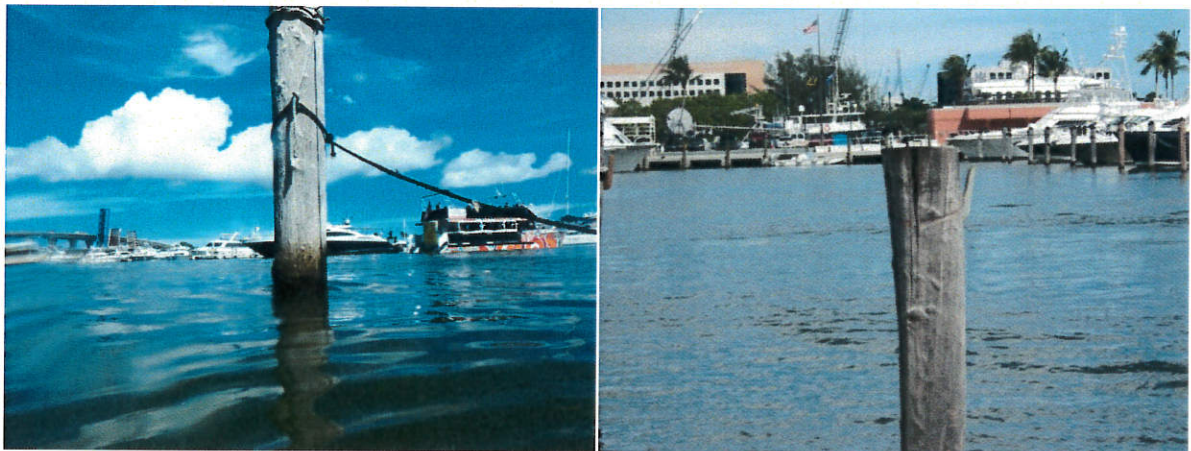
Photo 45: Mooring pile exhibited wide crack at top and missing plastic cap (right).

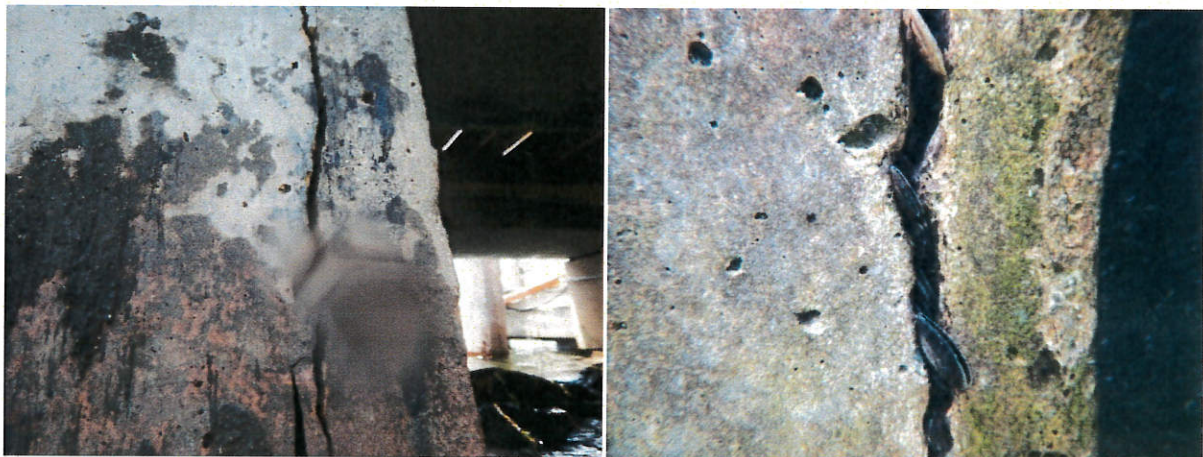
The existing concrete Pier G has minor to moderate level of deterioration to a few of the 18-inch square precast piling supporting the (25-inch by 36-inch pile caps). The existing concrete piling is given a rating of *Fair-Poor* in accordance with the ASCE manual. Based on the existing site conditions and anticipated rates of deterioration, the estimated remaining service life for this structure, if no action is taken, is approximately 4 to 6 years. This remaining service life does not include potential impacts due to coastal storm events or vessels.

Photo 46: Pier G: couple of 18-inch x 18-inch piles exhibited up to 1/4-inch cracks.

The current condition to the cast in place concrete piles exhibited minor deterioration. However, one isolated structural crack may affect the load capacity of the structure in the near future. Repairs are planned under this Project and will significantly extend the life of the structure.

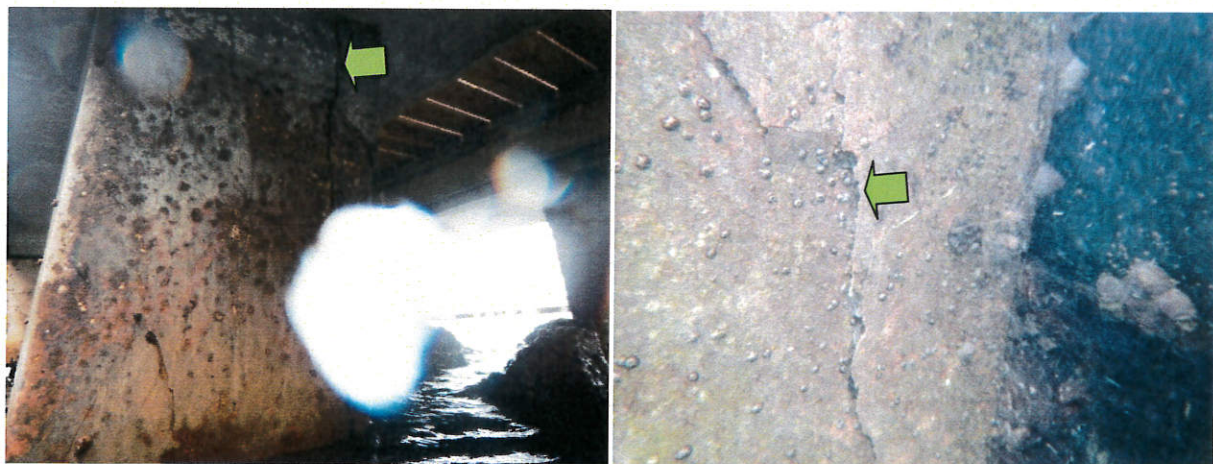
Photo 47: Pier G: couple of 18-inch x 18-inch piles exhibited up to 1/4-inch cracks.

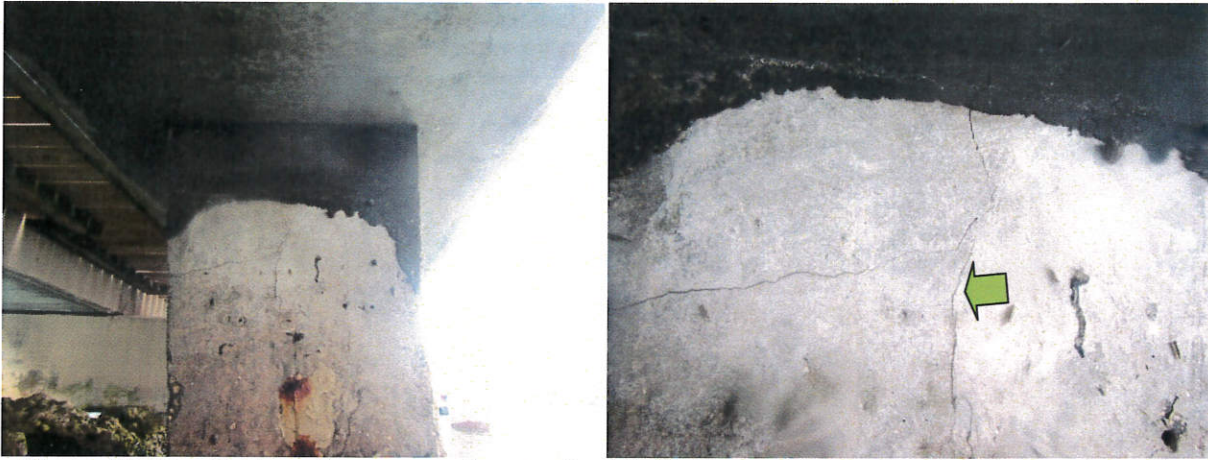
Photo 48: Pier G: sign of concrete piles repaired (left). Same pile, random hairline cracks at the top portion of concrete pile.

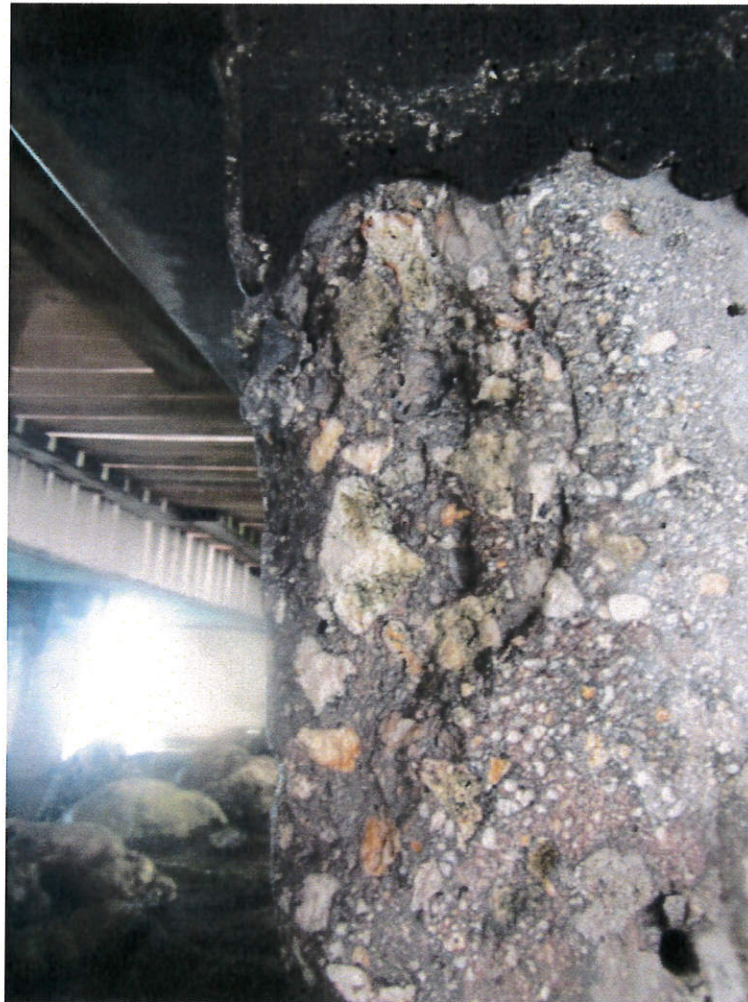
Photo 49: Pier G: Rough concrete surface worn.

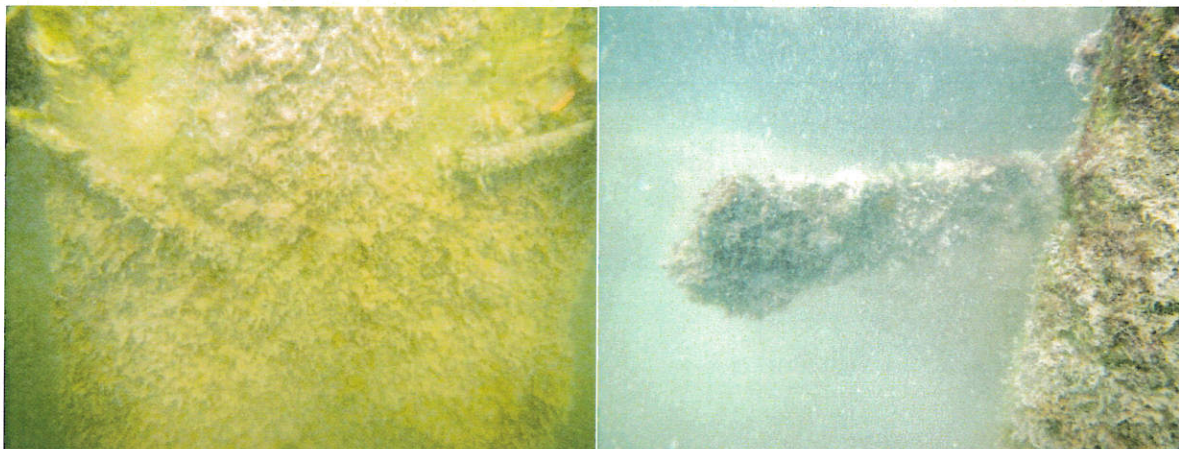
Photo 50: Pier G and South Concrete Pier: Random crib structure threaded rod deteriorated.

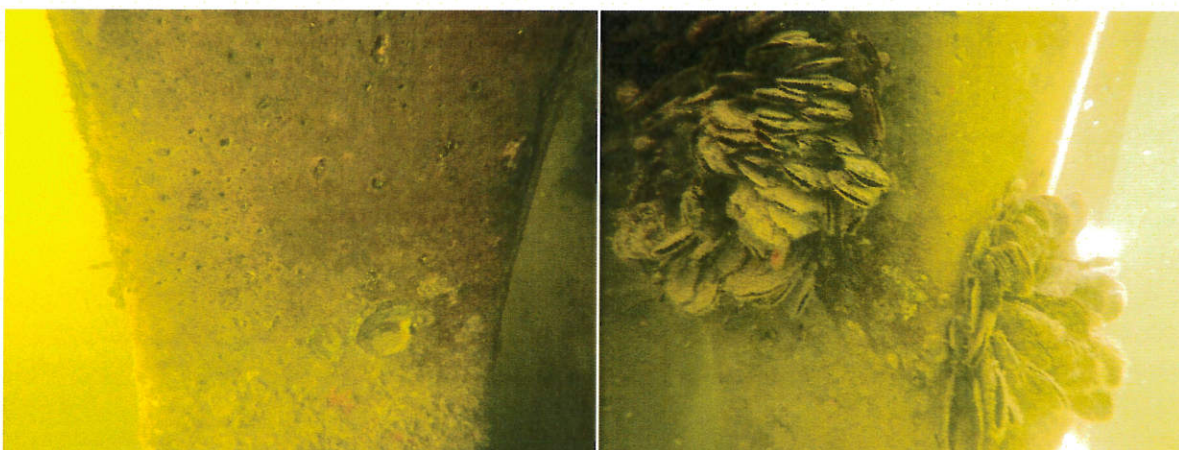
Photo 51: Below boardwalk piling - below water pile condition.

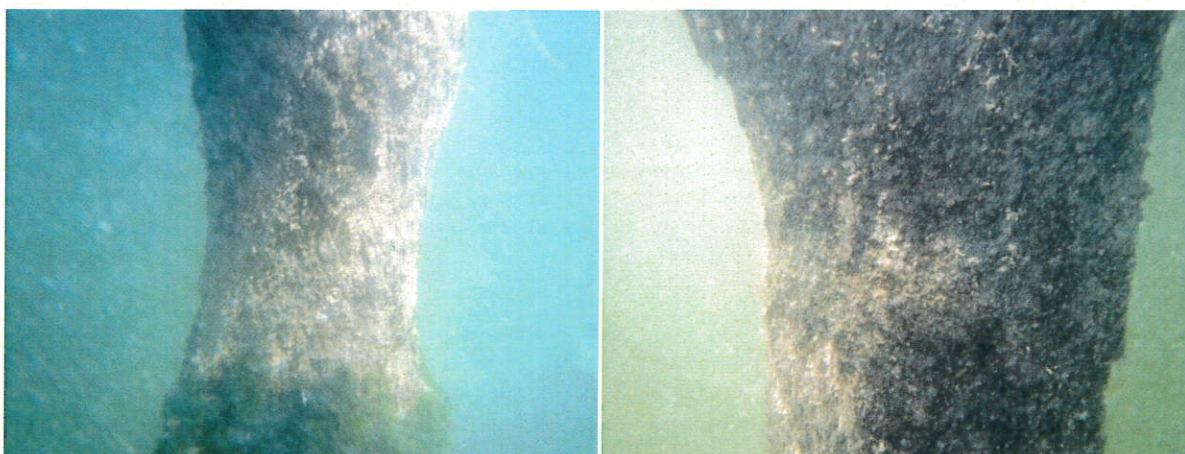
Photo 52: Timber mooring pile below water exhibited cross section loss and rot.

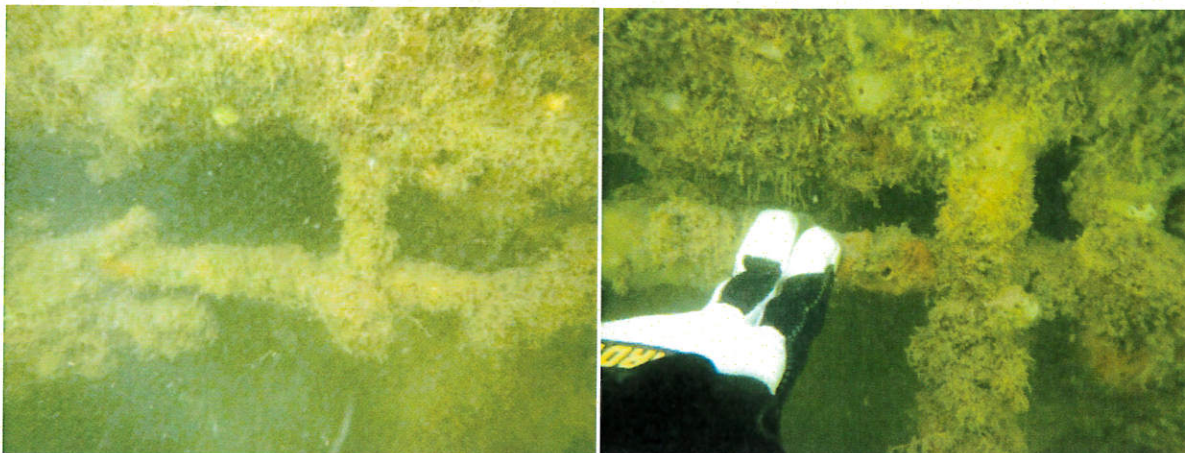
Photo 53: Random voids and exposed reinforcing at bottom of bulkhead.

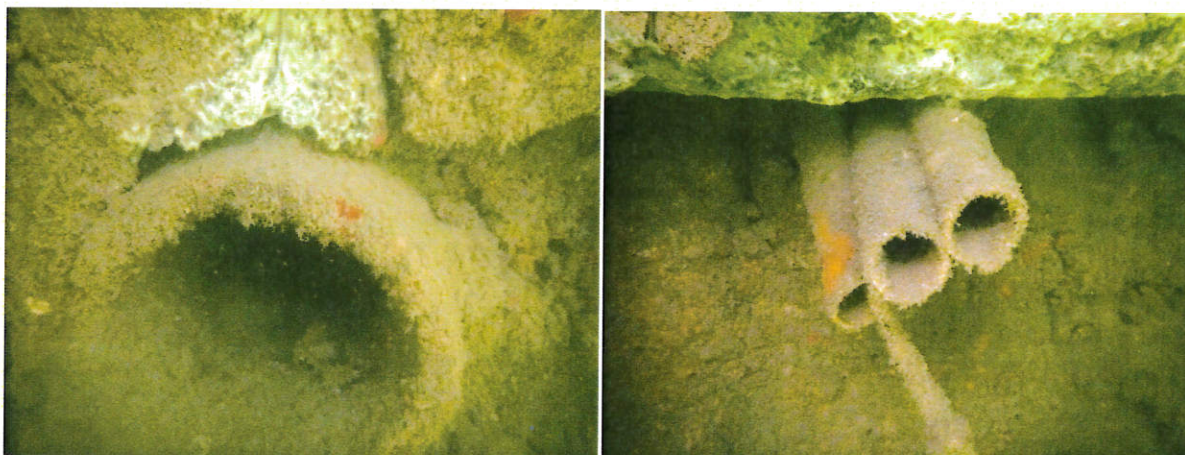
Photo 54: Abandoned outfall and electrical conduits at bulkhead.

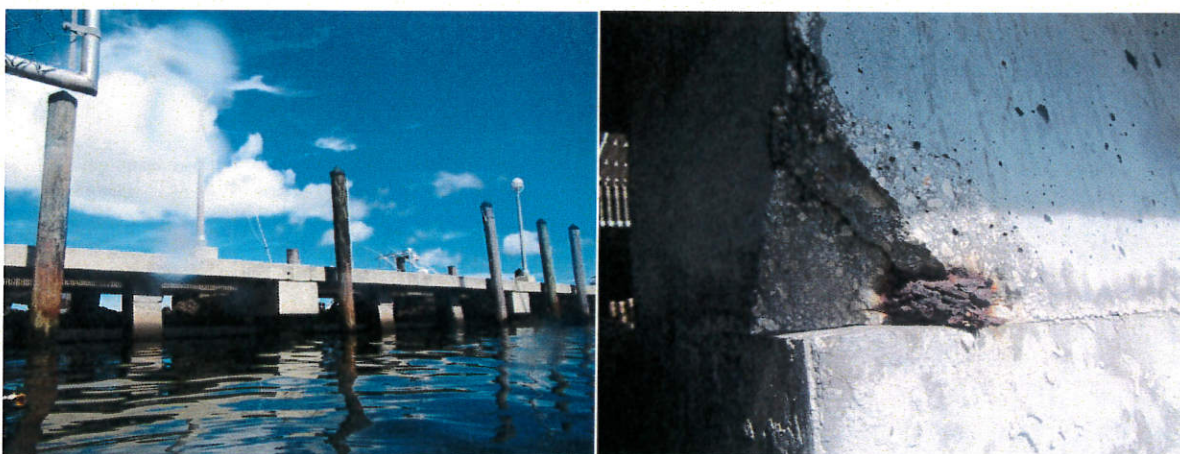
The existing concrete North Finger Concrete Pier has minor level of deterioration to a few of the 18-inch square precast piling supporting the (25-inch by 36-inch pile caps). The existing concrete piling is given a rating of *Fair* in accordance with the ASCE manual. Based on the existing site conditions and anticipated rates of deterioration, the estimated remaining service life for this structure, if no action is taken, is approximately 4 to 6 years. This remaining service life does not include potential impacts due to coastal storm events or vessels.

Photo 55: North Concrete Finger Pier (left). Minor concrete deterioration on few piles (right).

The current condition to the cast in place concrete piles exhibited minor deterioration. Repairs are planned under this Project and will significantly extend the life of the structure.
