Pier 5 at Miamarina, Miami Dade County, Florida

Overwater Deck, Bulkhead,
Pile Caps and Piling
Structural Investigation Report

August 2017

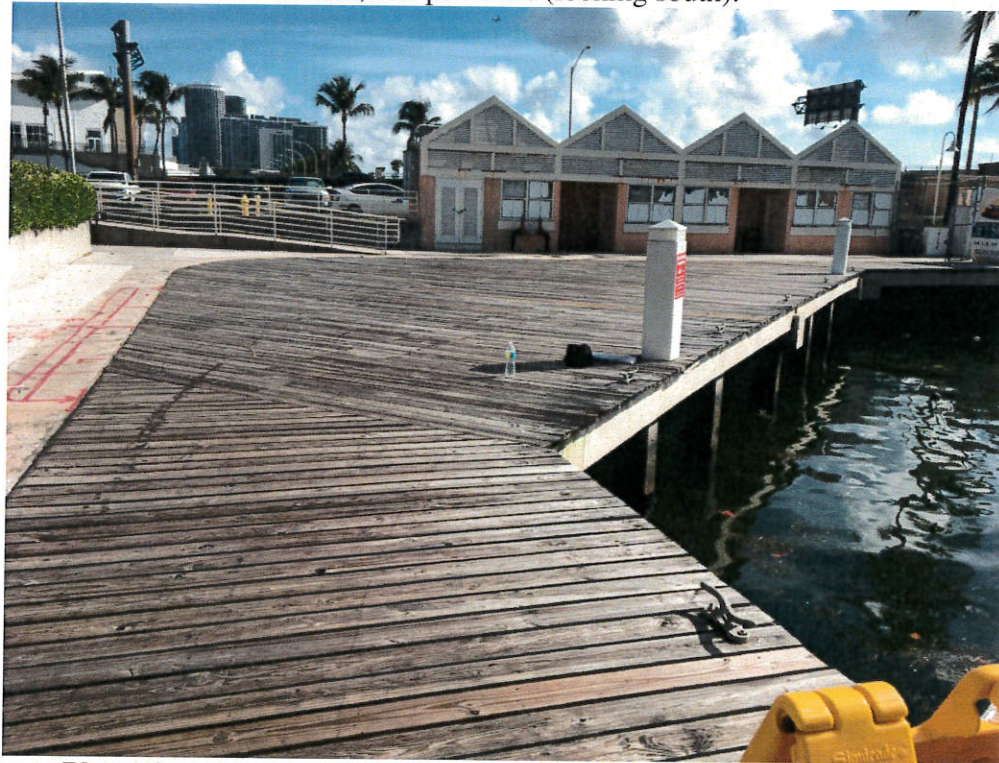
Photo 4: Existing wood deck corner, and pedestals (looking northeast).

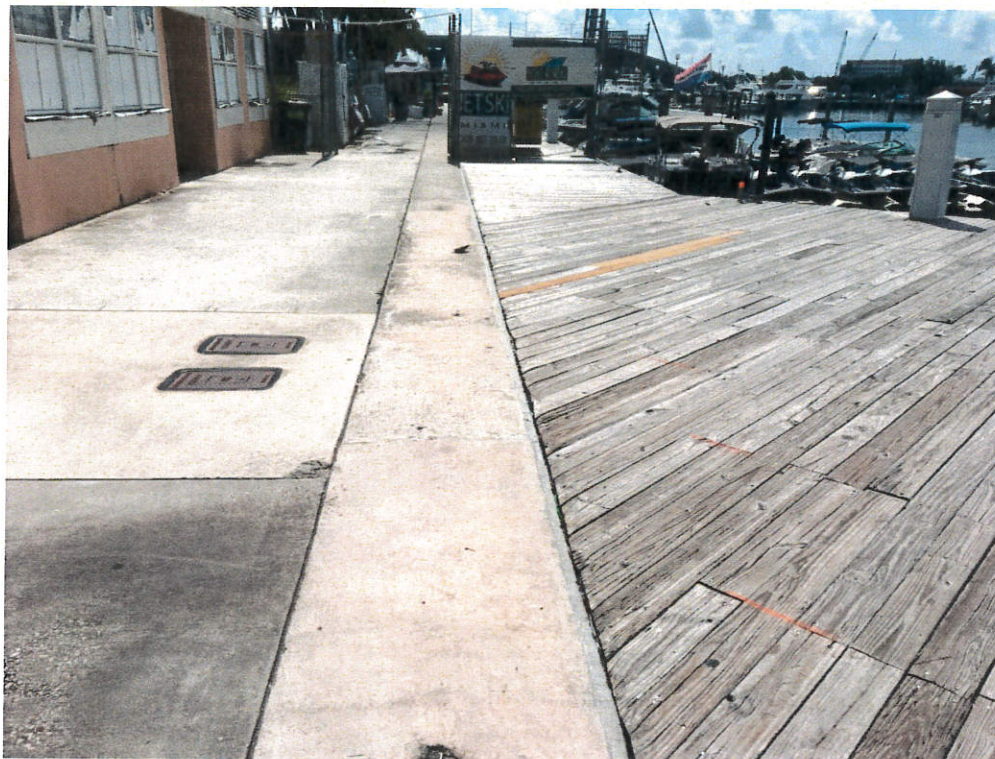
The existing bulkhead is approximately 32 inches wide and approximately 8 feet tall. The wall is continuous along the length of Pier 5 (overwater deck). It consists of a steel sheet pile wall with a cast in place concrete cap. Refer to (Photo 5) for a typical view of the bulkhead.

Photo 5: Existing bulkhead, sidewalk and wood deck (looking east).

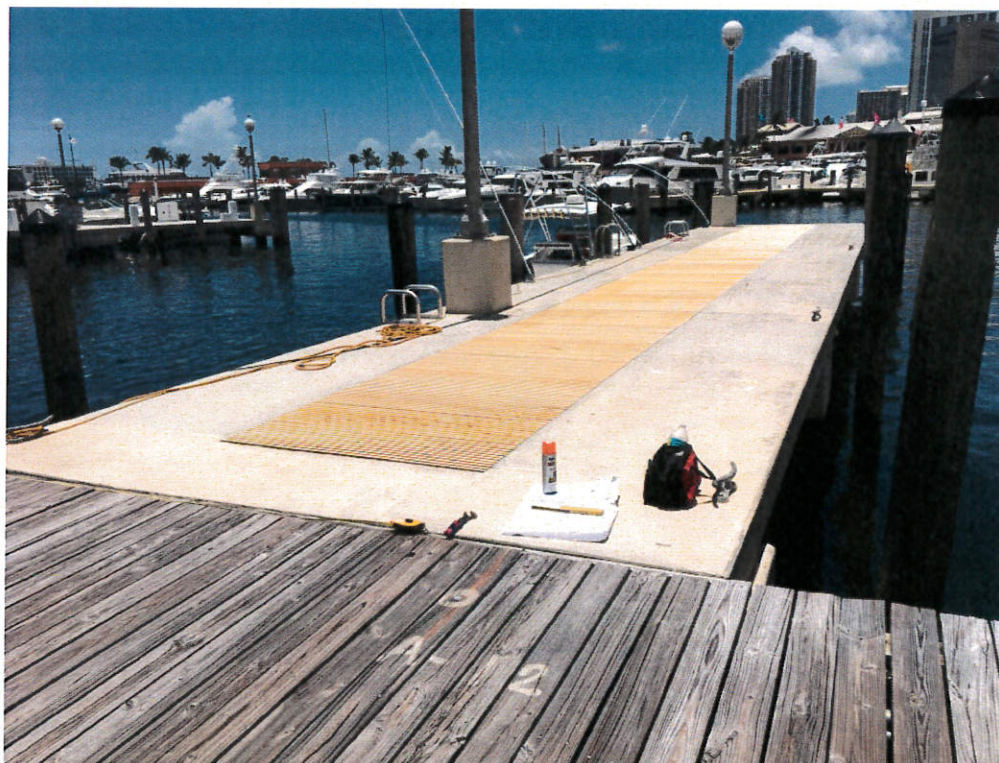
The existing structure in this area is part of a 14ft 9-inch wide by 74ft concrete dock with a 12-inch thick reinforced precast slab with a cast in place closure pour (photo 10). Some of the existing crib threaded rods containing the rock wave baffle under slab exhibited complete breakage similar to Pier G. The structure includes 18-in square precast concrete piling and some exhibited hairline cracks at the mean waterline.

Photo 10: Existing Miami Fire Rescue concrete pier (looking southeast).

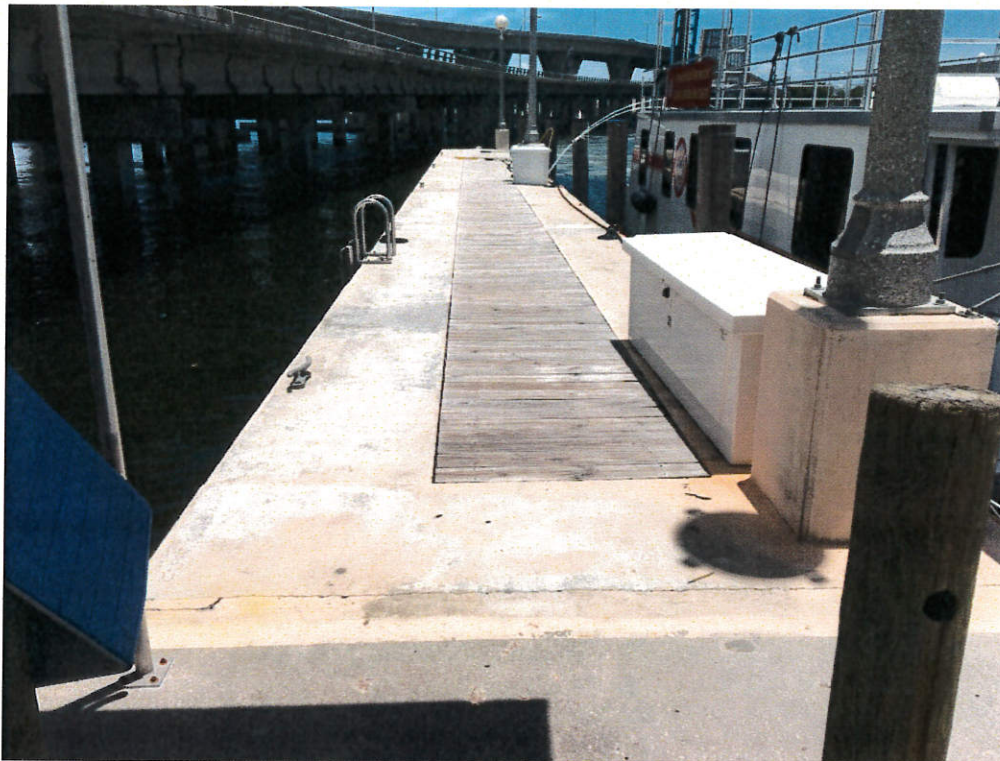
The existing structure in this area is part of a 9ft 8-inch wide concrete dock with a 12-inch thick reinforced precast slab with a cast in place closure pour (photo 13). The structure includes 18-in square precast concrete piling and some exhibited structural cracks at the mean waterline (photo 46 and 47). Also, some of the existing crib threaded rods containing the rock wave baffle under slab exhibited complete breakage (photo 50). The existing conditions, quantities, and locations will be illustrated in the Construction set.

Photo 13: Overall view of Pier G (looking east).

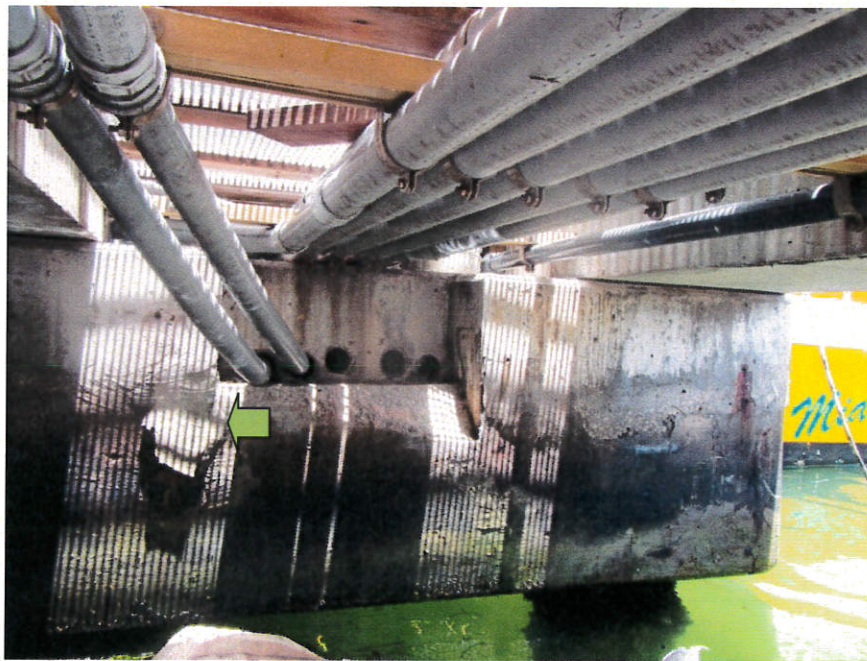
Photo 16: Underside at end of new construction (concrete beams); existing pile cap exhibited minor delamination, sign of previous repairs, corrosion stains, and hairline cracks (looking north). See photo #17 for reference.

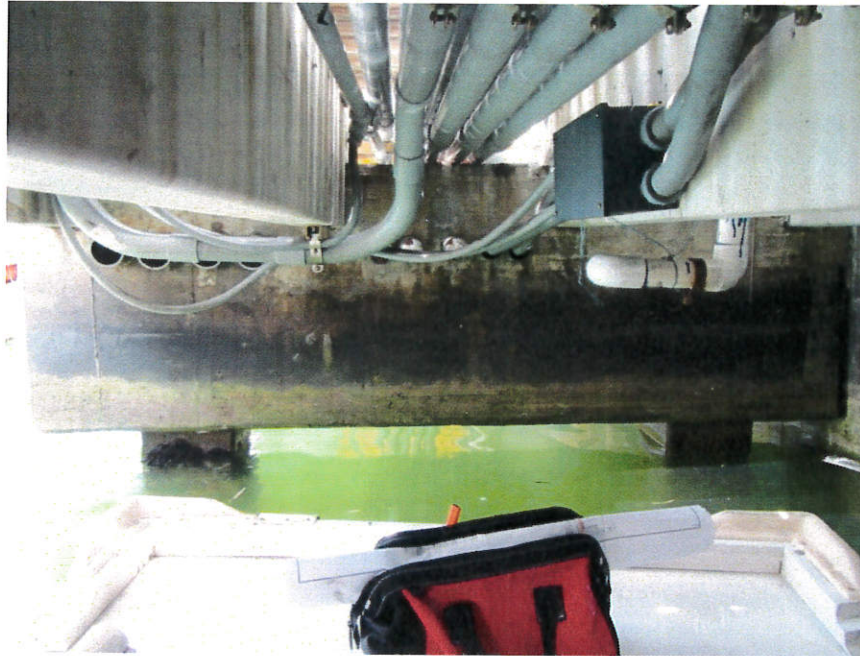
Photo 17: Underside at end of existing construction (wood decking and pre-cast concrete joists); this face of pile cap (Sta 0+00 looking south). Utility chase under wood decking from pile cap to pile cap.

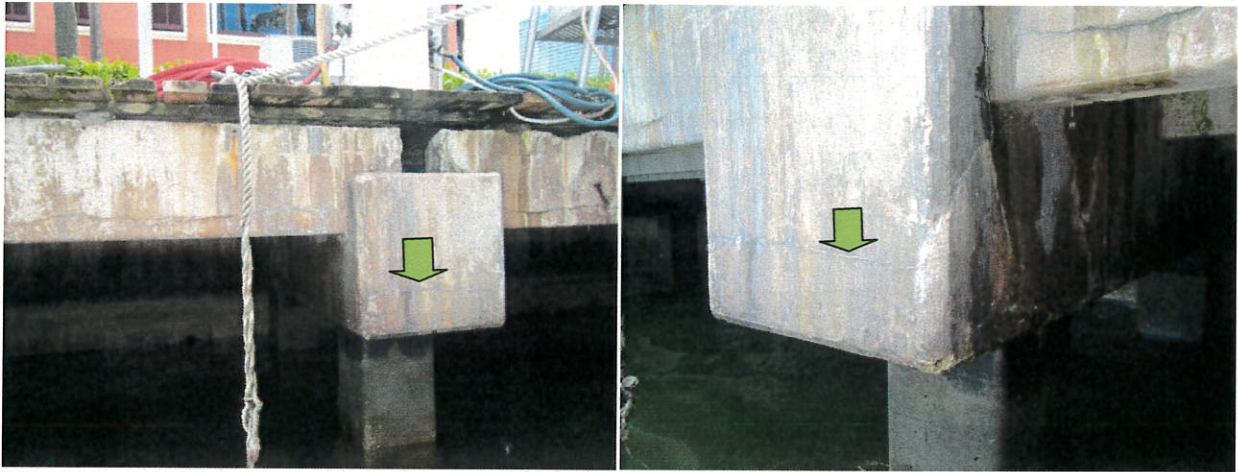
Photo 21: Early signs of deterioration - horizontal hairline crack across face of pile cap.

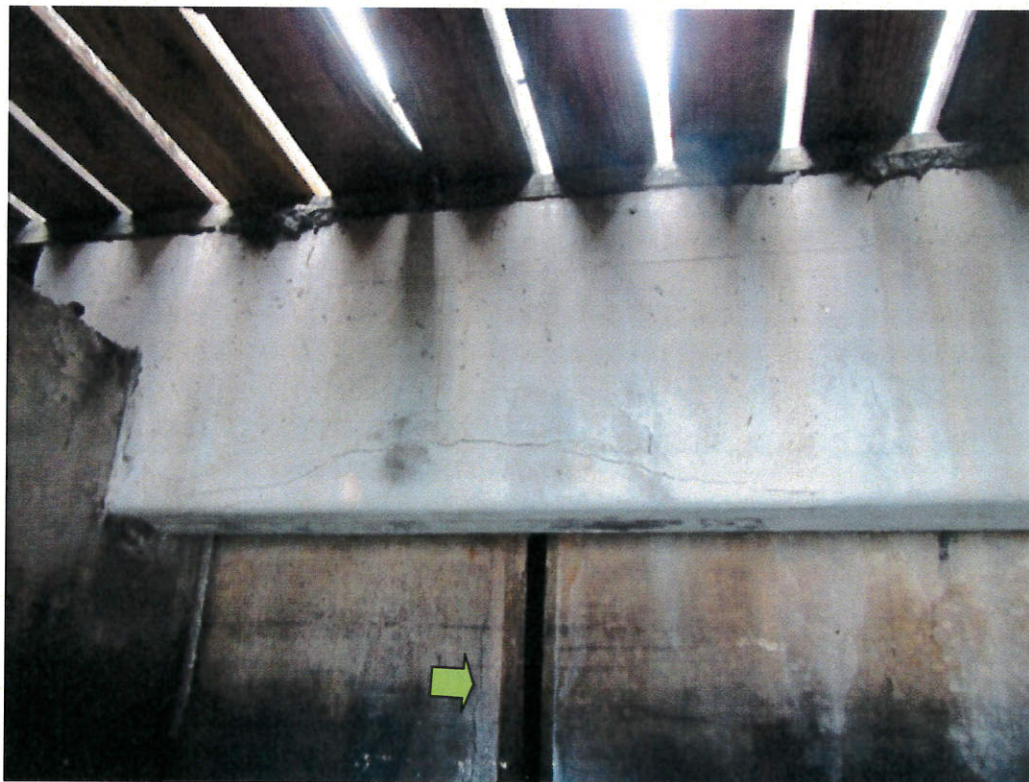
Photo 22: Vertical hairline crack parallel to expansion joint.

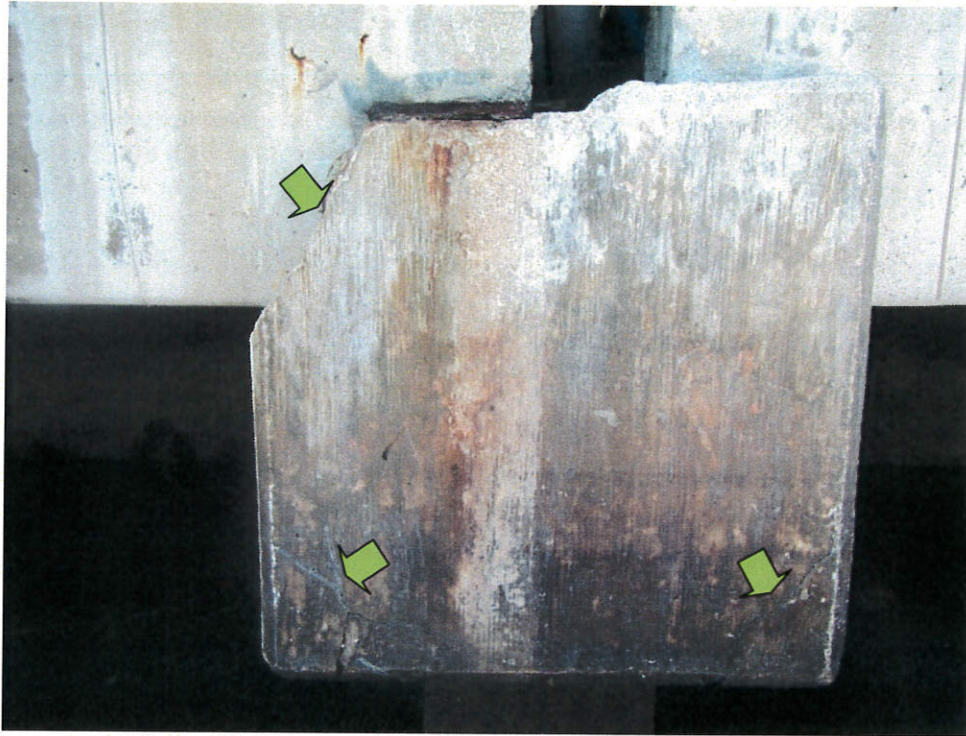
Photo 25: Pile cap side view, concrete spall, exposed steel (top arrow) And hairline cracks (bottom arrows).

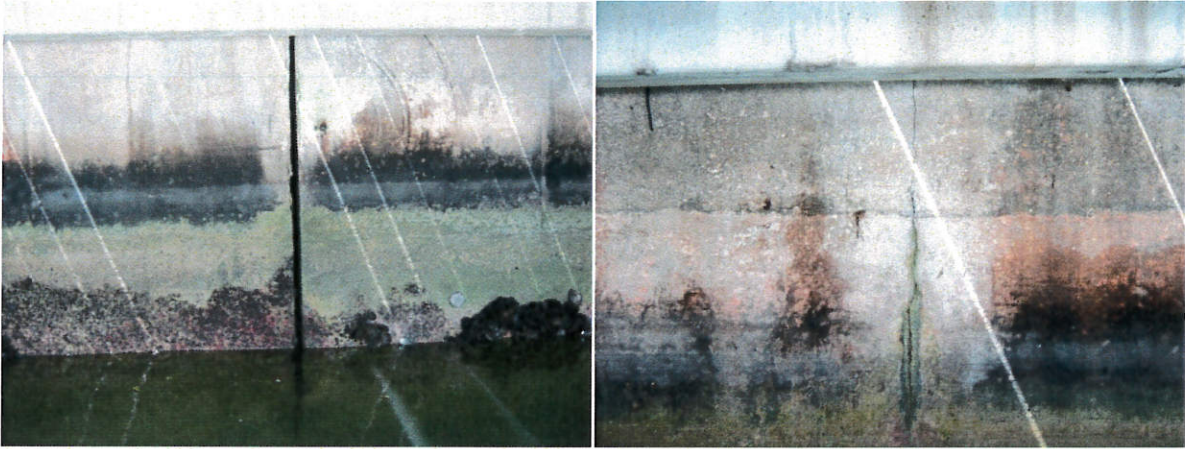
Photo 31: Loss of expansion joint material at expansion joint (left photo) typical. North face of bulkhead exhibited more hairline cracks typical (right photo).

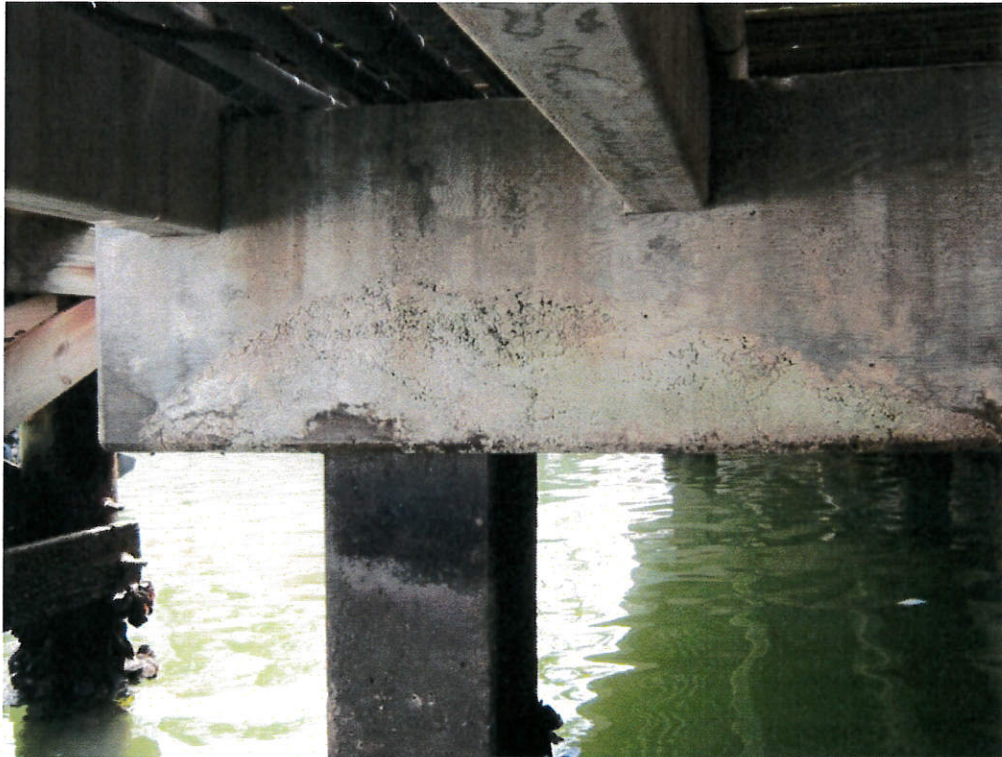
Photo 32: Random honeycombing on pile caps through Entire boardwalk.

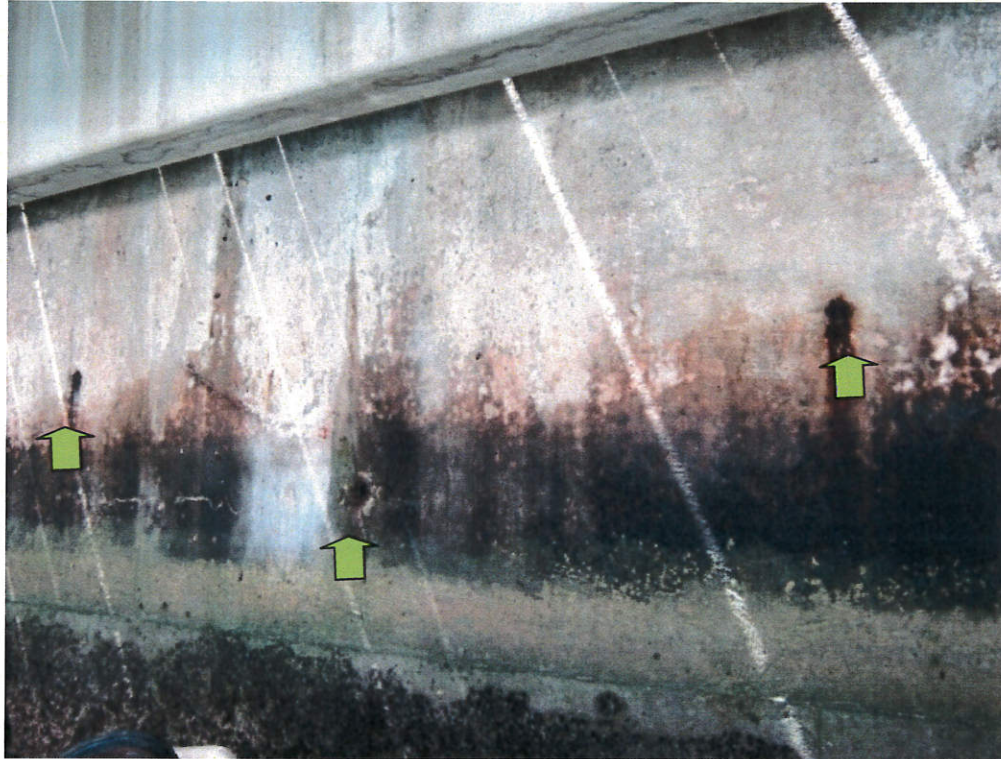
Photo 33: Corroded steel rods noted over the length of wall.

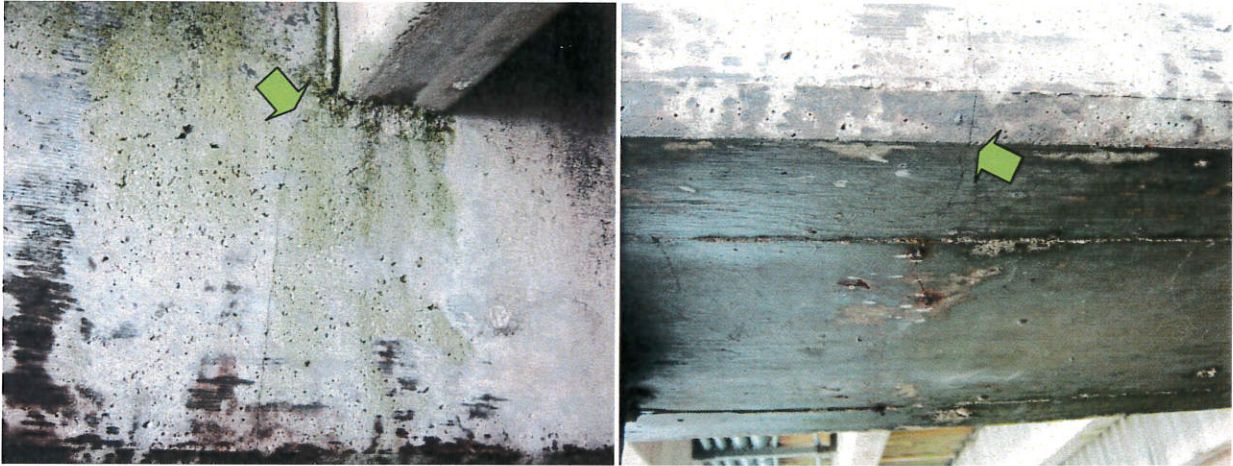
Photo 35: Vertical hairline crack to underside of pile cap.

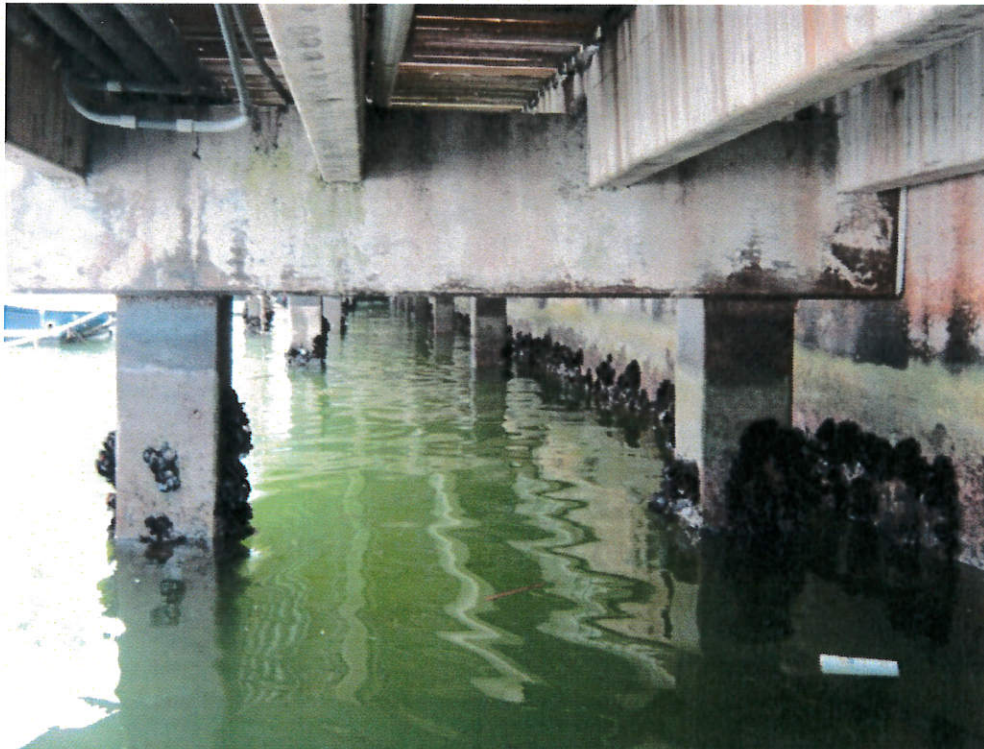
Photo 36: North segment of bulkhead exhibited more marine growth than the rest of wall.

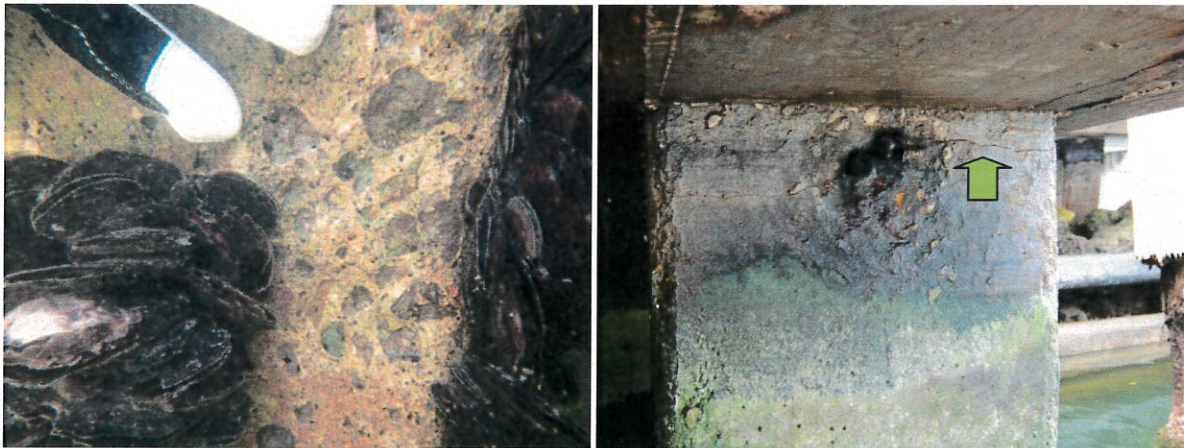
Photo 40: Below water line signs of abrasion (left). Horizontal hairline crack at top of concrete pile (right).

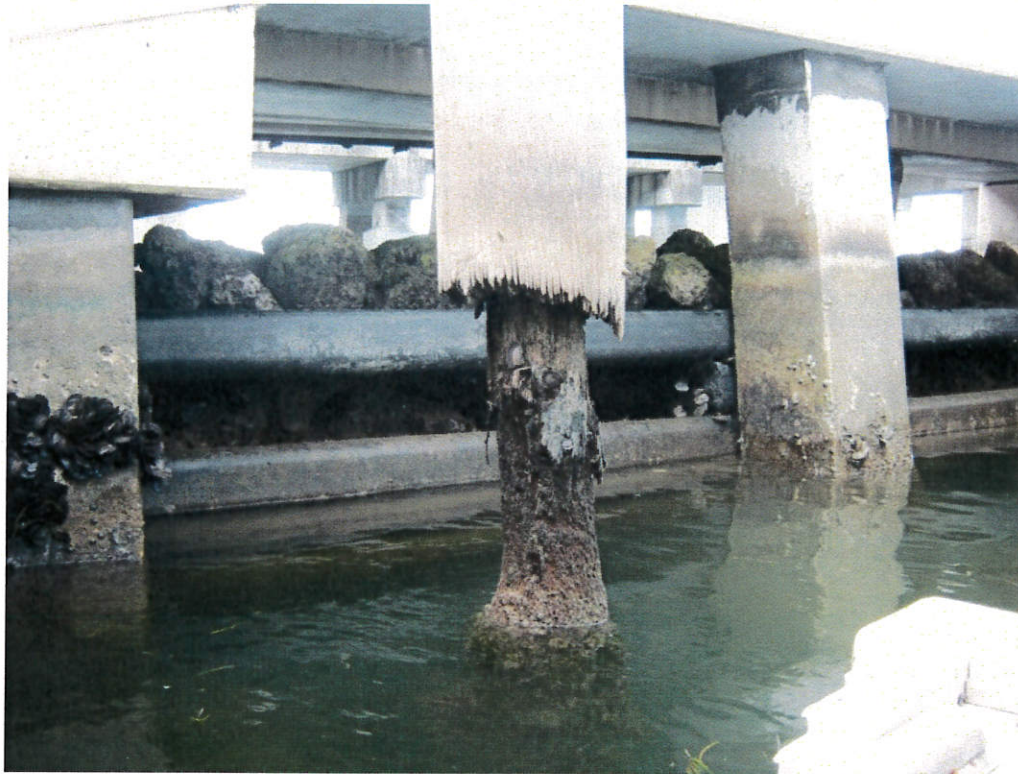
Photo 41: Northeast corner (Pier G) timber pile
Deterioration 50% cross section loss.

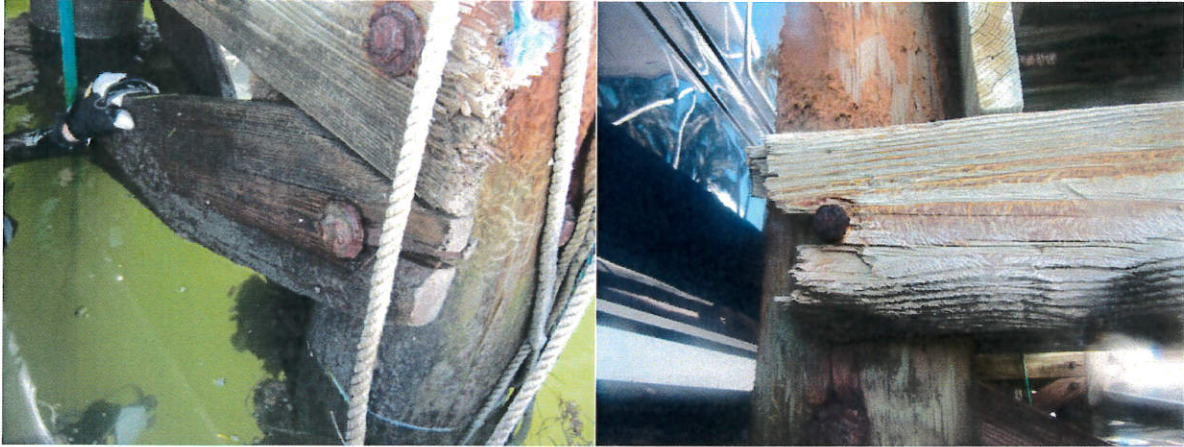
The finger pier structures were observed to be generally stable; however, some of the structural elements are in the mid/advance stages of deterioration to complete breakage or failure at the mean water line (photo 43). The existing conditions, quantities, and locations will be illustrated in the Construction set.

Photo 43: Corroded steel connection corroded and splinted cross bracing (left), horizontal brazing connection failed (right).

Several of the timber diagonal bracings, headers, and connection hardware, will need to be replaced.

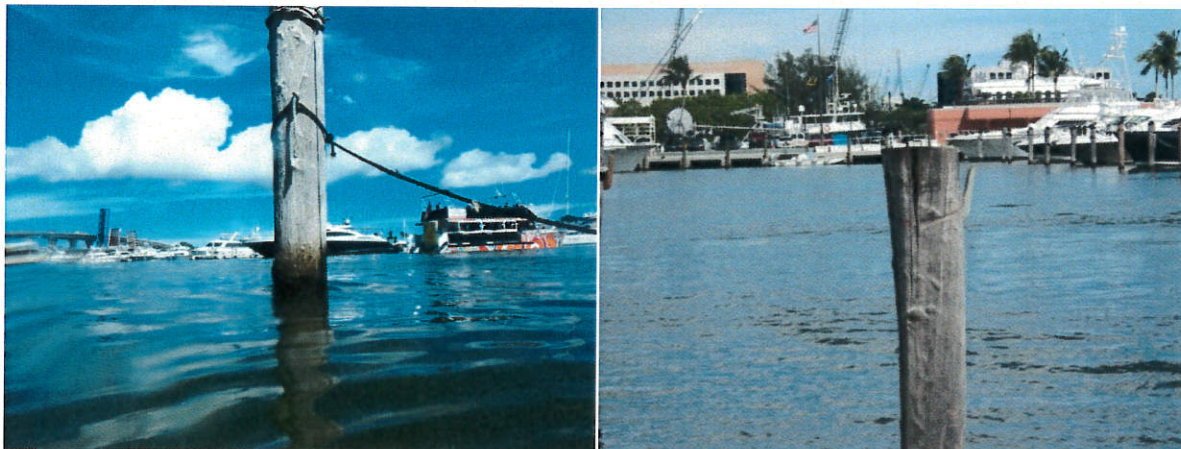
The timber structures were observed to be generally stable; however, the piles presented minor to moderate cracks and splits above the water line. Some piles presented up to 50% cross section loss at the mean water line. Refer to (photo 44 and 45) for a typical view of timber piles. Typical timber mooring pile replacements will be illustrated in the Design Development Plans and more detailed quantities and locations will be illustrated in the Construction set.

Photo 45: Mooring pile exhibited wide crack at top and missing plastic cap (right).

Several of the timber mooring piles need to be replaced due to current conditions. The extent of the deterioration of the piles presented vertical cracking, splitting, signs of impact loads, fungal rot (soften of the wood) and reduction of cross section area loss at the splash zone. Therefore, more wide spread of failures are likely to occur. Repairs are planned under this Project and will significantly extend the life of the structure.

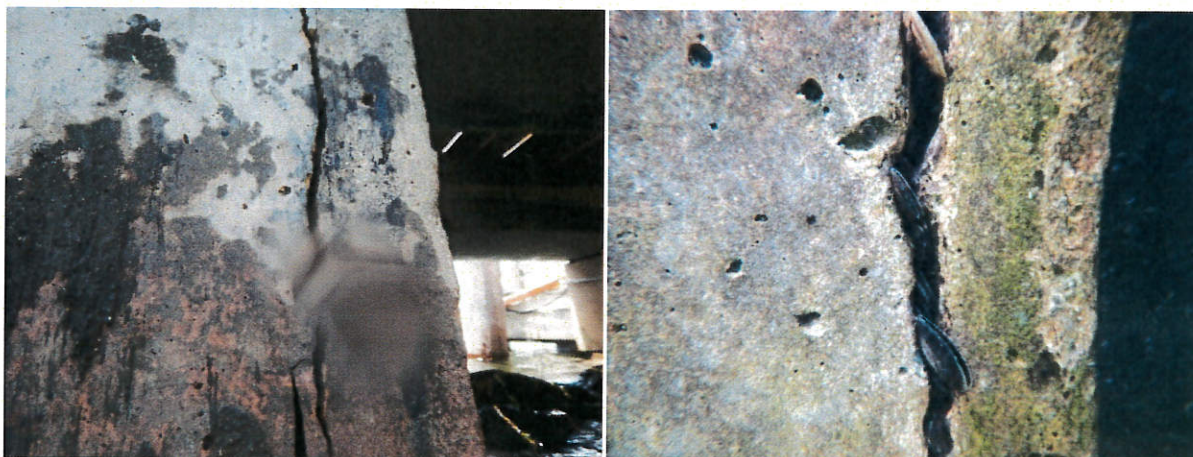
Photo 46: Pier G: couple of 18-inch x 18-inch piles exhibited up to 1/4-inch cracks.

The current condition to the cast in place concrete piles exhibited minor deterioration. However, one isolated structural crack may affect the load capacity of the structure in the near future. Repairs are planned under this Project and will significantly extend the life of the structure.

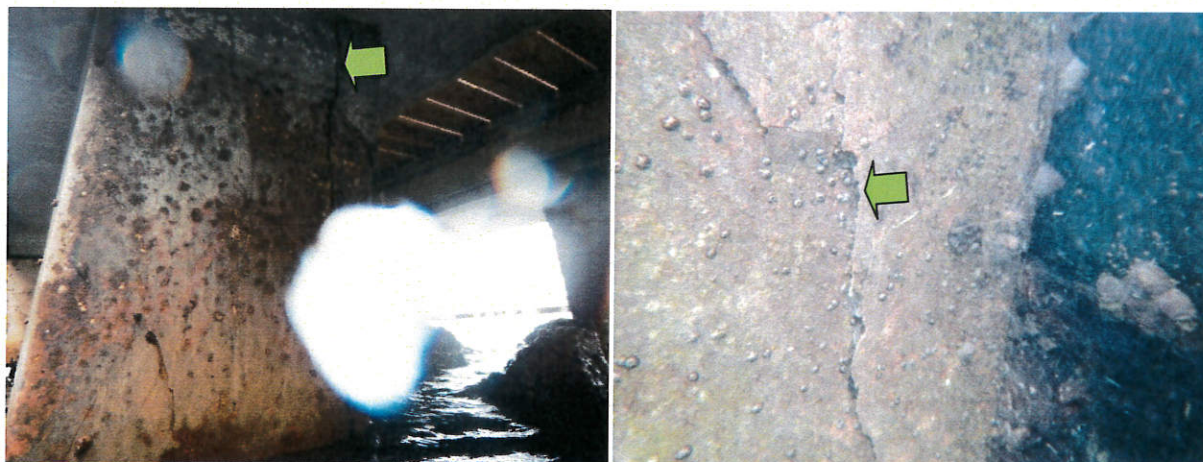
Photo 47: Pier G: couple of 18-inch x 18-inch piles exhibited up to 1/4-inch cracks.

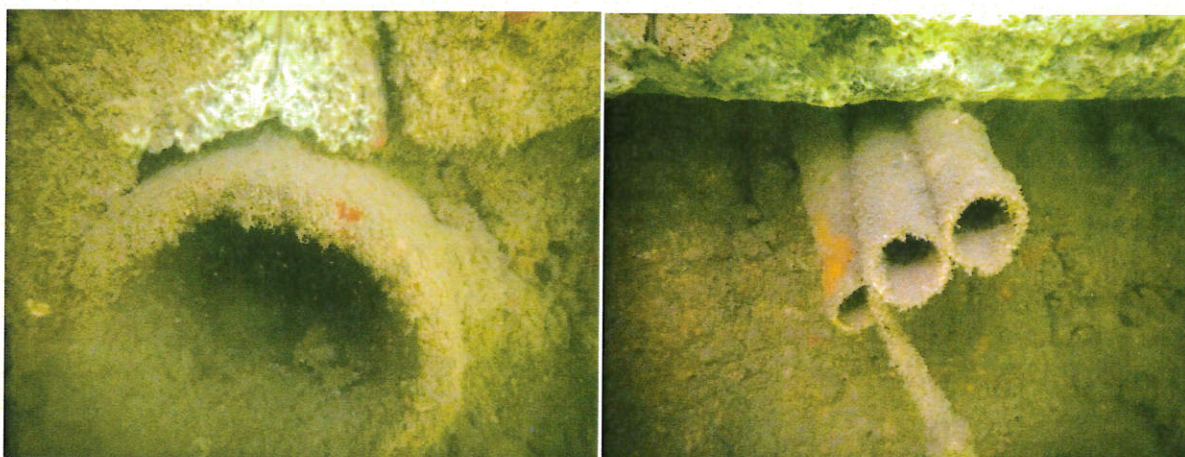
Photo 54: Abandoned outfall and electrical conduits at bulkhead.

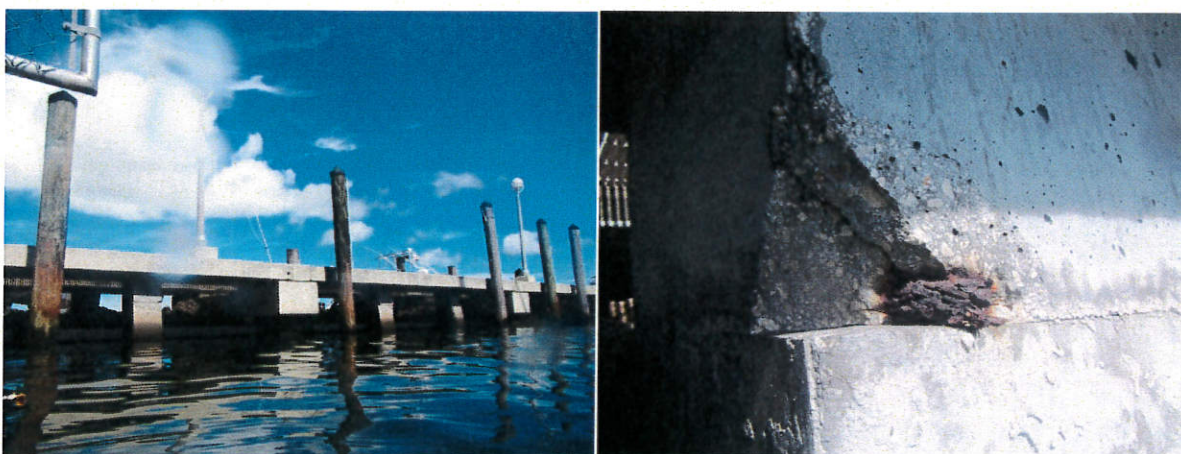
Photo 55: North Concrete Finger Pier (left). Minor concrete deterioration on few piles (right).

The current condition to the cast in place concrete piles exhibited minor deterioration. Repairs are planned under this Project and will significantly extend the life of the structure.
