**PRE-DEMOLITION ASBESTOS SURVEY**

**Curtis Park Ballpark and Pool  
1901 NW 24 Avenue  
Miami, FL 33125**

URS Project # 12640409

April 15, 2015

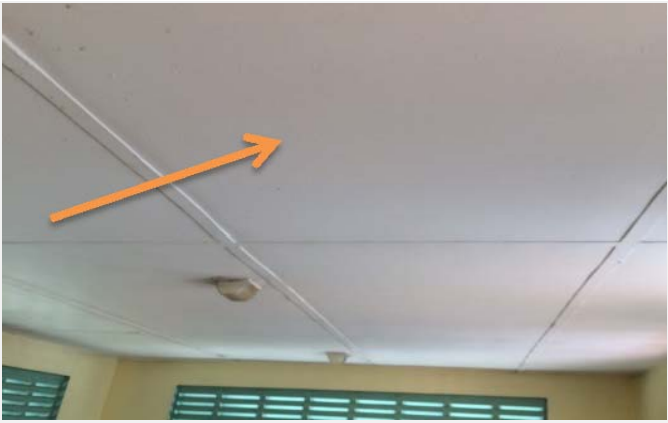
<b>HSA</b>	<b>2: 4’x8’ Cementitious Ceiling Panels</b>
<b>Asbestos Content:</b>	35% Chrysotile Asbestos
<b>Quantity</b>	Approximately 2,080 SF
<b>HSA Location(s)</b>	Pool House Building
<b>NESHAPS Category</b>	NF-2
<b>Physical Assessment</b>	Good
<b>Photo</b>

1. If the building is scheduled for demolition, any Category II Non-friable (NF-II) ACM identified in this report must be removed by a Florida licensed asbestos abatement contractor prior to demolition.
2. If abatement will be performed, URS recommends that an asbestos abatement work plan be developed to describe the appropriate engineering and administrative controls to be used for the safe and proper completion of the work. Additionally, project oversight and air monitoring should be performed by a Florida licensed asbestos consultant during asbestos abatement activities.

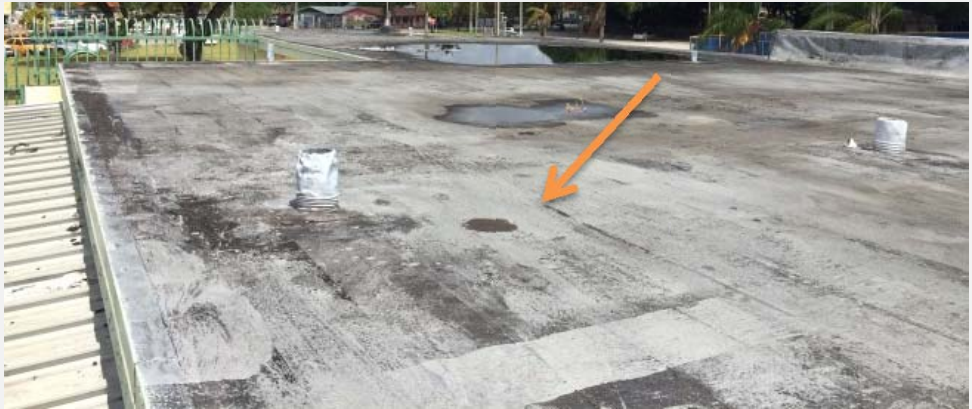
<b>HSA</b>	<b>4: Roof Flashing</b>
<b>Asbestos Content:</b>	2% Chrysotile Asbestos
<b>Quantity</b>	Approximately 440 SF
<b>HSA Location(s)</b>	Pool House Building Roof
<b>NESHAPS Category</b>	NF-I
<b>Physical Assessment</b>	Good
<b>Photo</b>

As the building is scheduled for demolition, the owner has the option of removing any Category I non-friable (NF-I) ACM to minimize potential liability and ensure compliance with EPA and OSHA regulations. However, the EPA will generally allow NF-1 ACM to remain in place during demolition as long as such materials remain in a non-friable state and are not subjected to mechanical drilling, sanding, abrading, grinding, or sawing during demolition activities. If the building is demolished with this type of ACM in place, there are several requirements of the building owner and demolition contractor that must be met in order to be in full compliance with the NESHAP regulation 40 CFR Part 61, these may include but are not necessarily limited to:

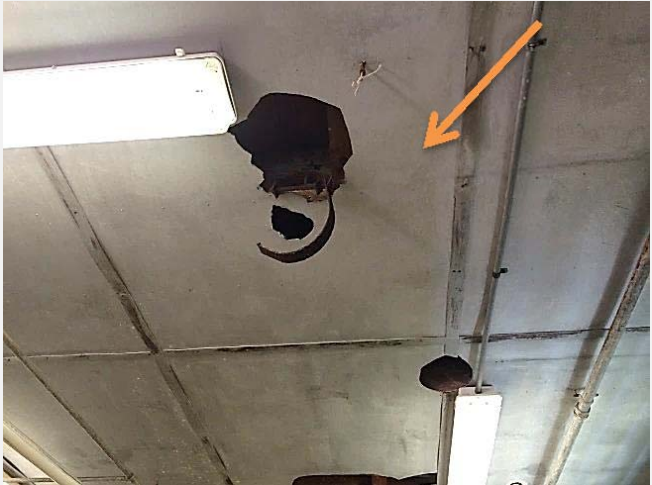
<b>HSA</b>	<b>9: 4'x8' Cementitious Ceiling Panels</b>
<b>Asbestos Content:</b>	30% Chrysotile Asbestos
<b>Quantity</b>	Approximately 810 SF
<b>HSA Location(s)</b>	Pump House Building
<b>NESHAPS Category</b>	NF-2
<b>Physical Assessment</b>	Good
<b>Photo</b>

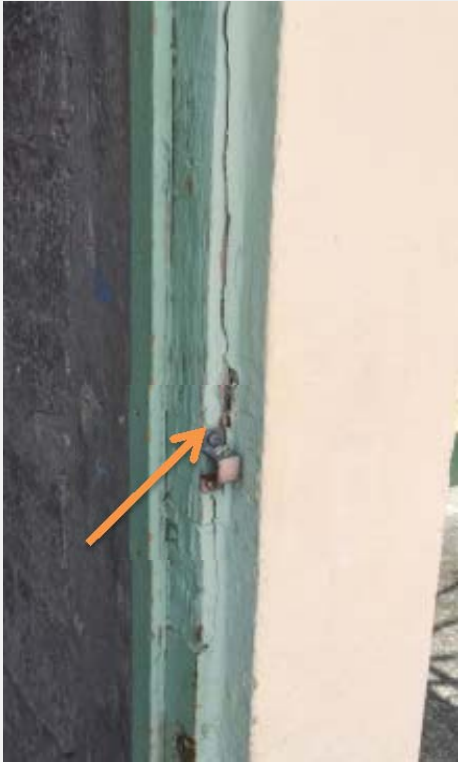
<b>HSA</b>	<b>10: Door Frame Caulk</b>
<b>Asbestos Content:</b>	2% Chrysotile Asbestos
<b>Quantity</b>	Approximately 24 LF on One Door
<b>HSA Location(s)</b>	Pump House Building
<b>NESHAPS Category</b>	NF-I
<b>Physical Assessment</b>	Good
<b>Photo</b>

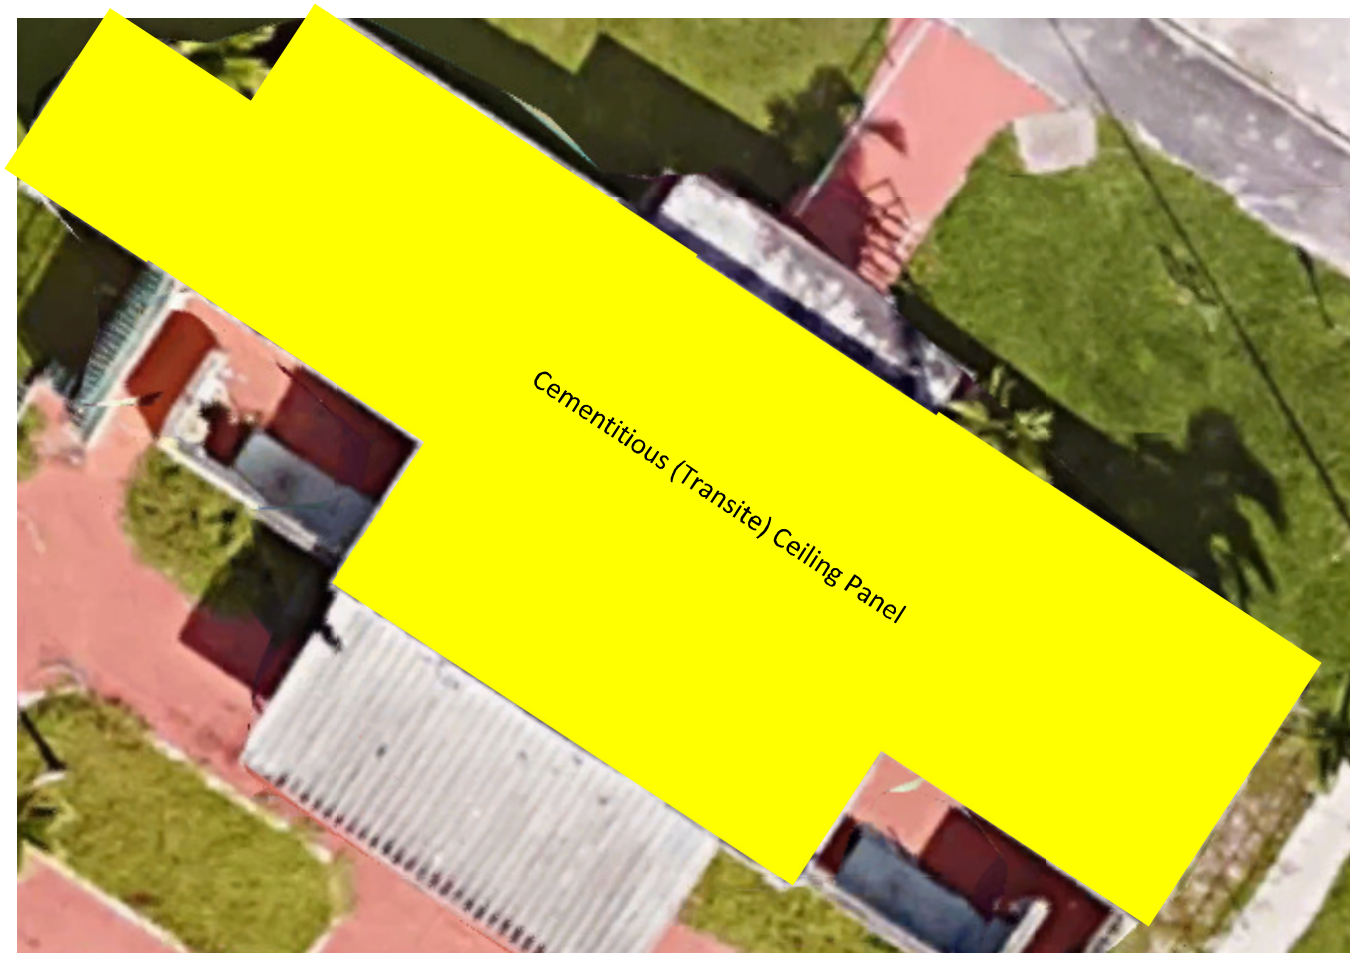
**Figure 1  
 POOL HOUSE  
 BUILDING**

**HSA 2 - ACM 4'x8'  
 CEMENTITIOUS  
 CEILING PANEL IN  
 POOL HOUSE  
 BUILDING**

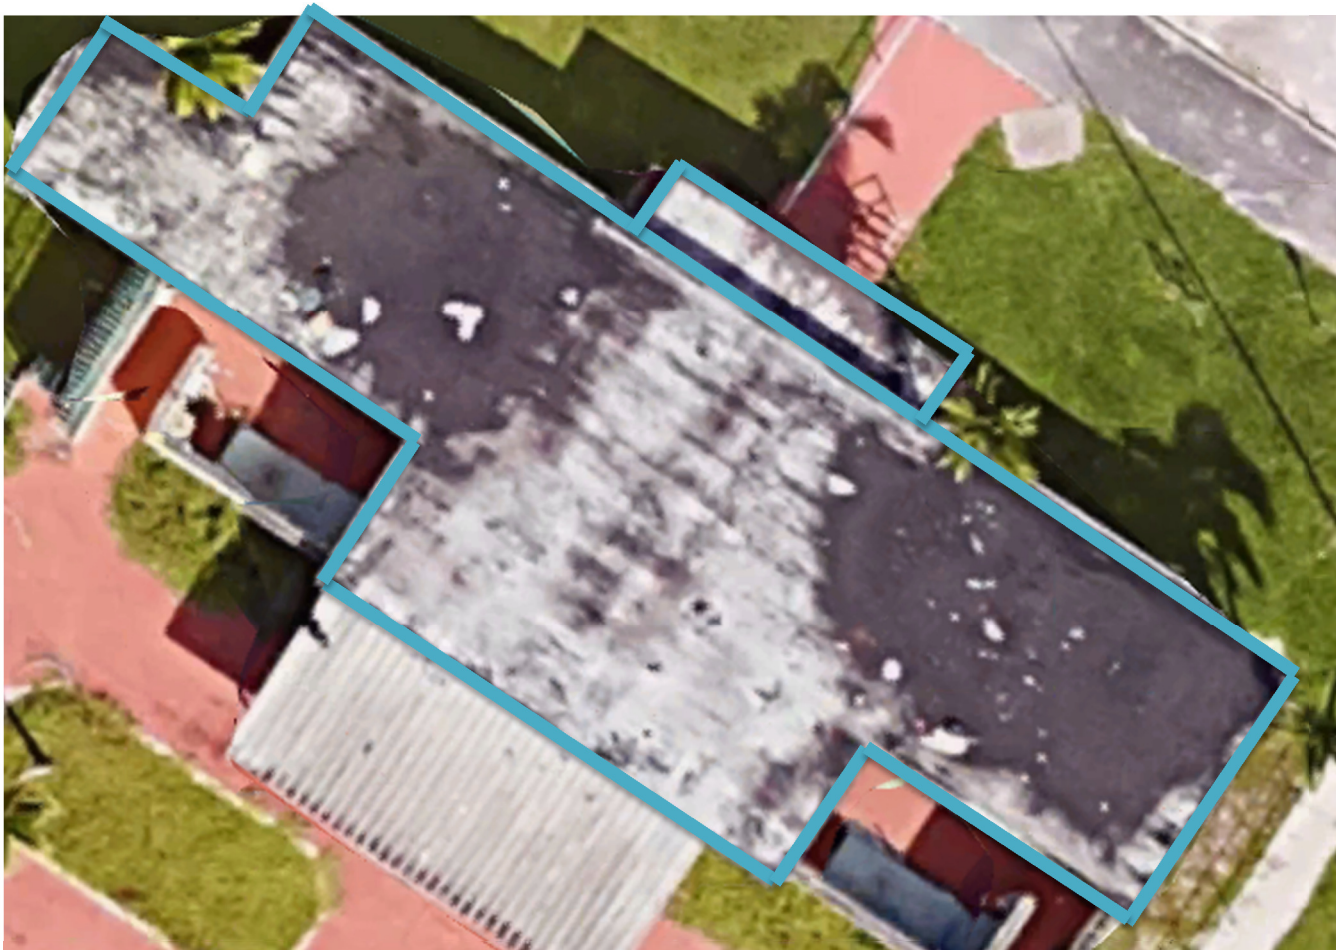
### Figure 2

HSA 4 - ACM  
ROOF FLASHING

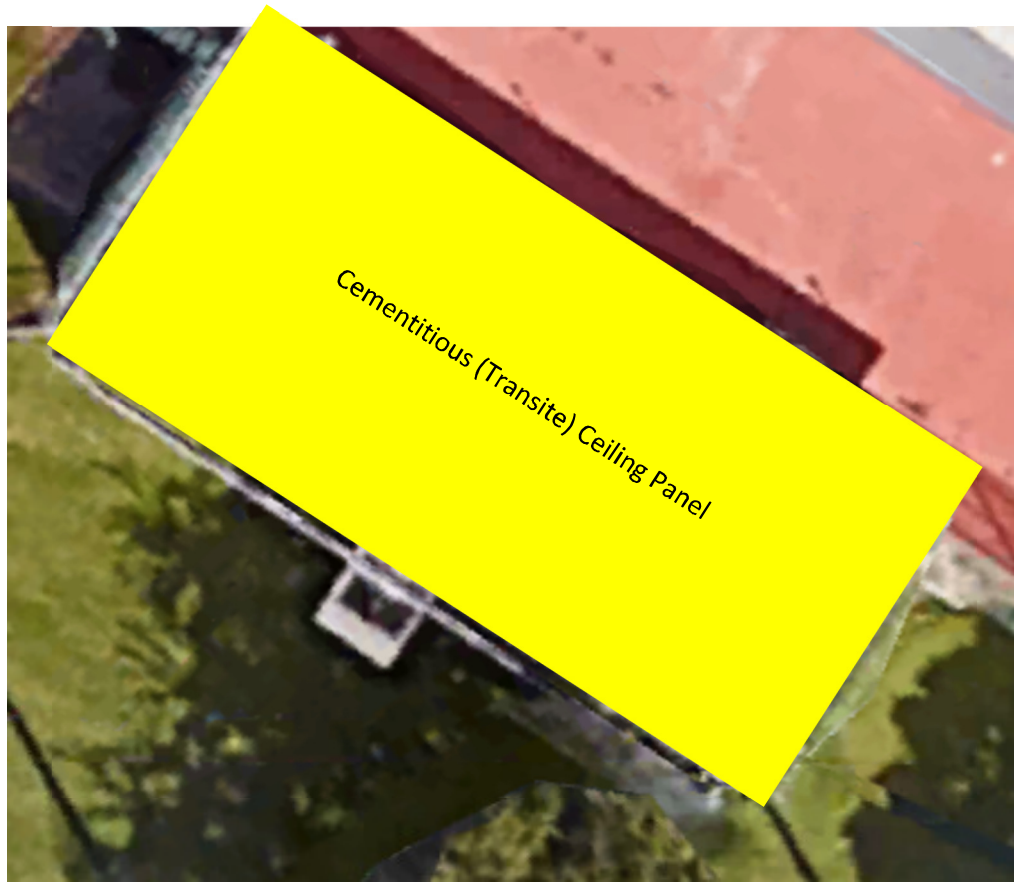
**Figure 3**  
**PUMP HOUSE**  
**BUILDING**

HSA 9 - ACM 4'x8'  
CEMENTITIOUS  
CEILING PANEL IN  
PUMP HOUSE  
BUILDING
