ENVIRONMENTAL SITE ASSESSMENT-PHASE I

**COMMERCIAL BUILDING- FORMER CITIZENS BANK
1367 N MIAMI AVENUE
MIAMI, FLORIDA 33132**

**MAY 2017
17-ESA 114**

USSE Project Number: 17-ESA 114

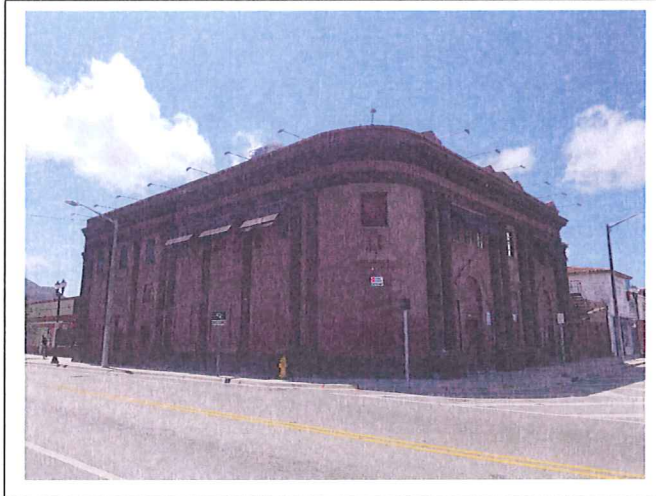
Photograph #1)
Subject Site: Bank Building
1367 N Miami Avenue
Miami, Florida 33132

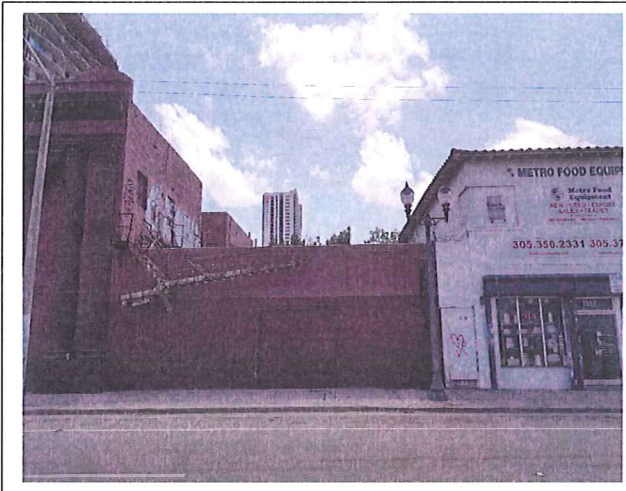
Photograph #15)
South structure of subject site

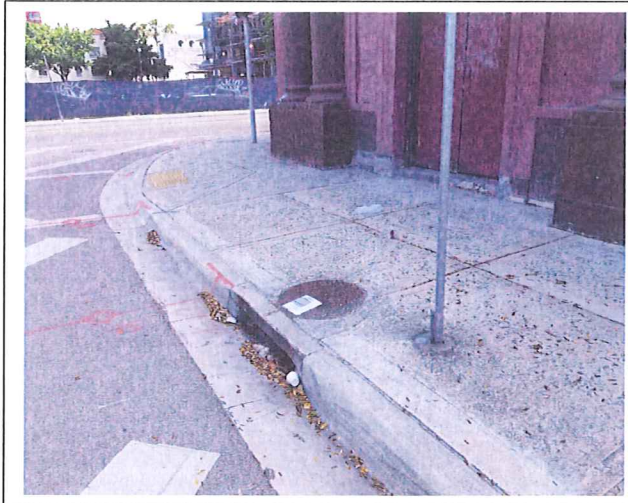
Photograph #17)
Storm drain West of subject site

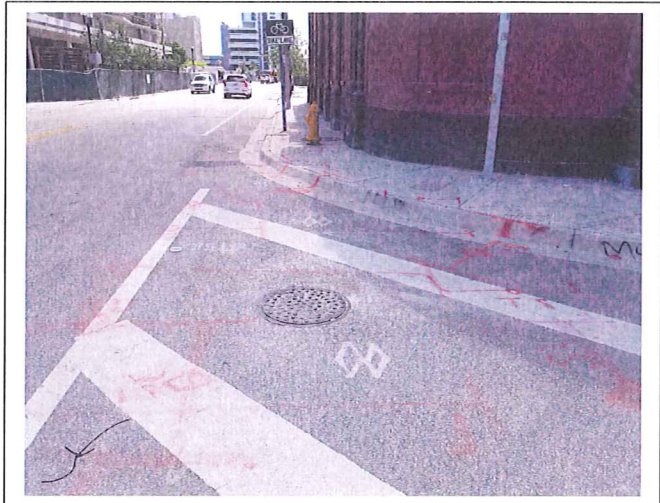
Photograph #18)
Sewer manhole Northwest corner of subject site

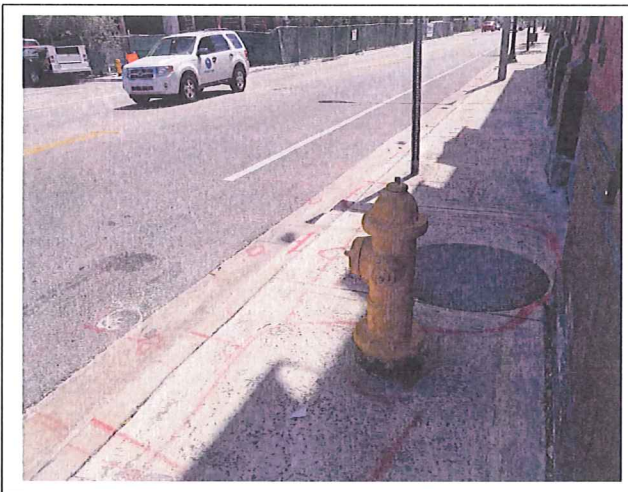
Photograph #19)
Fire hydrant Northwest corner of subject site

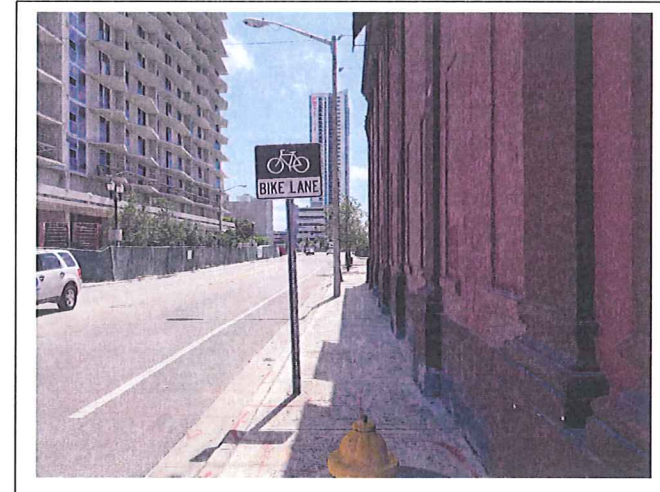
Photograph #20)
Viewing East along the North side of subject site
