**REPORT OF A GEOTECHNICAL EXPLORATION**

**NW 24 AVENUE IMPROVEMENTS**  
**NW 24<sup>TH</sup> AVENUE, FROM NW 28<sup>TH</sup> STREET TO NW 30<sup>TH</sup> STREET**  
**NW 25<sup>TH</sup> AVENUE, FROM NW 31<sup>ST</sup> STREET TO NW 32<sup>ND</sup> STREET**  
**NW 32<sup>ND</sup> STREET, FROM NW 22<sup>ND</sup> AVENUE TO NW 23<sup>RD</sup> AVENUE**  
CITY OF MIAMI  
PROJECT No. B-30723  
MIAMI-DADE COUNTY, FLORIDA

HRES Project No. HR15-1138R

July 11, 2016

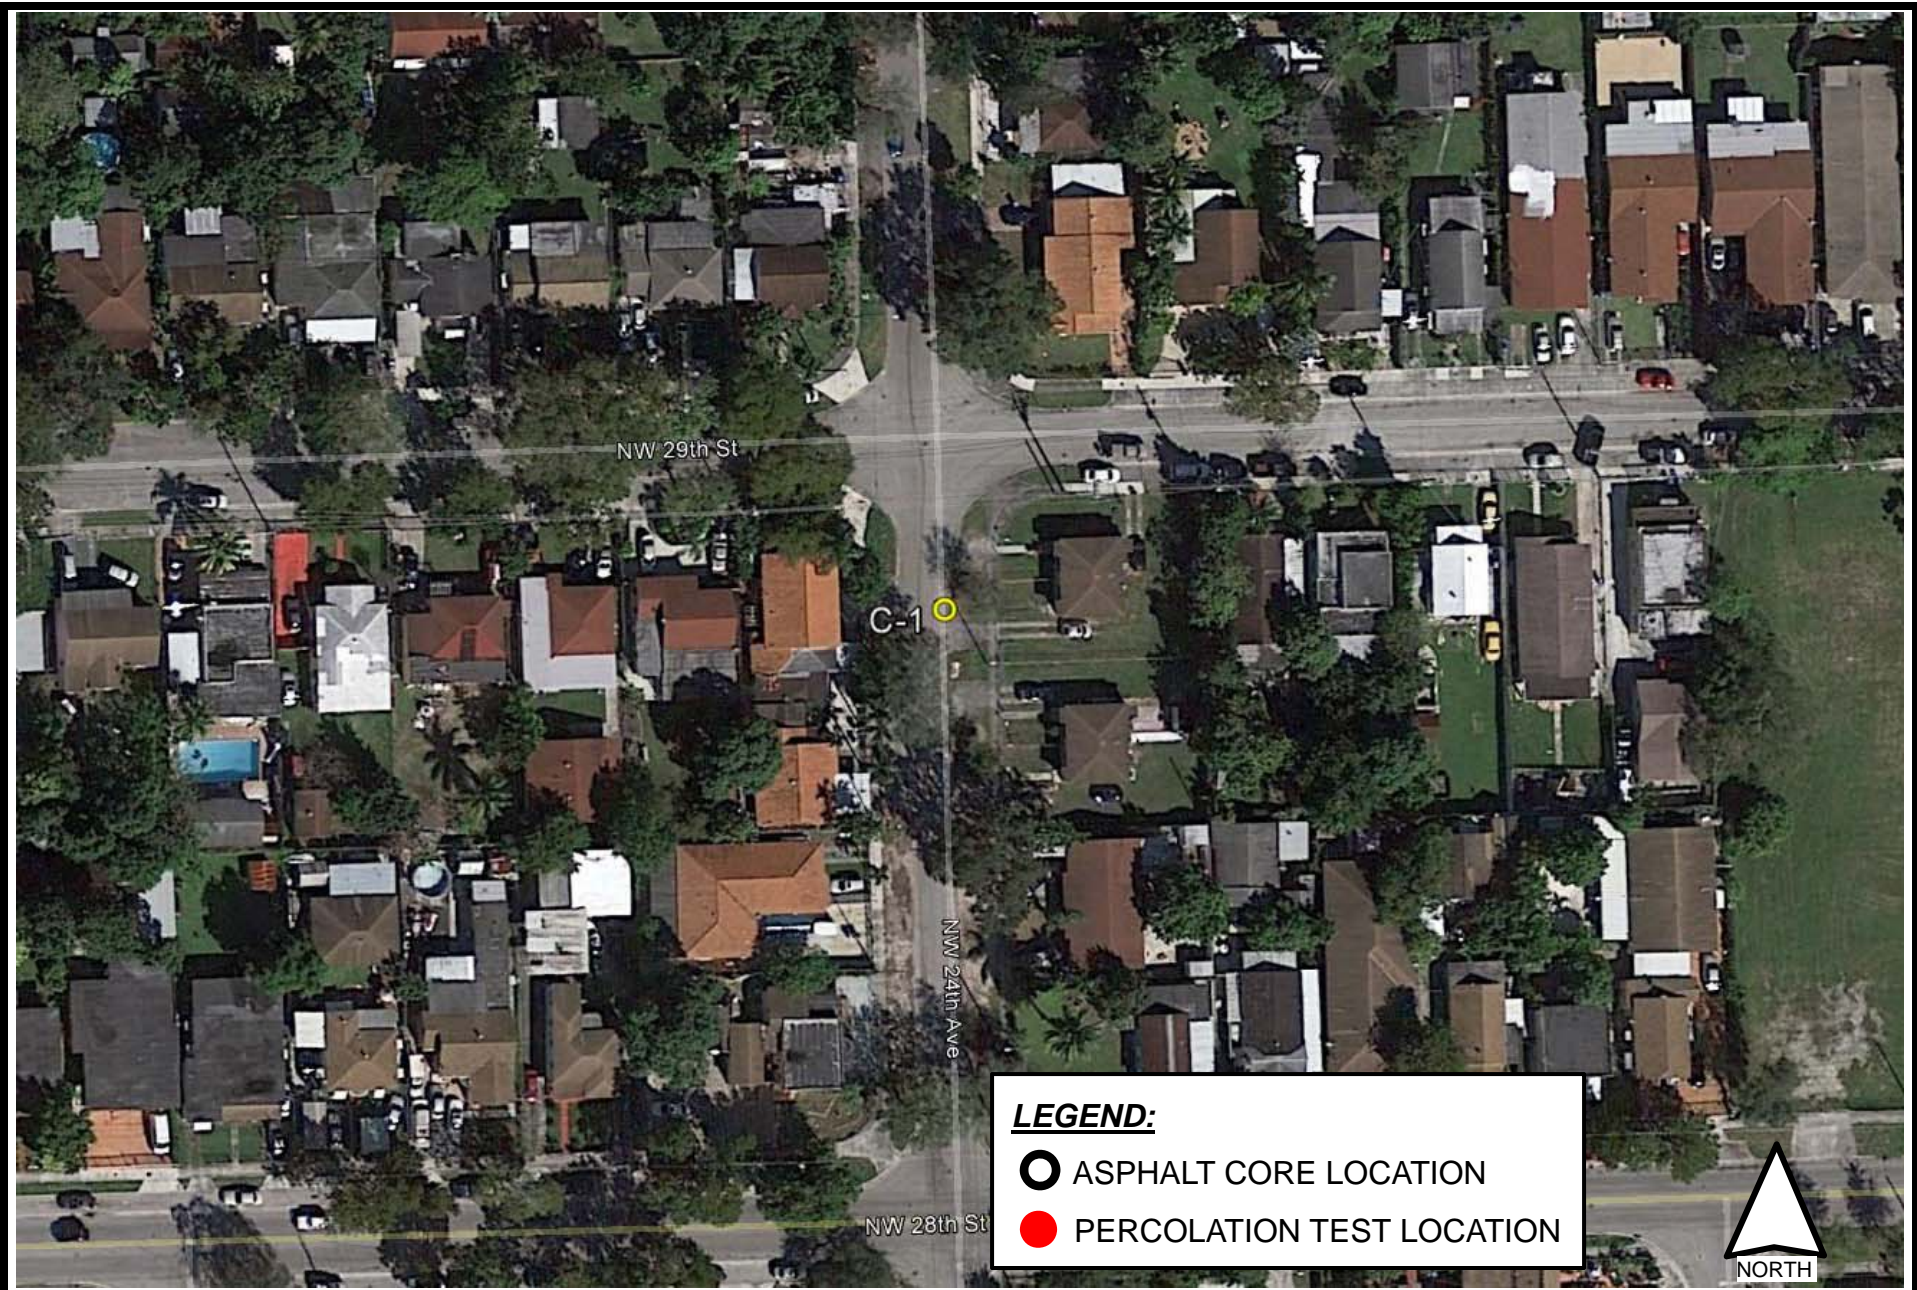
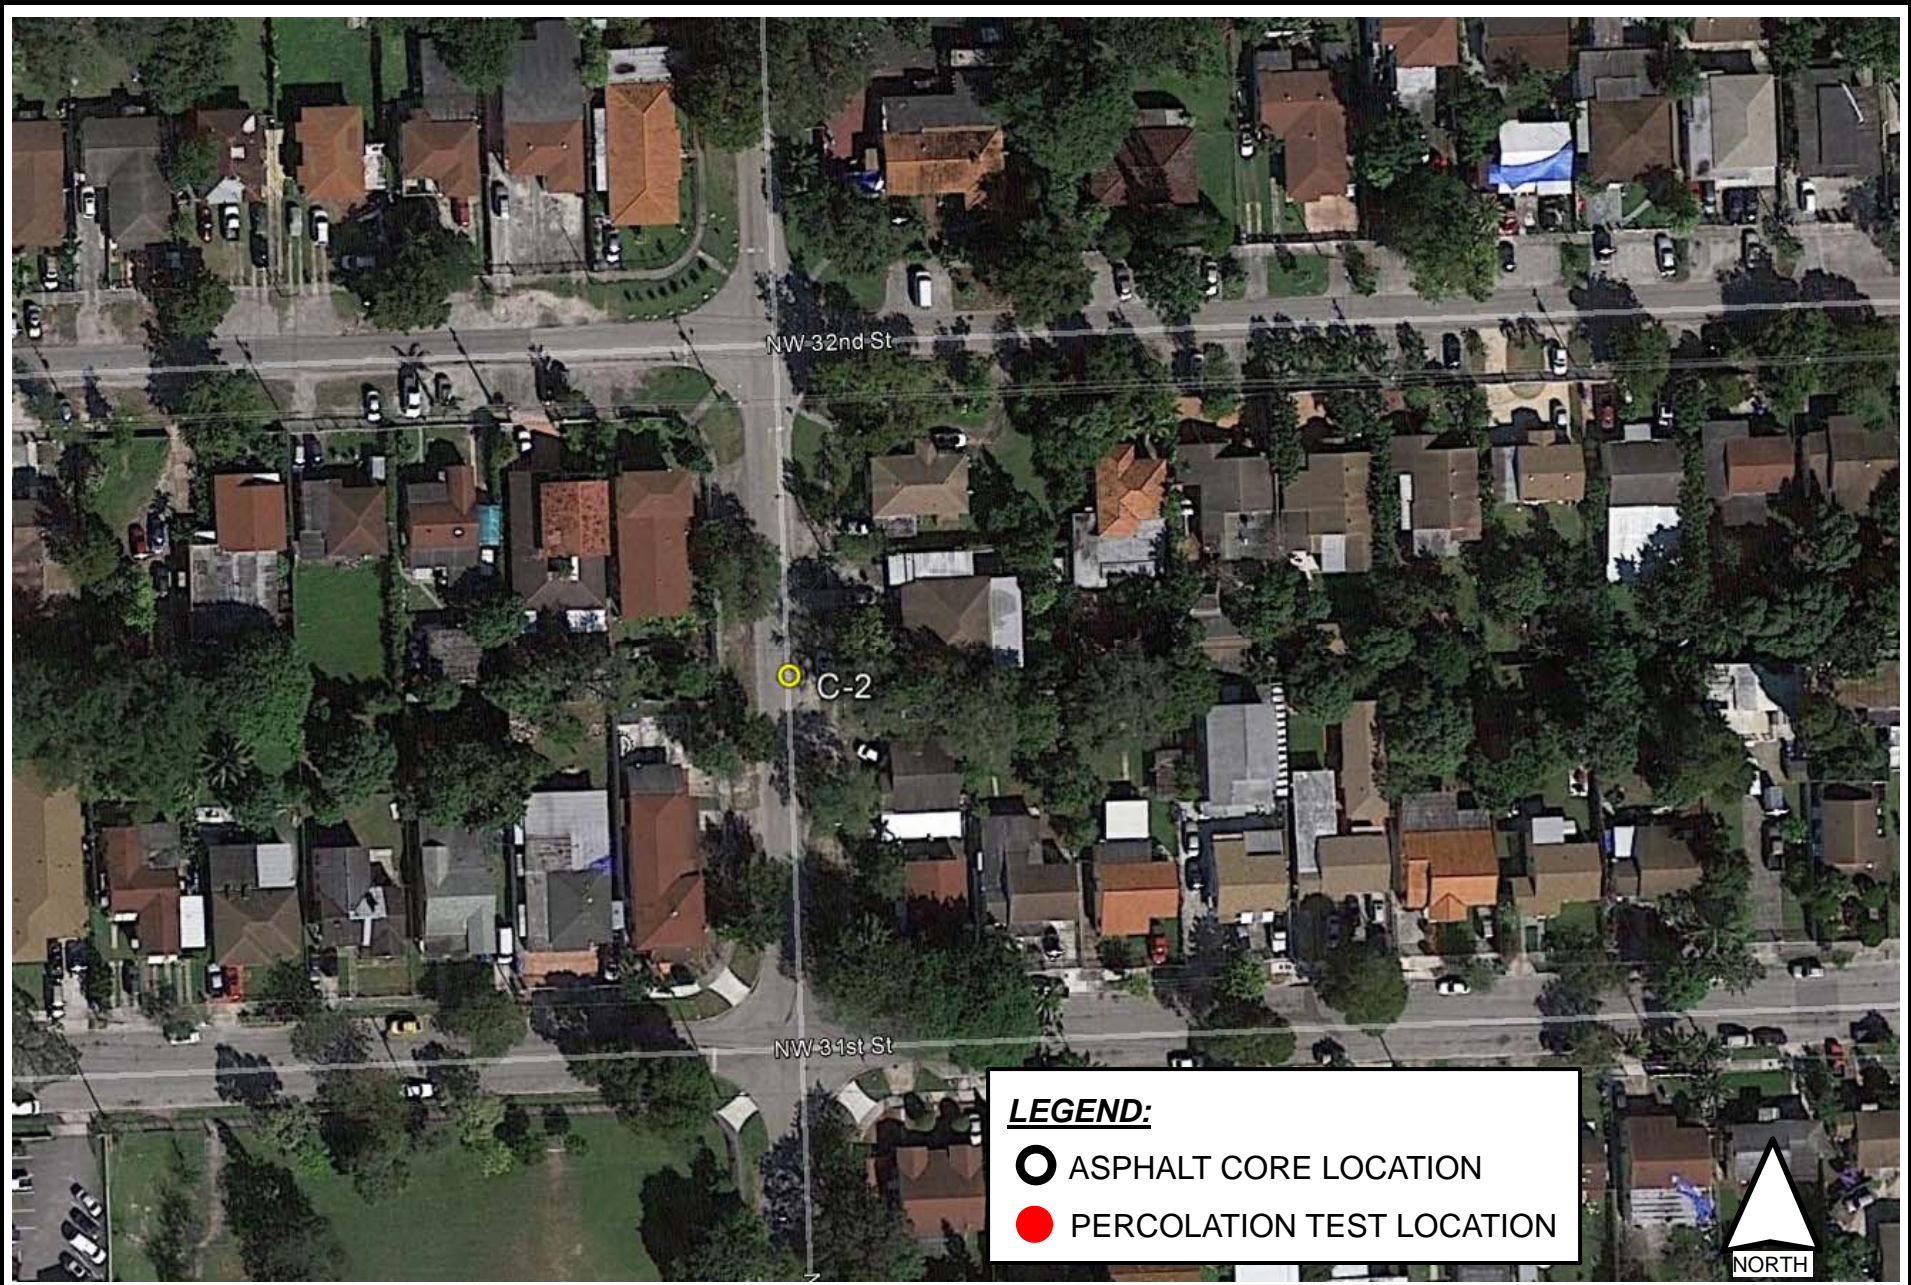
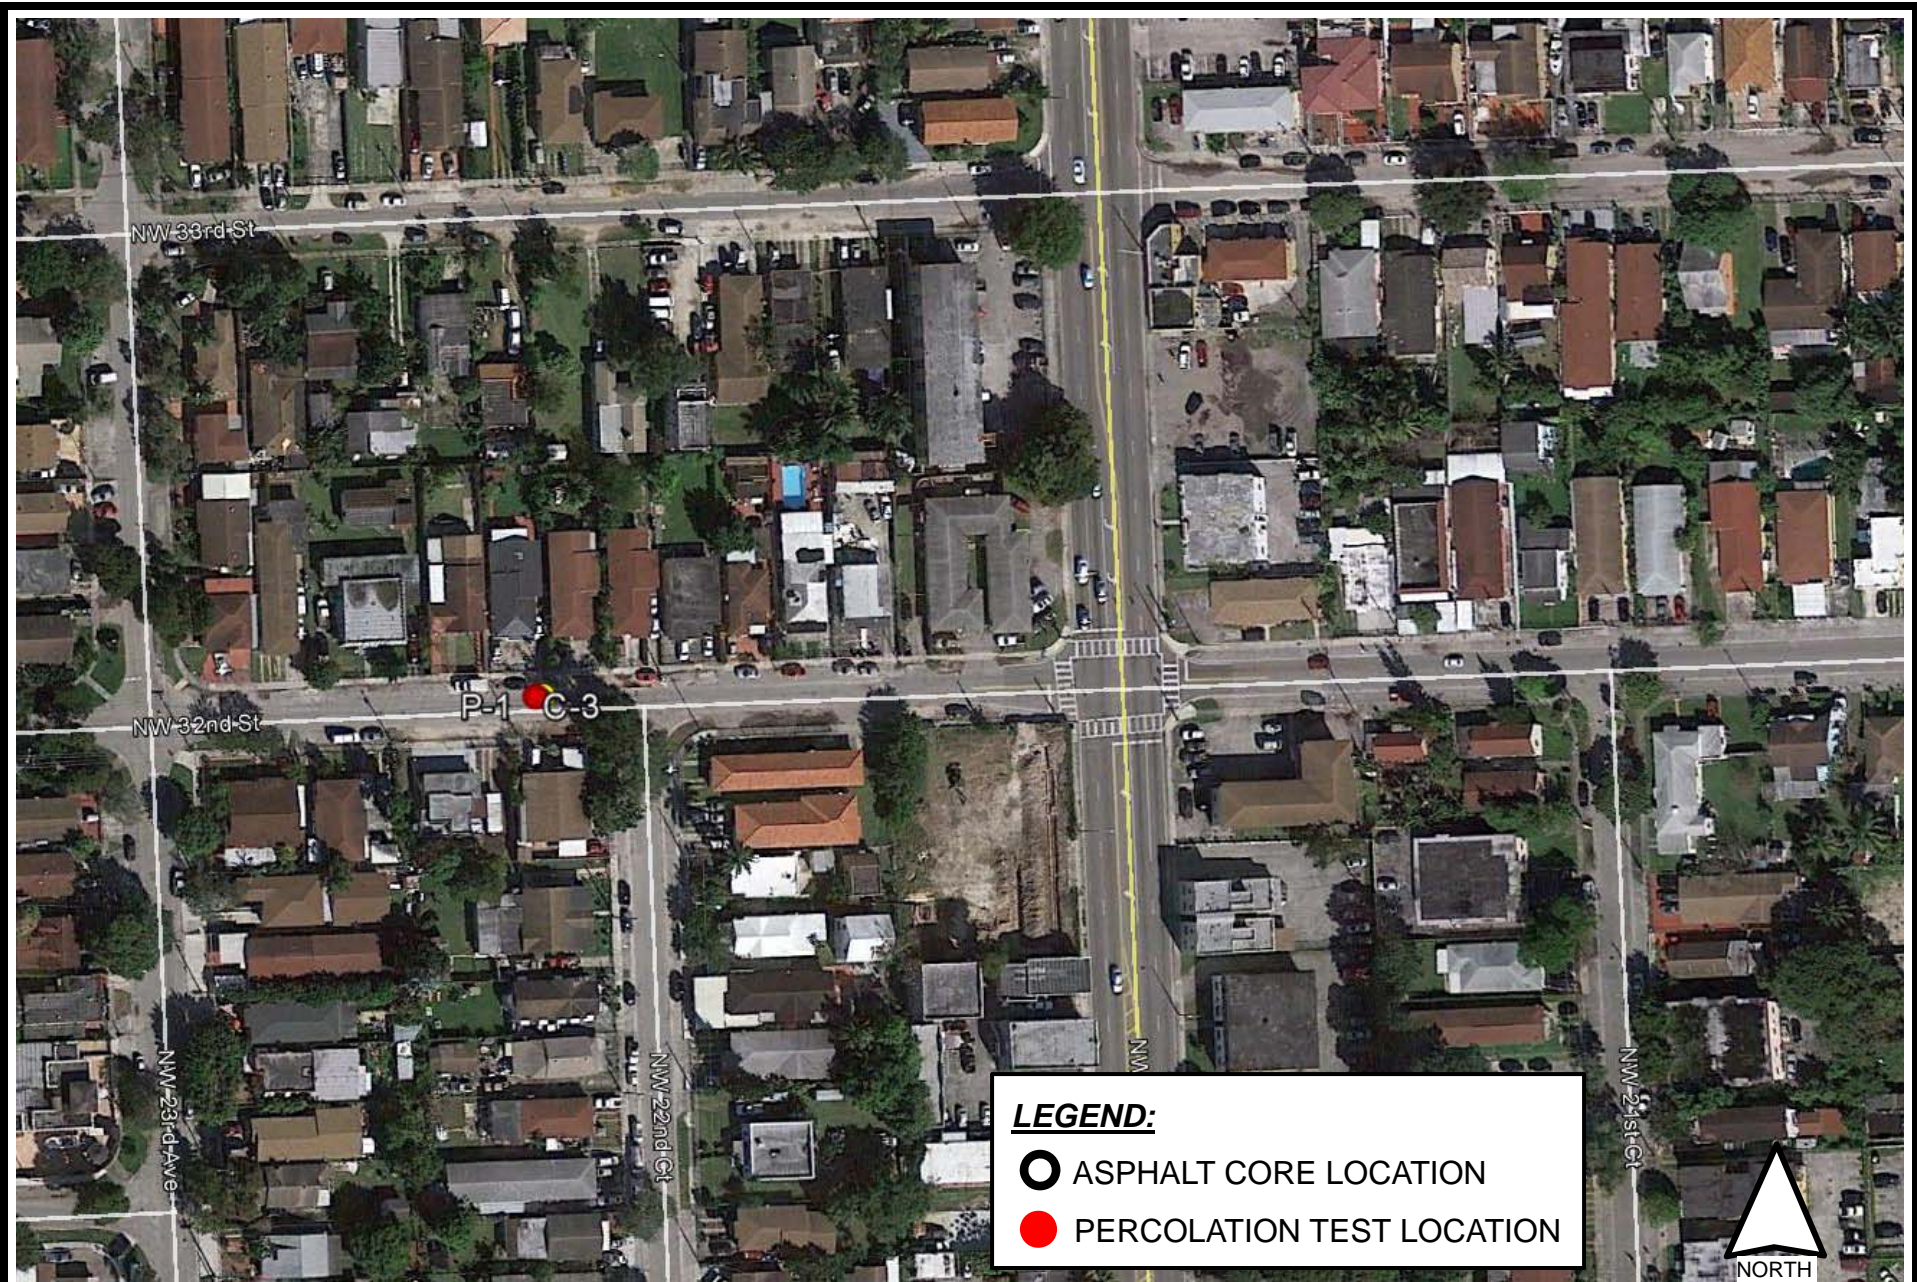
**FIELD EXPLORATION PLANS**

One SFWMD Usual Open - Hole Constant Head Percolation test was performed at the subject site. Percolation Test P-1 was conducted at one depth interval: from 0 to 15 feet. The reported location of the percolation test (northing and easting) is approximate. Attached is the Field Exploration Plan showing the percolation test location.

The location of the percolation test was selected by your office. The test was located in the field by our personnel using tape measurements from existing landmarks.

TEST NUMBER	PLANE COORDINATES		STATION	OFFSET ft.	REFERENCE BASELINE
	NORTHING	EASTING			
C-1	534649.658	907564.814	NA	NA	NA
C-2	535546.972	906855.503	NA	NA	NA
P-1	535778.031	908463.064	NA	NA	NA
C-3	535778.031	908467.999	NA	NA	NA

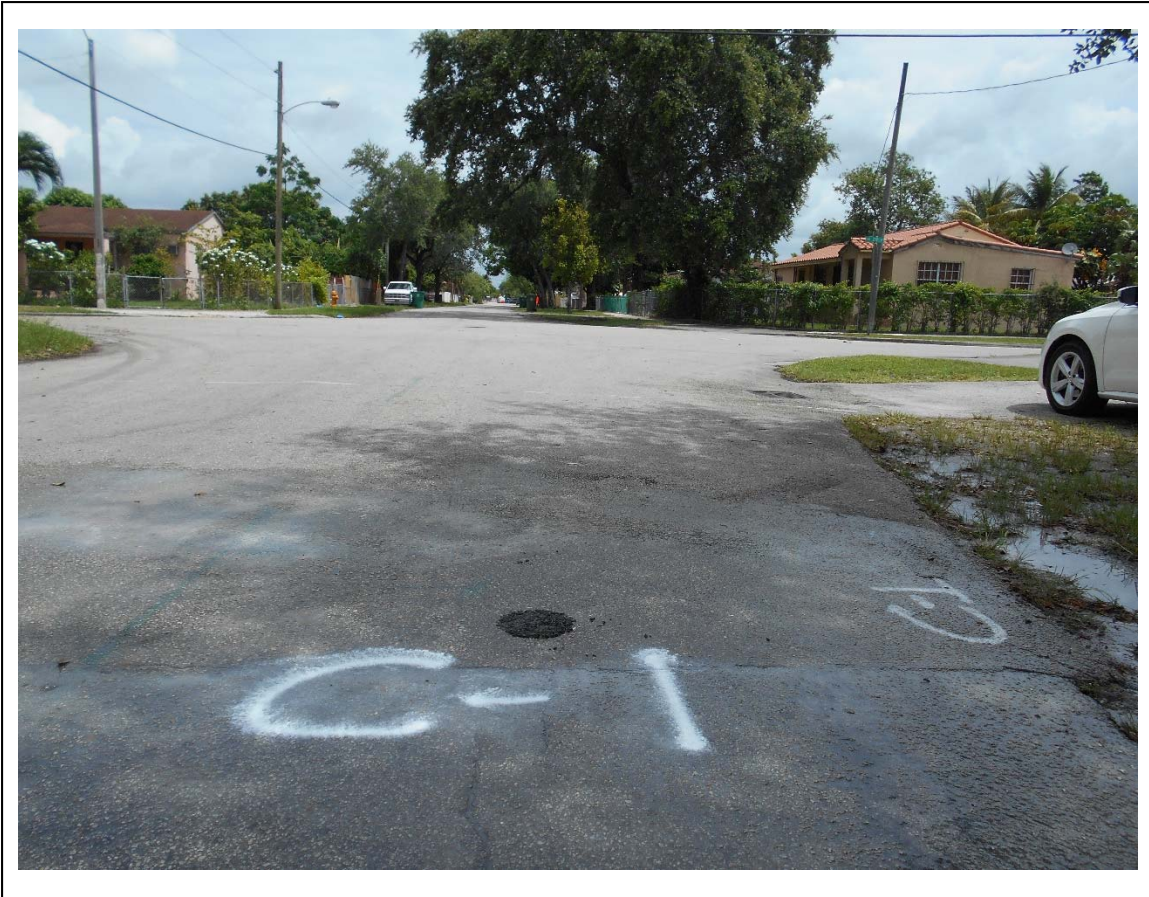
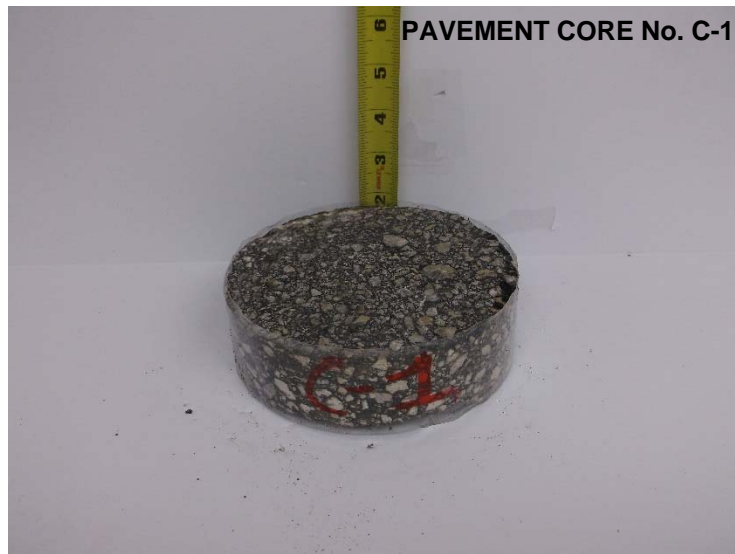
Core No. C-1 Core Thickness: 1.7 in.

Base –The base layer generally consisted of very dense to medium dense light brown silty fine sand with some limerock with an assigned AASHTO classification of A-1-b (from visual classification). The base material presented “N” values ranging from 5/6” to 30/6” blows/foot. The thickness of the base was measured from the slit-spoon sampler. The base thickness is approximately 6.0 inches.

Stabilized Subgrade – The stabilized subgrade layer at C-1 and C-2, consisted of medium dense brown silty fine sand with some limerock with an assigned AASHTO classification of A-1-b (from visual classification). The stabilized subgrade layer at C-3, consisted of medium dense brown silty fine sand with traces of limerock with an assigned AASHTO classification of A-2-4 (from visual classification). The minimum thickness of the layer is approximately 12.0 inches.

Northing: 534649.7 Offset: 907564.8

Core No.	Total Asphalt Thickness, inches	Base Thickness, inches	Stabilized Subgrade Thickness, inches
C-1	1.7	6.0 (A)	>12.0 (A)
C-2	1.0	6.0 (A)	>12.0 (A)
C-3	2.8	6.0 (A)	>12.0 (B)

FPID No.: _____					Name: <u>NW 24th Avenue Improvements</u>					Lanes: _____													
County: <u>Miami-Dade County</u>					S.R. No. _____					Shoulder Type & Cond: <u>Paved</u>													
Median Curbed? <u>N/A</u>					From _____					Inside: _____													
					To. _____					End Sta: _____ Length: _____ Outside: _____													
					Beg. Sta. _____					Other? _____ Curb & Gutter? _____													
					Lawn? _____																		
HRES Core No.	Core No.	Northing	Easting	Lane	Lane Description	Wheel Path	Pavement Layer (inches)							Base (inches)	Sub Base (inches)	Crack				Pavement Condition	Rut Depth (in)	Rut Location (ft)	Cross Slope (ft/6ft)
							Top									Depth (ft)	Type	Class	Extent				
							FC-2	FC-4	S-I	Binder	Type II	ABC-1	Core Length (in)										
C-1	1	534649.7	907564.8	NB	NW 24th Ave. NB lane at 4.0 ft. from EOP	Y	---	---	--	---	---	---	1.7	6.0 (A)	>12.0 (A)	---	---	---	---	P	--	--	--

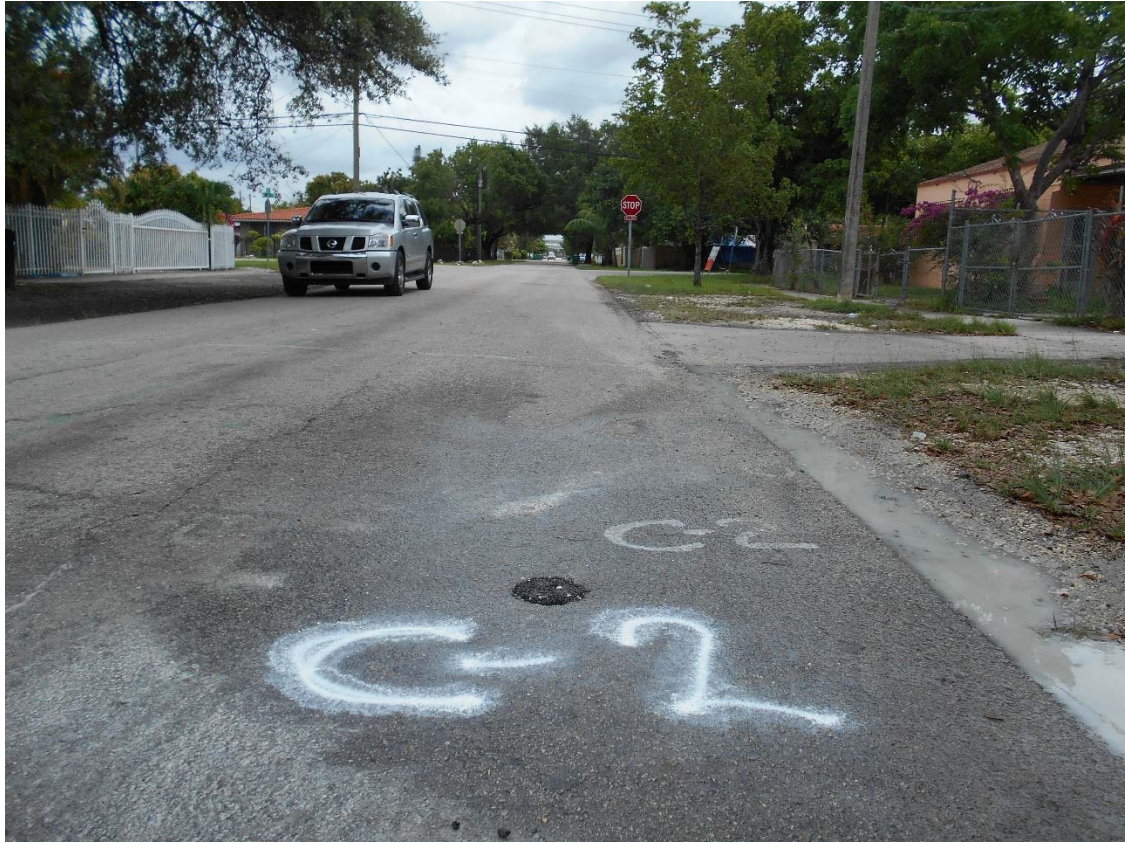
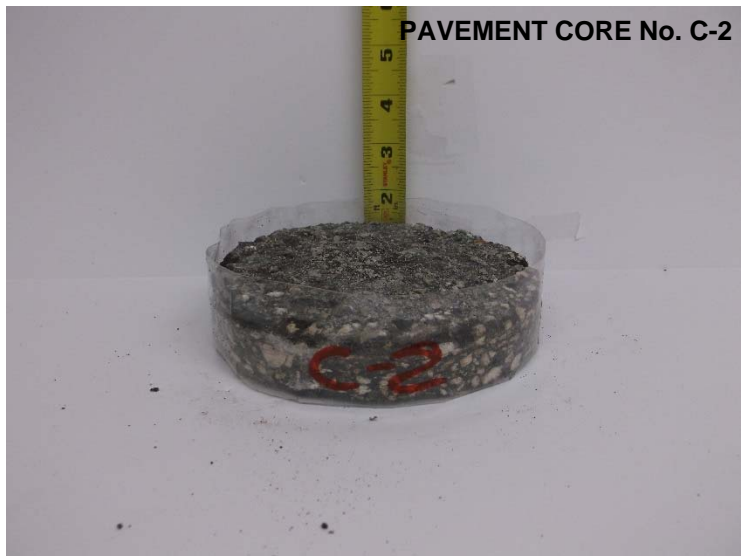
Core No. C-2 Core Thickness: 1.0 in.

Northing: 535547.0 Offset: 906855.5

C-2	2	535547.0	906855.5	NB	NW 25th Ave. NB lane at 3.5 ft. from EOP	Y	---	---	--	---	---	---	1.0	6.0 (A)	>12.0 (A)	---	---	---	---	P	--	--	--
C-3	3	535778.0	908468.0	WB	NW 32nd St. WB lane at 4.0 ft. from EOP	Y	---	---	--	---	---	---	2.8	6.0 (A)	>12.0 (B)	---	---	---	---	P	--	--	--

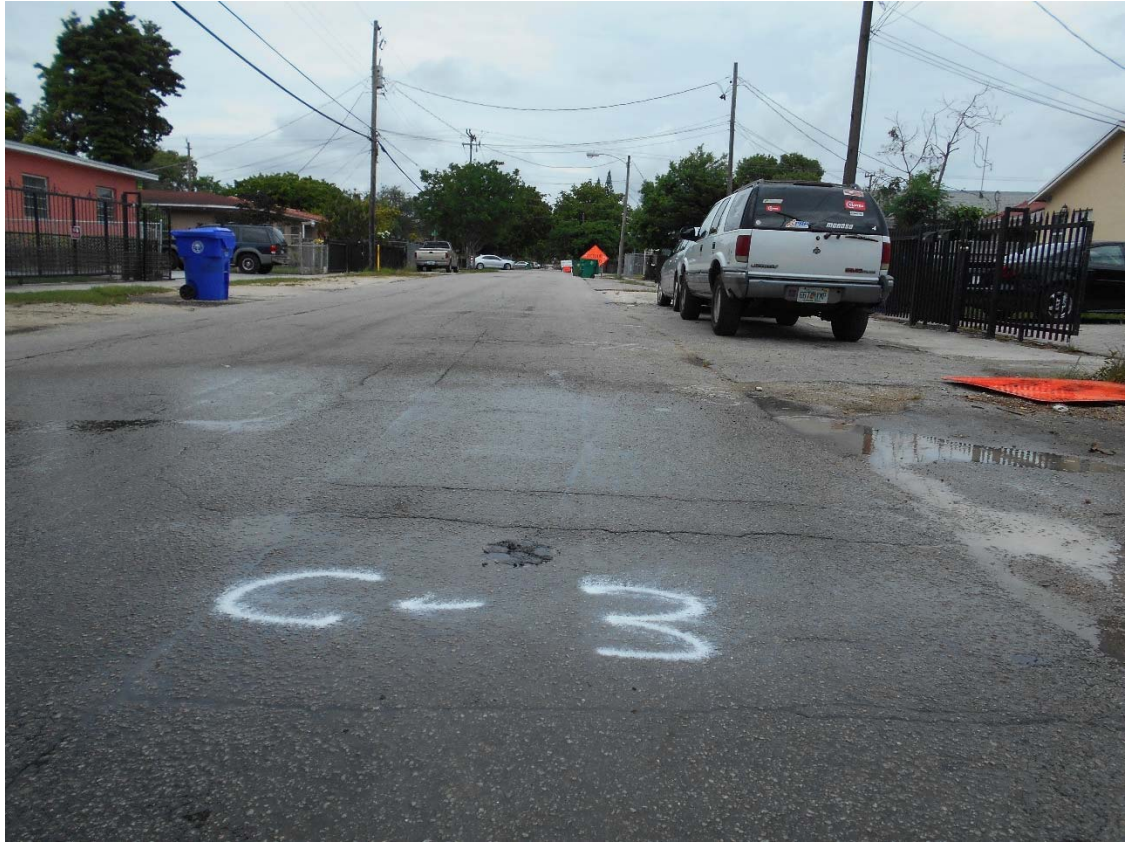
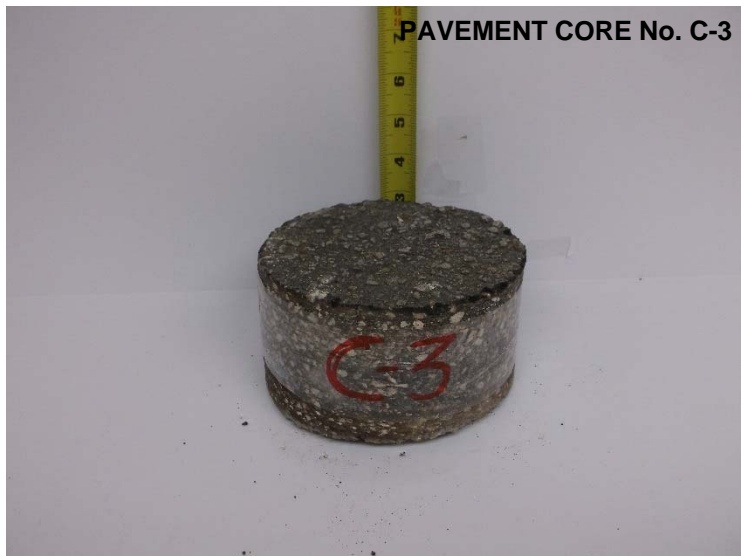
Core No. C-3 Core Thickness: 2.8 in.

Northing: 535778.0 Offset: 908468.0
