Field Observation Report

Project Name: MDC Miami Marine Stadium Boat Ramp

Date: 8/2/2017

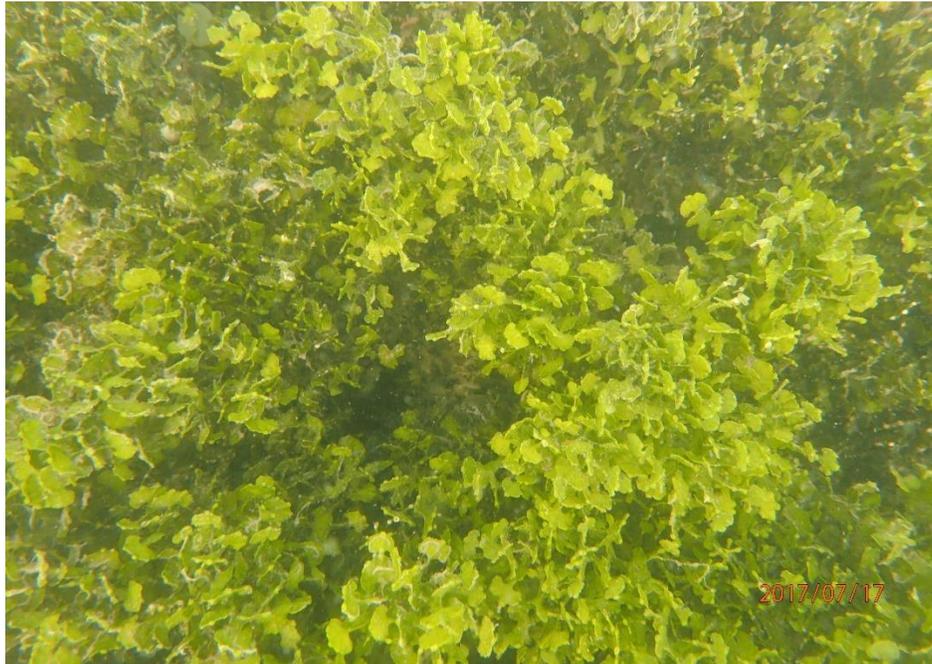
Photo 1. Dense *Halimeda* sp. macroalgae commonly found throughout the marine survey area.

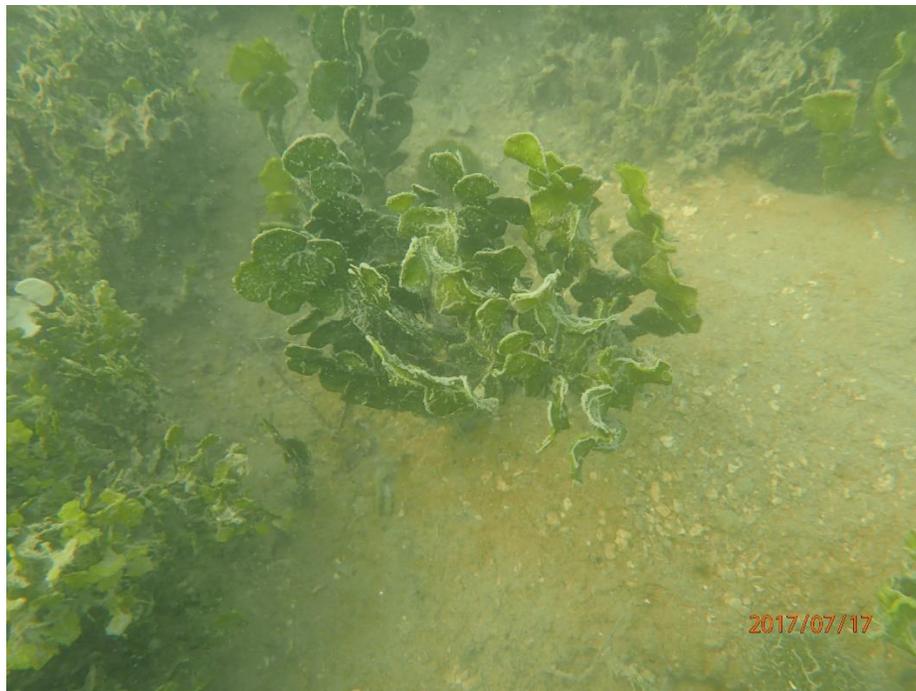
The substrate consisted of a sandy/silty, muck bottom layer with scattered shell and rock and dense macroalgae (refer to Photos 1-2). Three (3) species of seagrass were observed within the project boundaries including, turtle grass (*Thalassia testudinum*), shoal grass (*Halodule wrightii*) and manatee grass

Photo 2. *Halimeda* sp. with sand, muck, crushed rock and shell. Typical conditions throughout the survey area.

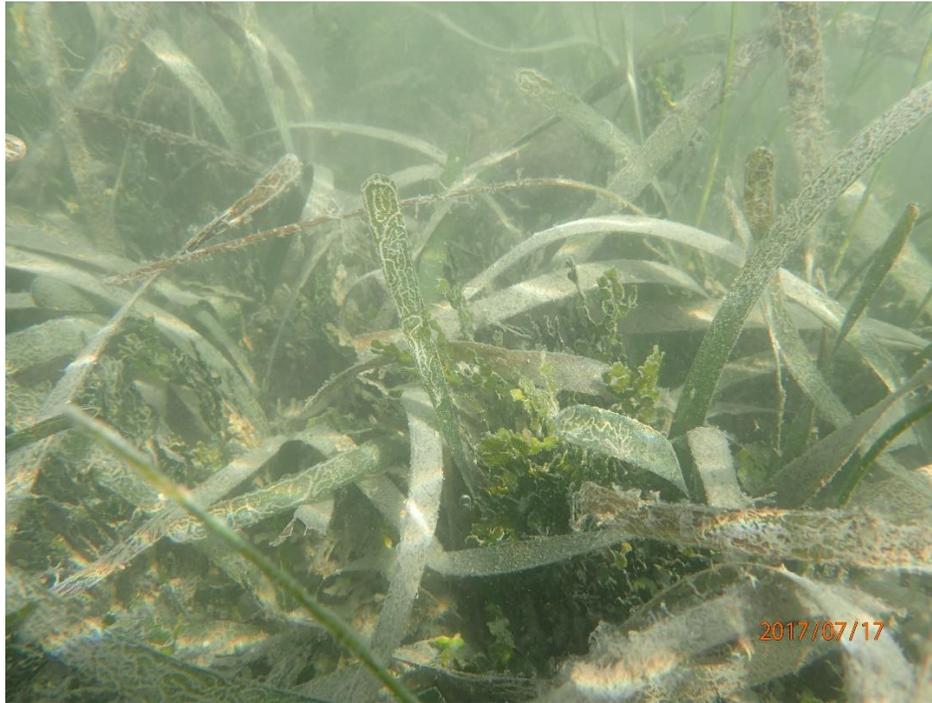
(*Syringodium filiforme*) (refer to Photos 3-4). Seagrass was observed in varying densities (sparse, moderate and dense) along all Transects, except Transect 6, which was devoid of marine resources. Seagrass was

Photo 3. *Syringodium filiforme*, *Thalassia testudinum* and *Halimeda* sp.

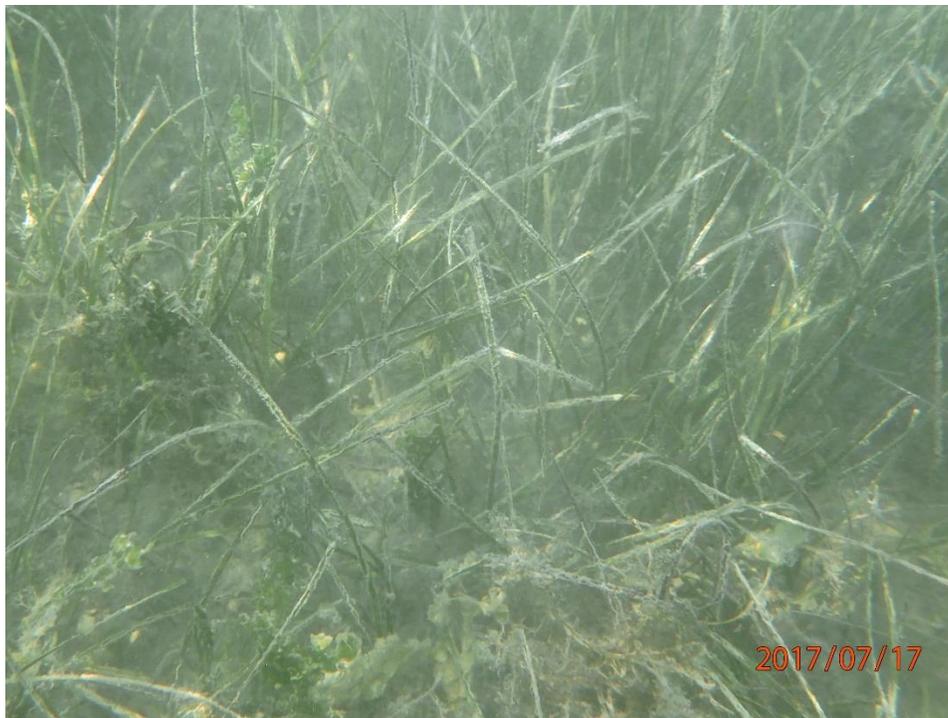
observed mainly within 10 to 35 feet from the shoreline and concentrated at the east and west ends of the Project site, with the middle of the Project site predominantly barren of seagrass. Patches of moderate density seagrass were observed along Transects 2, 3, 11 and 12 (refer to Photo 4). A patch of dense shoal grass was observed along Transect 3, approximately 10-14 feet from the shoreline.

Photo 4. Moderate density *Halodule wrightii* and *Halimeda* sp. macroalgae.

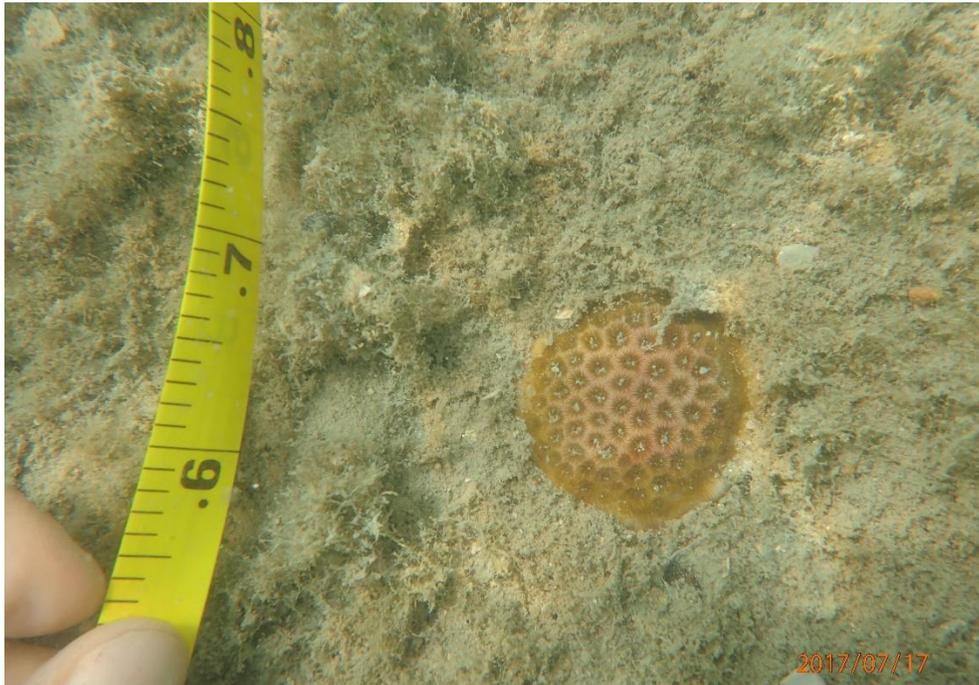
Approximately 52 massive starlet corals (*Siderastrea siderea*) corals were observed on the existing boat ramp, within 18 feet waterward of the shoreline. Most corals were observed within 8 to 10 feet waterward of the shoreline (refer to Photo 7). Two (2) corals were approximately 3 inches in diameter, 5 corals were between 1.5 and 2.5 inches in diameter, while the remaining corals were 1 inch or less in diameter (refer to Table 3). Two (2) small sponges were observed on the existing boat ramp between Transects 6 and 7. No other marine resources of significance were observed during the survey.

Photo 5. *Siderastrea siderea* coral observed on the existing concrete boat ramp.

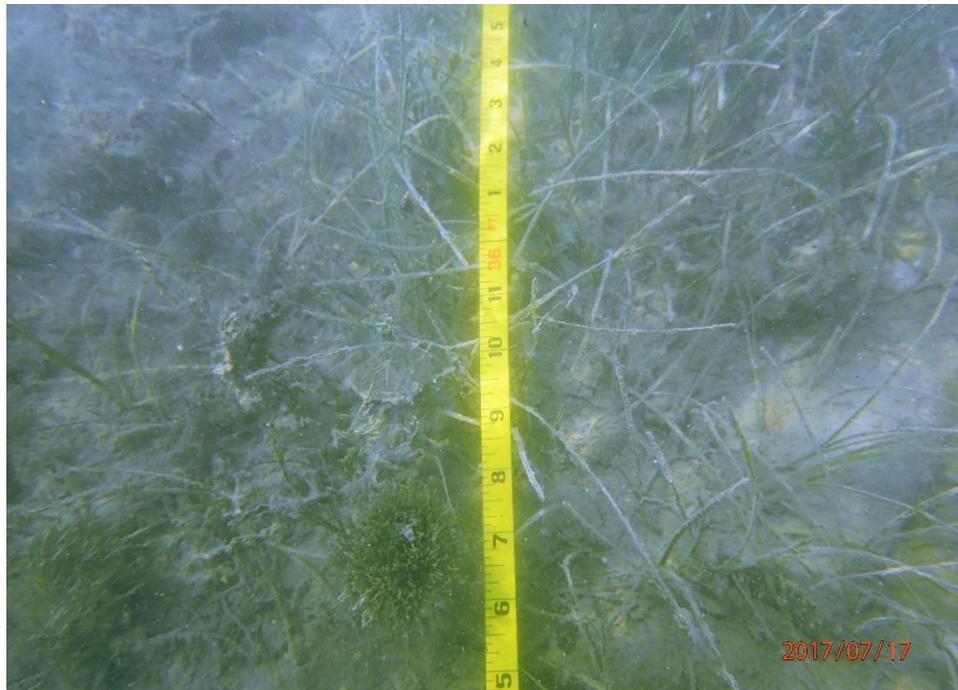
Photo 6. Sparse *Halodule wrightii* and *Penicillus capitatus*.

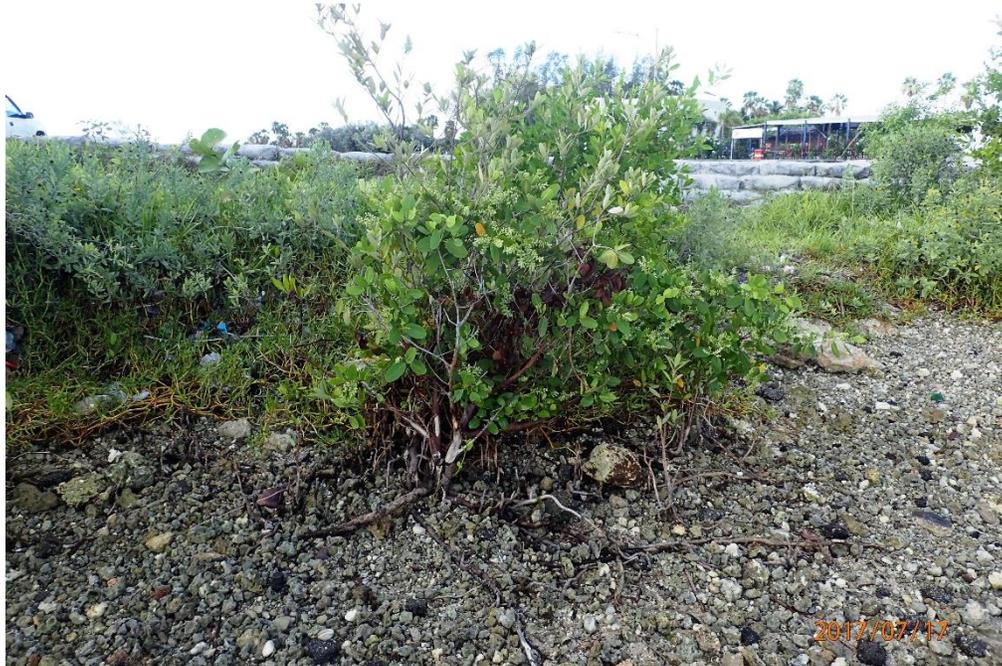
Vegetation begins waterward of the concrete bags, adjacent to the asphalt parking lot, approximately 15 feet landward of the waterline at the time of the survey. Three (3) white mangroves (*Laguncularia racemosa*), 1 black mangrove (*Avicennia germinans*), 4 silver buttonwood trees (*Conocarpus erectus*) and 3 seagrape (*Coccoloba uvifera*) saplings were observed within this area, as well as saltmeadow cordgrass (*Spartina patens*), sea-oxeye-daisy (*Borrchia frutescens*), an Australian pine (*Casuarina* sp.) and seaside mahoe (*Thespesia populnea*) (refer to Photos 6 and 7).

Photo 7. *Laguncularia racemosa*, *Conocarpus erectus* and *Avicennia germinans*.

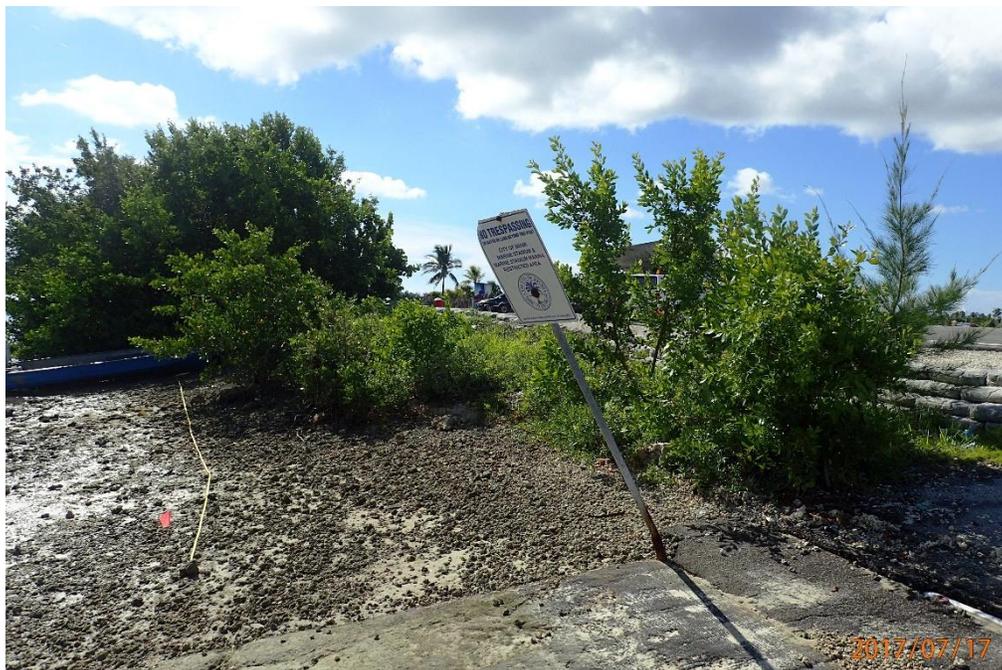
Photo 8. View of the adjacent shoreline (looking east).

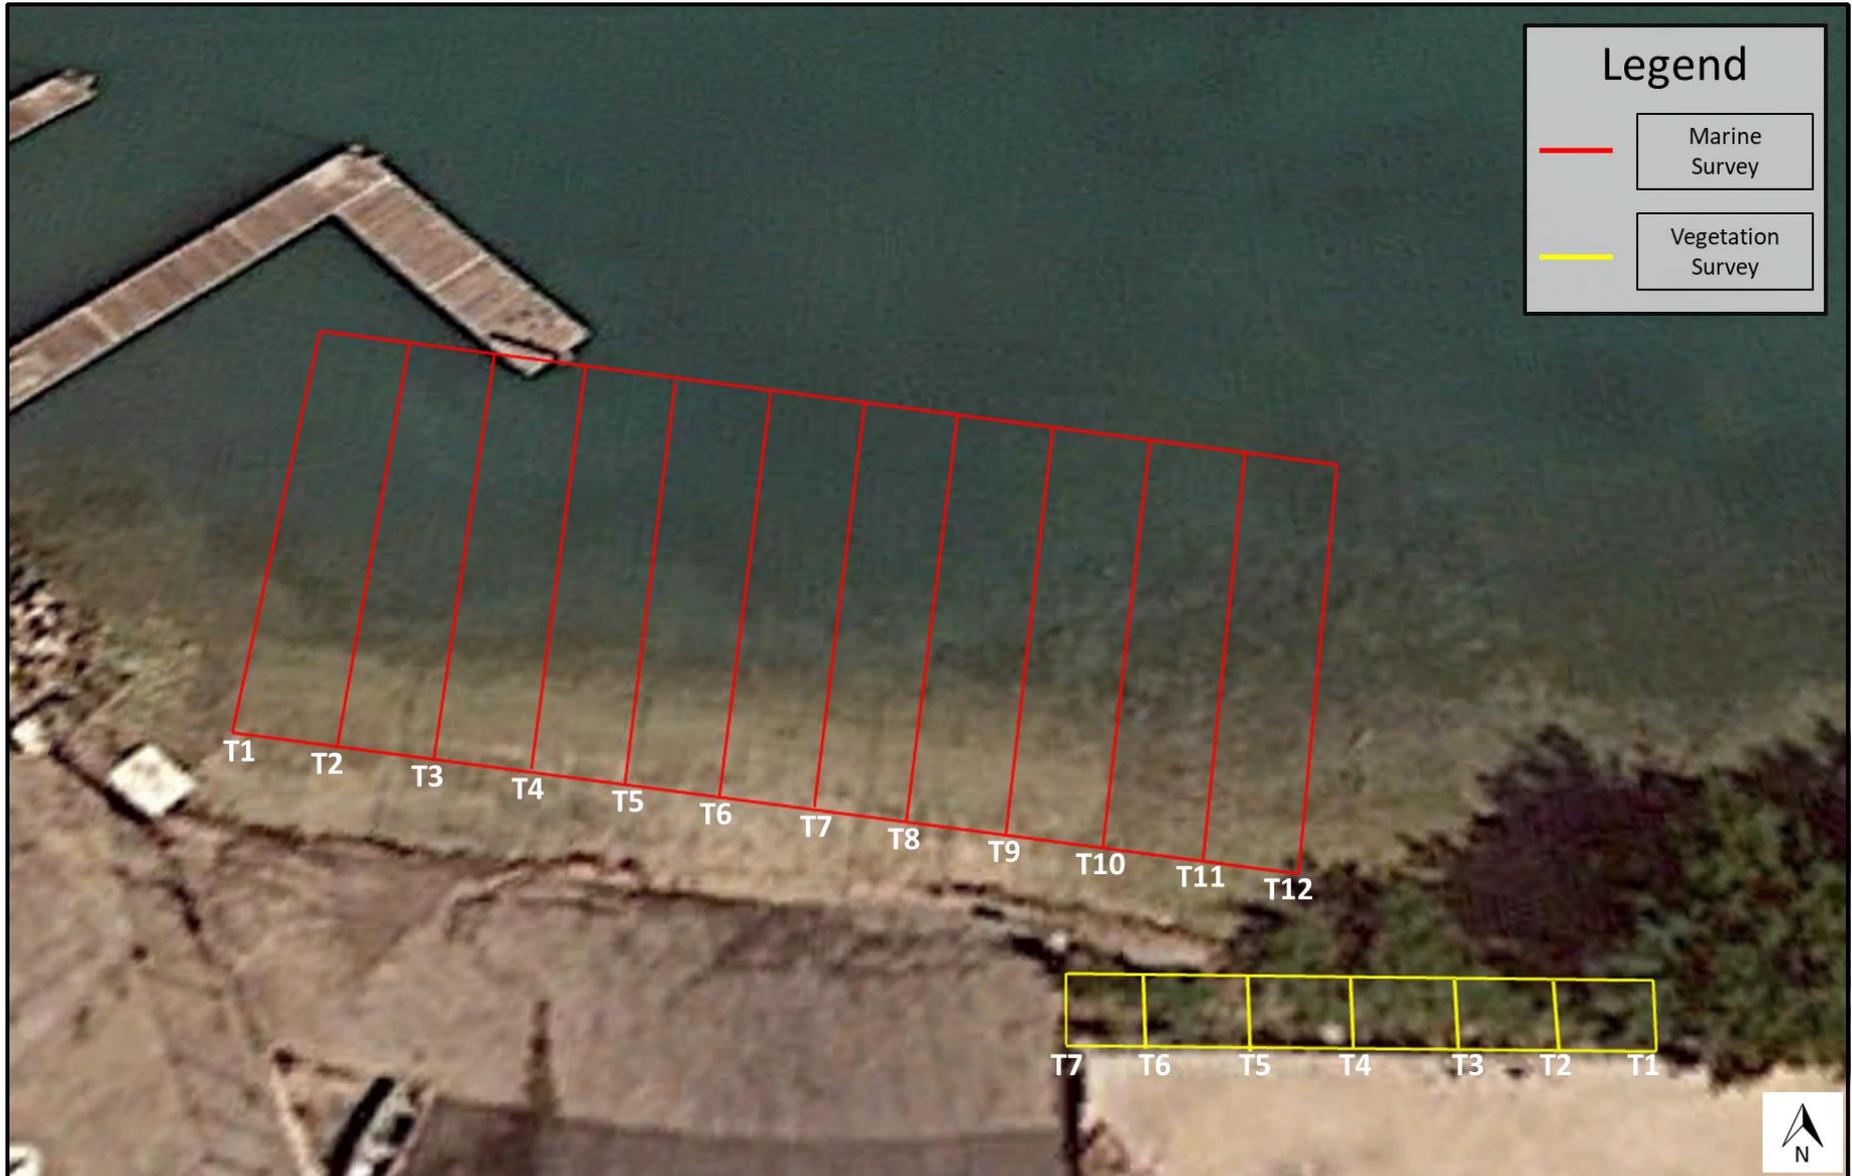
Figure 1. Map of Marine and Vegetation Survey Areas

The shoreline was used as a reference point to determine the location of marine resources. The NOAA Tides and Currents datum was utilized to determine the approximate shoreline location at the time of the survey. Refer to Figure 1 for a map of the surveyed area.

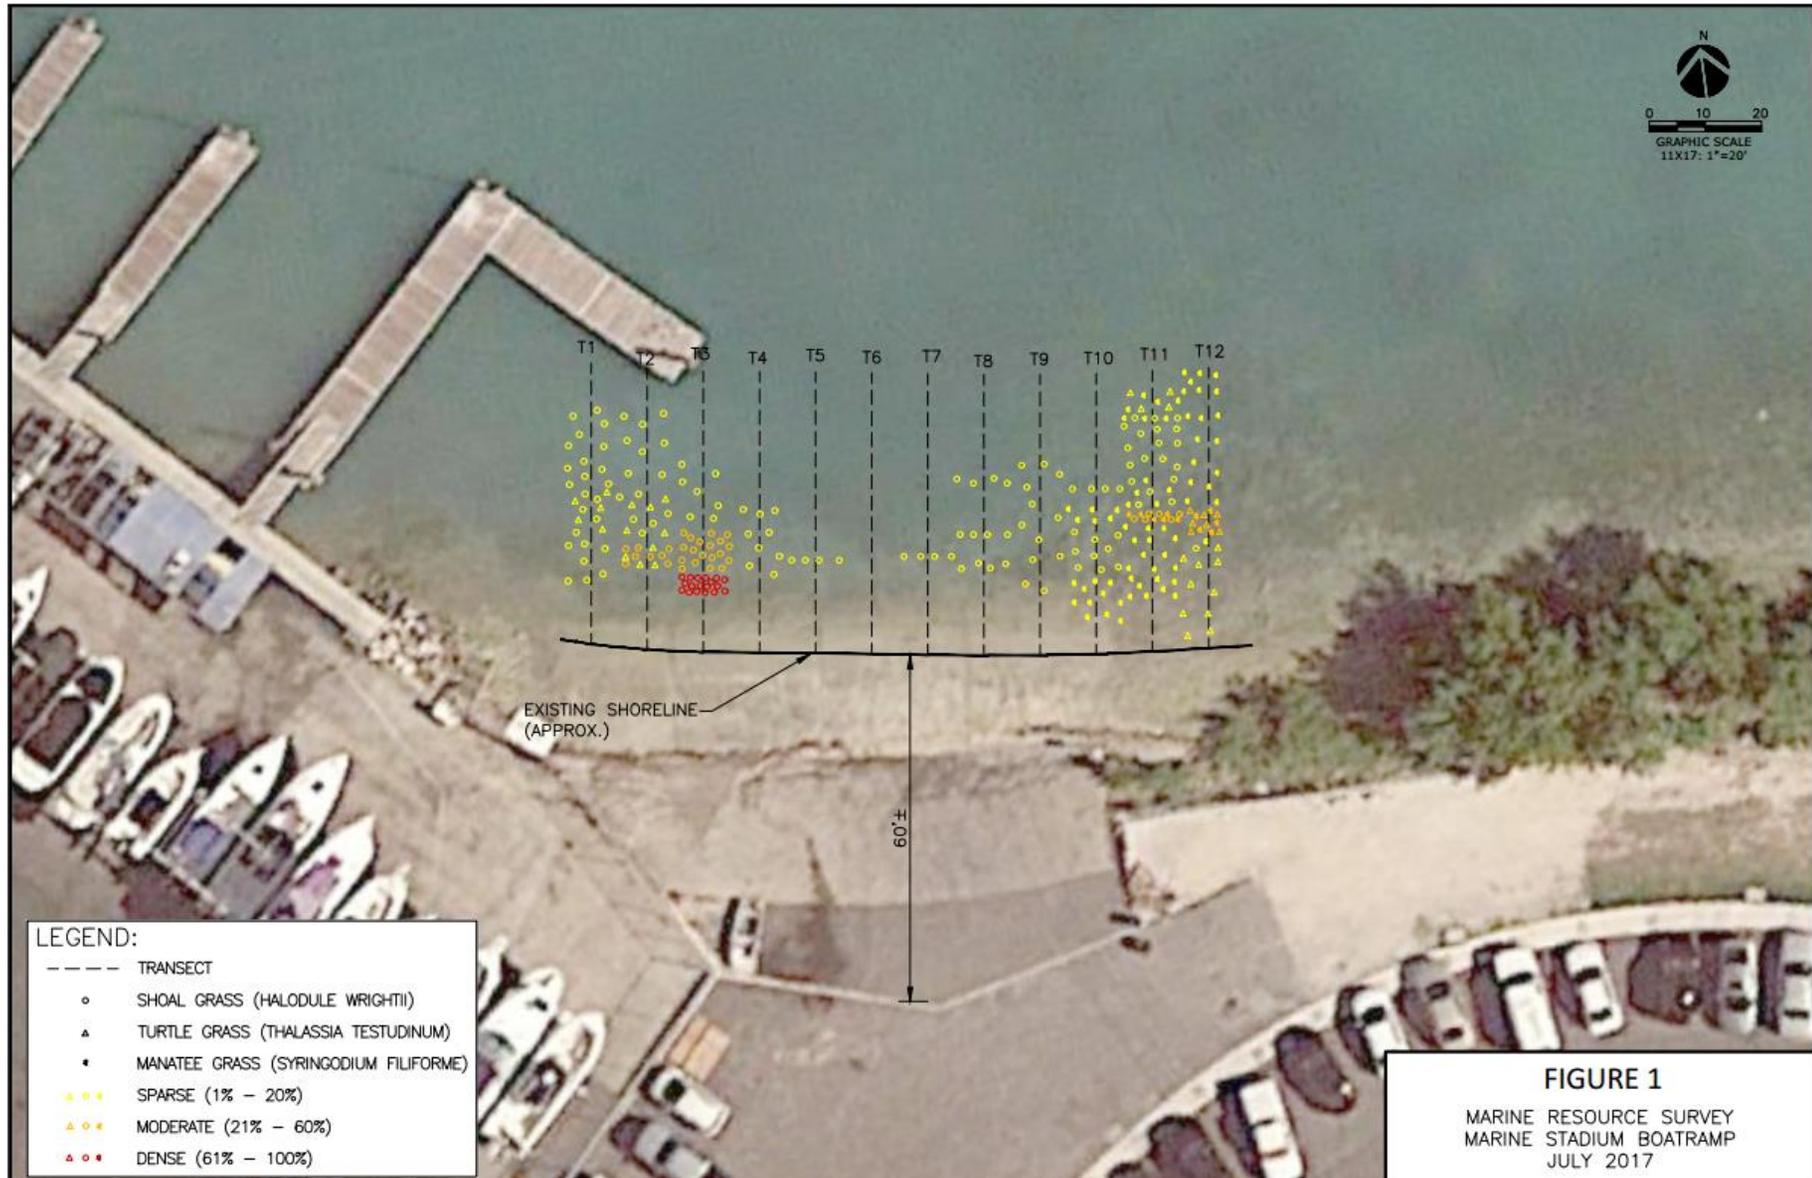
Figure 2. Basemap Depicting Marine Resources and Vegetation

The density estimated in mixed beds was for all species of seagrass. In addition to collecting data, the biologist took representative photographs of existing benthic communities. The areas of sparse, moderate, and dense seagrass were plotted onto a map in the office and used to extrapolate seagrass coverage and density in the areas between the 12 surveyed transects. The estimates of seagrass density are therefore conservative, since seagrass data was extrapolated between transects, which were spaced approximately every 10 feet. The basemap assumes that there is seagrass present in the areas between transects where seagrass was observed (refer to Figure 2 for the basemap) for seagrass coverage.

A diversity of macroalgae species, including; *Penicillus capitatus*, *Halimeda* sp., *Udotea* sp. and *Caulerpa* sp. dominated the submerged environment. Seagrass was dominant only in Transect 3, between 10-22 feet waterward of the shoreline. Shoal grass was present in all transects with seagrass, while manatee grass was only observed in Transects 10-12. Turtle grass was found in sparse patches along Transects 1, 2, 11 and 12. Refer to the Figure 2 for the basemap.
