Corrective Action Plan - Version 2

Wagner Creek/Seybold Canal

Volume 1 — Text and Appendices A through F

CH2MHILL
Constructors, Inc.

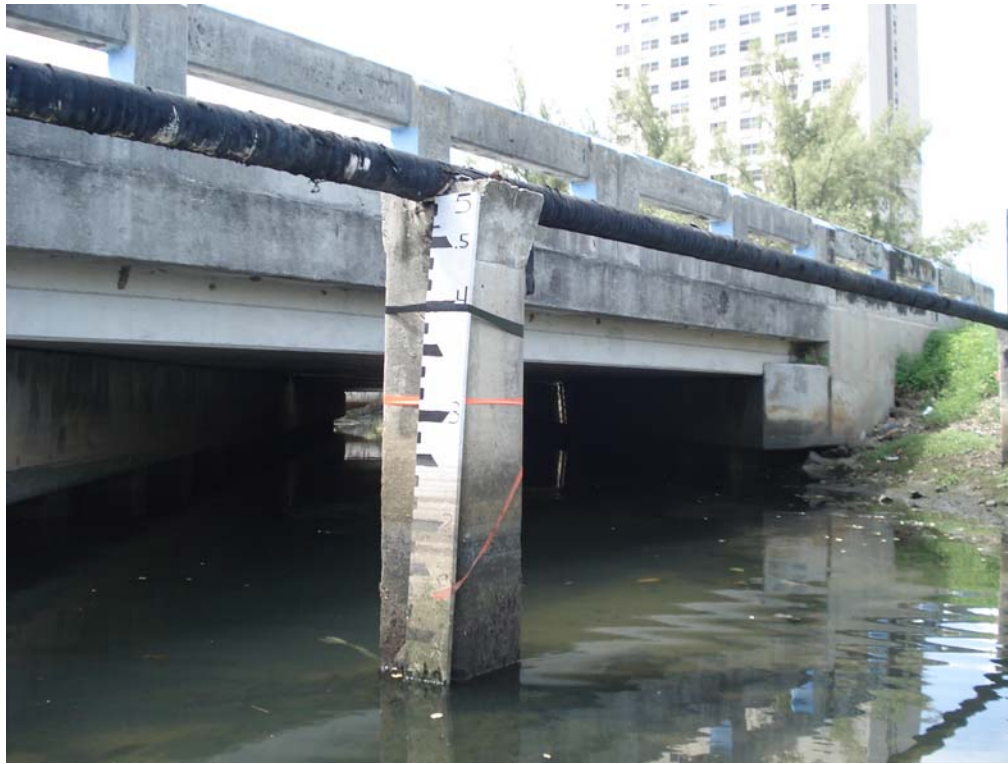
Stream gauge within Wagner Creek at the NW 14th Avenue bridge.

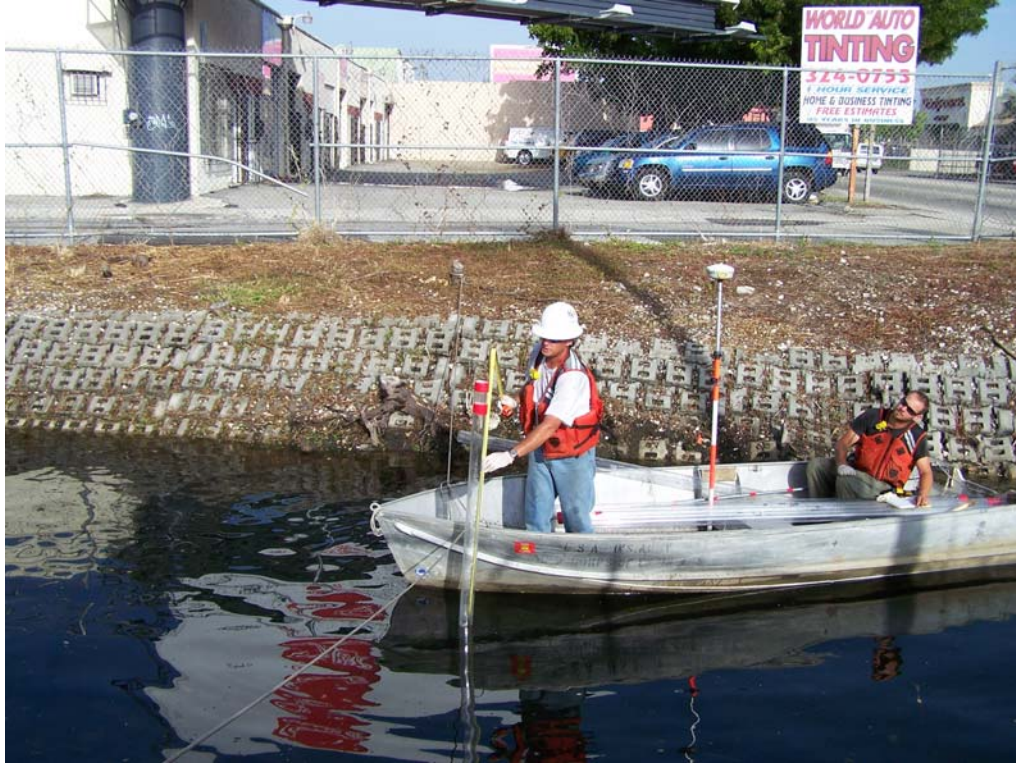
Measuring sample core depth within Wagner Creek at transect CH-1.

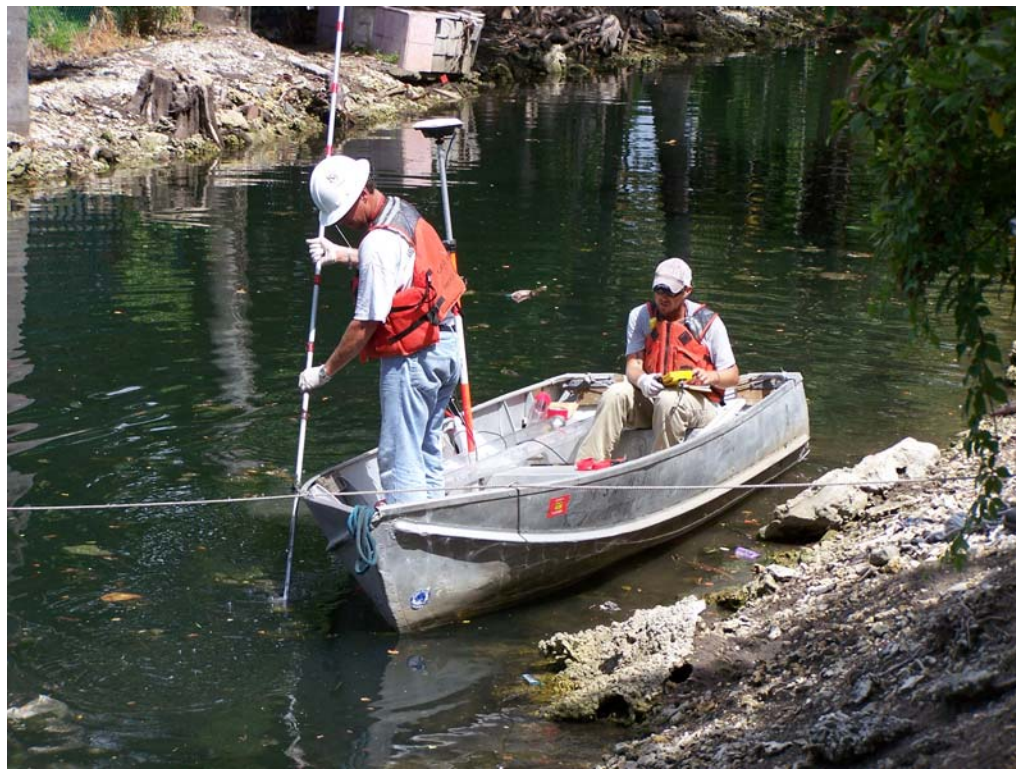
Advancing the probe rod to determine sediment thickness within Wagner Creek at transect CH-14.

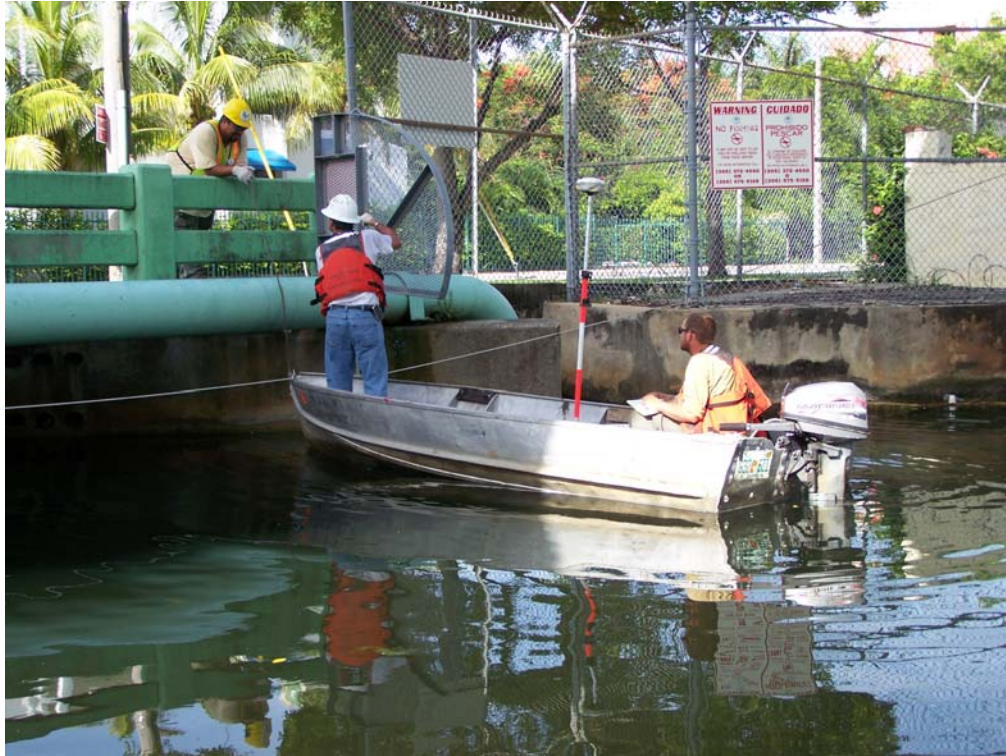
Collecting sediment core near NW 11th Street bridge within Wagner Creek at transect CH-32.

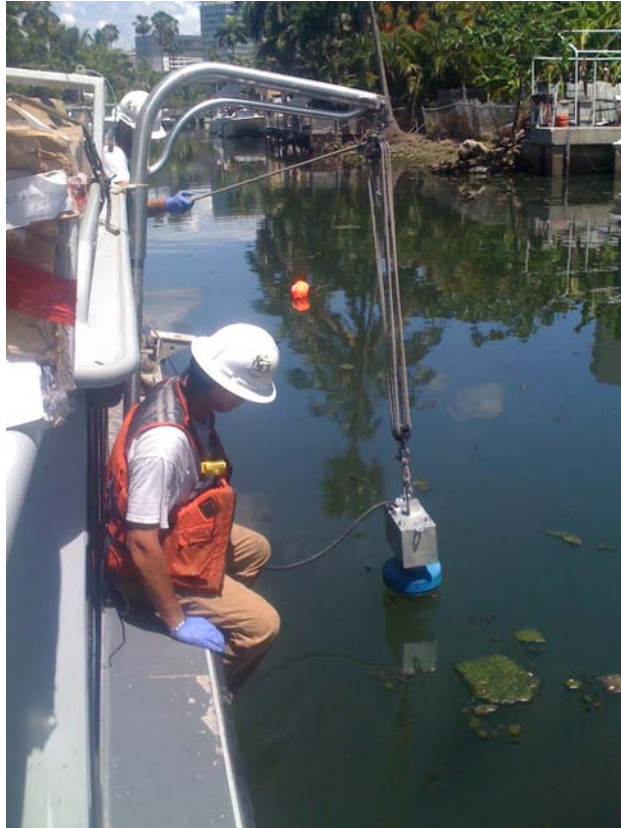
Vibecore advancing into sediment at location CH-41 within Seybold Canal.
