SOLID WASTE DELINEATION REPORT

Douglas Park
2795 SW 37th Avenue
Miami, Florida

Prepared for
City of Miami
Capital Improvement Programs

URS Corporation
January 2014

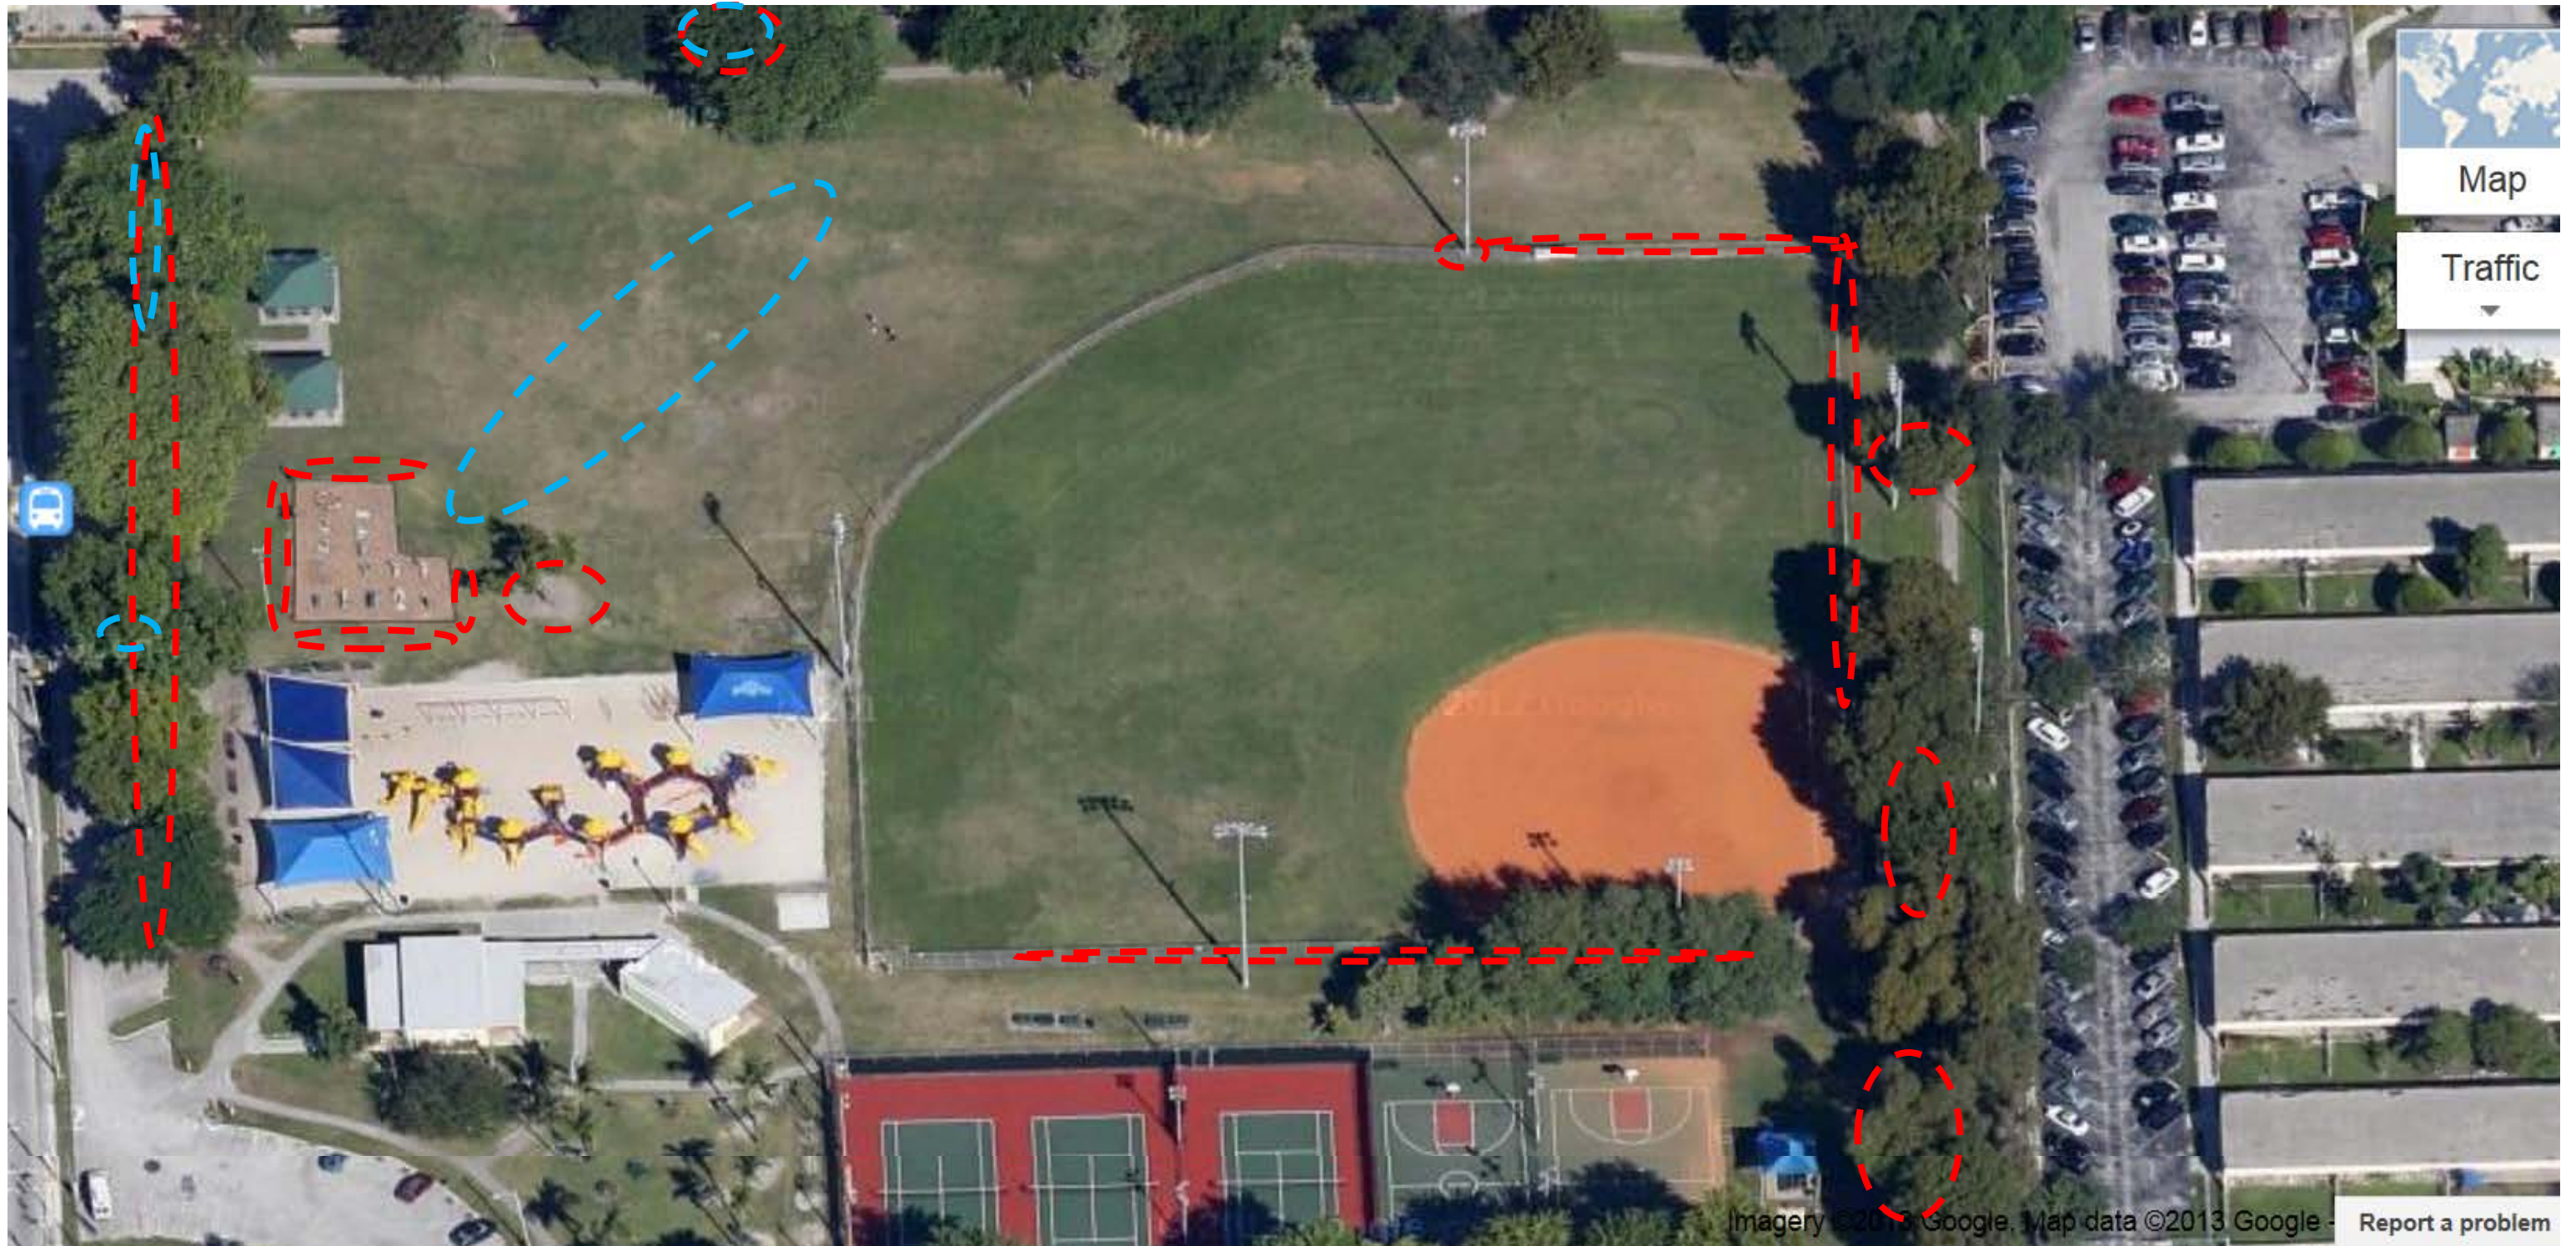
Approximate areas where melted glass were noted at the surface.

Approximate areas where melted glass were noted at depth during exploratory boring or sampling.
