DOUBLE RING INFILTRATION TEST

Date: 2/28/17
Job: DR-170367

Project Name: Fern-Isle Redevelopment Project
Project Location: 2300 NW 14 Street, Miami, Florida

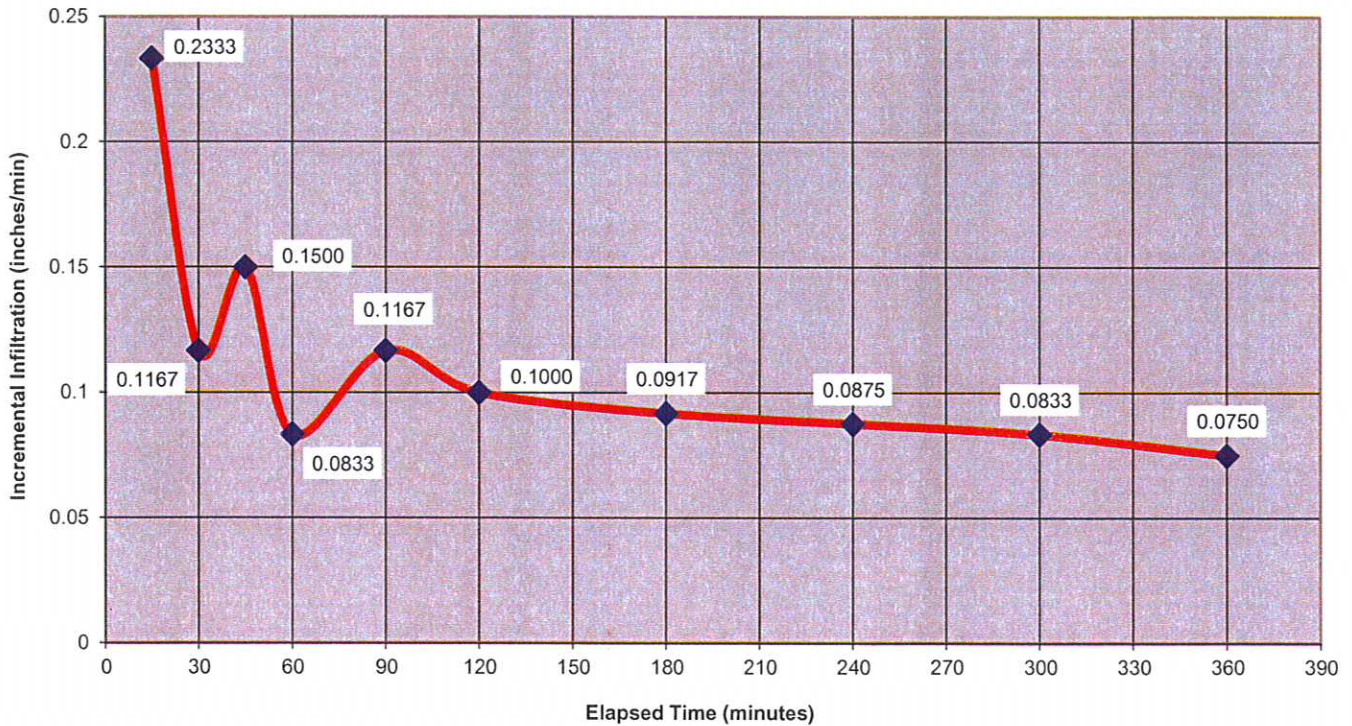
Infiltration Rate VS Time

Test No.: DR-1 **Test Ring Diam.:** 12 inches and 24 inches **Test Water Level:** 20 Inches

Avg. Infiltration Rate (per square foot): 0.1138 inches/min

Surface Description: Brown sand with some gravel

Per ASTM D-3385: Standard Test Method for Infiltration Rate of Soils in Field Using Double-Ring Infiltrometer

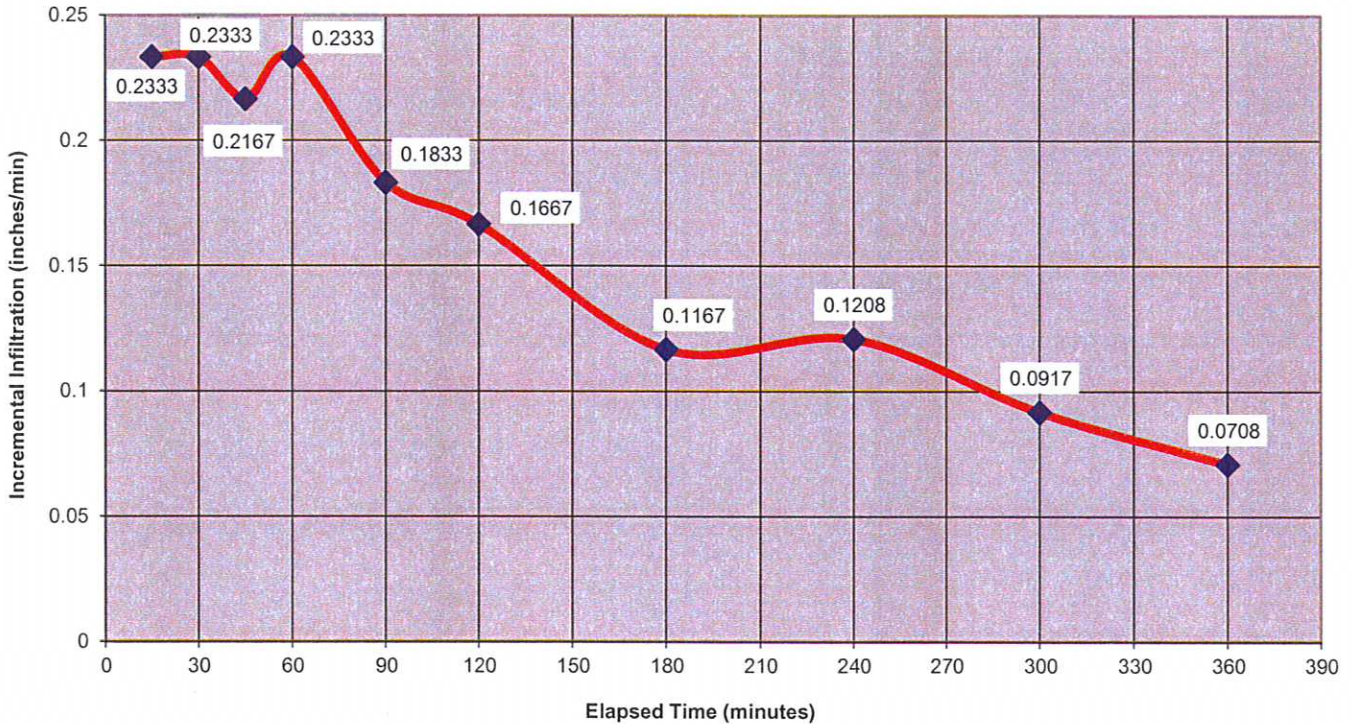
Infiltration Rate VS Time

Test No.: DR-2 **Test Ring Diam.:** 12 inches and 24 inches **Test Water Level:** 20 Inches

Avg. Infiltration Rate (per square foot): 0.1667 inches/min

Surface Description: Brown sand with some gravel

Per ASTM D-3385: Standard Test Method for Infiltration Rate of Soils in Field Using Double-Ring Infiltrometer
