*Corrective Action Plan - Version 2*

# Wagner Creek/Seybold Canal

Volume 2 — Appendices G through I

Submitted to  
City of Miami

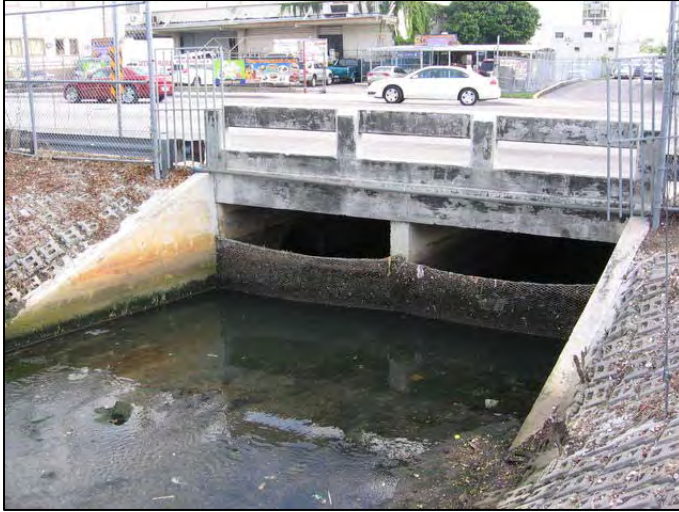
IMG\_0353

Address:	1500 NW 20 <sup>th</sup> St.
Folio #	0131350051790
Access Agreement	
Description:	Bridge crossing Wagner Creek at NW 20 <sup>th</sup> St.
Water Body:	Wagner Creek
Operational Section:	1
Easting:	912271.524
Northing:	531831.226
Bank Location:	Crosses creek
Picture #:	353
Condition:	Good
Damage to Structure and Picture #'s	N/A
End of Structure:	N/A
End of Structure Picture #:	N/A

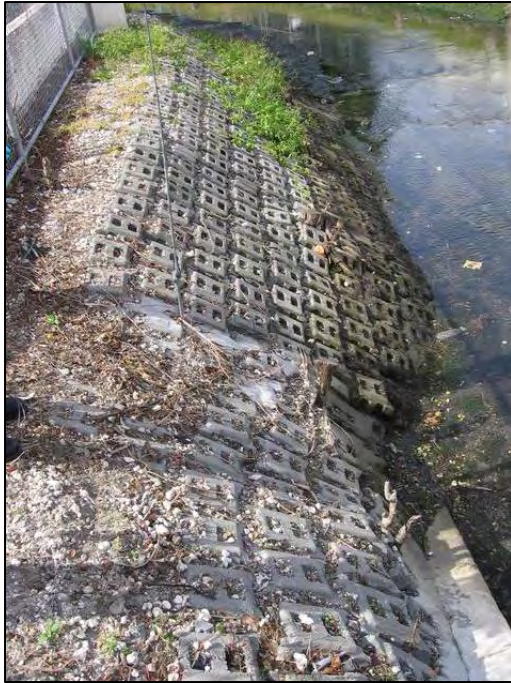
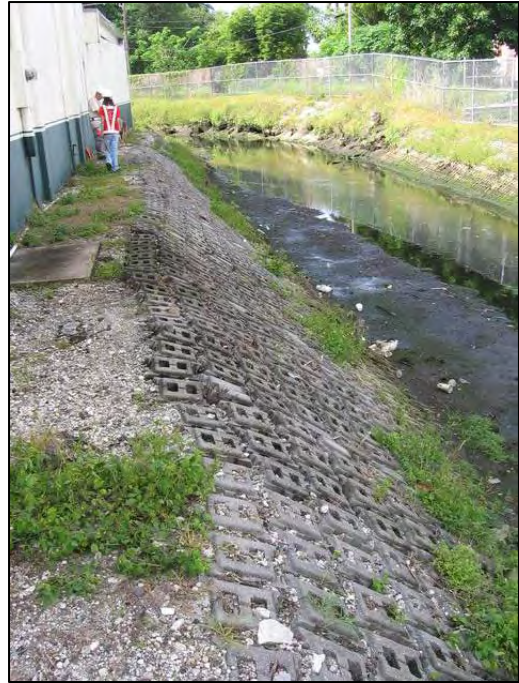
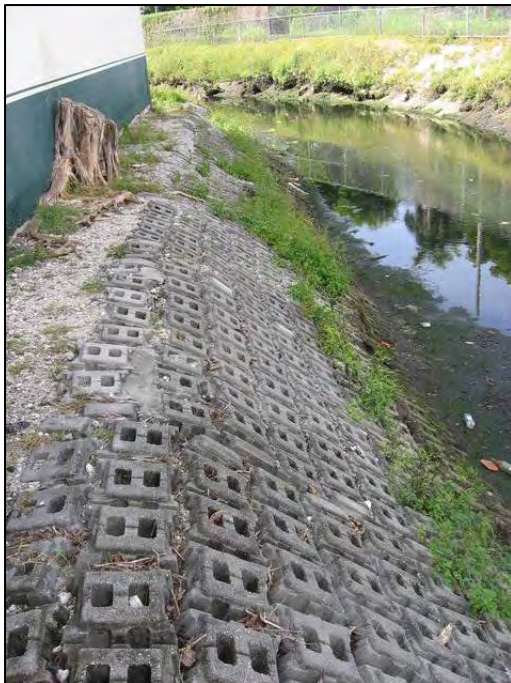
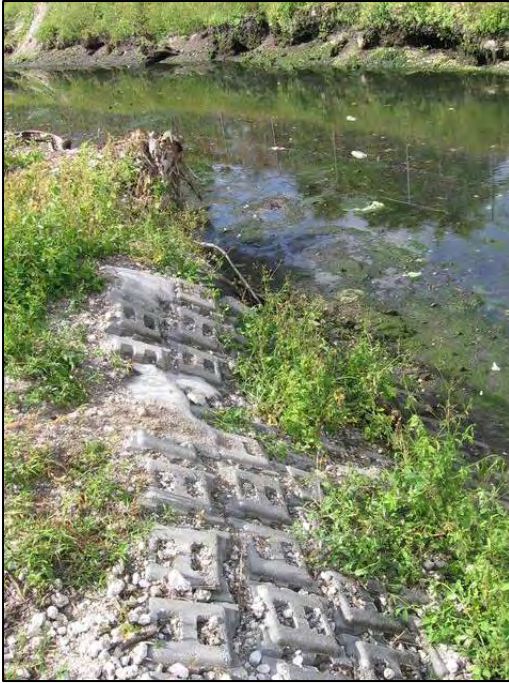
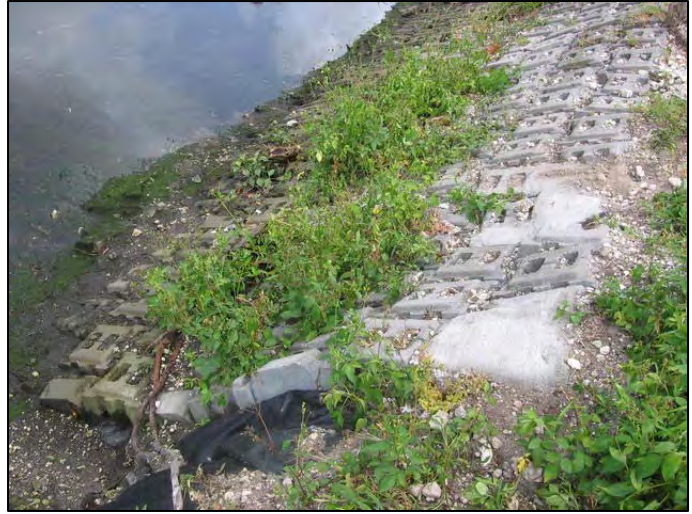
Structure S-2 Pictures

Address	1500 NW 20 <sup>th</sup> St.
Folio #	0131350051790
Access Agreement	
Description	Concrete brick erosion control structure
Water Body	Wagner Creek
Operational Section	1
Easting	912275.201
Northing	531828.065
Bank Location	East
Picture #	354-358
Condition	Fair
Damage to Structure and Picture #'s	N/A
End of Structure	S-3
End of Structure Picture #	361

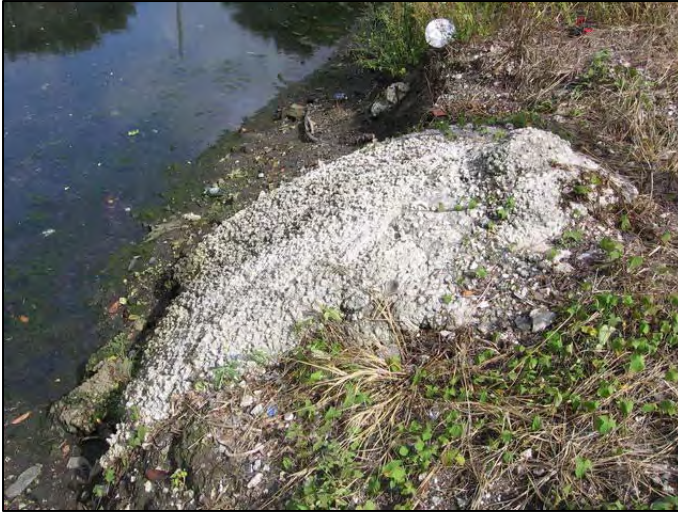
IMG\_0365

Address	N/A
Folio #	N/A
Access Agreement	N/A
Description	Concrete mass on bank
Water Body	Wagner Creek
Operational Section	1
Easting	912364.855
Northing	531590.536
Bank Location	East
Picture #	365
Condition	Fair
Damage to Structure and Picture #'s	N/A
End of Structure	N/A
End of Structure Picture #	N/A

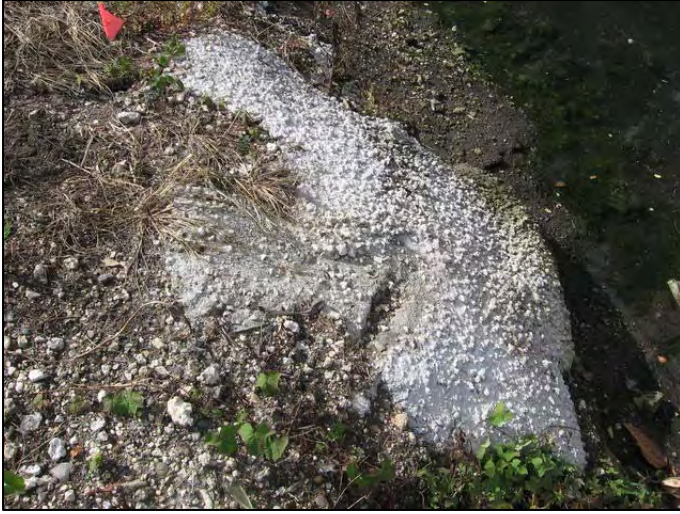
IMG\_0366

Address	N/A
Folio #	N/A
Access Agreement	N/A
Description	Concrete mass on bank
Water Body	Wagner Creek
Operational Section	1
Easting	912372.735
Northing	531577.291
Bank Location	East
Picture #	366
Condition	Fair
Damage to Structure and Picture #'s	N/A
End of Structure	N/A
End of Structure Picture #	N/A

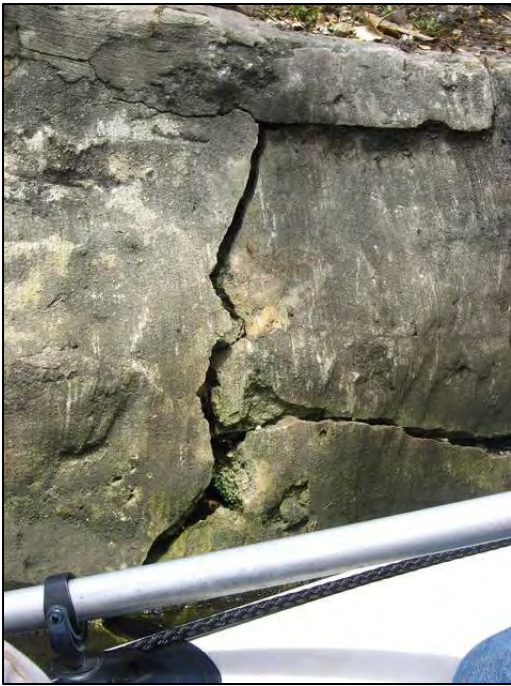
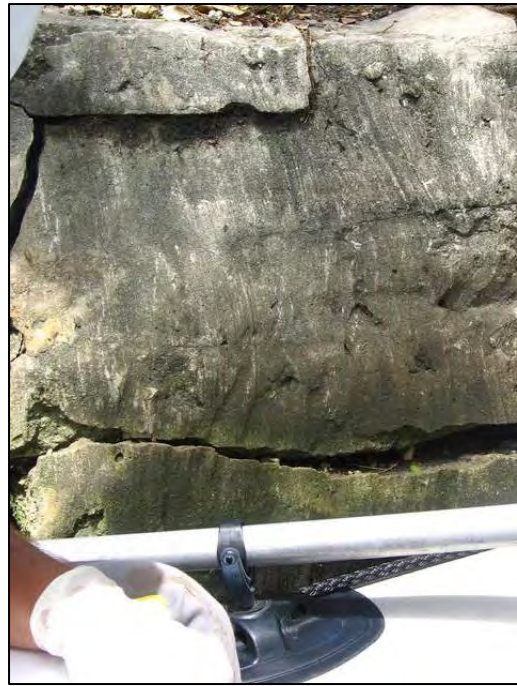
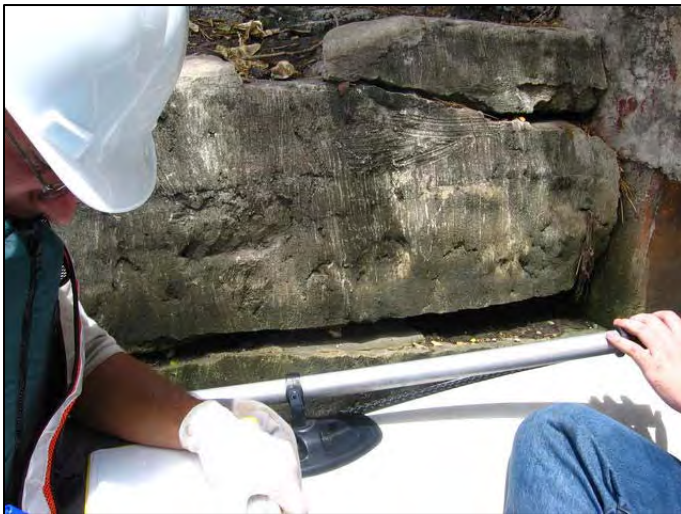
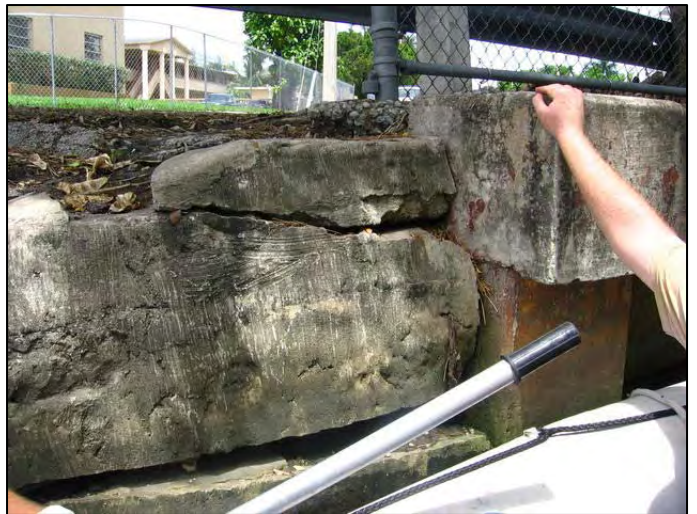
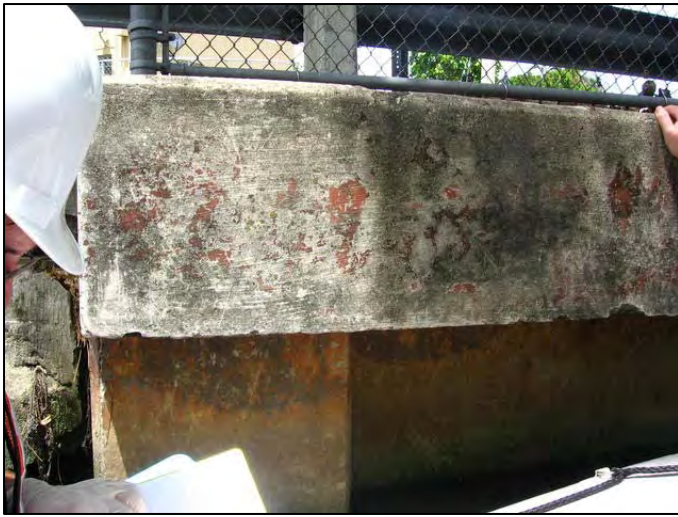
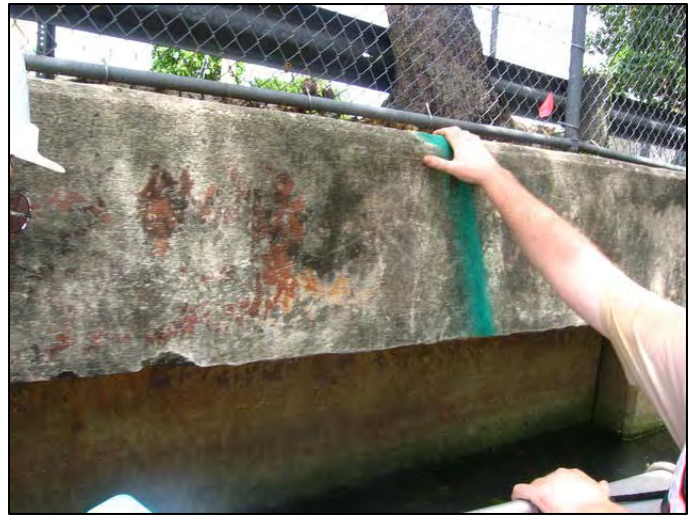
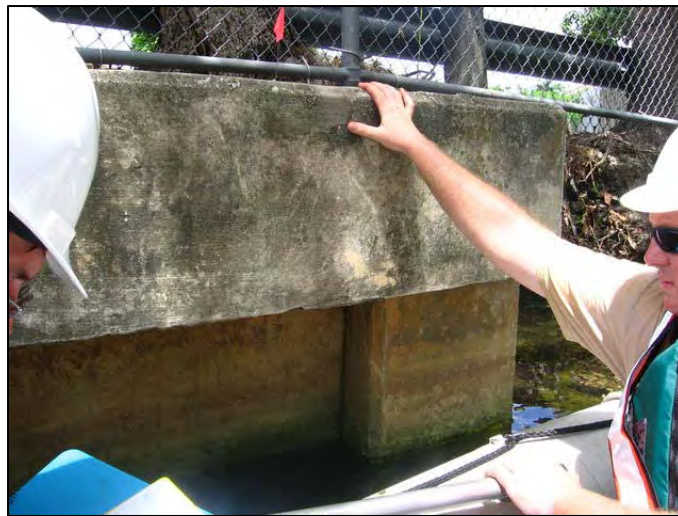
Structure S-6 Pictures

Address	N/A
Folio #	N/A
Access Agreement	N/A
Description	Concrete seawall
Water Body	Wagner Creek
Operational Section	1
Easting	912396.625
Northing	531550.268
Bank Location	East
Picture #	430-432
Condition	Fair
Damage to Structure and Picture #'s	C-1, C-2, C-3; 426-429
End of Structure	S-7
End of Structure Picture #	430-432

Date:	Structure Label:	Specific Condition Label:	Water Body:	Operational Section	Latitude:	Longitude:	Northing	Easting	Picture #	Bank Location	Description:	Structure Type:	Condition
6/25/2008	S-1		Wagner Creek	1	25.79470	-80.22161	531831.226	912271.524	353	20th Street Bridge	Concrete/brick Erosion Control Wall	Bridge	Good
6/25/2008	S-2		Wagner Creek	1	25.79470	-80.22161	531828.065	912275.201	354	East	End of structure S-2	Erosion control structure	Fair
6/25/2008	S-3		Wagner Creek	1	25.79431	-80.22159	531673.341	912296.101	361	East	Concrete mass on bank / debris	Concrete mass	Fair
6/25/2008	S-4		Wagner Creek	1	25.79397	-80.22136	531590.536	912372.735	366	East	Concrete mass on bank / debris	Concrete mass	Fair
6/25/2008	S-5		Wagner Creek	1	25.79403	-80.22124	531545.202	912396.625	430	East	Crack on Sea Wall		N/A
6/25/2008	S-6	C-1	Wagner Creek	1	25.79403	-80.22124	531545.096	912399.641	428	East	Crack on Sea Wall		N/A

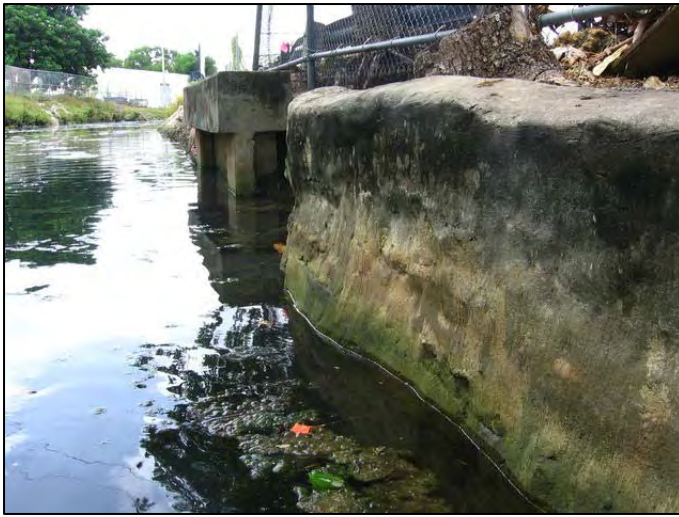
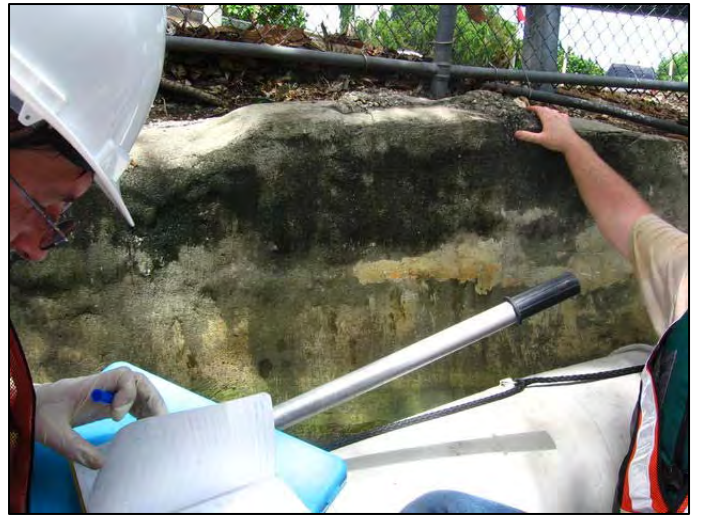
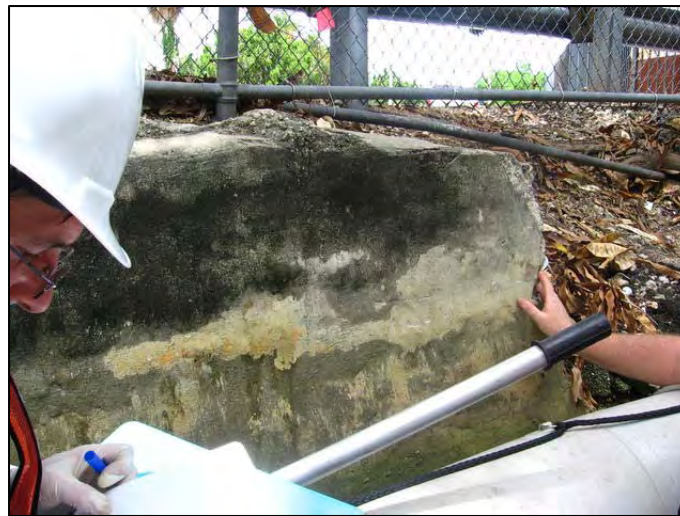
Structure S-8 Pictures

Address	N/A
Folio #	N/A
Access Agreement	N/A
Description	Concrete seawall
Water Body	Wagner Creek
Operational Section	1
Easting	912417.516
Northing	531527.757
Bank Location	East
Picture #	433-435
Condition	Fair
Damage to Structure and Picture #'s	N/A
End of Structure	S-9
End of Structure Picture #	435

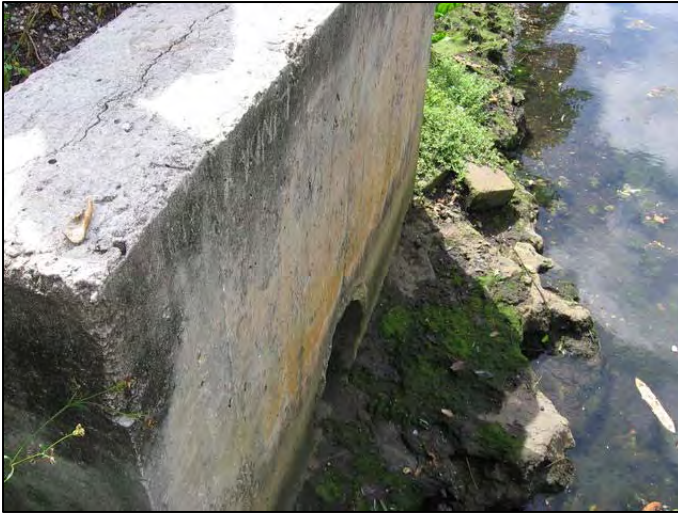
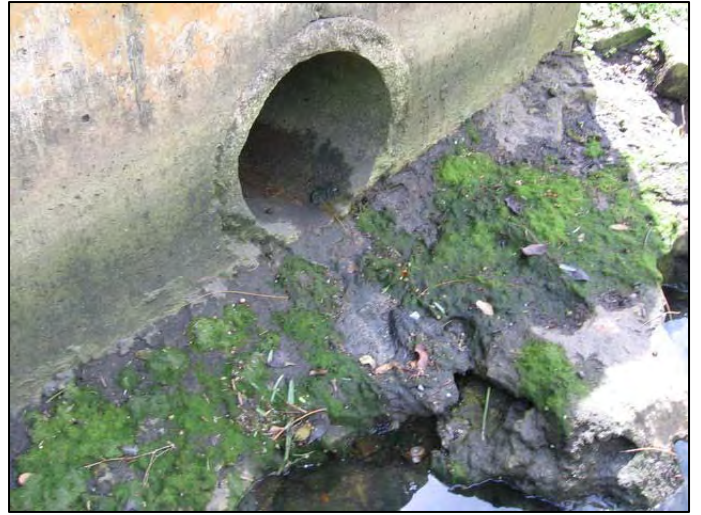
**Structure S-10 Pictures**

Address	1434 NW 19 <sup>th</sup> Terrace
Folio #	0131350050410
Access Agreement	
Description	12" Concrete culvert
Water Body	Wagner Creek
Operational Section	1
Easting	912470.404
Northing	531470.062
Bank Location	East
Picture #	379-380
Condition	Good
Damage to Structure and Picture #'s	N/A
End of Structure	N/A
End of Structure Picture #	N/A

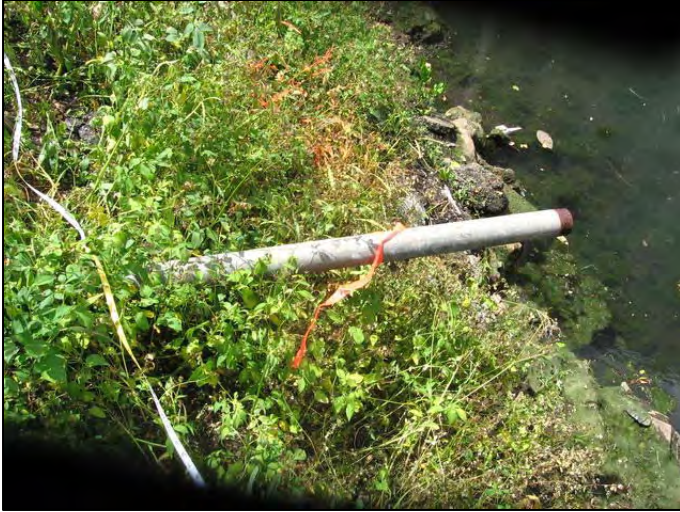
IMG\_0382

Address	1434 NW 19 <sup>th</sup> Terrace
Folio #	0131350050410
Access Agreement	
Description	3" Steel pipe
Water Body	Wagner Creek
Operational Section	1
Easting	912503.510
Northing	531432.505
Bank Location	East
Picture #	382
Condition	Fair
Damage to Structure and Picture #'s	N/A
End of Structure	N/A
End of Structure Picture #	N/A

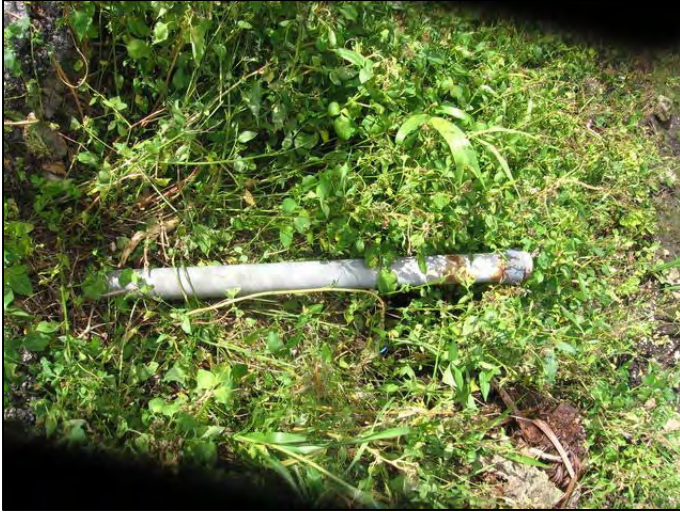
IMG\_0383

Address	1434 NW 19 <sup>th</sup> Terrace
Folio #	0131350050410
Access Agreement	
Description	3" Steel pipe
Water Body	Wagner Creek
Operational Section	1
Easting	912519.565
Northing	531420.150
Bank Location	East
Picture #	383
Condition	Fair
Damage to Structure and Picture #'s	N/A
End of Structure	N/A
End of Structure Picture #	N/A

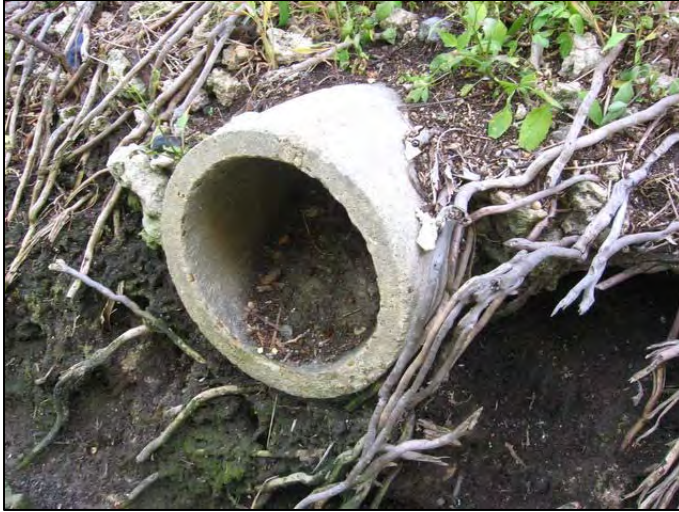
IMG\_0388

Address	1434 NW 19 <sup>th</sup> Terrace
Folio #	0131350050410
Access Agreement	
Description	8" Concrete pipe
Water Body	Wagner Creek
Operational Section	1
Easting	912542.938
Northing	531384.172
Bank Location	East
Picture #	388
Condition	Good
Damage to Structure and Picture #'s	N/A
End of Structure	N/A
End of Structure Picture #	N/A

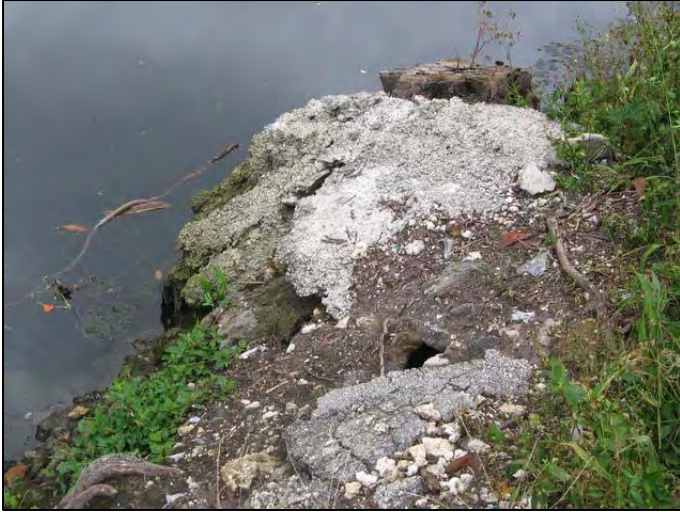
IMG\_0389

Address	1434 NW 19 <sup>th</sup> Terrace
Folio #	0131350050410
Access Agreement	
Description	Concrete mass on bank
Water Body	Wagner Creek
Operational Section	1
Easting	912573.171
Northing	531358.975
Bank Location	East
Picture #	389
Condition	Fair
Damage to Structure and Picture #'s	N/A
End of Structure	N/A
End of Structure Picture #	N/A

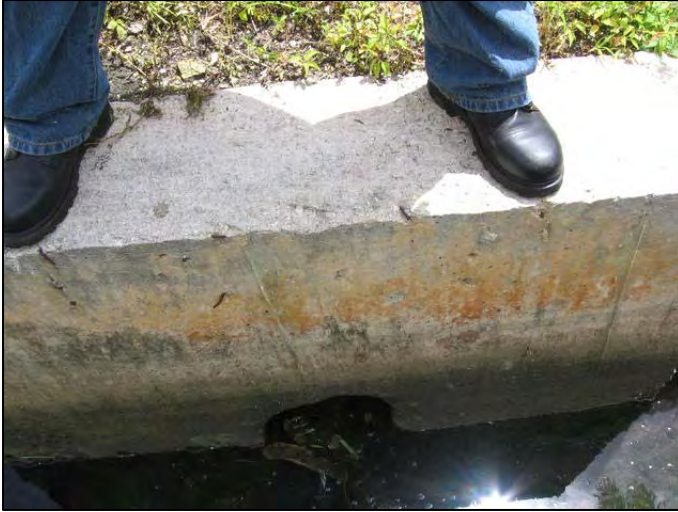
IMG\_0392

Address	1434 NW 19 <sup>th</sup> Terrace
Folio #	0131350050410
Access Agreement	
Description	Concrete culvert
Water Body	Wagner Creek
Operational Section	1
Easting	912631.565
Northing	531295.174
Bank Location	East
Picture #	392
Condition	Good
Damage to Structure and Picture #'s	N/A
End of Structure	N/A
End of Structure Picture #	N/A

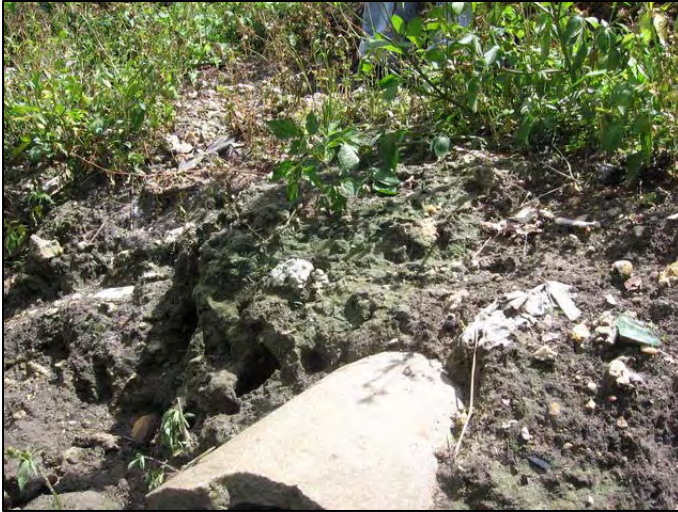
IMG\_0397

Address	1434 NW 19 <sup>th</sup> Terrace
Folio #	0131350050410
Access Agreement	
Description	Concrete pipe
Water Body	Wagner Creek
Operational Section	1
Easting	912669.385
Northing	531254.661
Bank Location	East
Picture #	397
Condition	Fair
Damage to Structure and Picture #'s	N/A
End of Structure	N/A
End of Structure Picture #	N/A

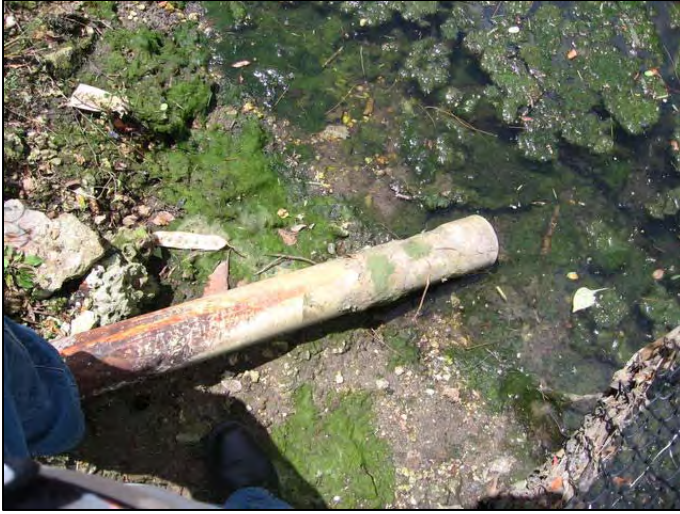
IMG\_0399

Address	1434 NW 19 <sup>th</sup> Terrace
Folio #	0131350050410
Access Agreement	
Description	PVC pipe
Water Body	Wagner Creek
Operational Section	1
Easting	912675.165
Northing	531245.421
Bank Location	East
Picture #	399
Condition	Fair
Damage to Structure and Picture #'s	N/A
End of Structure	N/A
End of Structure Picture #	N/A

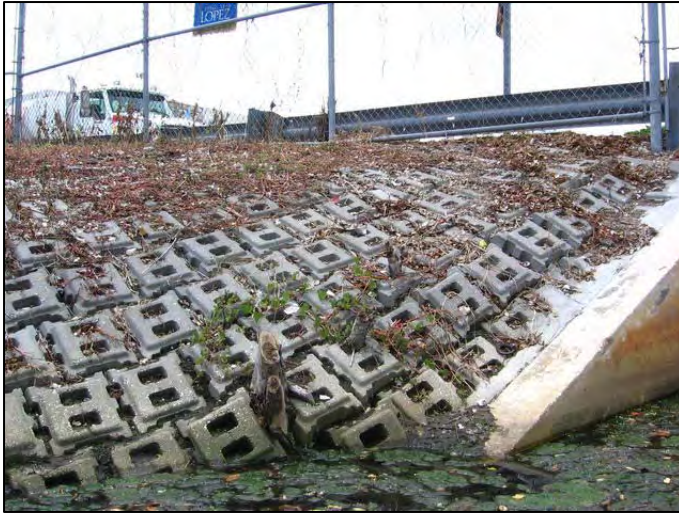
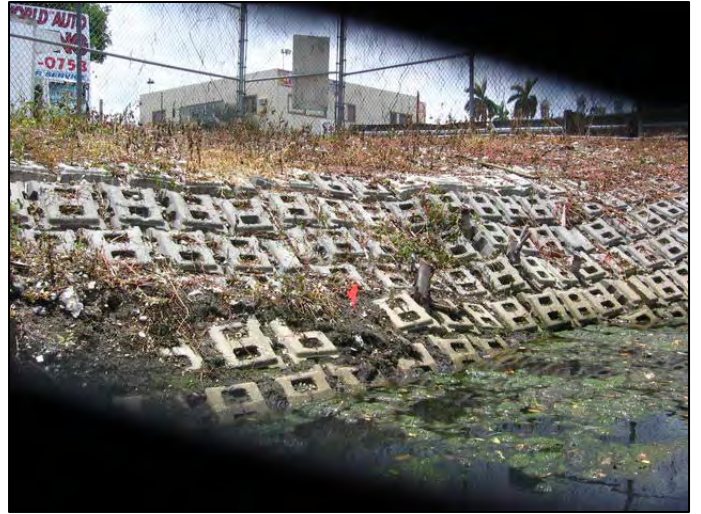
Structure S-18 Pictures

Address	1600 NW 20 <sup>th</sup> St.
Folio #	0131350051830
Access Agreement	
Description	Concrete brick erosion control structure
Water Body	Wagner Creek
Operational Section	1
Easting	912243.908
Northing	531808.964
Bank Location	West
Picture #	409-421
Condition	Fair
Damage to Structure and Picture #'s	N/A
End of Structure	S-19
End of Structure Picture #	421

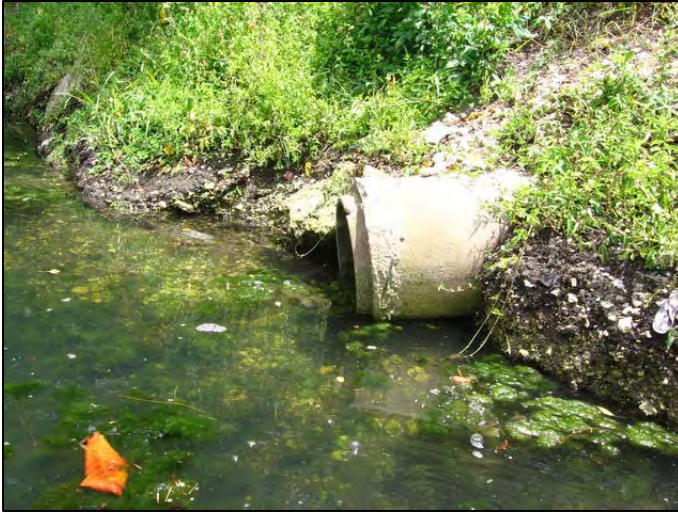
IMG\_0423

Address	N/A
Folio #	N/A
Access Agreement	N/A
Description	Concrete pipe
Water Body	Wagner Creek
Operational Section	1
Easting	912359.887
Northing	531548.300
Bank Location	West
Picture #	423
Condition	Fair
Damage to Structure and Picture #'s	N/A
End of Structure	N/A
End of Structure Picture #	N/A

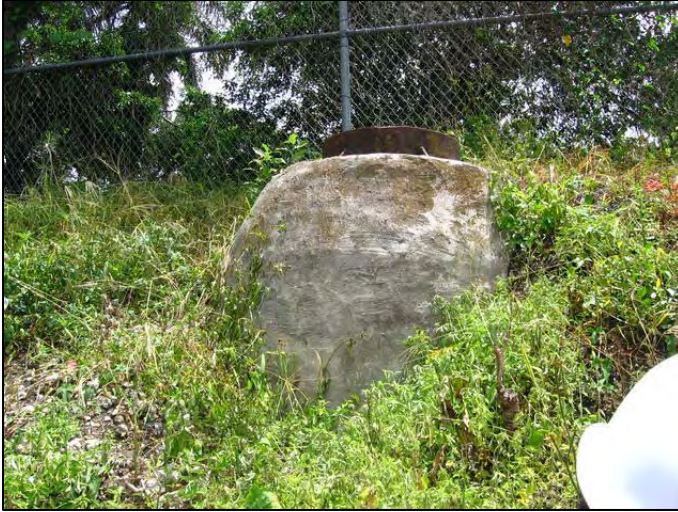
IMG\_0424

Address	N/A
Folio #	N/A
Access Agreement	N/A
Description	Manhole with concrete base
Water Body	Wagner Creek
Operational Section	1
Easting	912356.215
Northing	531551.760
Bank Location	West
Picture #	424
Condition	Fair
Damage to Structure and Picture #'s	N/A
End of Structure	N/A
End of Structure Picture #	N/A

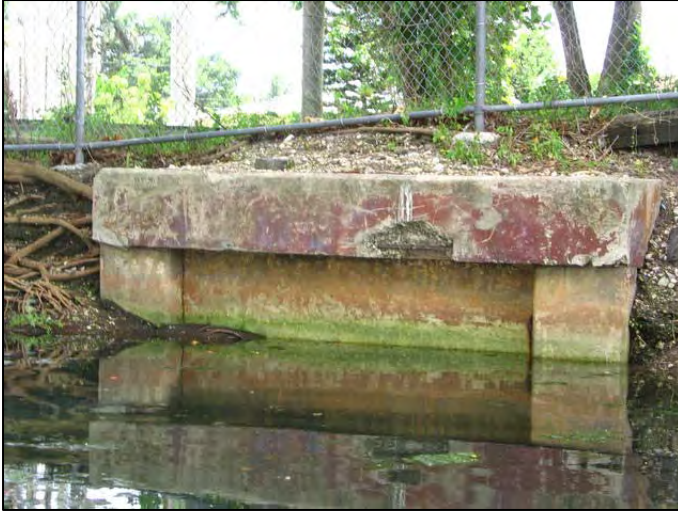
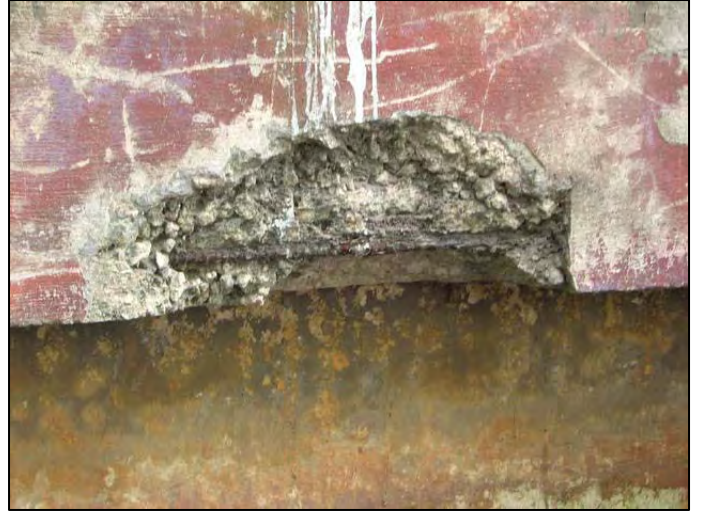
**Structure S-22 Pictures**

Address	
Folio #	
Access Agreement	
Description	Concrete seawall
Water Body	Wagner Creek
Operational Section	1
Easting	912407.480
Northing	531488.565
Bank Location	West
Picture #	436
Condition	Fair
Damage to Structure and Picture #'s	C-1, 437
End of Structure	N/A
End of Structure Picture #	N/A

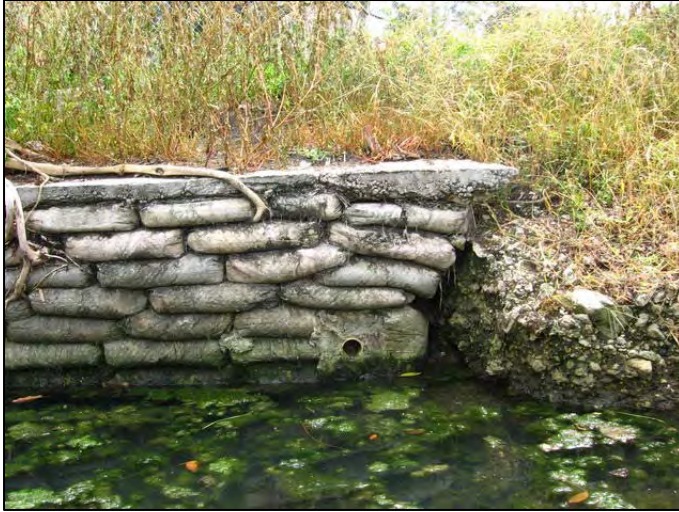
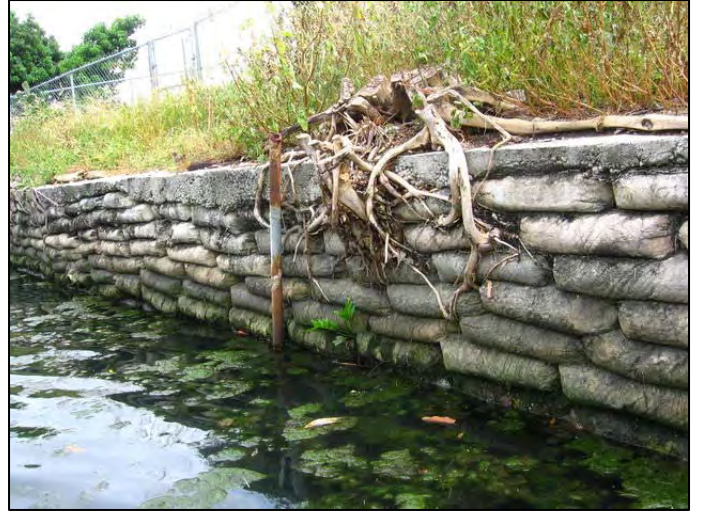
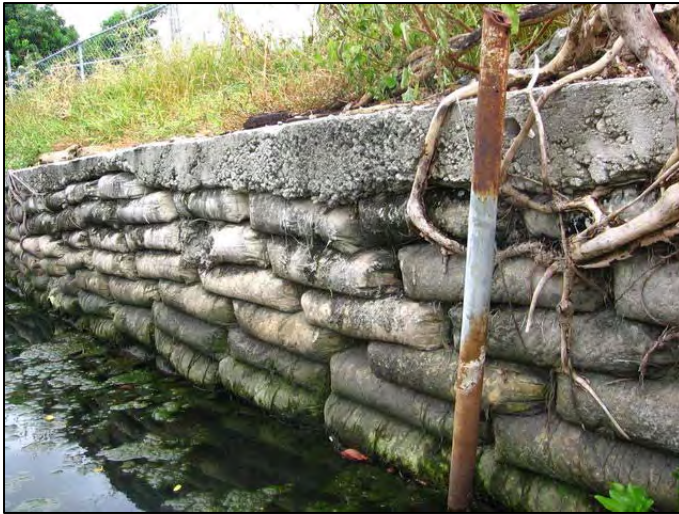
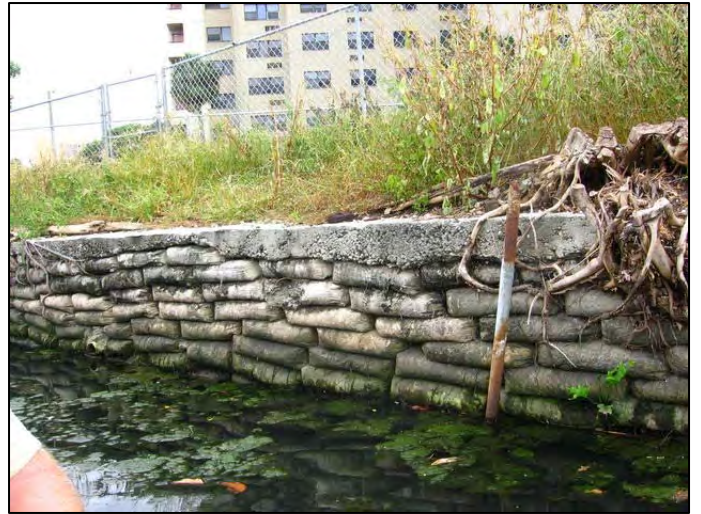
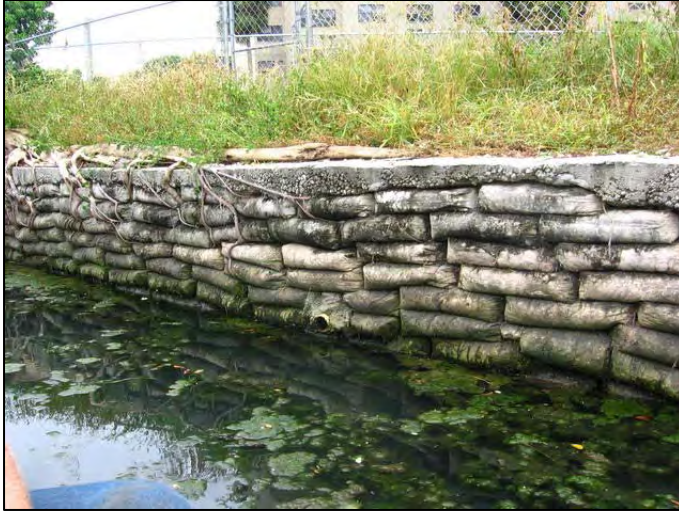
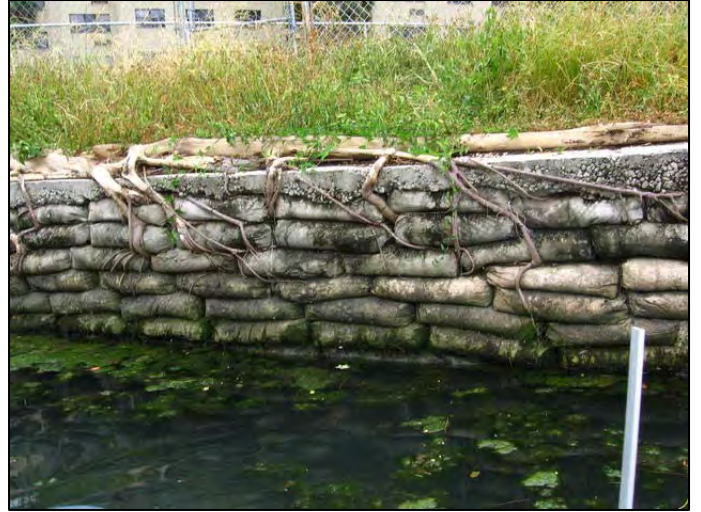
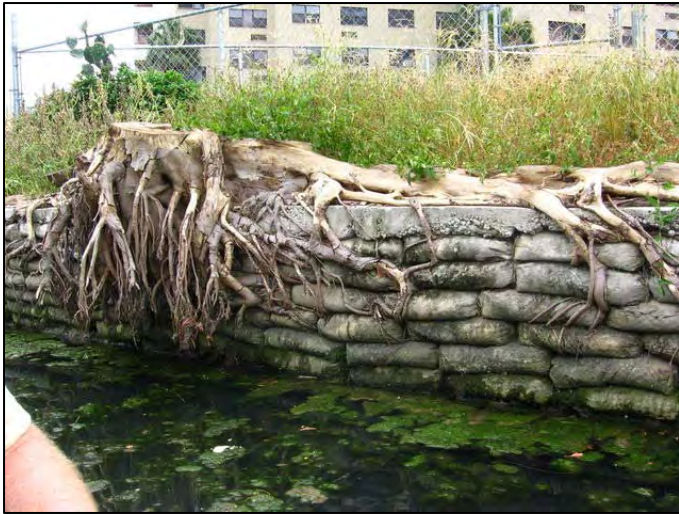
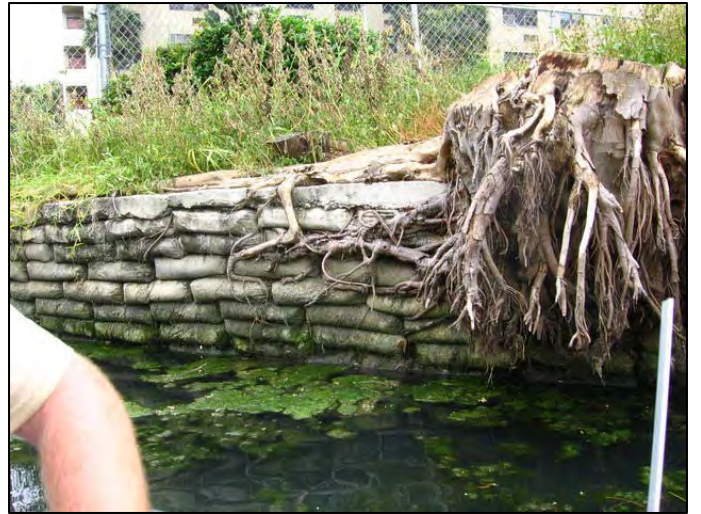
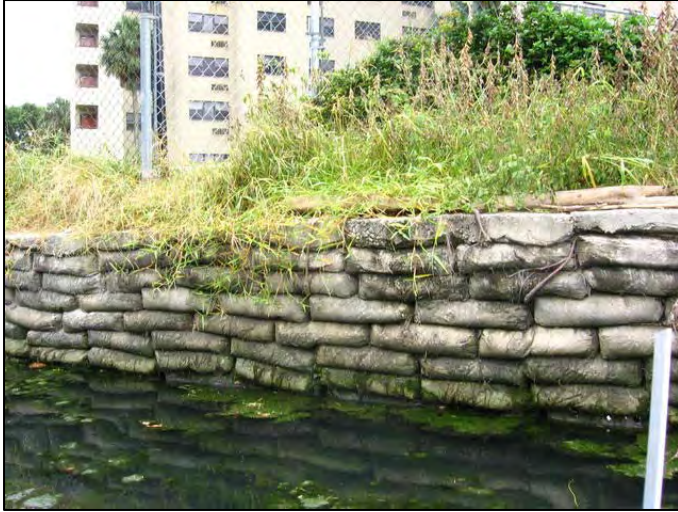
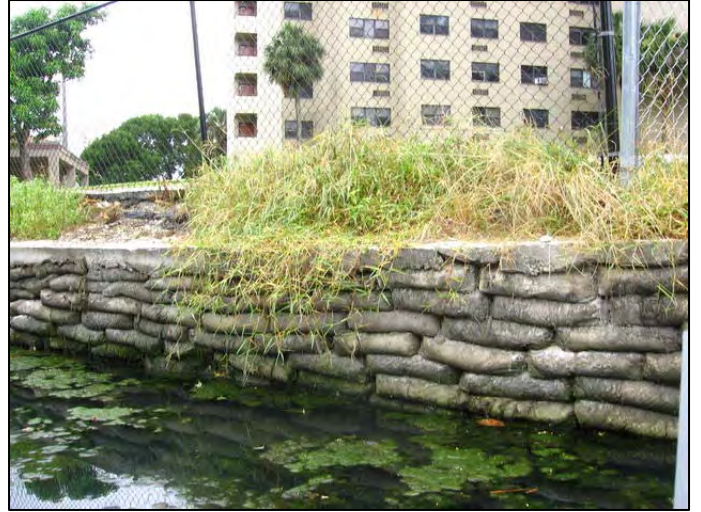
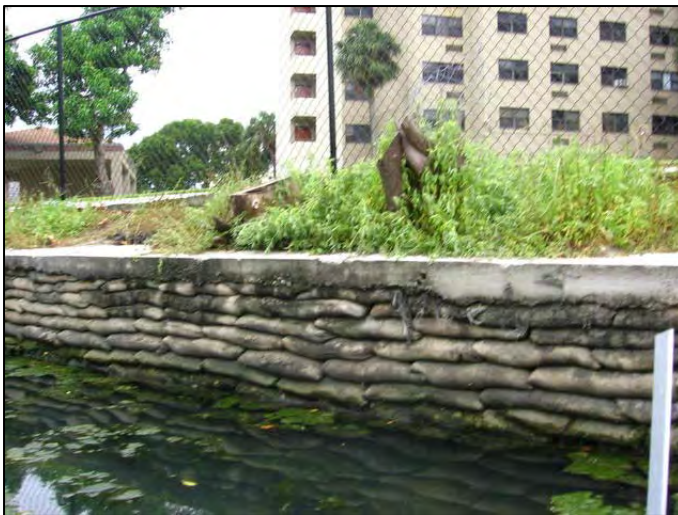
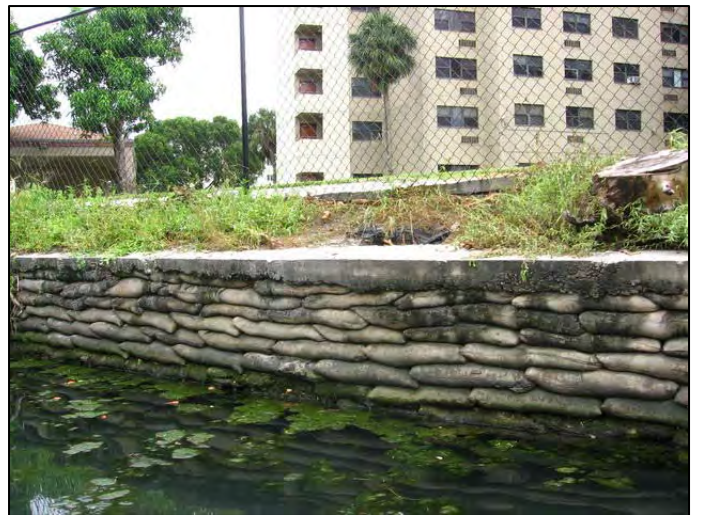
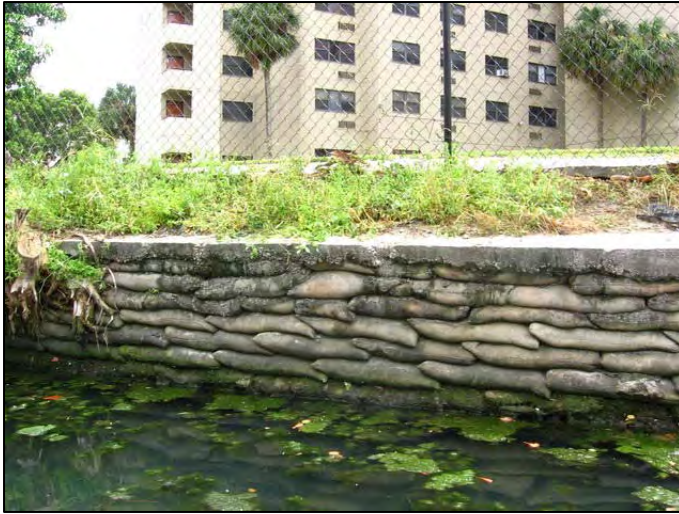
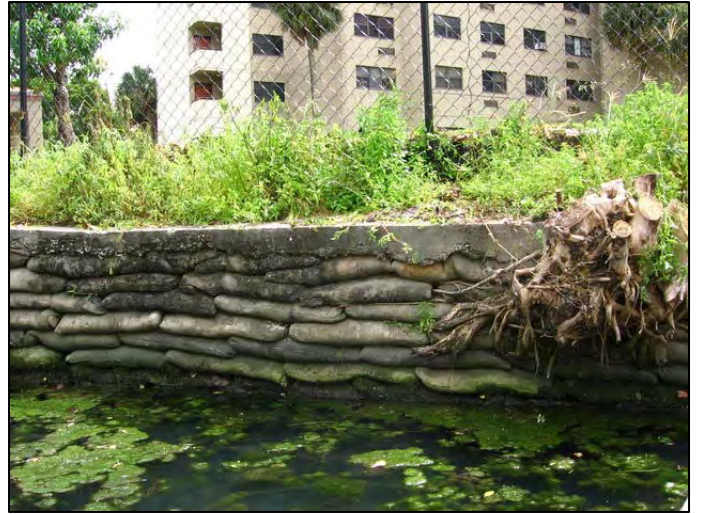
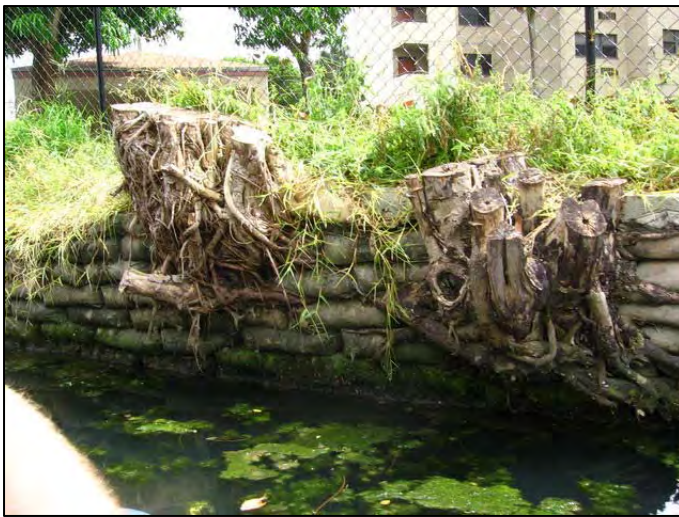
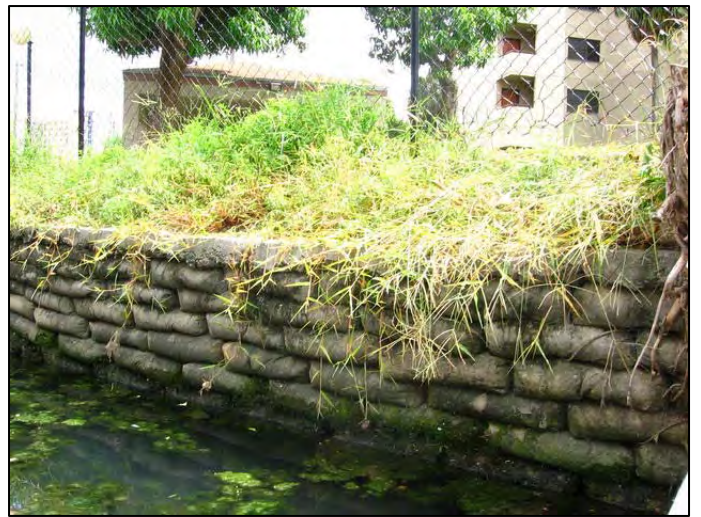
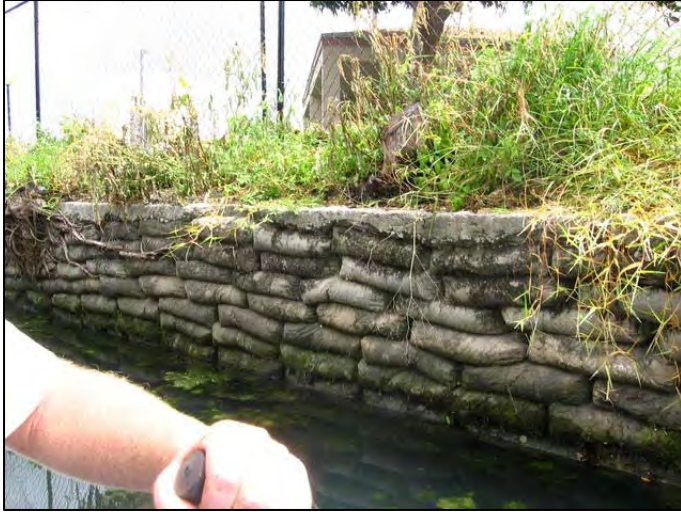
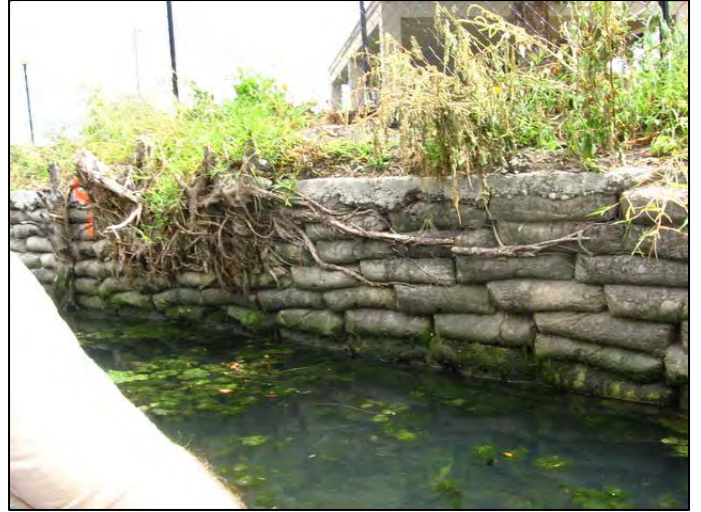
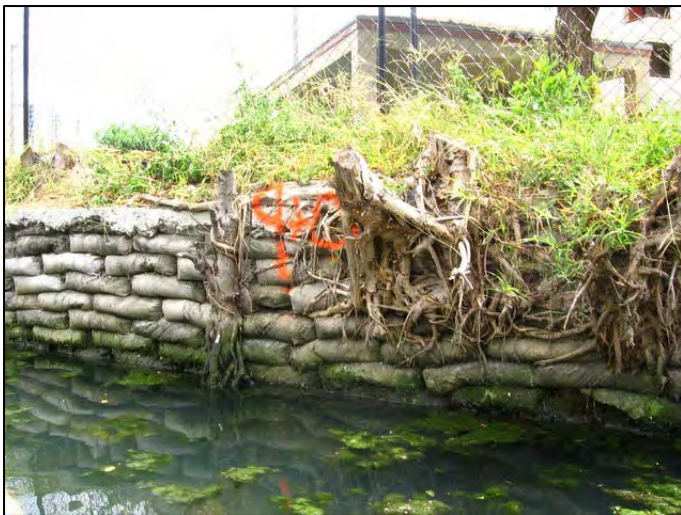
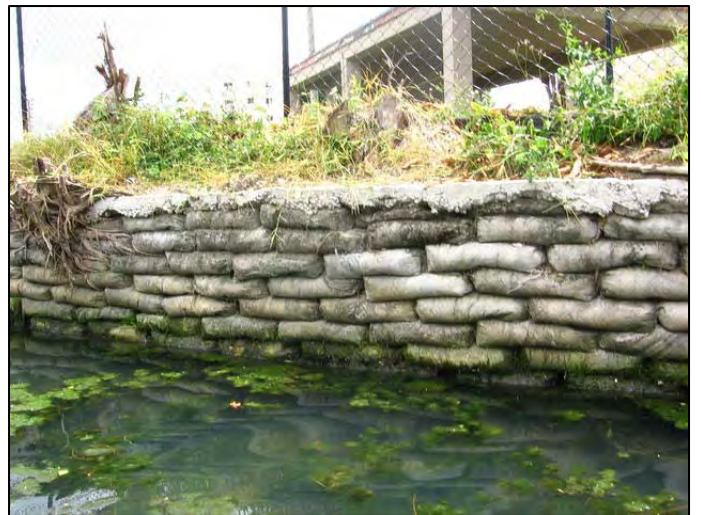
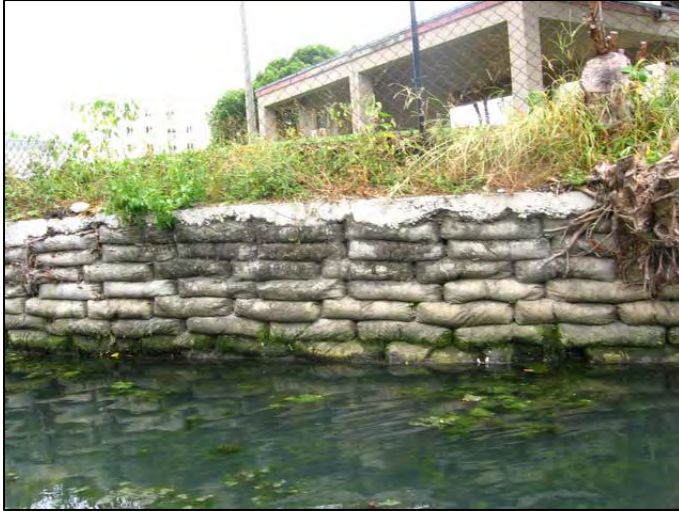
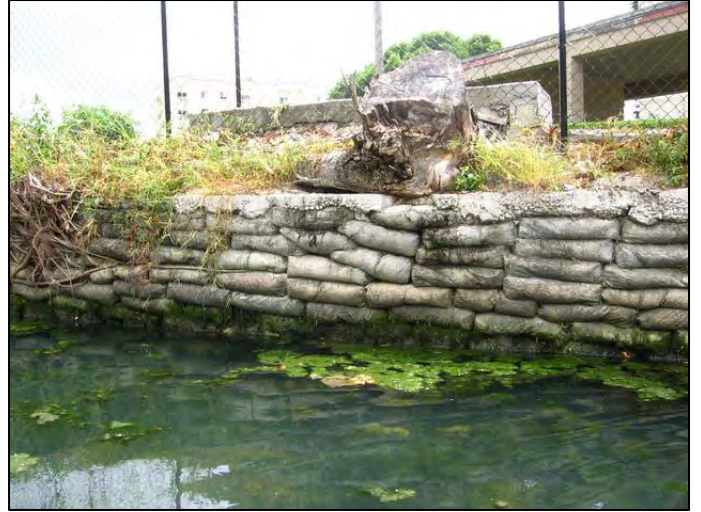
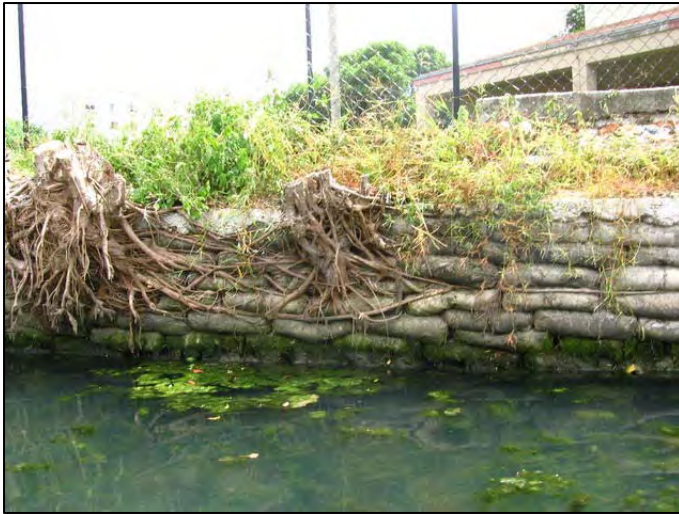
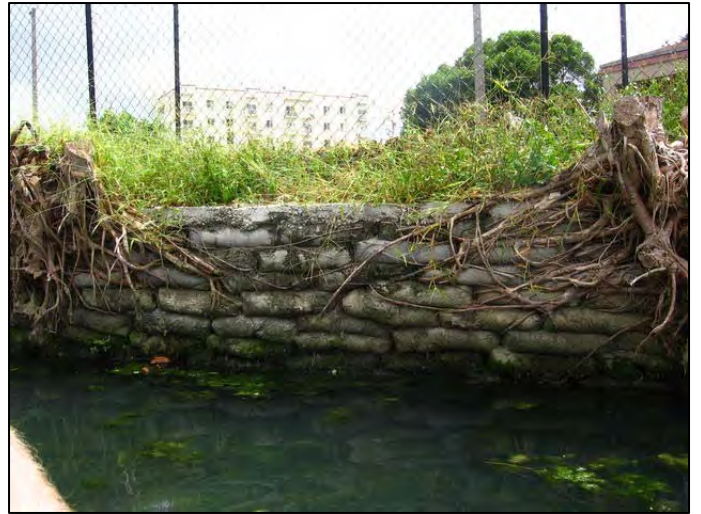
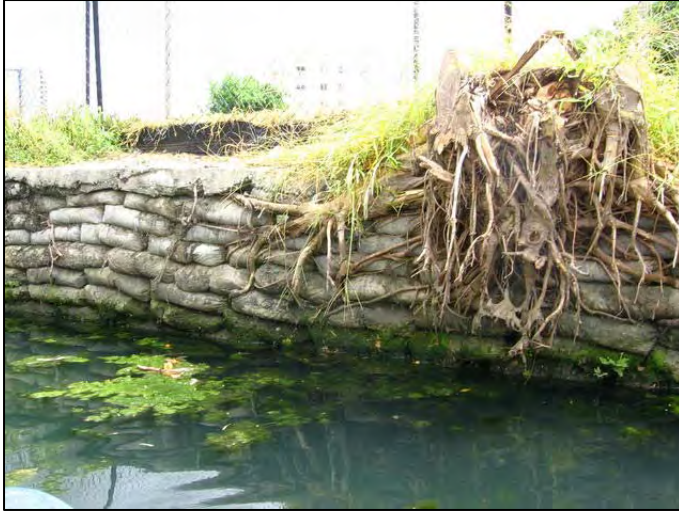
Structure S-23 Pictures

Address	1919 NW 15 <sup>th</sup> Ave.; 1855 NW 15 <sup>th</sup> Ave.; 1700 NW 14 <sup>th</sup> Ave.
Folio #	0131350690010; 0131350690020; 0131350870011
Access Agreement	
Description	Concrete sandbag seawall
Water Body	Wagner Creek
Operational Section	1
Easting	912657.247
Northing	531219.762
Bank Location	West
Picture #	441-484, 539-553
Condition	Fair
Damage to Structure and Picture #'s	C-1, 537-538
End of Structure	S-32
End of Structure Picture #	554

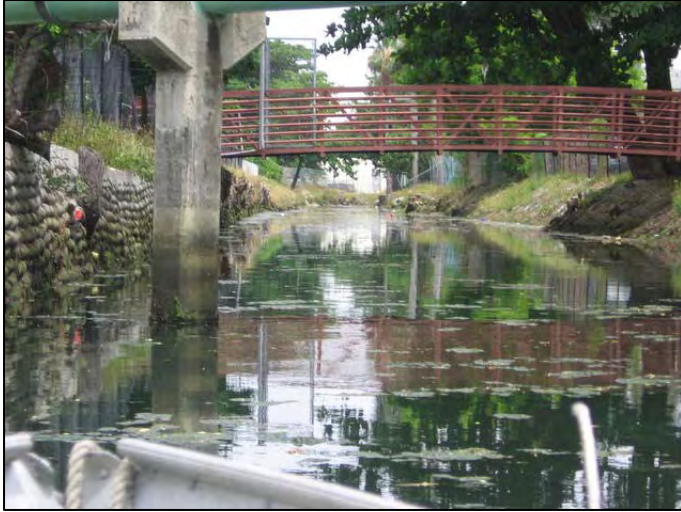
IMG\_0555

Address	N/A
Folio #	N/A
Access Agreement	N/A
Description	West piling for utility
Water Body	Wagner Creek
Operational Section	1
Easting	912999.379
Northing	530887.071
Bank Location	West
Picture #	555
Condition	Good
Damage to Structure and Picture #'s	N/A
End of Structure	N/A
End of Structure Picture #	N/A
