*Corrective Action Plan - Version 2*

# Wagner Creek/Seybold Canal

Volume 2 — Appendices G through I

Submitted to  
City of Miami

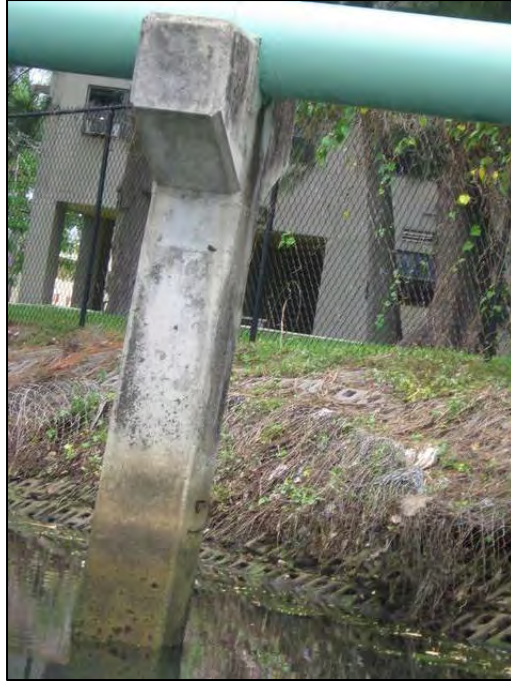
IMG\_0556

Address	N/A
Folio #	N/A
Access Agreement	N/A
Description	Center piling for utility
Water Body	Wagner Creek
Operational Section	1
Easting	912999.379
Northing	530887.071
Bank Location	Center of canal
Picture #	556
Condition	Good
Damage to Structure and Picture #'s	N/A
End of Structure	N/A
End of Structure Picture #	N/A

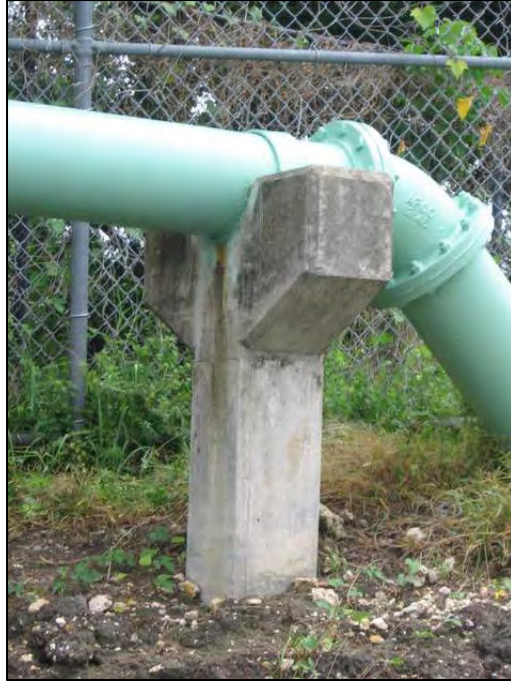
IMG\_0557

Address	N/A
Folio #	N/A
Access Agreement	N/A
Description	East piling for utility
Water Body	Wagner Creek
Operational Section	1
Easting	912999.379
Northing	530887.071
Bank Location	East
Picture #	557
Condition	Good
Damage to Structure and Picture #'s	N/A
End of Structure	N/A
End of Structure Picture #	N/A

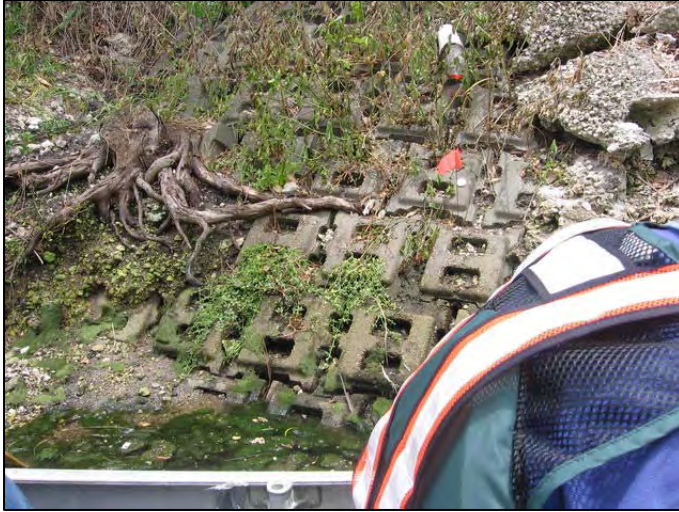
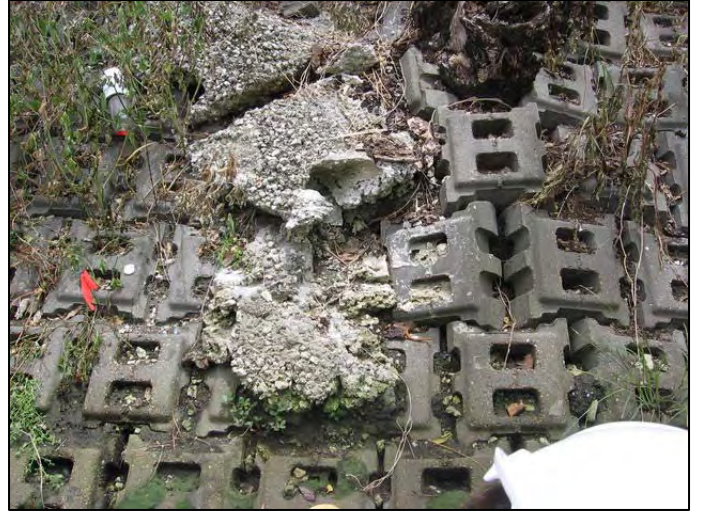
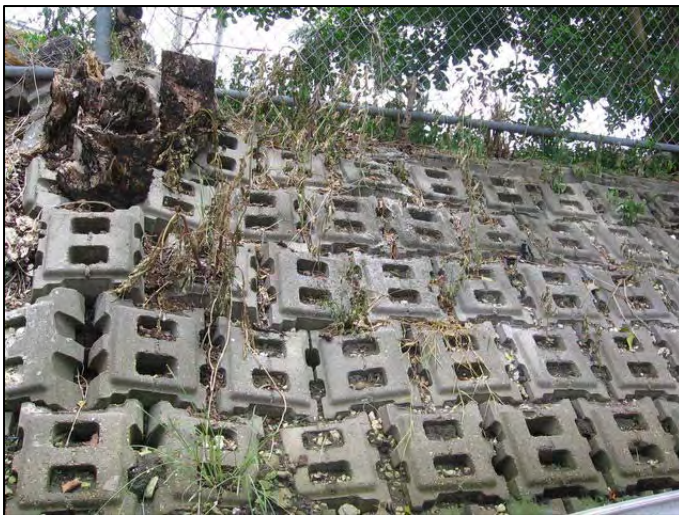
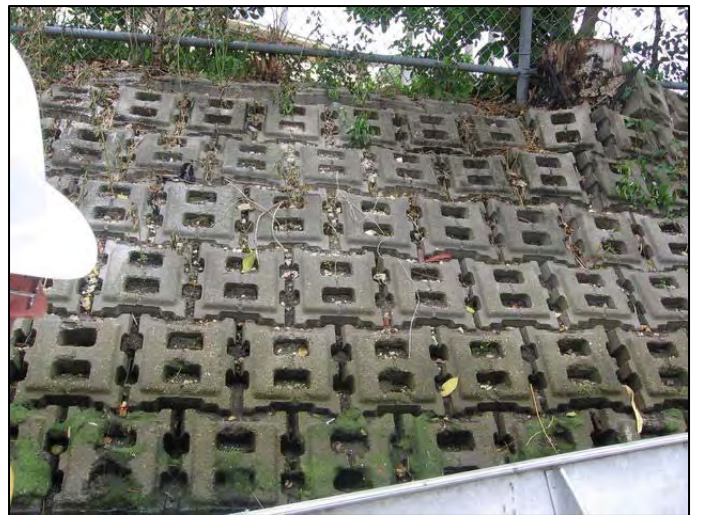
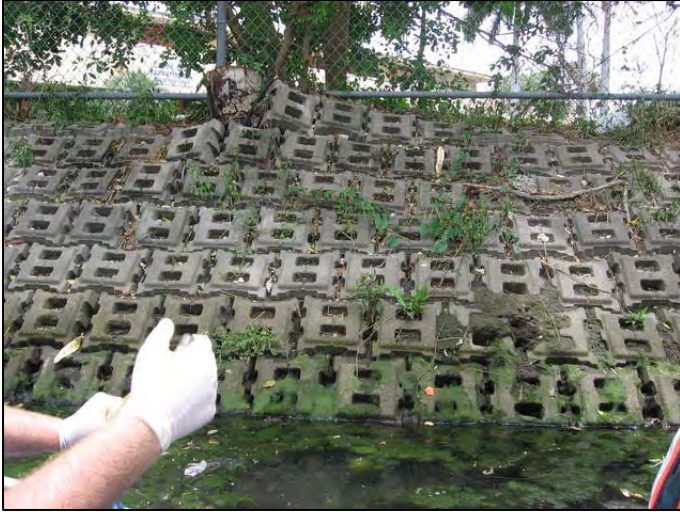
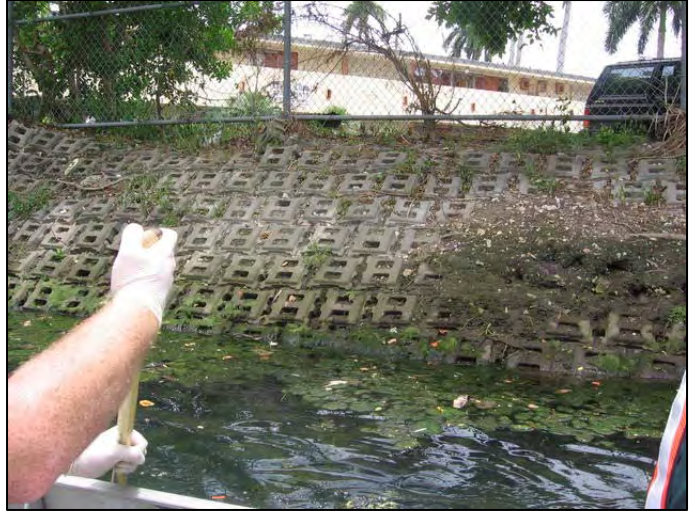
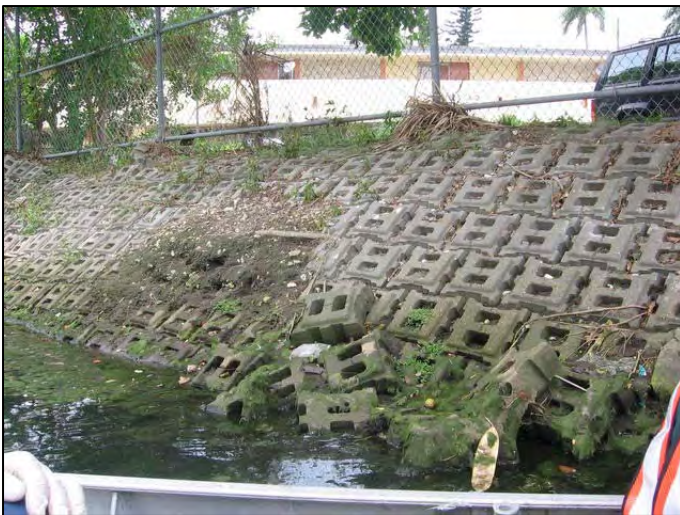
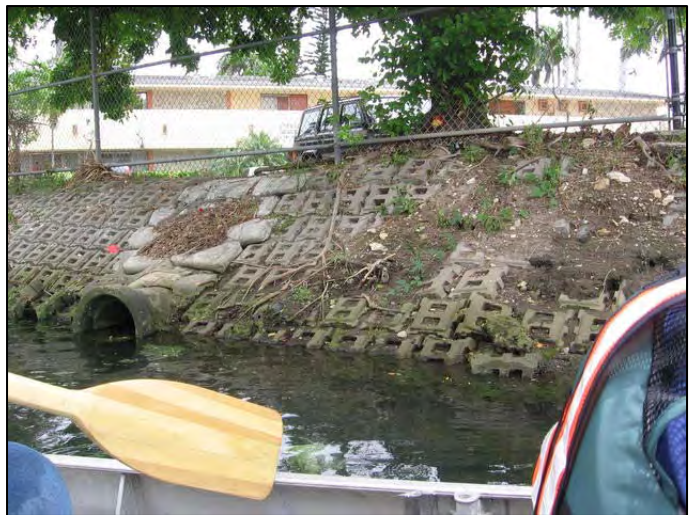
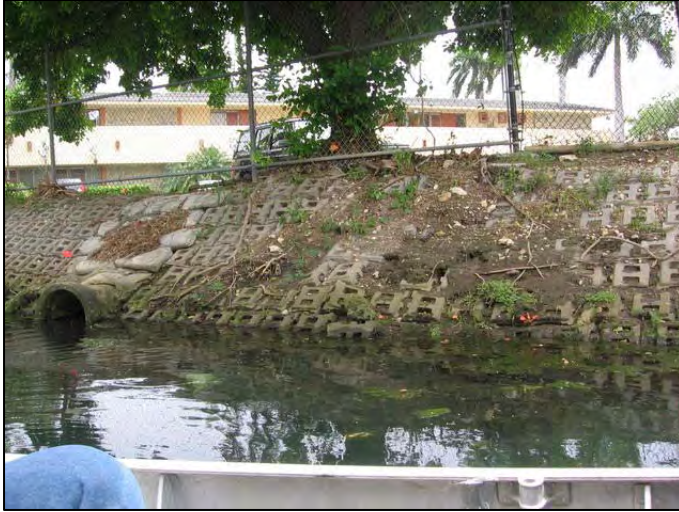
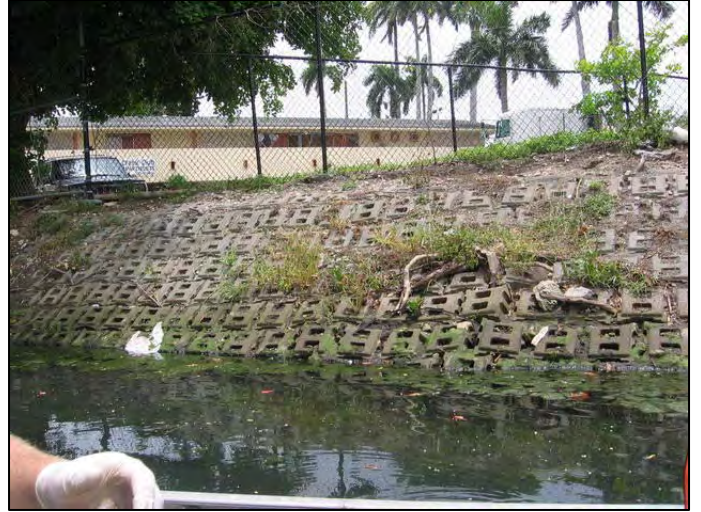
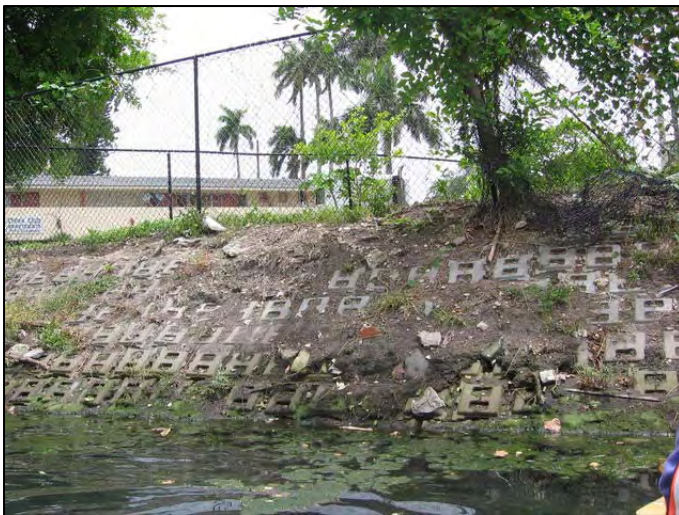
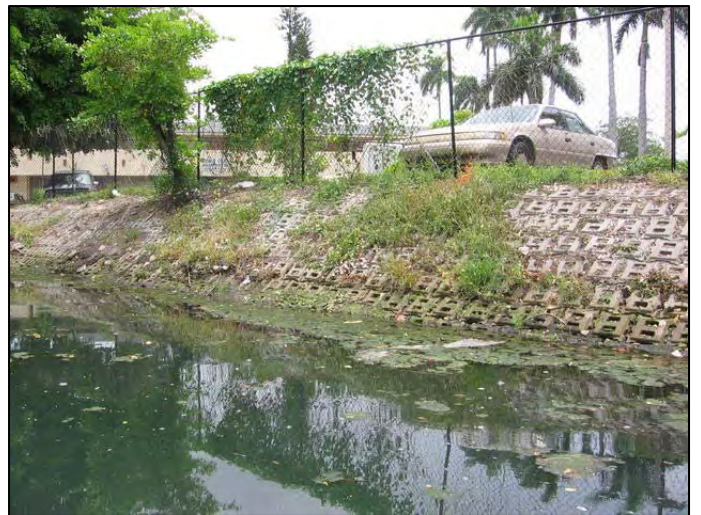
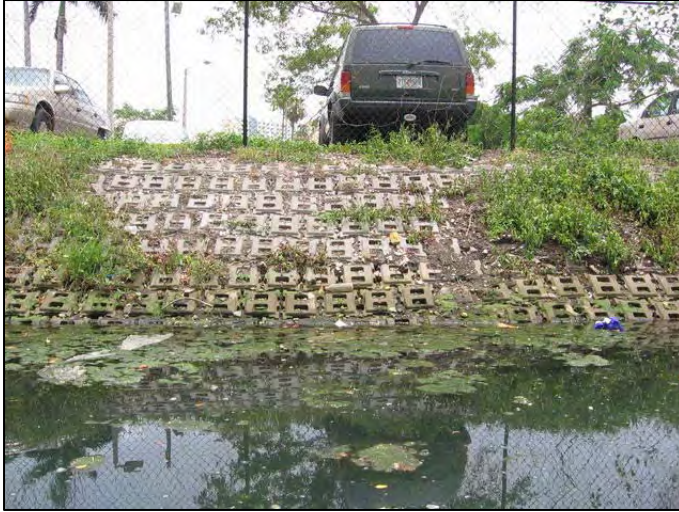
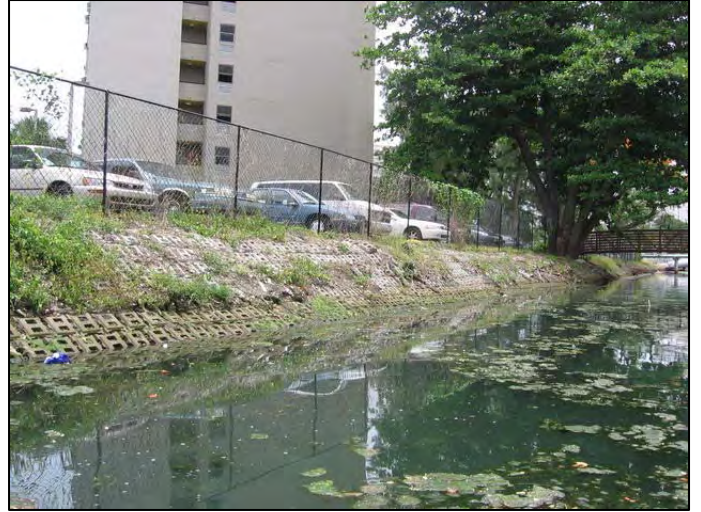
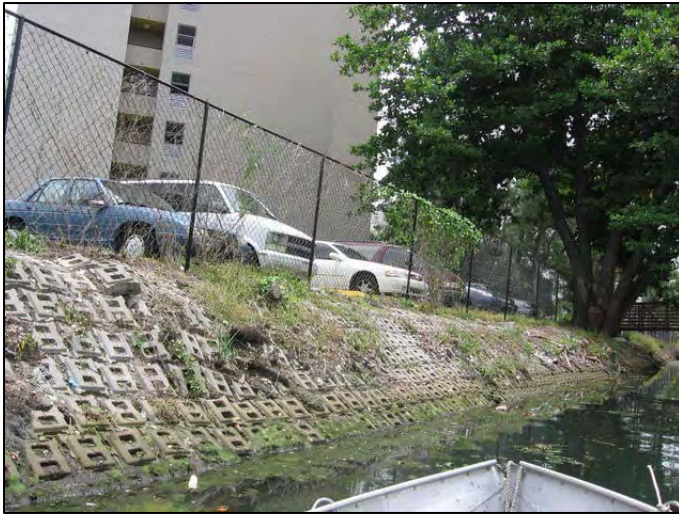
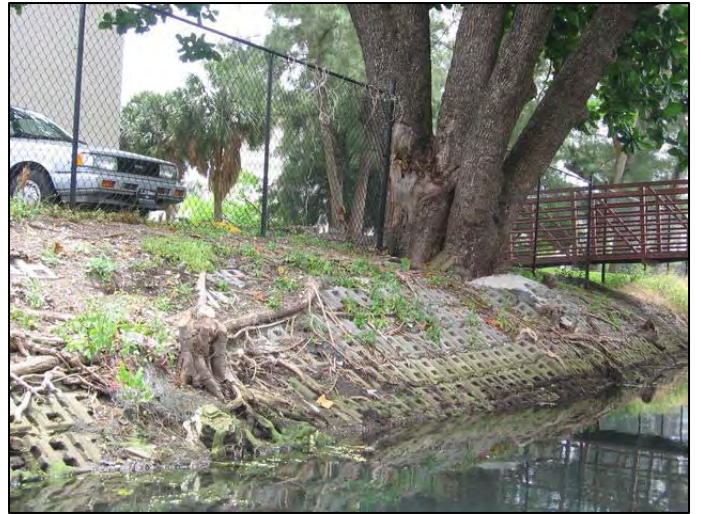
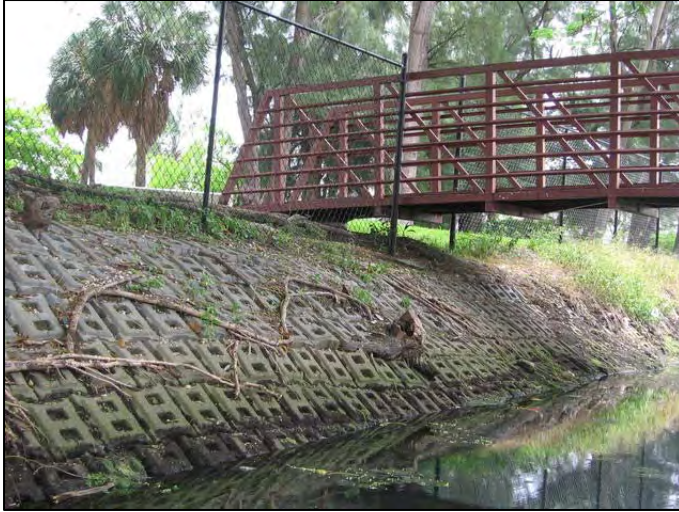
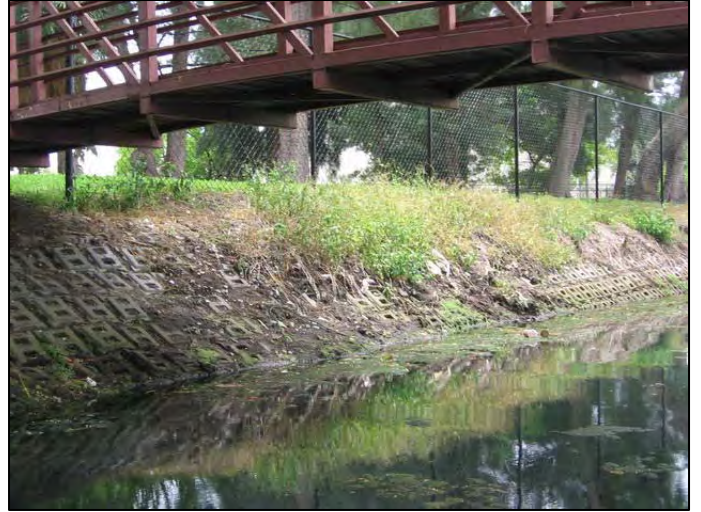
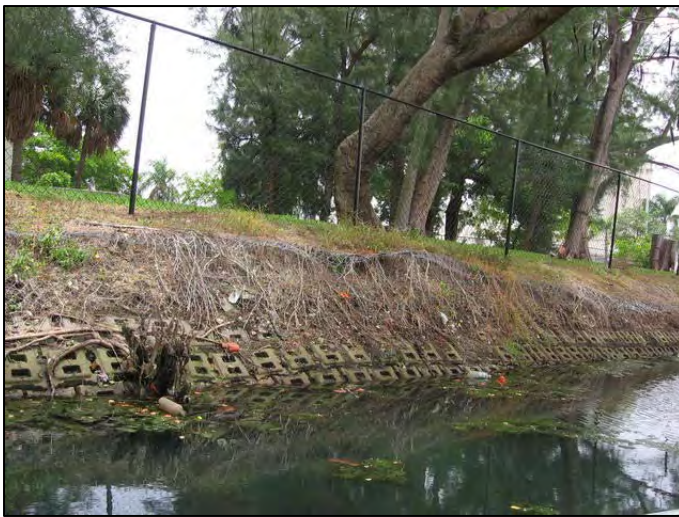
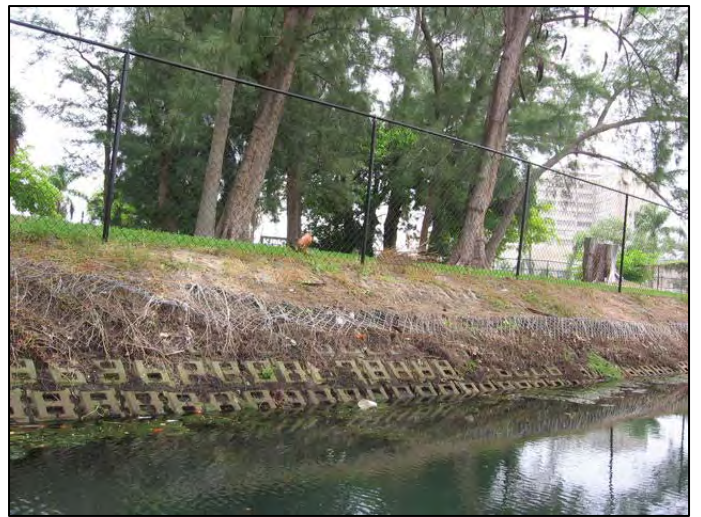
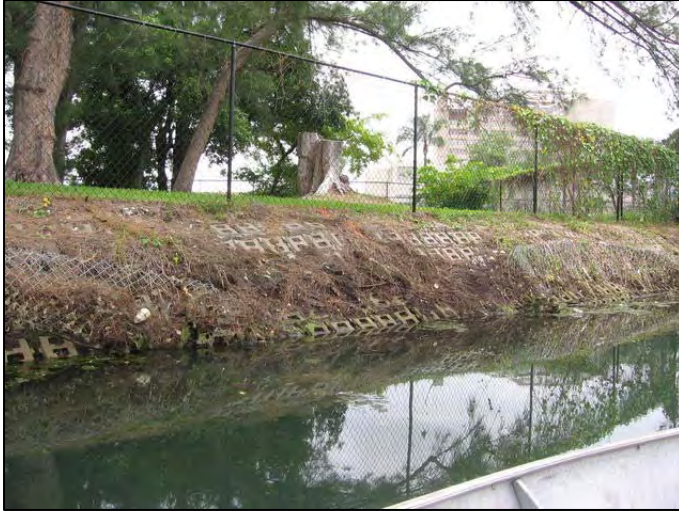
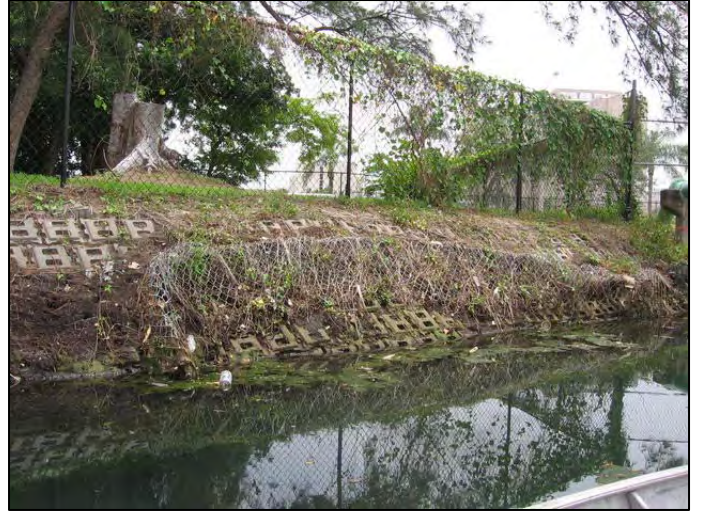
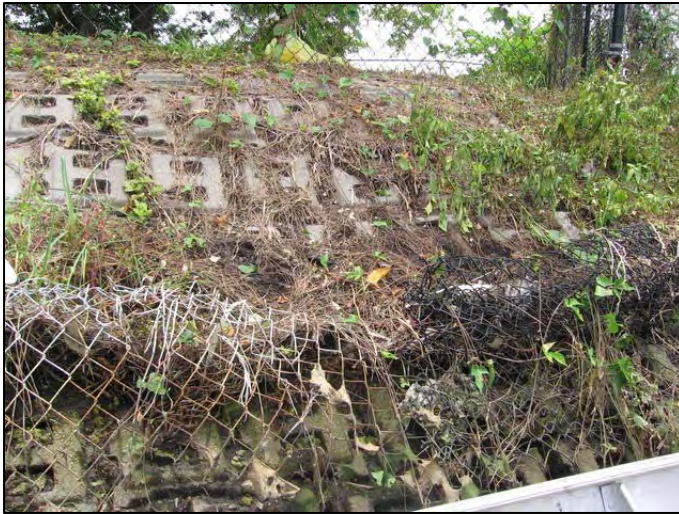
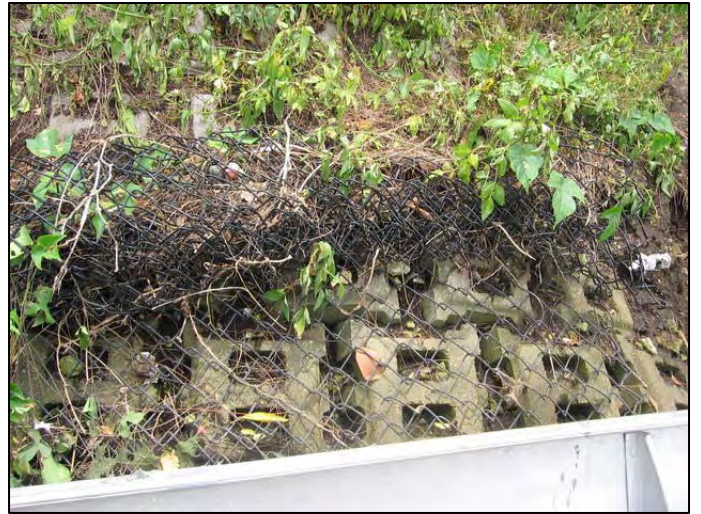
Structure S-36 Pictures

Address	1400 NW 19 <sup>th</sup> St.
Folio #	0131350630010
Access Agreement	
Description	Concrete brick erosion control structure
Water Body	Wagner Creek
Operational Section	1
Easting	912717.817
Northing	531201.628
Bank Location	East
Picture #	559-565, 567-583
Condition	Fair
Damage to Structure and Picture #'s	N/A
End of Structure	S-38
End of Structure Picture #	584

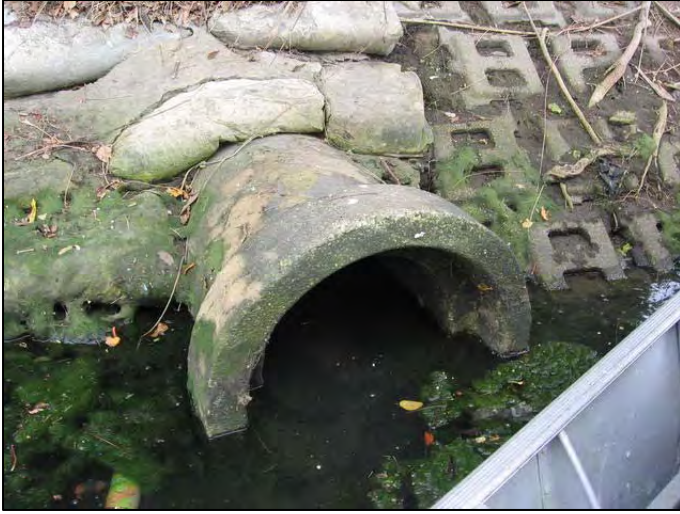
IMG\_0566

Address	1400 NW 19 <sup>th</sup> St.
Folio #	0131350630010
Access Agreement	
Description	Concrete culvert
Water Body	Wagner Creek
Operational Section	1
Easting	912741.173
Northing	531147.245
Bank Location	East
Picture #	566
Condition	Fair
Damage to Structure and Picture #'s	N/A
End of Structure	N/A
End of Structure Picture #	N/A

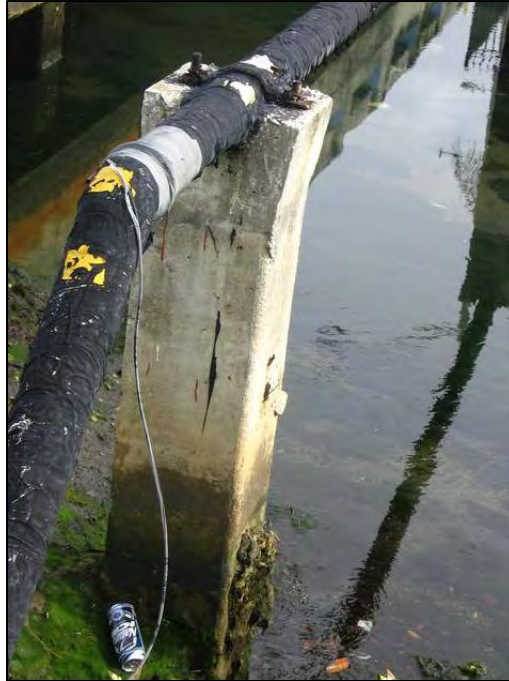
IMG\_0485

Address	N/A
Folio #	N/A
Access Agreement	N/A
Description	West piling for utility
Water Body	Wagner Creek
Operational Section	2
Easting	913150.557
Northing	530683.932
Bank Location	West
Picture #	485
Condition	Fair
Damage to Structure and Picture #'s	N/A
End of Structure	N/A
End of Structure Picture #	N/A

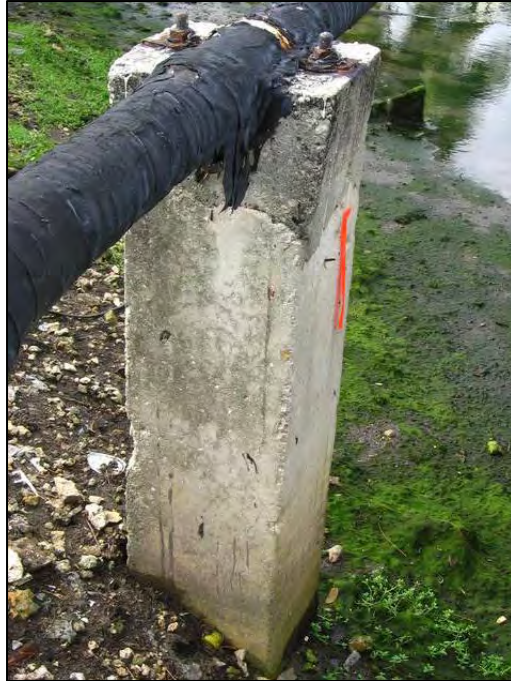
IMG\_0489

Address	N/A
Folio #	N/A
Access Agreement	N/A
Description	East piling for utility
Water Body	Wagner Creek
Operational Section	2
Easting	913148.893
Northing	530734.543
Bank Location	East
Picture #	489
Condition	Fair
Damage to Structure and Picture #'s	N/A
End of Structure	N/A
End of Structure Picture #	N/A

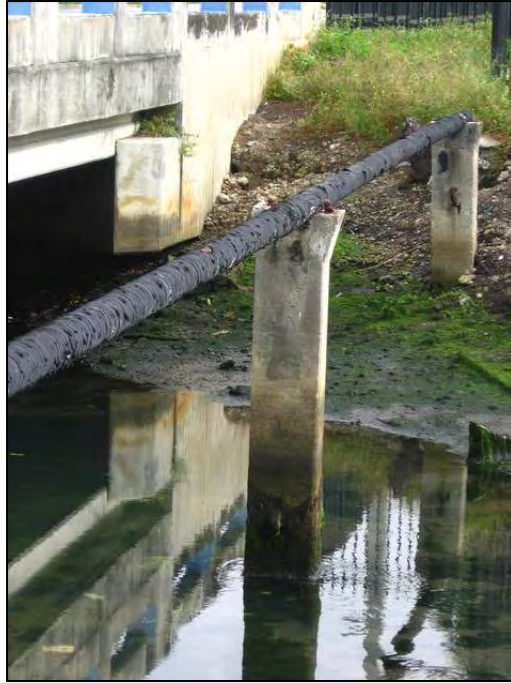
IMG\_0486

Address	N/A
Folio #	N/A
Access Agreement	N/A
Description	Center piling for utility
Water Body	Wagner Creek
Operational Section	2
Easting	913150.687
Northing	530710.396
Bank Location	Center of canal
Picture #	486
Condition	Fair
Damage to Structure and Picture #'s	N/A
End of Structure	N/A
End of Structure Picture #	N/A

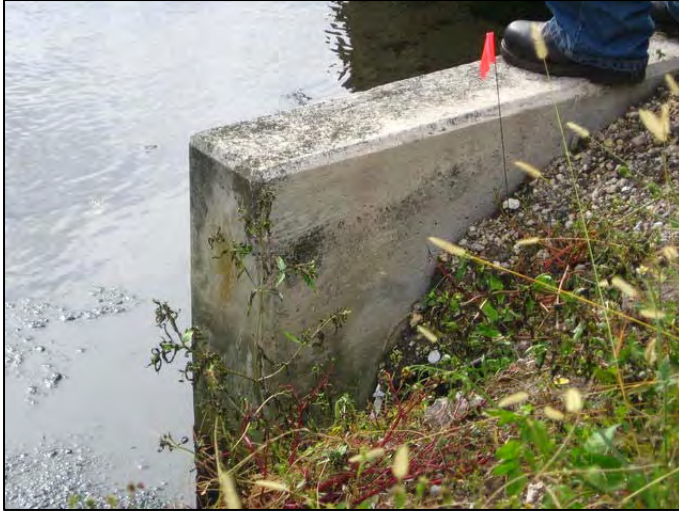
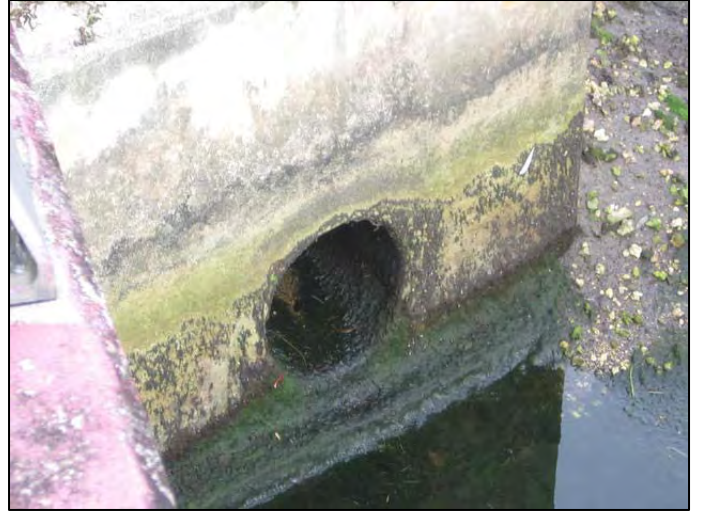
**Structure S-27 Pictures**

Address	1201 NW 16 <sup>th</sup> St.
Folio #	0131350000160
Access Agreement	
Description	Concrete seawall and 18" concrete culvert on NW 17 <sup>th</sup> Ave. bridge
Water Body	Wagner Creek
Operational Section	2
Easting	913248.744
Northing	530586.211
Bank Location	West
Picture #	491, 495
Condition	Good
Damage to Structure and Picture #'s	N/A
End of Structure	N/A
End of Structure Picture #	N/A

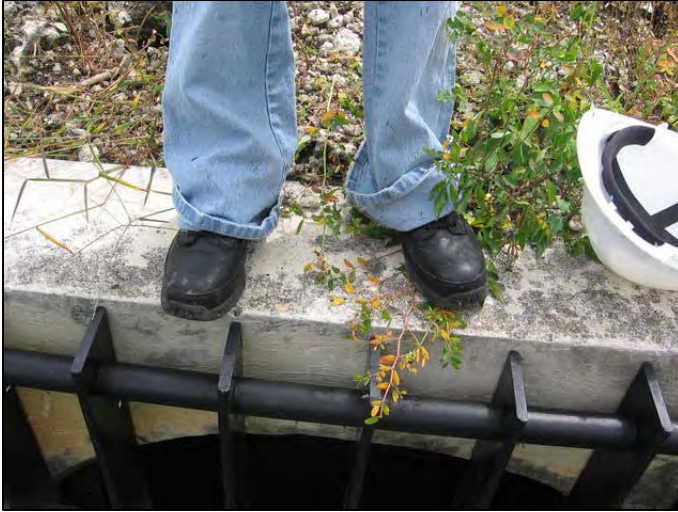
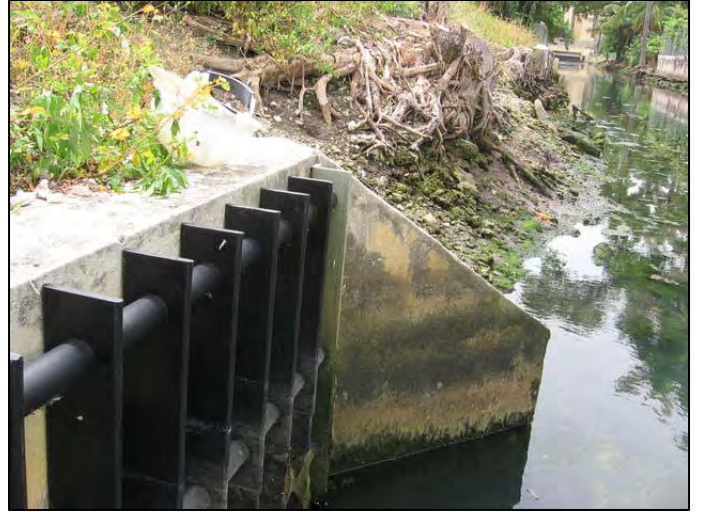
**Structure S-28 Pictures**

Address	1310 NW 16 <sup>th</sup> St.
Folio #	0131350560010
Access Agreement	
Description	Concrete culvert with metal grate
Water Body	Wagner Creek
Operational Section	2
Easting	913483.345
Northing	530371.560
Bank Location	East
Picture #	527, 528
Condition	Fair
Damage to Structure and Picture #'s	N/A
End of Structure	N/A
End of Structure Picture #	N/A

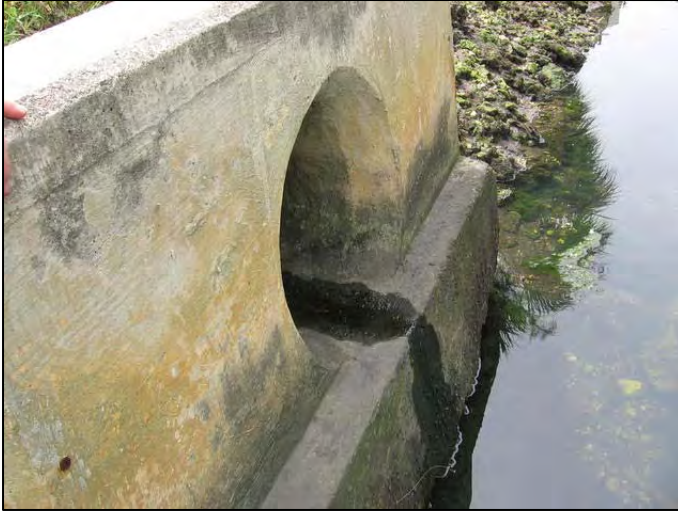
IMG\_0529

Address	1310 NW 16 <sup>th</sup> St.
Folio #	0131350560010
Access Agreement	
Description	Concrete culvert
Water Body	Wagner Creek
Operational Section	2
Easting	913549.137
Northing	530294.229
Bank Location	East
Picture #	529
Condition	Good
Damage to Structure and Picture #'s	N/A
End of Structure	N/A
End of Structure Picture #	N/A

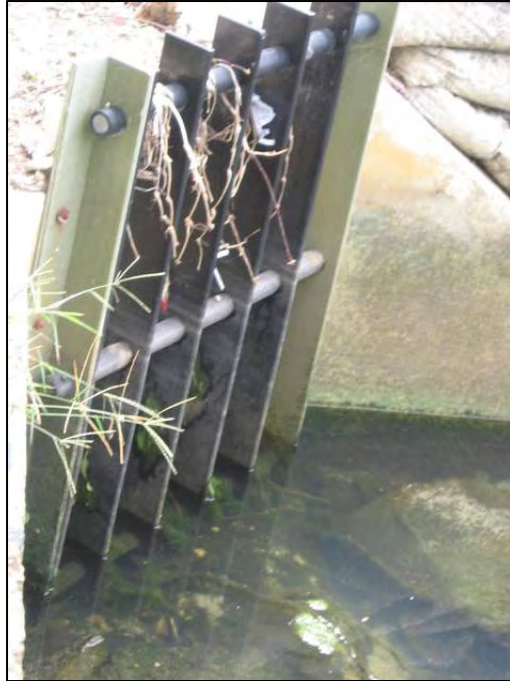
IMG\_0535

Address	1310 NW 16 <sup>th</sup> St.
Folio #	0131350560010
Access Agreement	
Description	Concrete culvert with metal grate
Water Body	Wagner Creek
Operational Section	2
Easting	913618.169
Northing	530242.775
Bank Location	East
Picture #	535
Condition	Good
Damage to Structure and Picture #'s	N/A
End of Structure	N/A
End of Structure Picture #	N/A

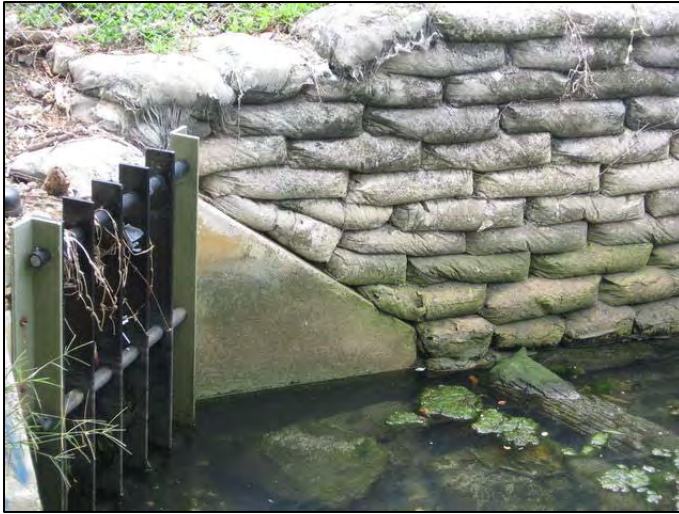
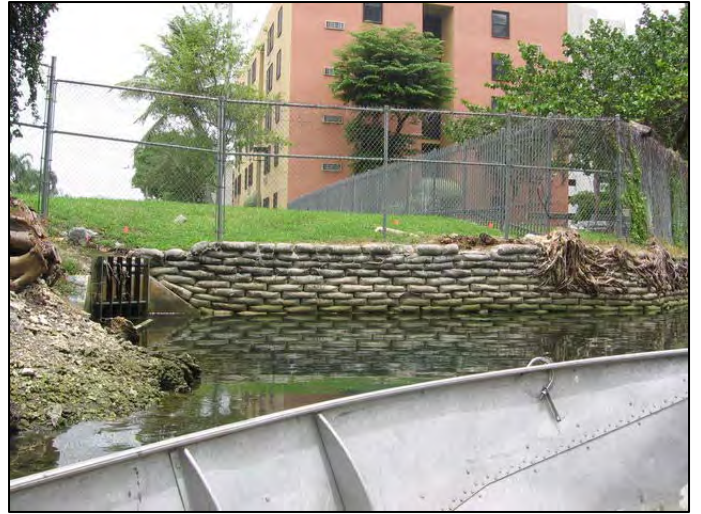
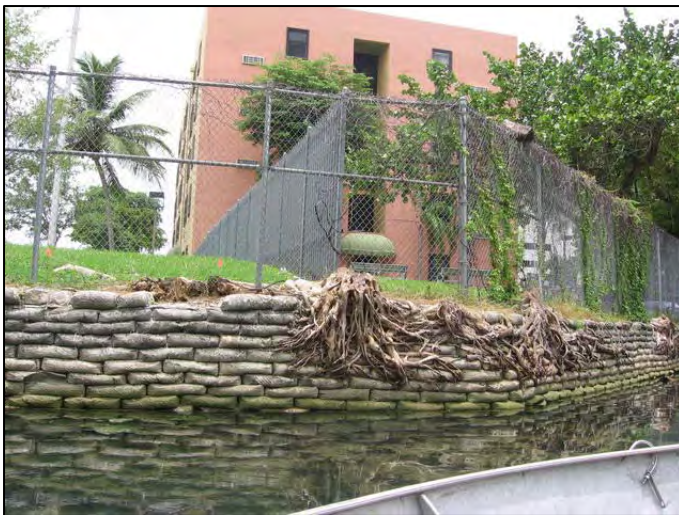
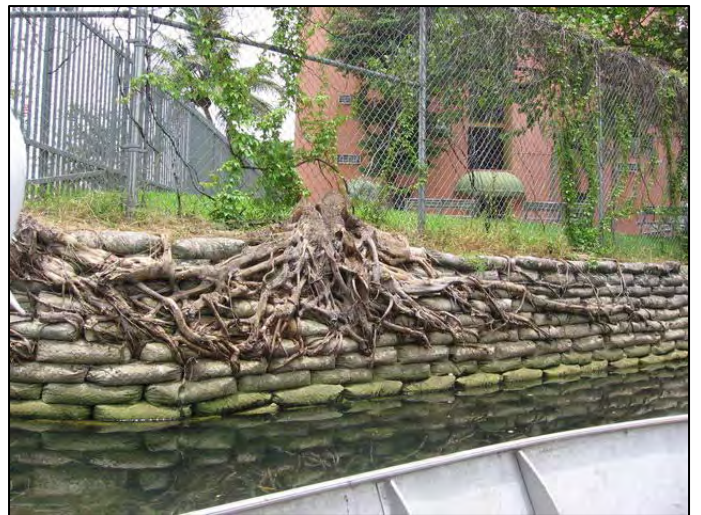
Structure S-31 Pictures

Address	1310 NW 16 <sup>th</sup> St.
Folio #	0131350560010
Access Agreement	
Description	Concrete sandbag seawall
Water Body	Wagner Creek
Operational Section	2
Easting	913621.694
Northing	530241.768
Bank Location	East
Picture #	536, 593-599, 601-605
Condition	Fair
Damage to Structure and Picture #'s	C-1, 593; C-2, 593; C-3, 600; C-4, 603
End of Structure	S-42
End of Structure Picture #	605

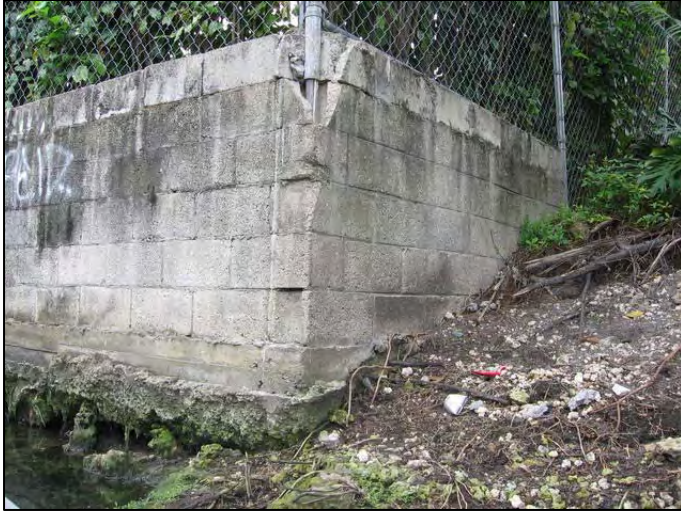
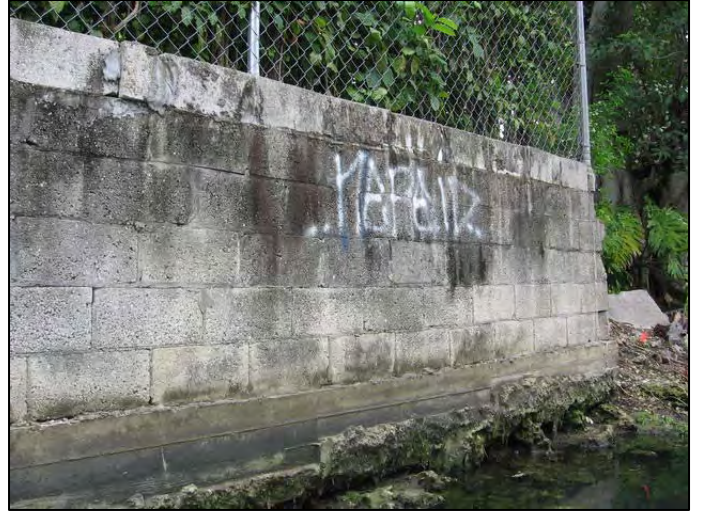
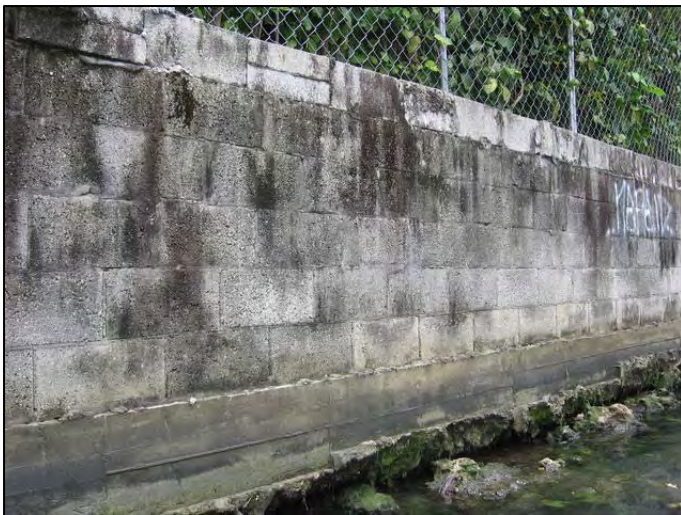
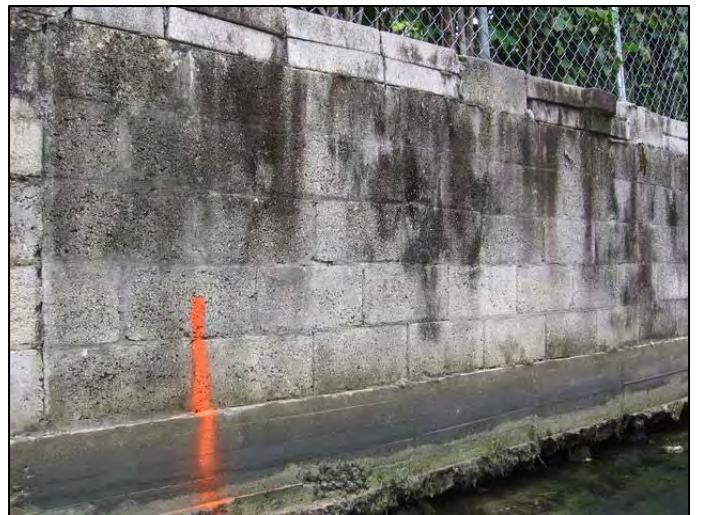
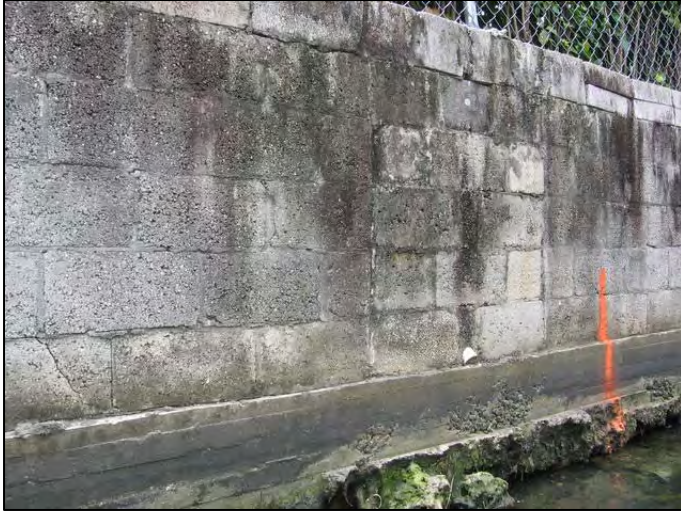
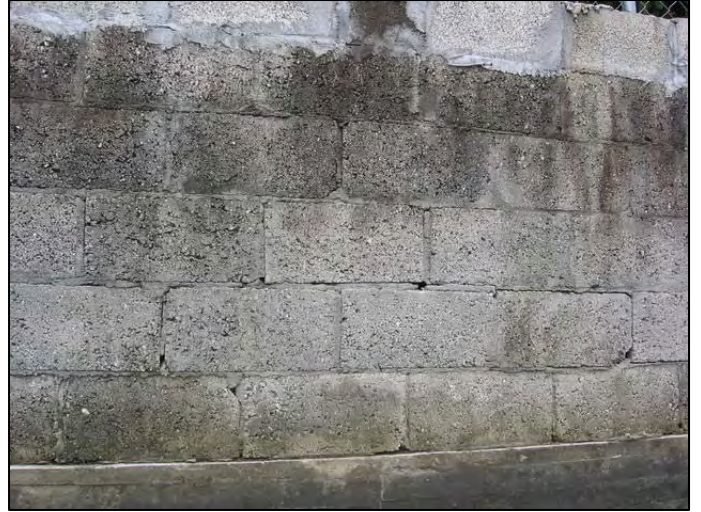
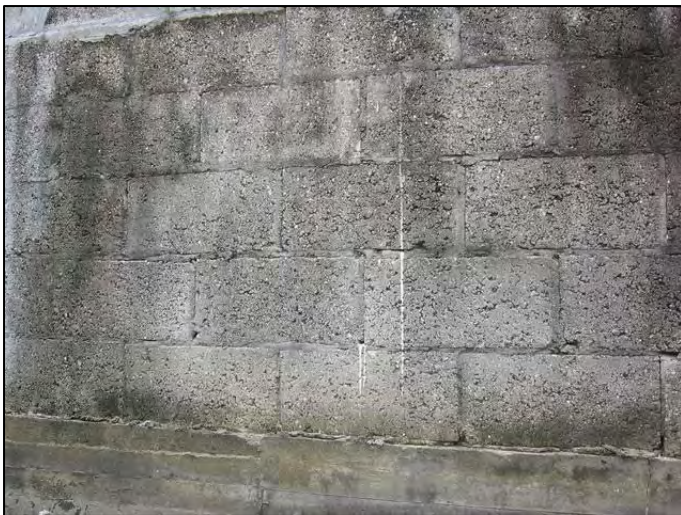
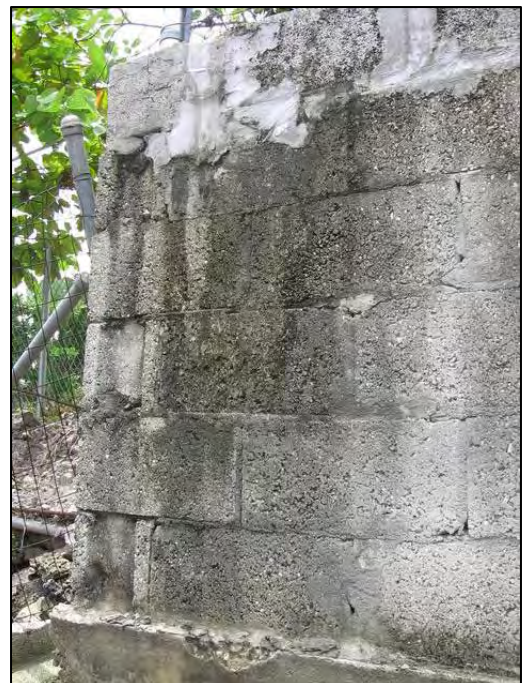
Structure S-39 Pictures

Address	1571 NW 13 <sup>th</sup> Ct.
Folio #	0131350240090
Access Agreement	
Description	Concrete seawall
Water Body	Wagner Creek
Operational Section	2
Easting	913549.409
Northing	530250.989
Bank Location	West
Picture #	585-591
Condition	Fair
Damage to Structure and Picture #'s	N/A
End of Structure	S-40
End of Structure Picture #	592

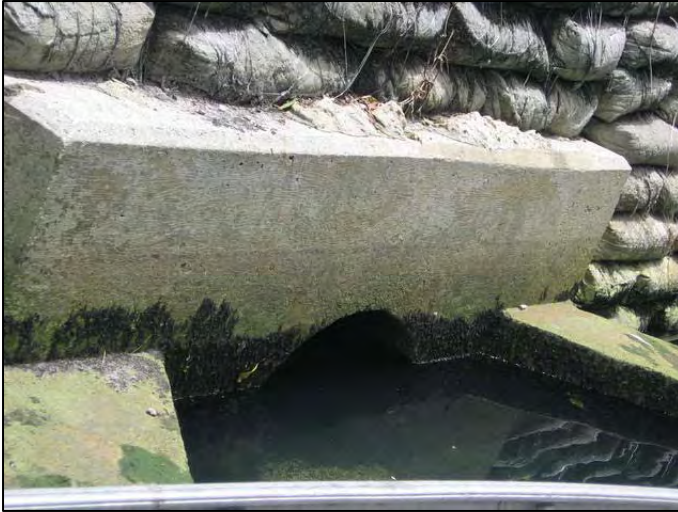
IMG\_0604

Address	1310 NW 16 <sup>th</sup> St.
Folio #	0131350560010
Access Agreement	
Description	Concrete culvert within structure S-31
Water Body	Wagner Creek
Operational Section	2
Easting	913711.946
Northing	530110.408
Bank Location	East
Picture #	604
Condition	Fair
Damage to Structure and Picture #'s	N/A
End of Structure	N/A
End of Structure Picture #	N/A

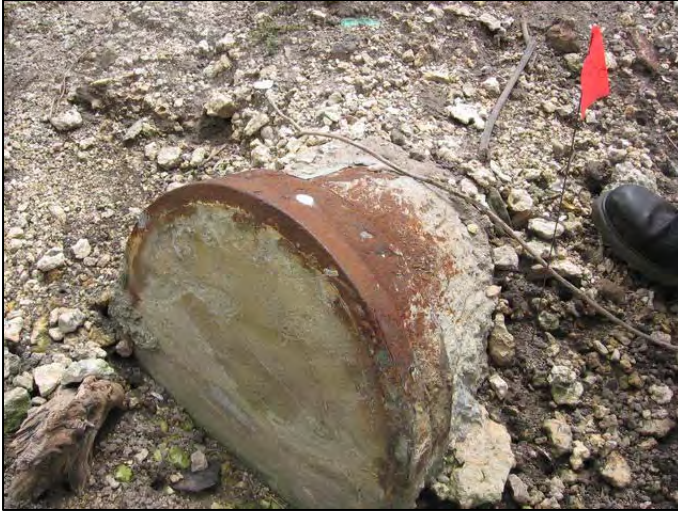
IMG\_0613

Address	1501 NW 13 <sup>th</sup> Ct.
Folio #	0131350240020
Access Agreement	
Description	Capped off steel pipe
Water Body	Wagner Creek
Operational Section	2
Easting	913836.886
Northing	529912.658
Bank Location	West
Picture #	613
Condition	Fair
Damage to Structure and Picture #'s	N/A
End of Structure	N/A
End of Structure Picture #	N/A

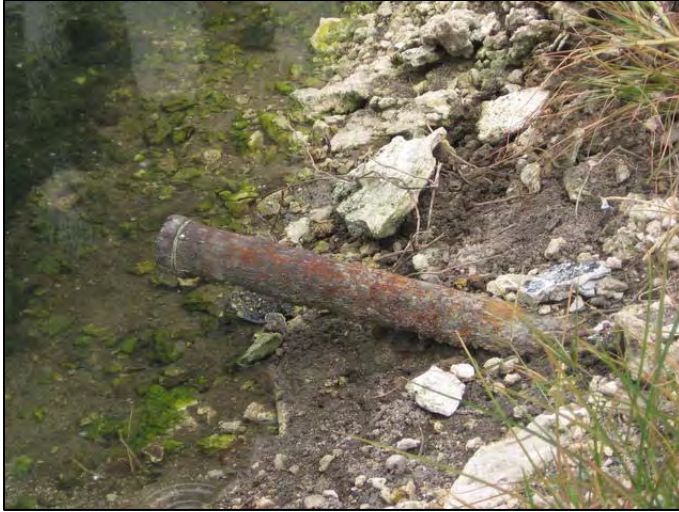
IMG\_0620

Address	1501 NW 13 <sup>th</sup> Ct.
Folio #	0131350240020
Access Agreement	
Description	Steel pipe
Water Body	Wagner Creek
Operational Section	2
Easting	913770.869
Northing	530000.144
Bank Location	West
Picture #	620
Condition	Fair
Damage to Structure and Picture #'s	N/A
End of Structure	N/A
End of Structure Picture #	N/A

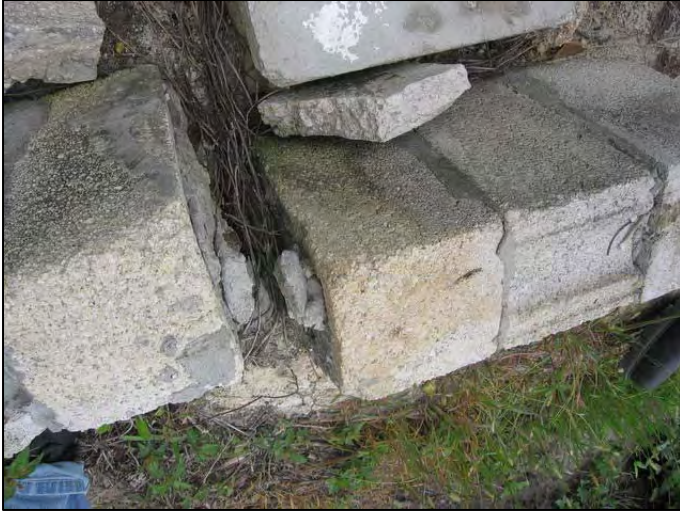
IMG\_0622

Address	1511 NW 13TH CT
Folio #	0131350240030
Access Agreement	
Description	Small concrete wall
Water Body	Wagner Creek
Operational Section	2
Easting	913725.025
Northing	530044.475
Bank Location	West
Picture #	622
Condition	Poor
Damage to Structure and Picture #'s	N/A
End of Structure	N/A
End of Structure Picture #	N/A

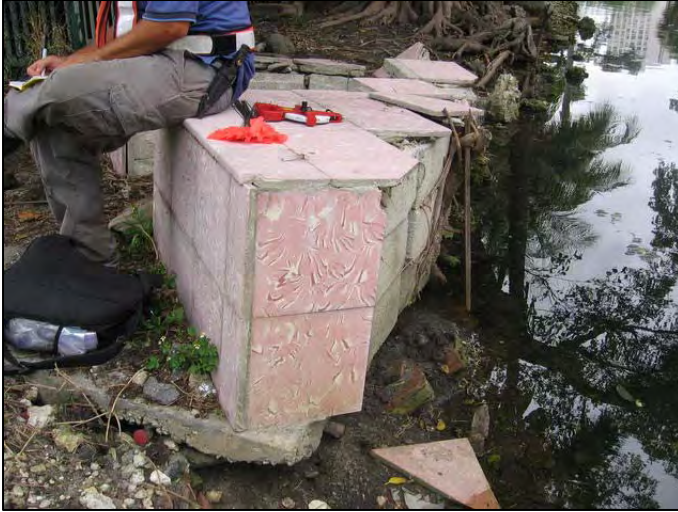
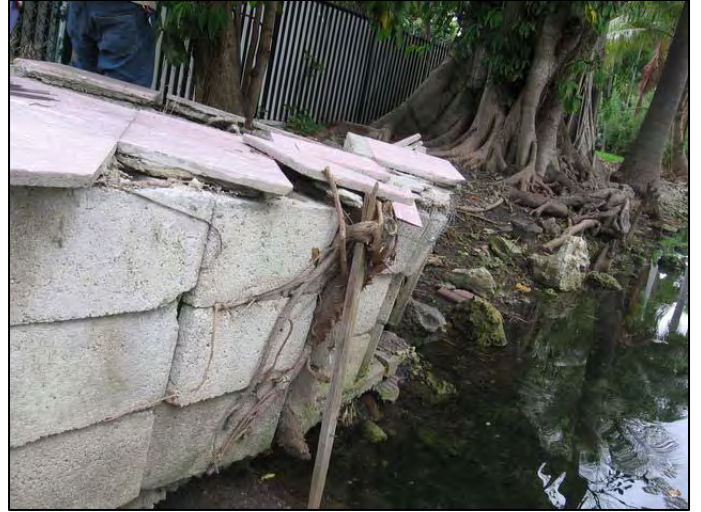
**Structure S-46 Pictures**

Address	1521 NW 13 <sup>th</sup> Ct.
Folio #	0131350240040
Access Agreement	
Description	Unknown concrete and brick structure
Water Body	Wagner Creek
Operational Section	2
Easting	913704.233
Northing	530062.831
Bank Location	West
Picture #	627-628
Condition	Poor
Damage to Structure and Picture #'s	N/A
End of Structure	N/A
End of Structure Picture #	N/A
