*Corrective Action Plan - Version 2*

# Wagner Creek/Seybold Canal

Volume 2 — Appendices G through I

Submitted to  
City of Miami

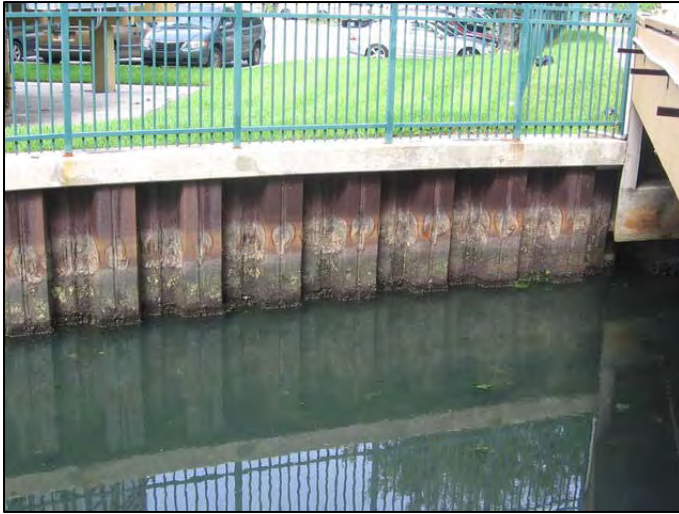
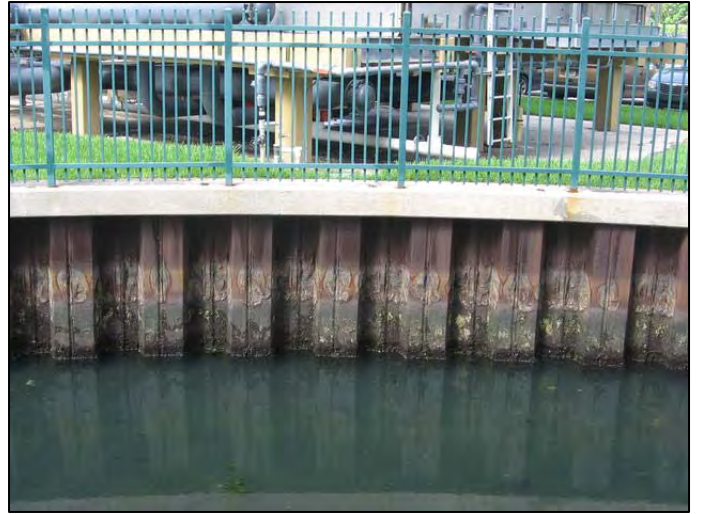
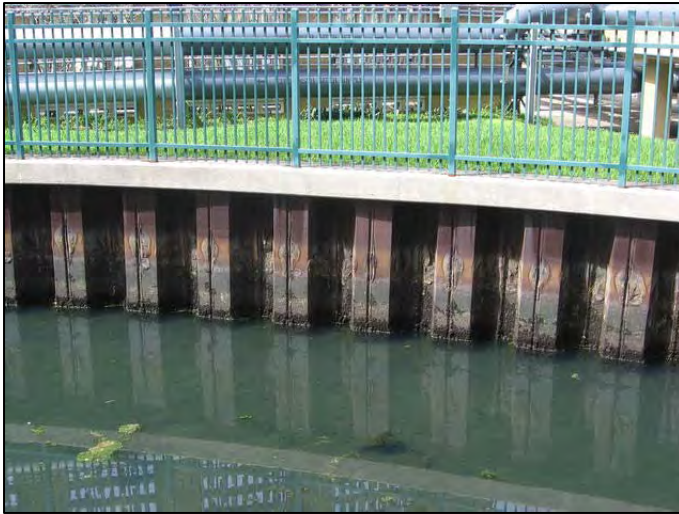
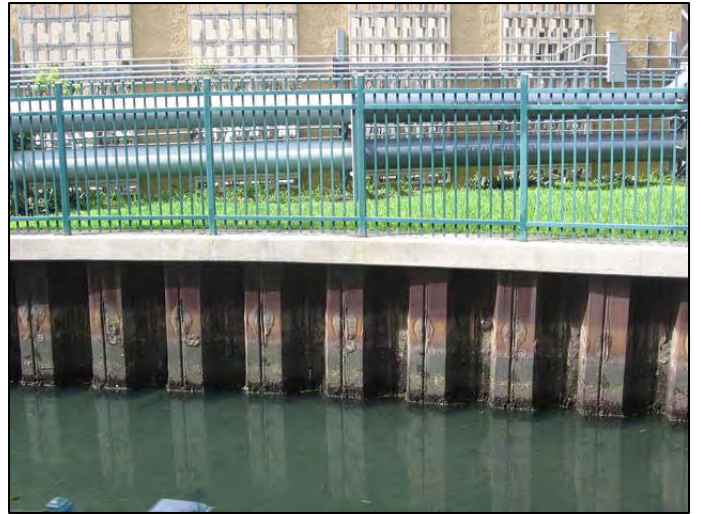
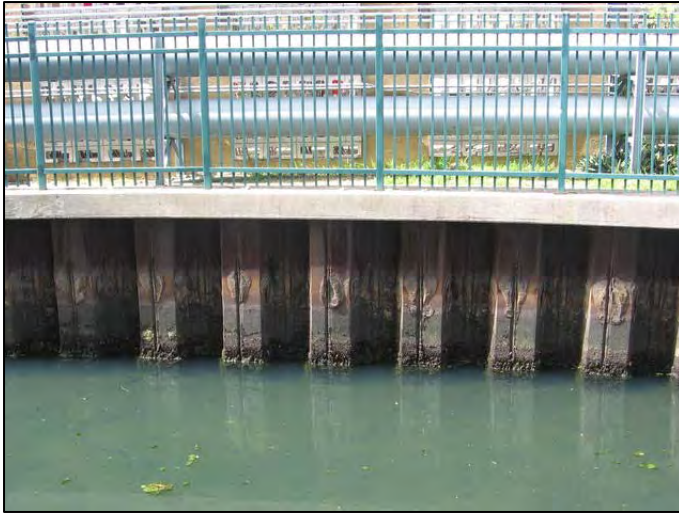
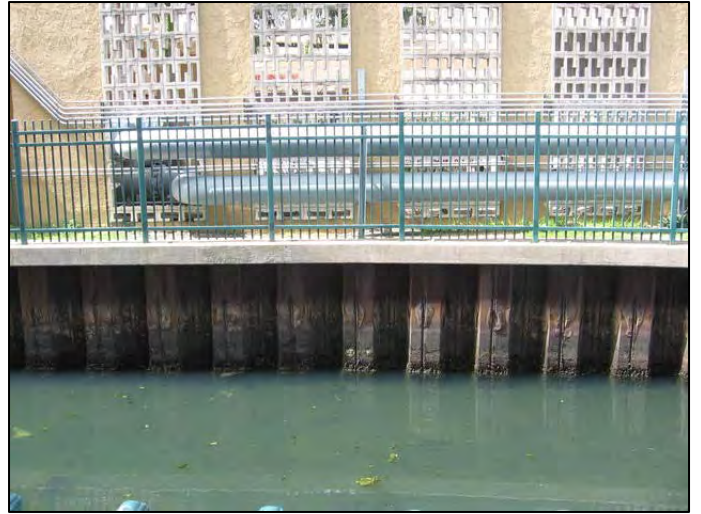
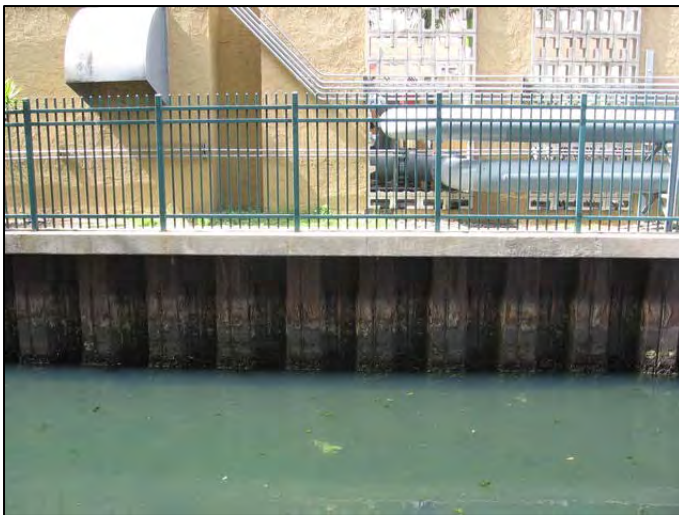
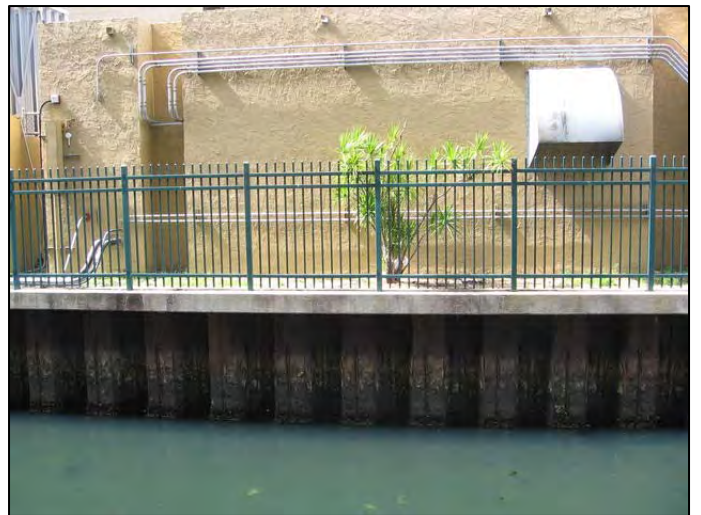
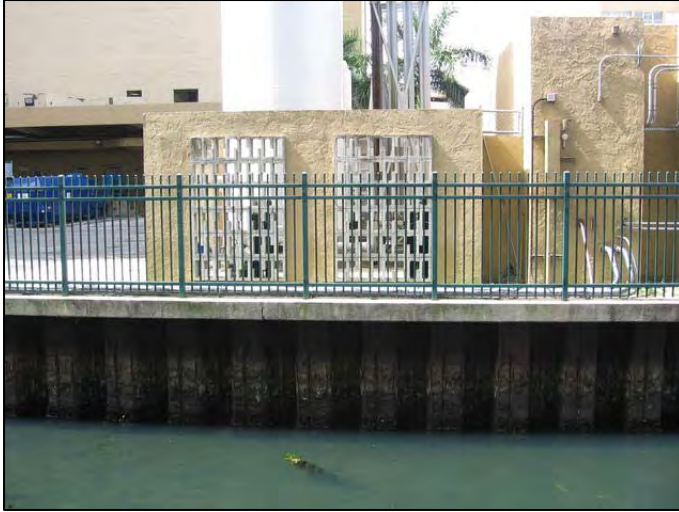
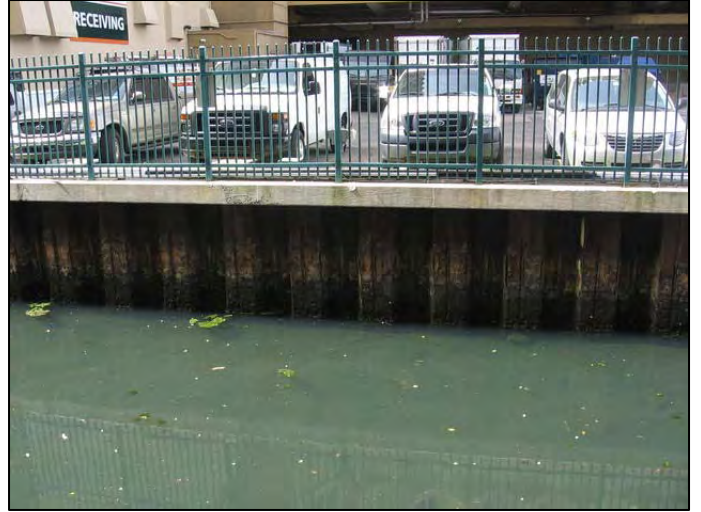
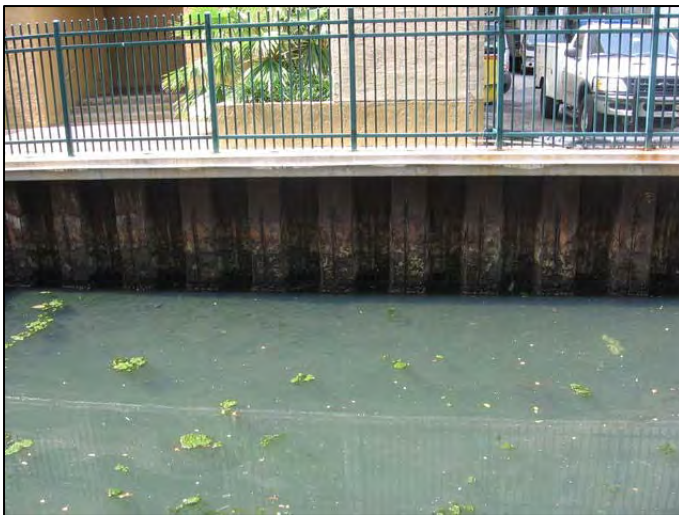
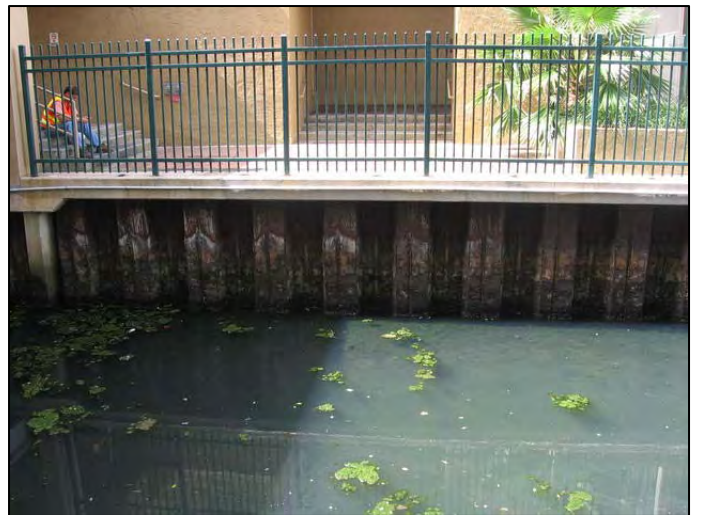
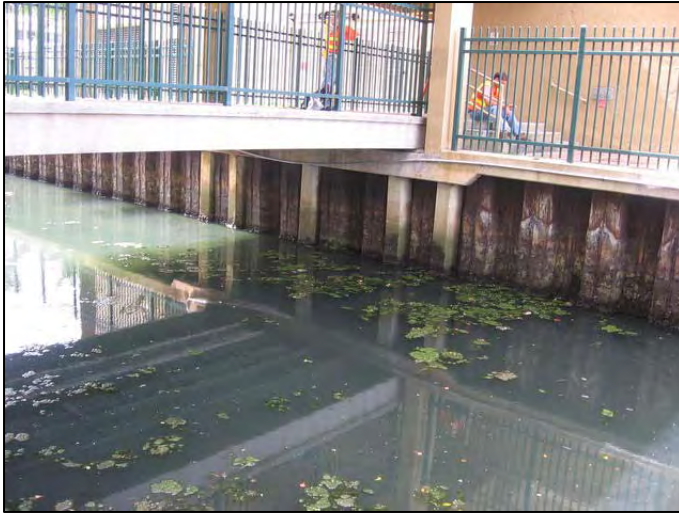
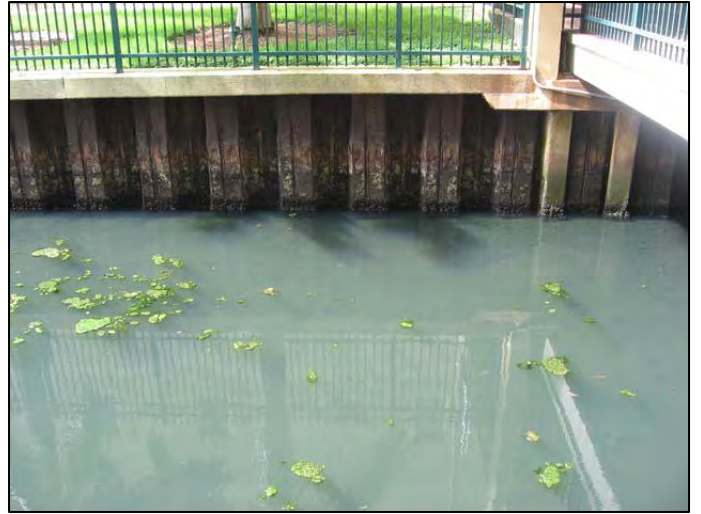
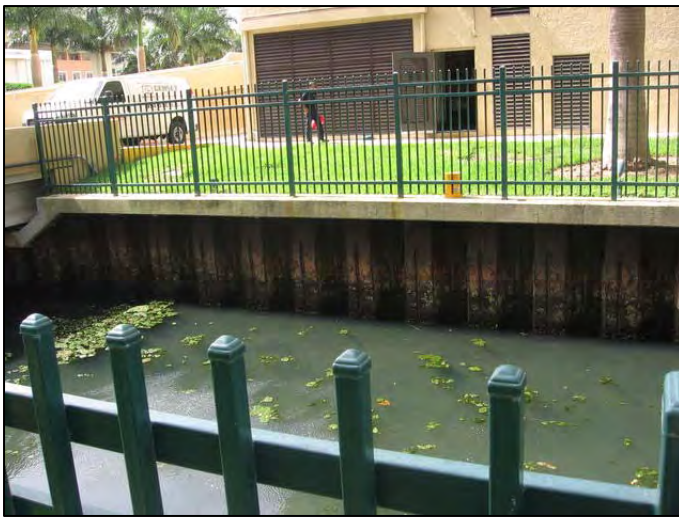
Structure S-47 Pictures

Address	1500 NW 12 <sup>th</sup> Ave.; 1500 NW 12 <sup>th</sup> Ave.
Folio #	0131350450020; 0131350450010
Access Agreement	
Description	Metal seawall with concrete cap and metal railing
Water Body	Wagner Creek
Operational Section	3
Easting	913725.025
Northing	530044.475
Bank Location	West
Picture #	647-709
Condition	Fair
Damage to Structure and Picture #'s	N/A
End of Structure	S-48
End of Structure Picture #	709

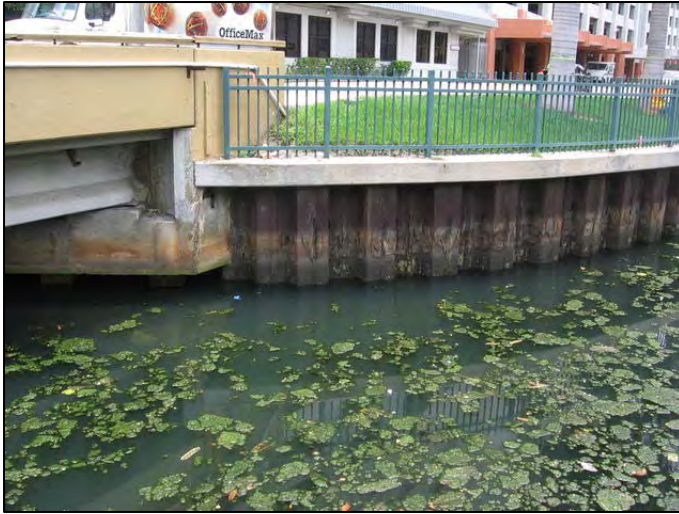
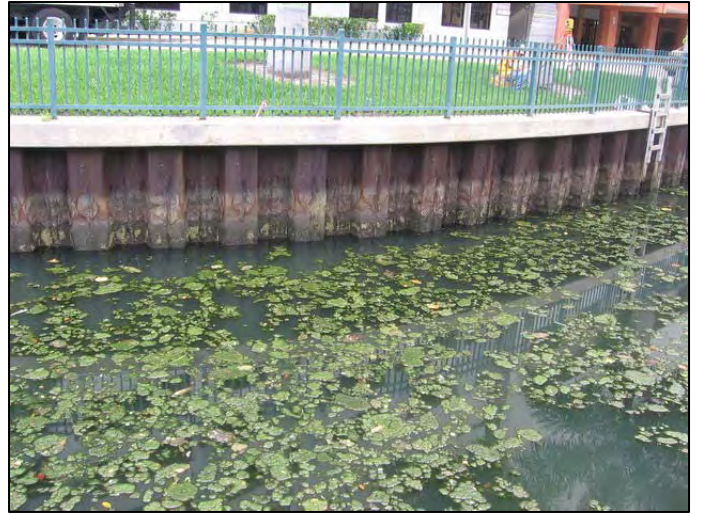
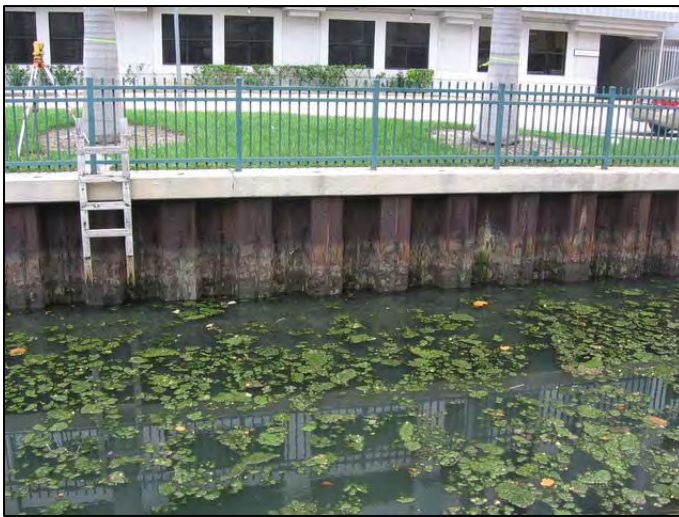
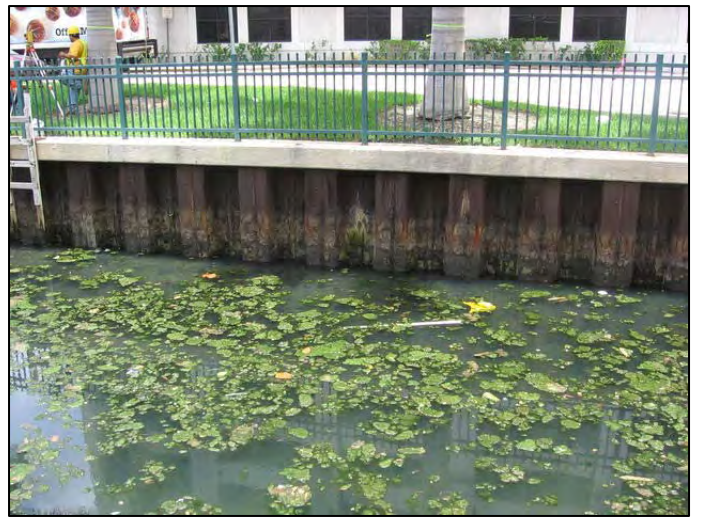
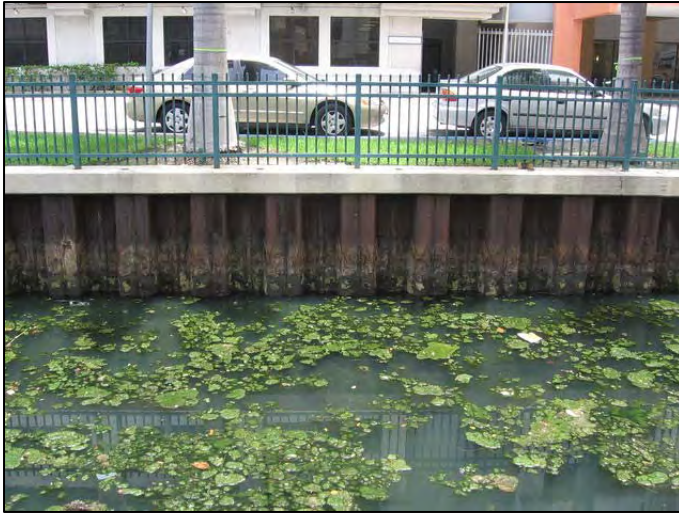
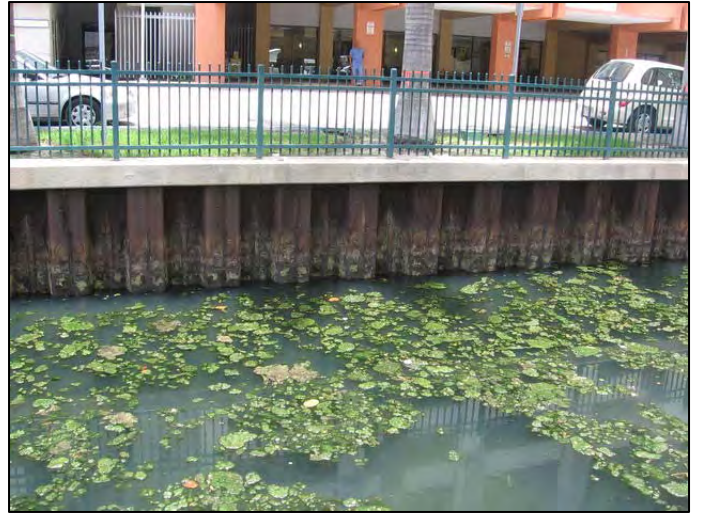
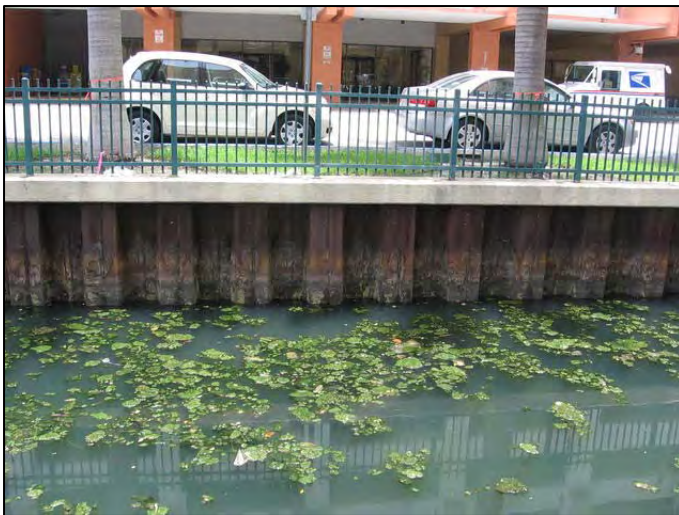
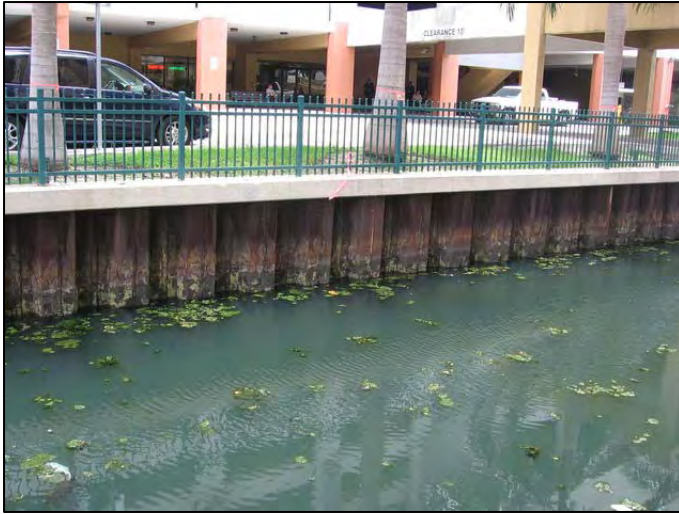
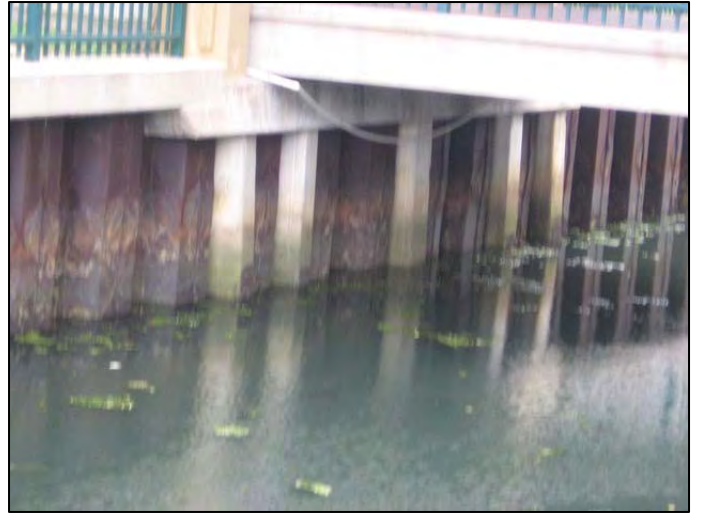
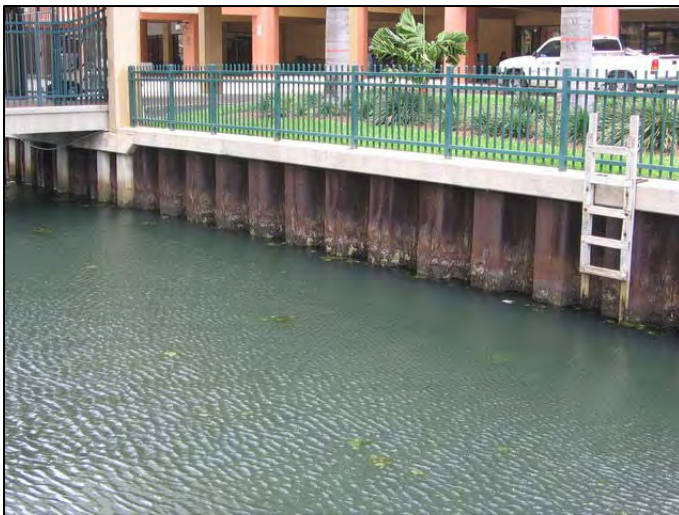
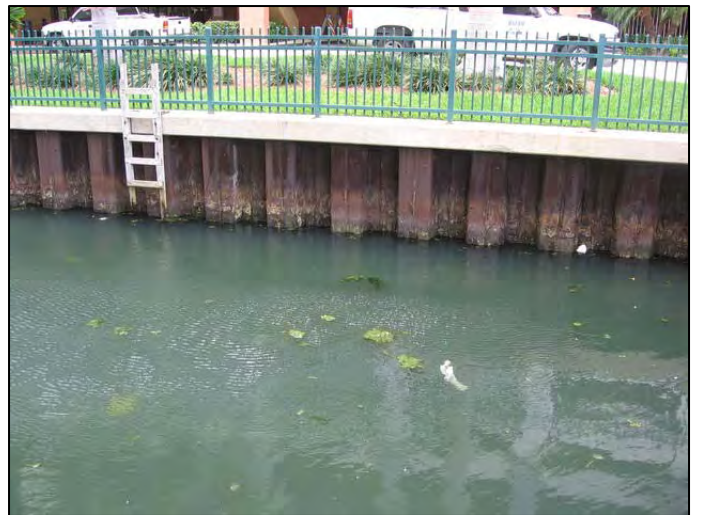
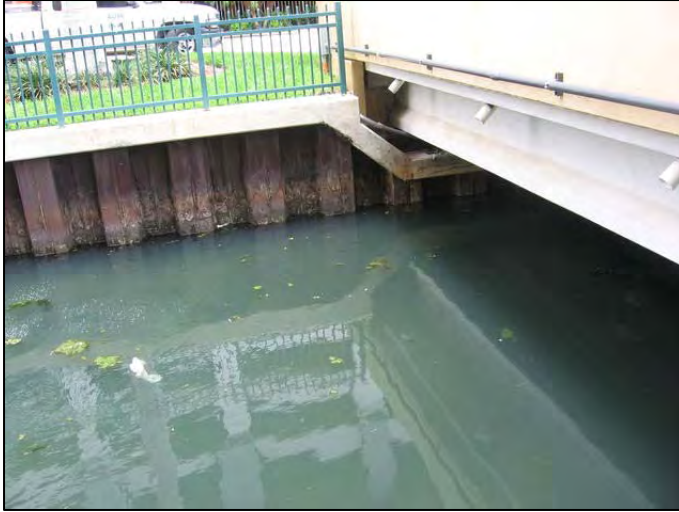
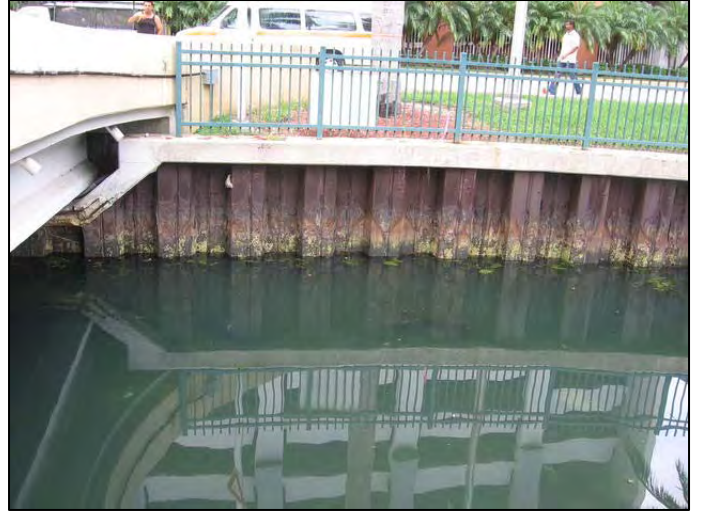
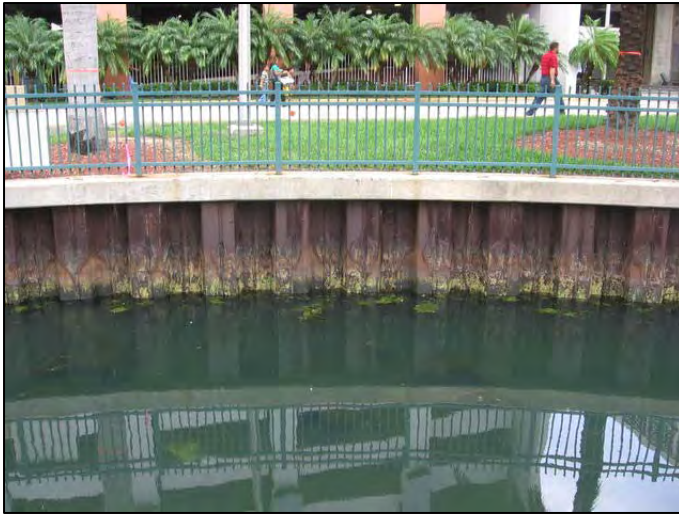
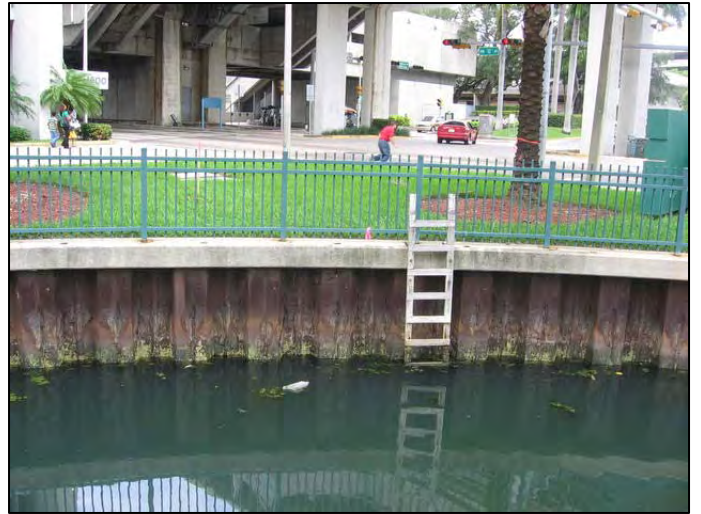
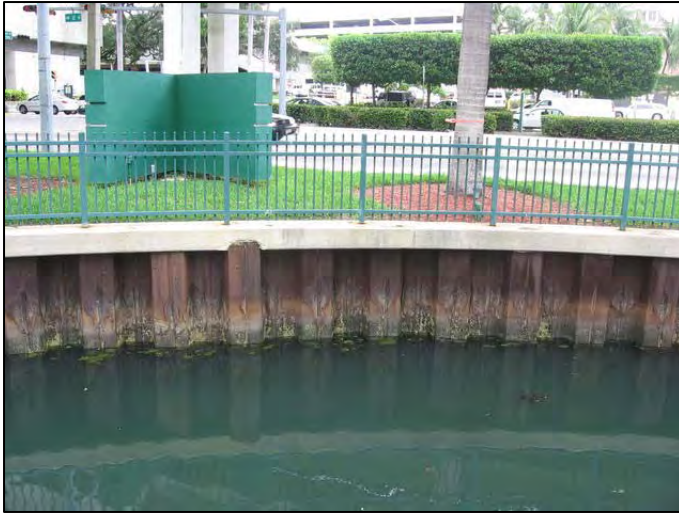
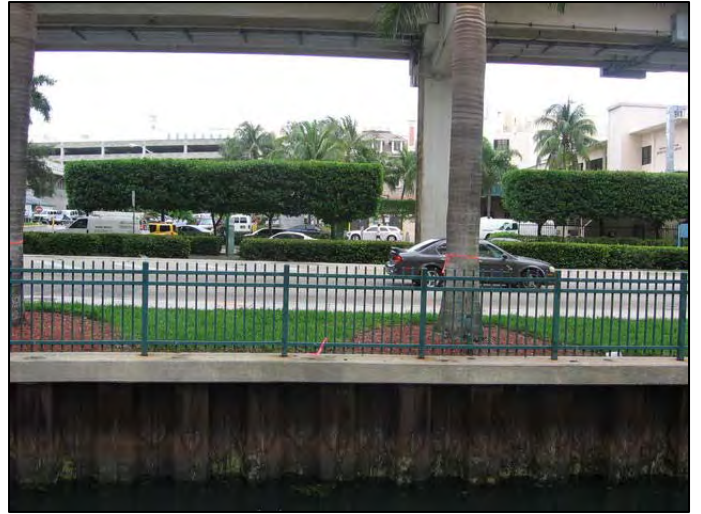
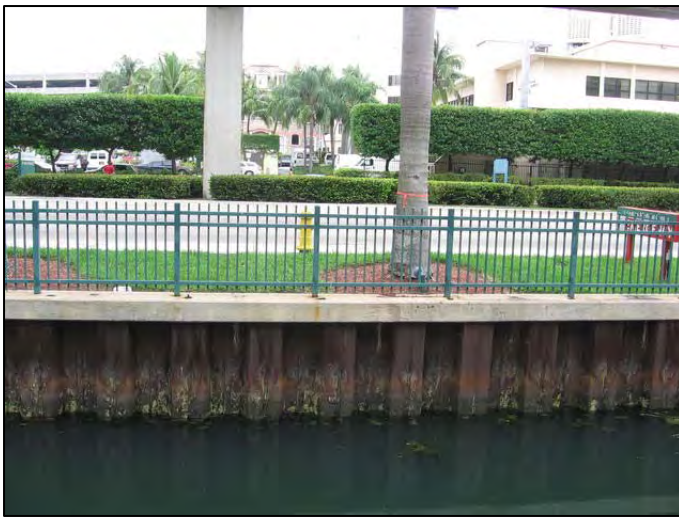
Structure S-50 Pictures

Address	1400 NW 12TH AVE
Folio #	0131350450030
Access Agreement	
Description	Metal seawall with concrete cap and metal railing
Water Body	Wagner Creek
Operational Section	3
Easting	913909.899
Northing	529943.801
Bank Location	East
Picture #	750-752, 754-760, 790-792, 751a-760a, 761-775
Condition	Fair
Damage to Structure and Picture #'s	N/A
End of Structure	S-49
End of Structure Picture #	776

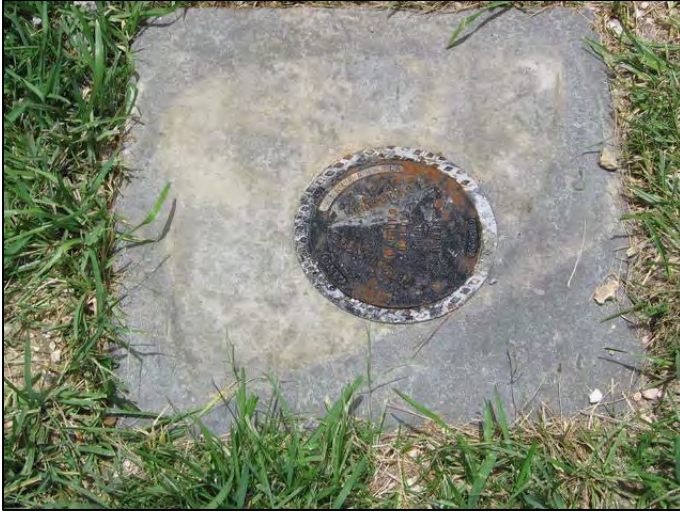
IMG\_0789

Address	1400 NW 12TH AVE
Folio #	0131350450030
Access Agreement	
Description	Water monitoring well
Water Body	Wagner Creek
Operational Section	3
Easting	914266.397
Northing	529832.817
Bank Location	West
Picture #	789
Condition	Good
Damage to Structure and Picture #'s	N/A
End of Structure	N/A
End of Structure Picture #	N/A

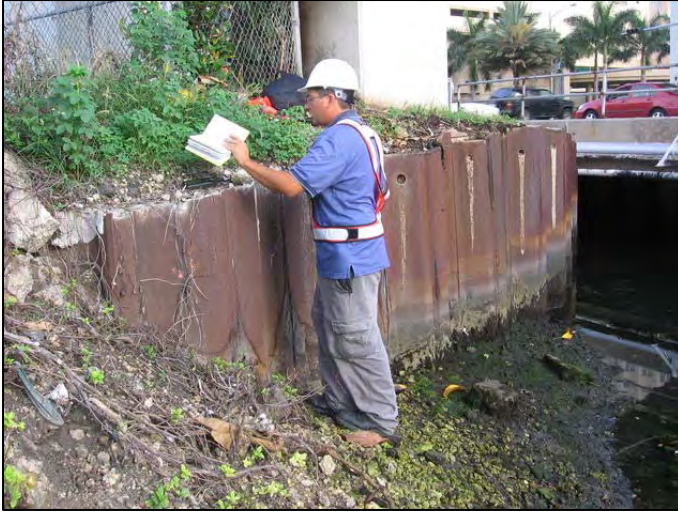
IMG\_0808

Address	1265 NW 12 <sup>th</sup> Ave.
Folio #	0131350750010
Access Agreement	
Description	Metal seawall
Water Body	Wagner Creek
Operational Section	4
Easting	914554.533
Northing	529218.359
Bank Location	West
Picture #	808
Condition	Fair
Damage to Structure and Picture #'s	N/A
End of Structure	N/A
End of Structure Picture #	N/A

S-57 25.78739 N  
 S-52 80.21478 W  
 pic -808  
 25.78739 N  
 80.21478 W  
 cond. Fr. X Coast

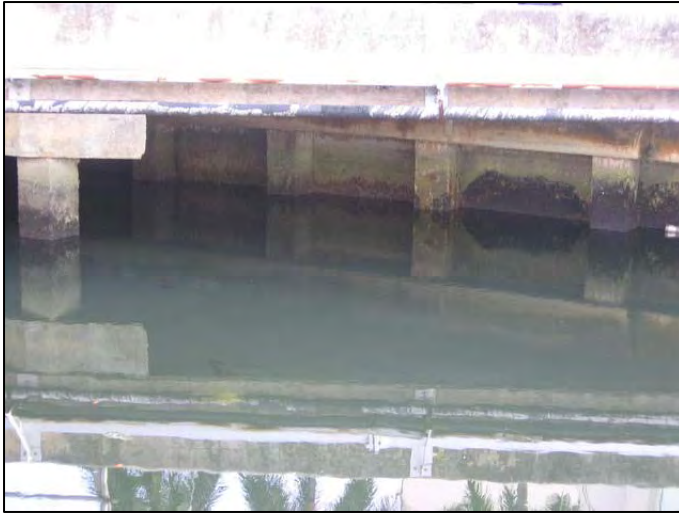
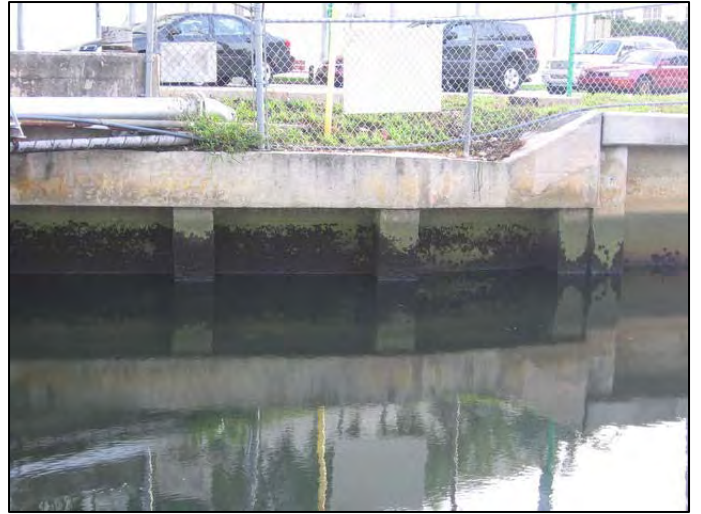
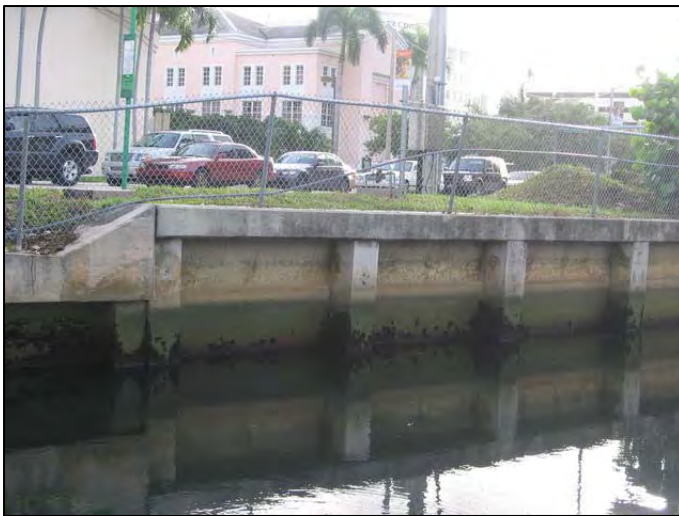
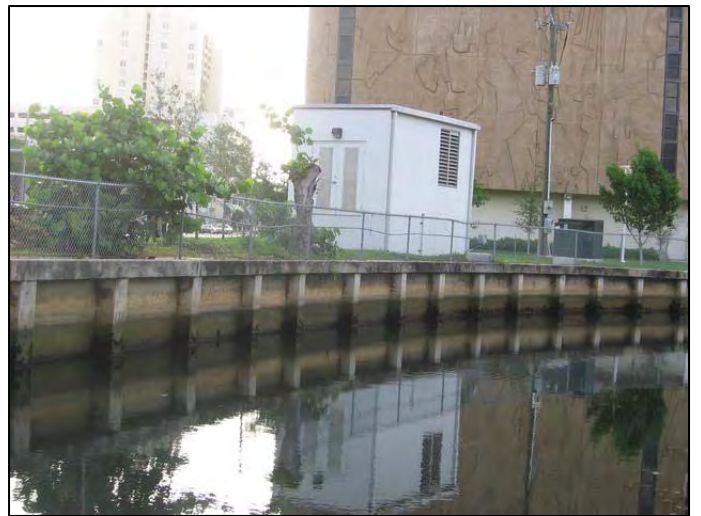
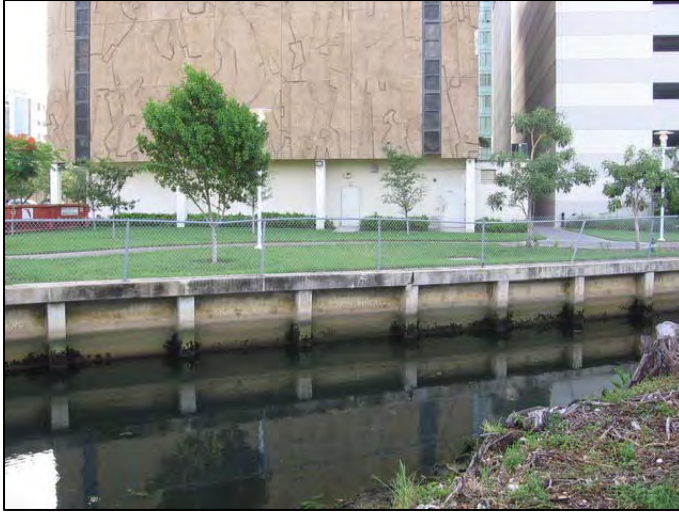
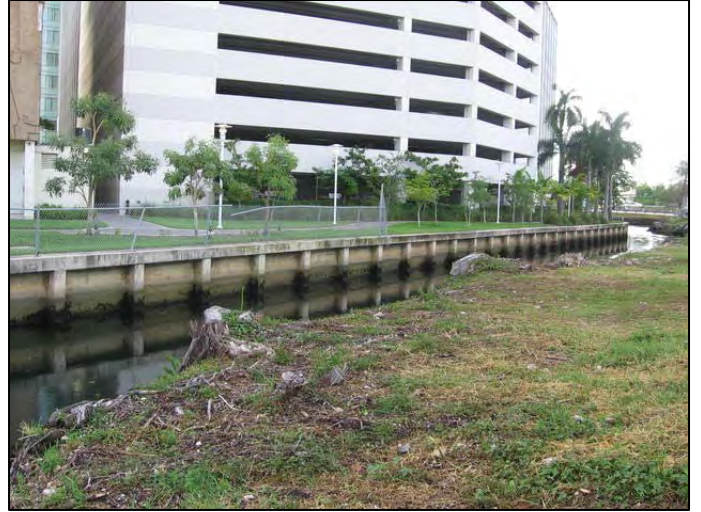
Structure S-53 Pictures

Address	1150 NW 14 <sup>th</sup> St.
Folio #	0131350620010
Access Agreement	
Description	Seawall - Concrete on north end, metal on south end
Water Body	Wagner Creek
Operational Section	4
Easting	914590.327
Northing	529231.927
Bank Location	East
Picture #	809-818
Condition	Fair
Damage to Structure and Picture #'s	N/A
End of Structure	S-60
End of Structure Picture #	818

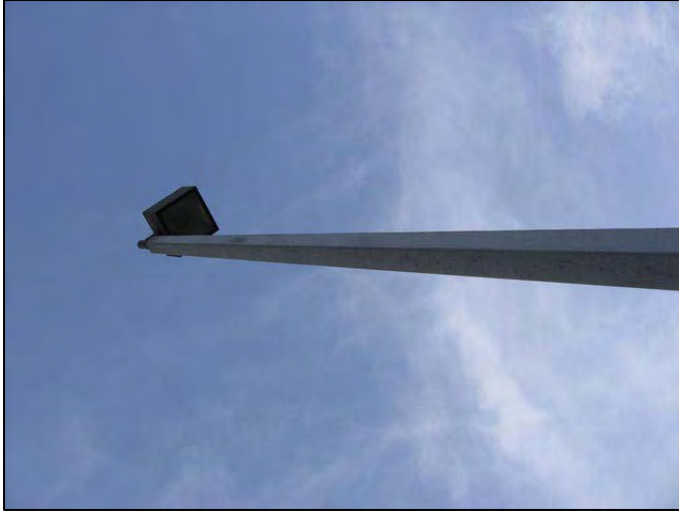
IMG\_0822

Address	1265 NW 12 <sup>th</sup> Ave.
Folio #	0131350750010
Access Agreement	
Description	Street lamp with concrete base
Water Body	Wagner Creek
Operational Section	4
Easting	914784.306
Northing	528993.064
Bank Location	West
Picture #	822
Condition	Good
Damage to Structure and Picture #'s	N/A
End of Structure	N/A
End of Structure Picture #	N/A

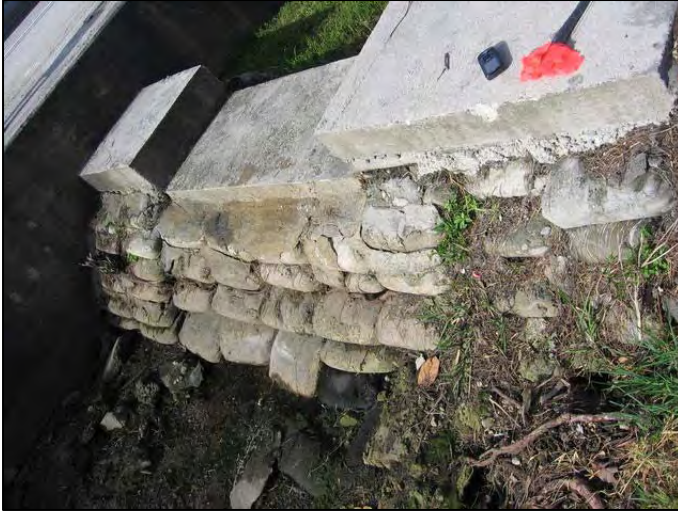
IMG\_0824

Address	1155 NW 11TH ST
Folio #	0131350000166
Access Agreement	
Description	Concrete sandbag seawall with concrete cap
Water Body	Wagner Creek
Operational Section	4
Easting	914950.855
Northing	528823.195
Bank Location	West
Picture #	824
Condition	Fair
Damage to Structure and Picture #'s	N/A
End of Structure	N/A
End of Structure Picture #	N/A

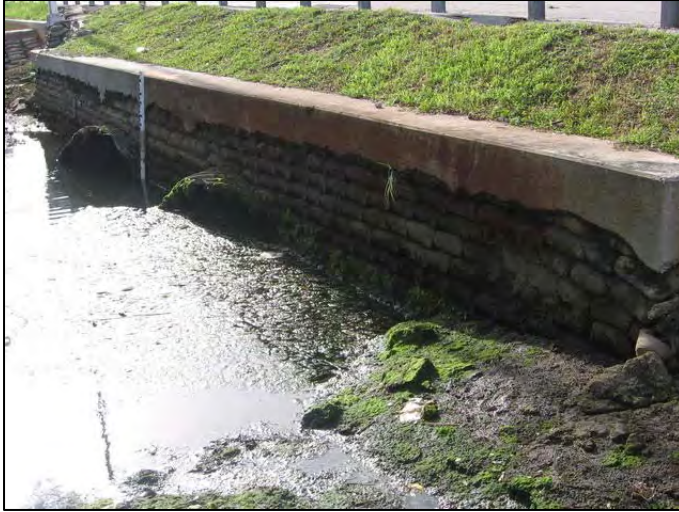
IMG\_0825

Address	N/A
Folio #	N/A
Access Agreement	N/A
Description	Culvert going under exit for 12th Ave (SR 836)
Water Body	Wagner Creek
Operational Section	4
Easting	914996.907
Northing	528824.620
Bank Location	Crosses canal
Picture #	825
Condition	Fair
Damage to Structure and Picture #'s	N/A
End of Structure	N/A
End of Structure Picture #	N/A

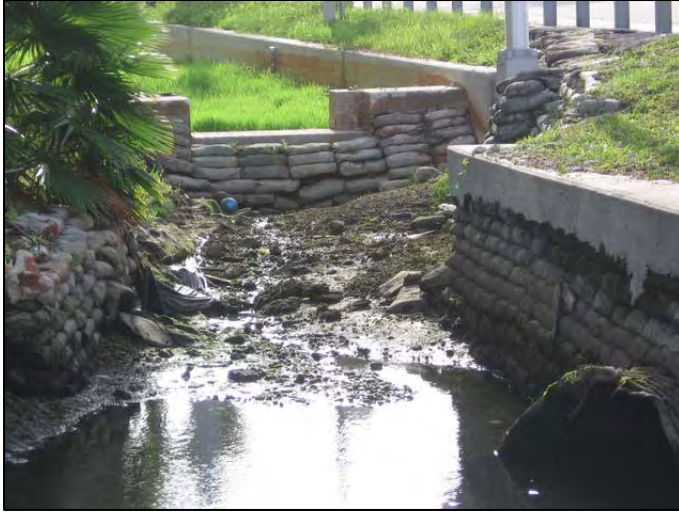
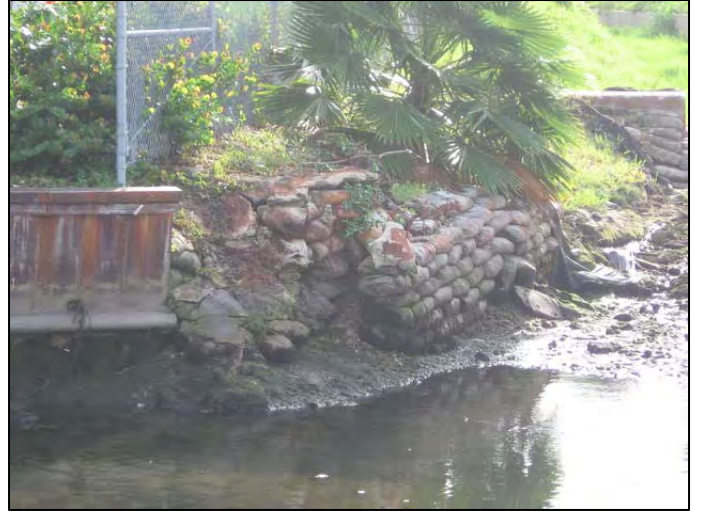
**Structure S-58 Pictures**

Address	N/A
Folio #	N/A
Access Agreement	N/A
Description	Concrete sandbag seawall with concrete cap
Water Body	Wagner Creek
Operational Section	4
Easting	915042.346
Northing	528841.061
Bank Location	East
Picture #	826-827
Condition	Poor
Damage to Structure and Picture #'s	C-1, 826-827
End of Structure	N/A
End of Structure Picture #	N/A

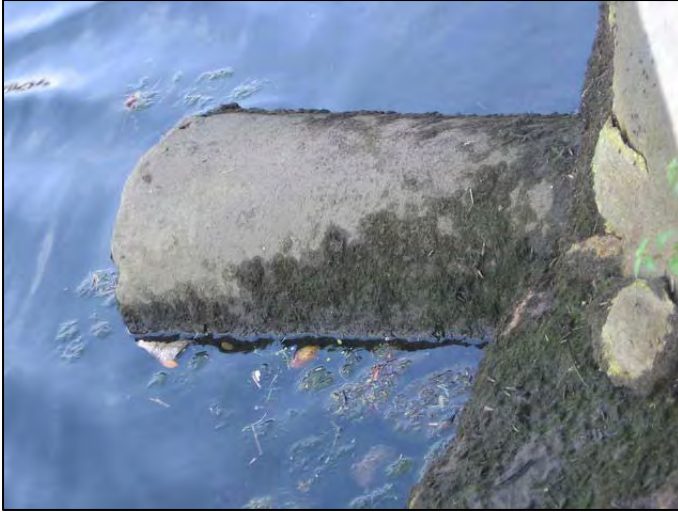
IMG\_0840

Address	1150 NW 14 <sup>th</sup> St.
Folio #	0131350620010
Access Agreement	
Description	Concrete pipe
Water Body	Wagner Creek
Operational Section	4
Easting	914918.515
Northing	528932.591
Bank Location	East
Picture #	840
Condition	Fair
Damage to Structure and Picture #'s	N/A
End of Structure	N/A
End of Structure Picture #	N/A

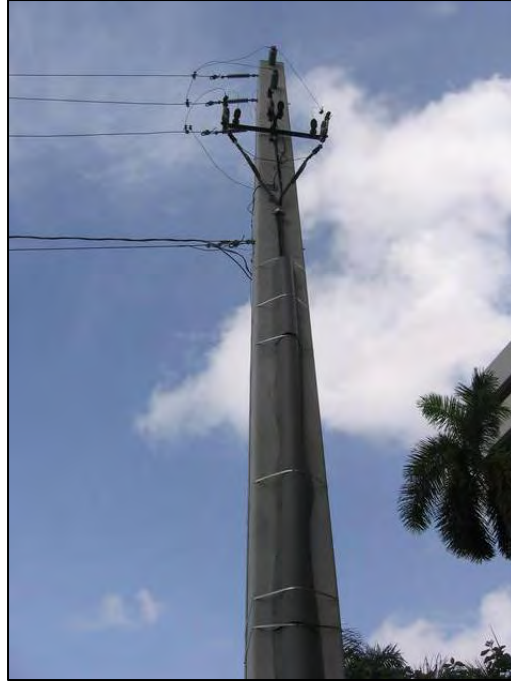
IMG\_0841

Address	1150 NW 14 <sup>th</sup> St.
Folio #	0131350620010
Access Agreement	
Description	Concrete utility post
Water Body	Wagner Creek
Operational Section	4
Easting	914911.676
Northing	528938.717
Bank Location	East
Picture #	841
Condition	Good
Damage to Structure and Picture #'s	N/A
End of Structure	N/A
End of Structure Picture #	N/A

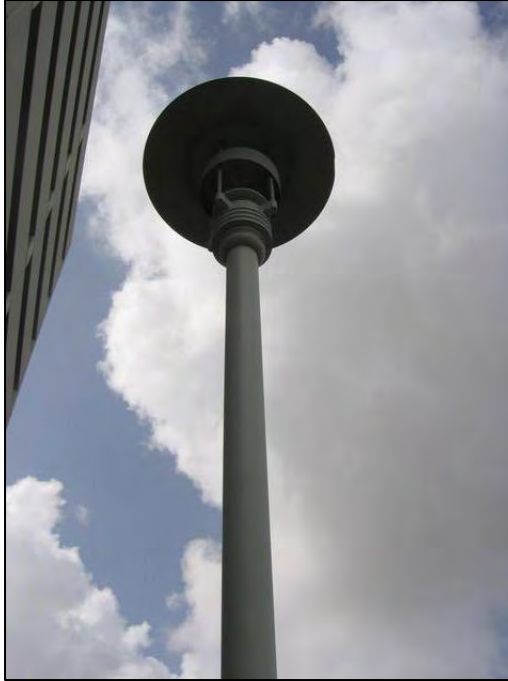
IMG\_0860

Address	1150 NW 14 <sup>th</sup> St.
Folio #	0131350620010
Access Agreement	
Description	Metal lamp post
Water Body	Wagner Creek
Operational Section	4
Easting	914810.275
Northing	529055.985
Bank Location	East
Picture #	860
Condition	Good
Damage to Structure and Picture #'s	N/A
End of Structure	N/A
End of Structure Picture #	N/A

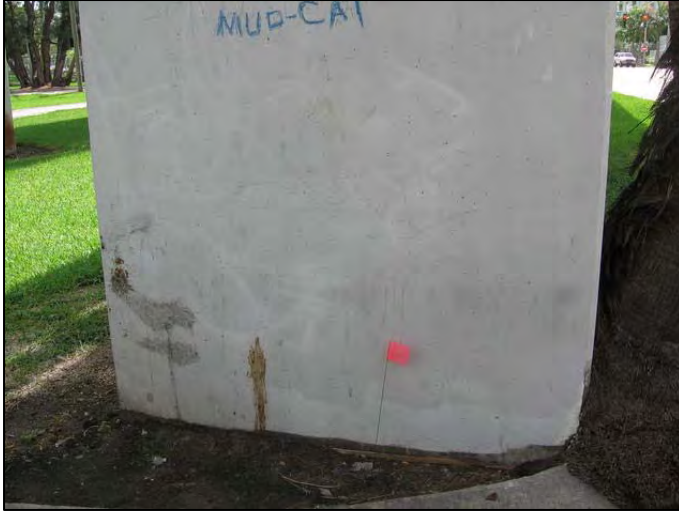
IMG\_0882

Address	1140 NW 8 <sup>th</sup> St. Rd.
Folio #	0131350280020
Access Agreement	
Description	Metal bridge support
Water Body	Wagner Creek
Operational Section	5
Easting	916017.522
Northing	528029.955
Bank Location	East
Picture #	882
Condition	Good
Damage to Structure and Picture #'s	N/A
End of Structure	N/A
End of Structure Picture #	N/A

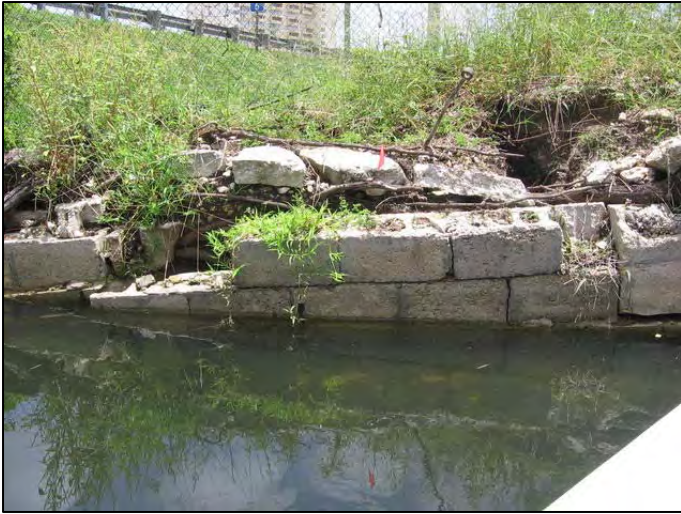
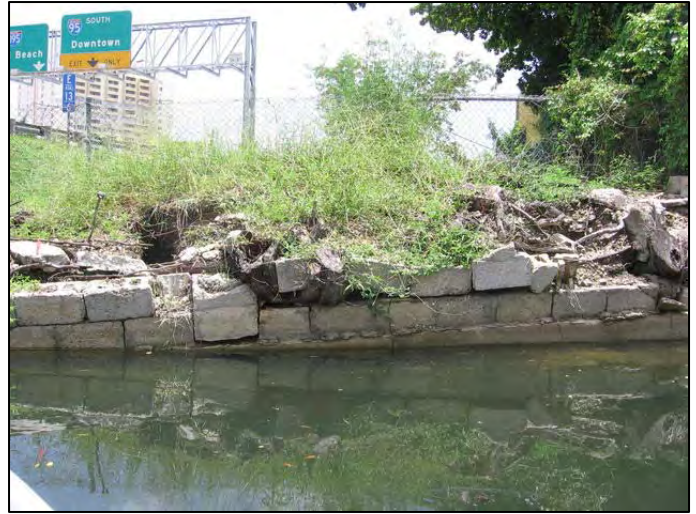
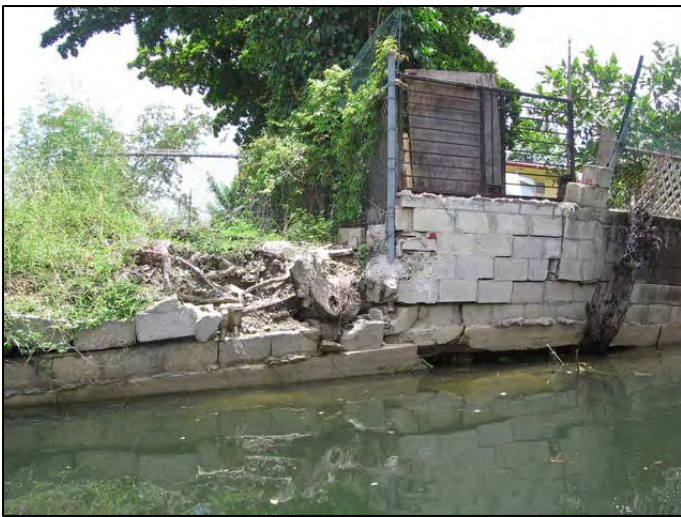
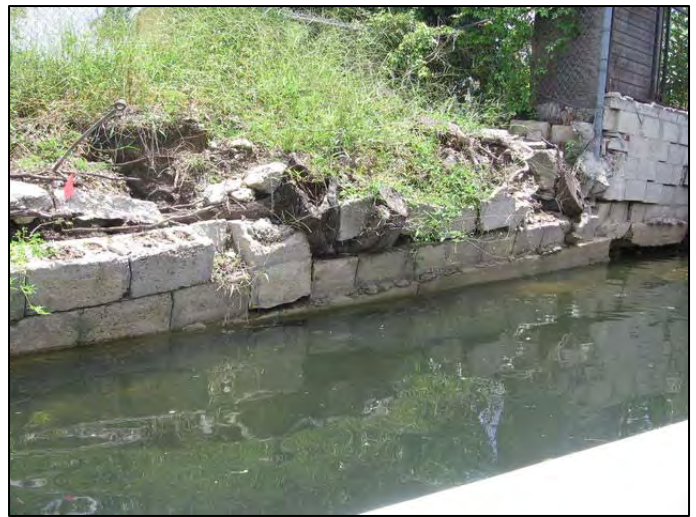
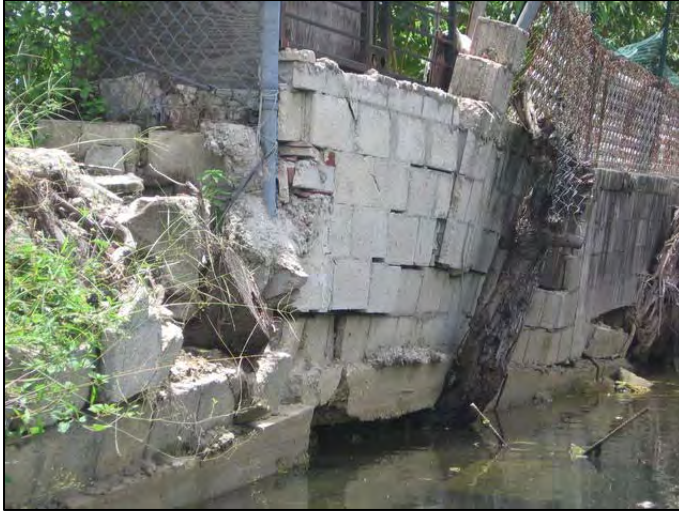
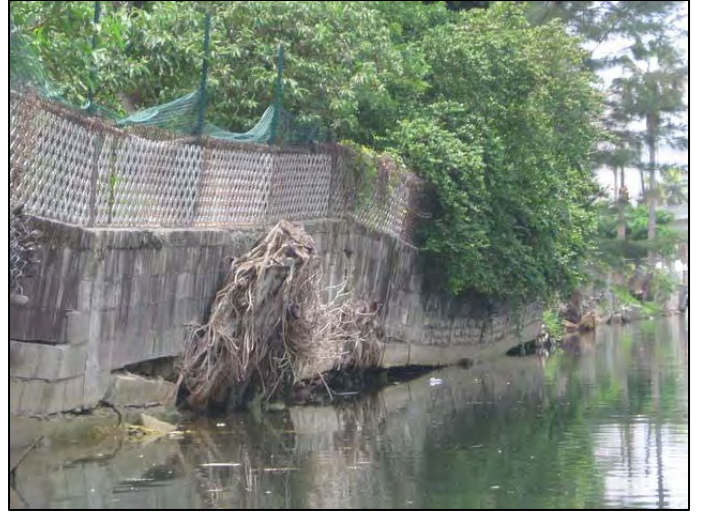
Structure S-64 Pictures

Address	N/A
Folio #	N/A
Access Agreement	N/A
Description	Collapsing concrete block seawall
Water Body	Wagner Creek
Operational Section	5
Easting	915180.210
Northing	528660.430
Bank Location	East
Picture #	884-894
Condition	Poor
Damage to Structure and Picture #'s	N/A
End of Structure	S-65
End of Structure Picture #	895

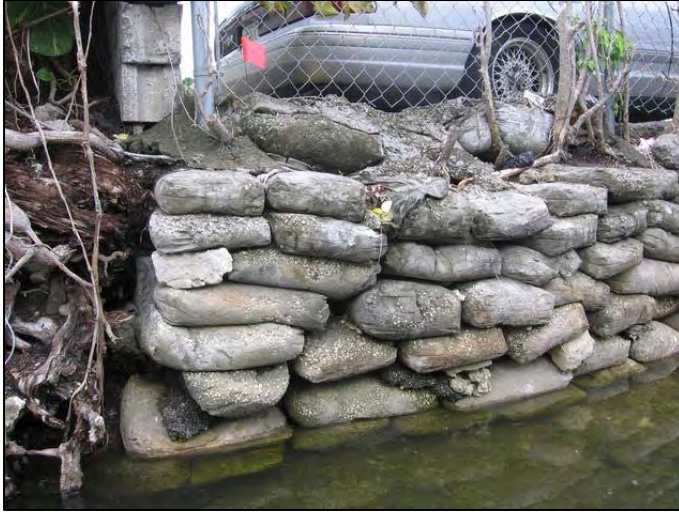
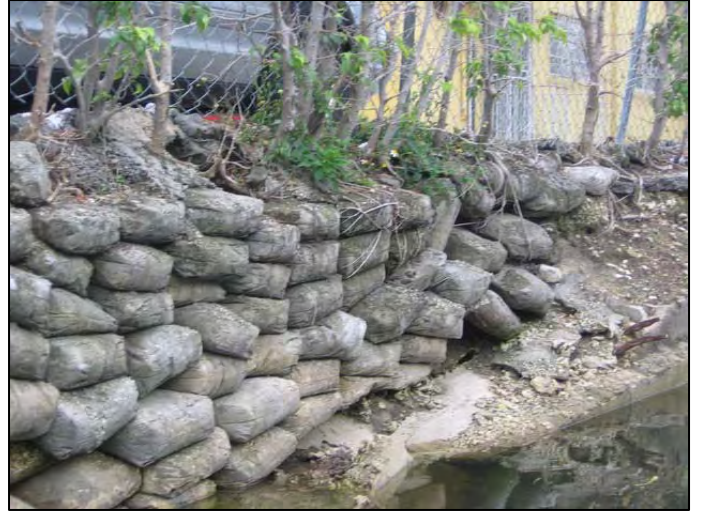
**Structure S-66 Pictures**

Address	1040 Spring Garden Rd.
Folio #	0131350070040
Access Agreement	
Description	Collapsing concrete sandbag seawall
Water Body	Wagner Creek
Operational Section	5
Easting	915387.910
Northing	528502.160
Bank Location	East
Picture #	906
Condition	Poor
Damage to Structure and Picture #'s	N/A
End of Structure	S-67
End of Structure Picture #	907
