*Corrective Action Plan - Version 2*

# Wagner Creek/Seybold Canal

Volume 2 — Appendices G through I

Submitted to  
City of Miami

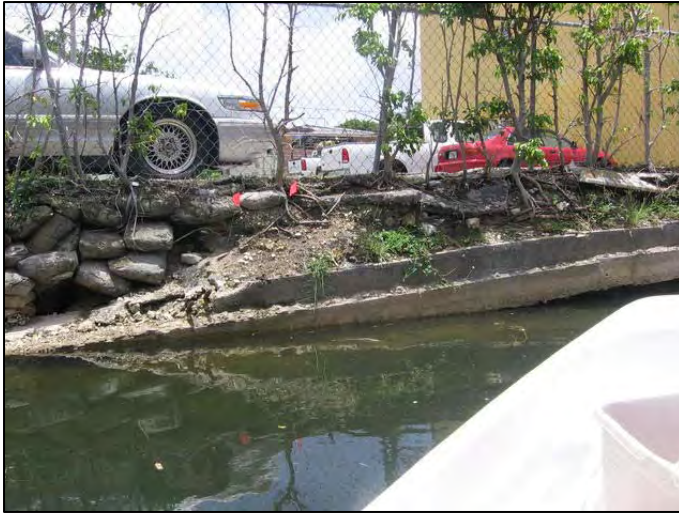
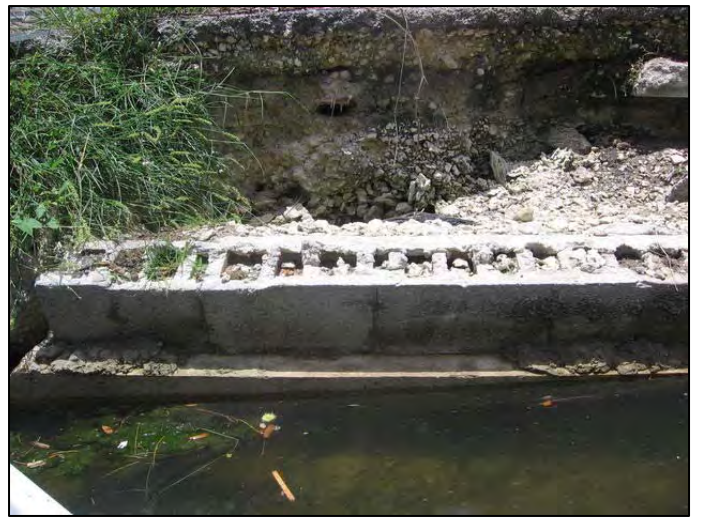
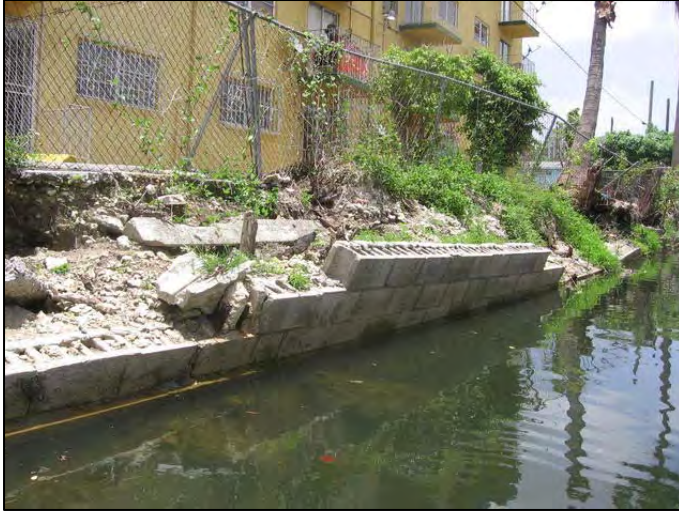
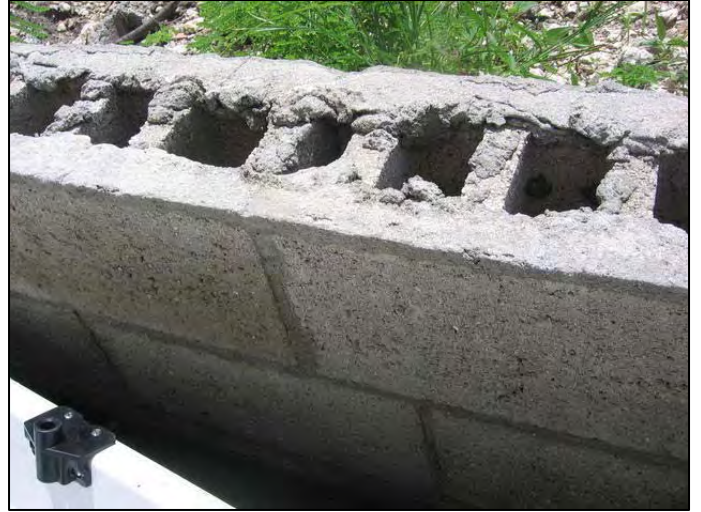
Structure S-68 Pictures

Address	1040 Spring Garden Rd.
Folio #	0131350070040
Access Agreement	
Description	Collapsing concrete sandbag seawall
Water Body	Wagner Creek
Operational Section	5
Easting	915402.390
Northing	528490.200
Bank Location	East
Picture #	908-910, 912-922, 925-927, 929-930
Condition	Poor
Damage to Structure and Picture #'s	N/A
End of Structure	S-70
End of Structure Picture #	930

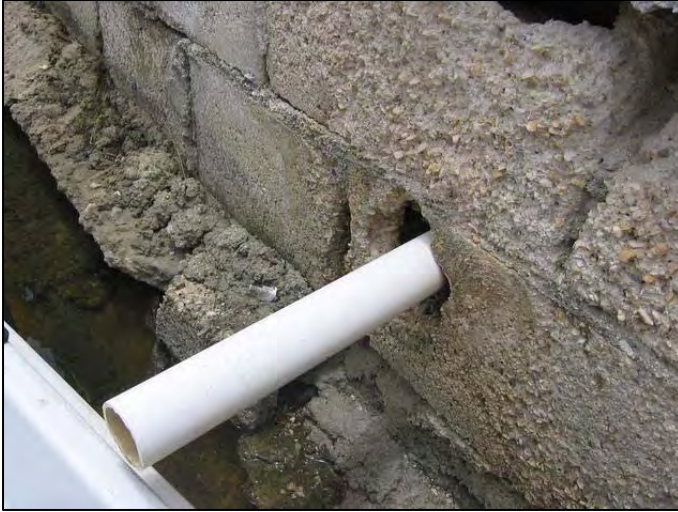
IMG\_0928

Address	1040 Spring Garden Rd.
Folio #	0131350070040
Access Agreement	
Description	PVC pipe
Water Body	Wagner Creek
Operational Section	5
Easting	915512.210
Northing	528401.990
Bank Location	East
Picture #	928
Condition	Good
Damage to Structure and Picture #'s	N/A
End of Structure	N/A
End of Structure Picture #	N/A

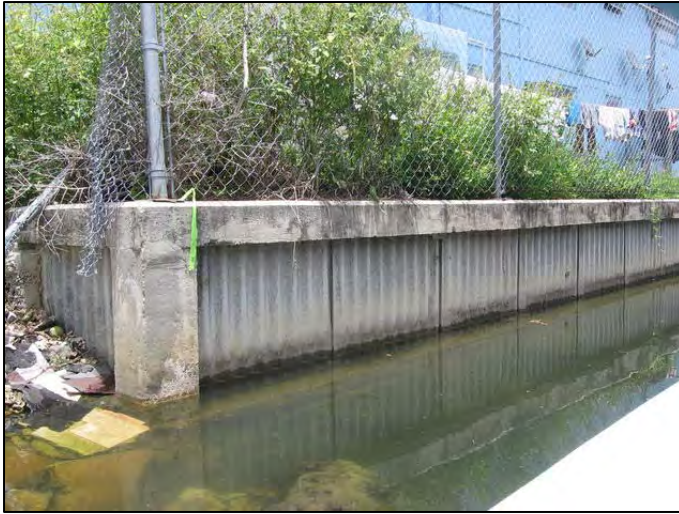
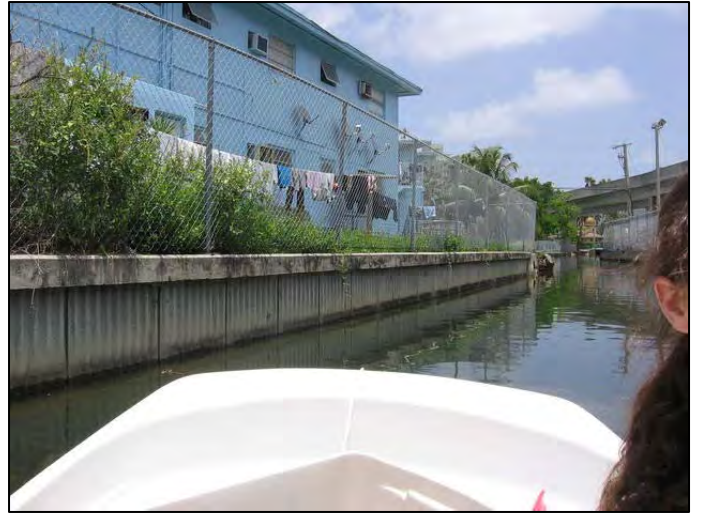
Structure S-71 Pictures

Address	1000 Spring Garden Rd.
Folio #	0131350070010
Access Agreement	
Description	Metal seawall with concrete borders
Water Body	Wagner Creek
Operational Section	5
Easting	915628.110
Northing	528311.090
Bank Location	East
Picture #	932-937
Condition	Fair
Damage to Structure and Picture #'s	N/A
End of Structure	S-72
End of Structure Picture #	937

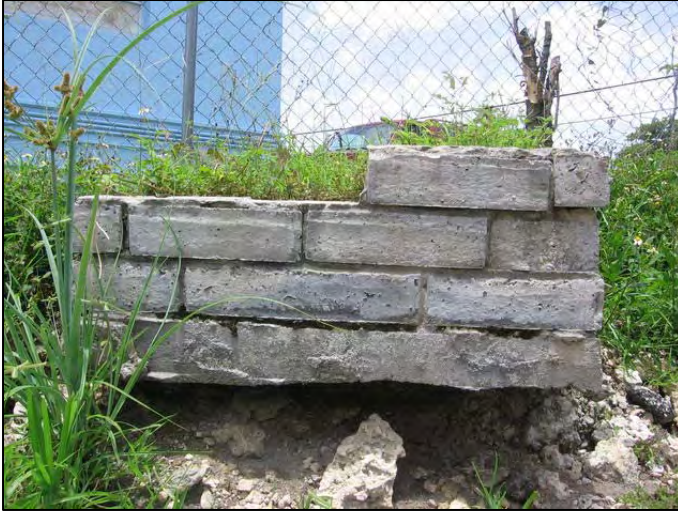
IMG\_0938

Address	1000 Spring Garden Rd.
Folio #	0131350070010
Access Agreement	
Description	Unknown concrete brick structure
Water Body	Wagner Creek
Operational Section	5
Easting	915746.620
Northing	528244.810
Bank Location	East
Picture #	938
Condition	N/A
Damage to Structure and Picture #'s	N/A
End of Structure	N/A
End of Structure Picture #	N/A

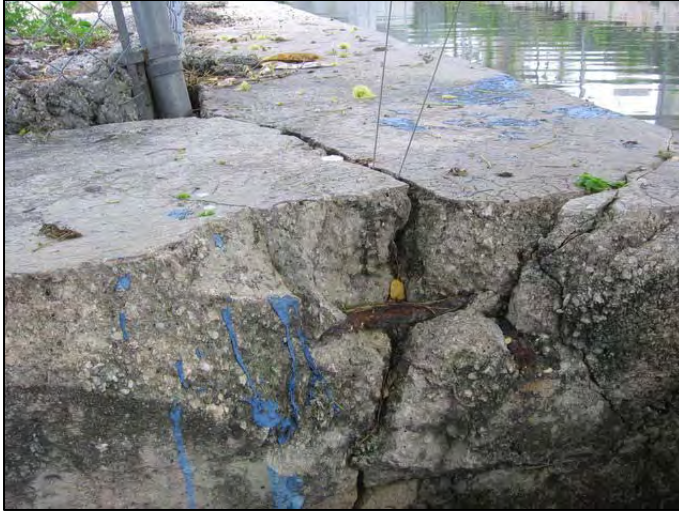
IMG\_0939

Address	1150 NW 8 <sup>th</sup> St. Rd.
Folio #	0131350280060
Access Agreement	
Description	Concrete seawall
Water Body	Wagner Creek
Operational Section	5
Easting	915746.620
Northing	528244.810
Bank Location	East
Picture #	939-947
Condition	Fair
Damage to Structure and Picture #'s	C-1, 939; C-2, 948
End of Structure	S-75
End of Structure Picture #	949

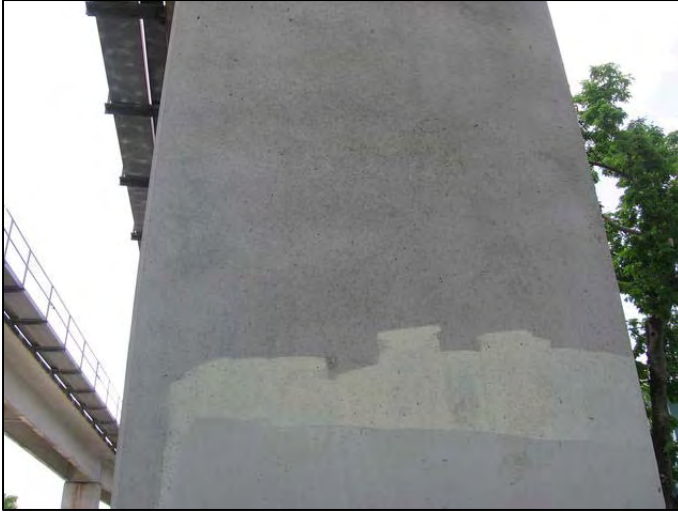
IMG\_0950

Address	1140 NW 8 <sup>th</sup> St. Rd.
Folio #	0131350280020
Access Agreement	
Description	Metrorail support near east bank
Water Body	Wagner Creek
Operational Section	5
Easting	915971.947
Northing	528083.377
Bank Location	East
Picture #	950
Condition	Good
Damage to Structure and Picture #'s	N/A
End of Structure	N/A
End of Structure Picture #	N/A

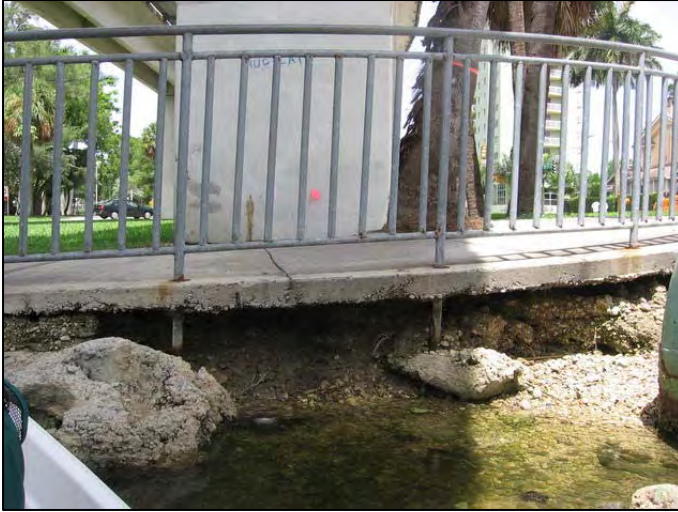
IMG\_0952

Address	N/A
Folio #	N/A
Access Agreement	N/A
Description	Sidewalk near NW 8th St. Rd. and NW 11th St
Water Body	Wagner Creek
Operational Section	5
Easting	915994.465
Northing	528033.452
Bank Location	East
Picture #	952
Condition	Fair
Damage to Structure and Picture #'s	N/A
End of Structure	N/A
End of Structure Picture #	N/A

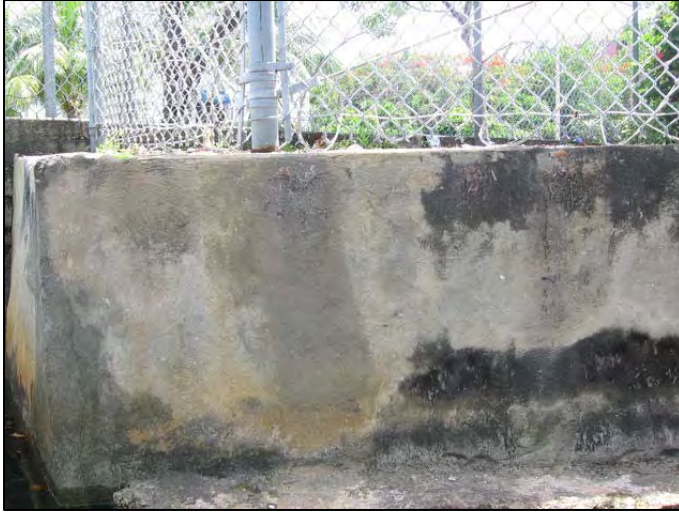
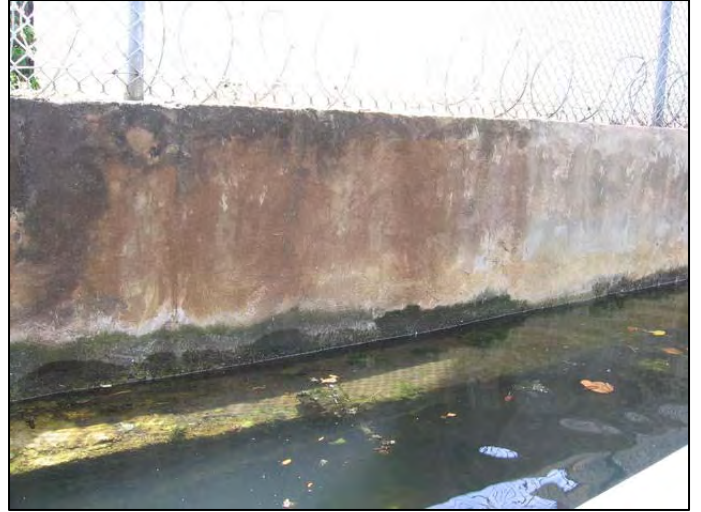
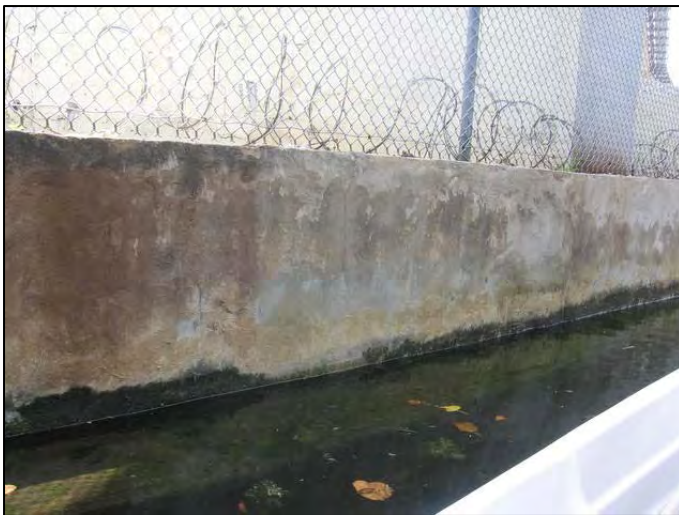
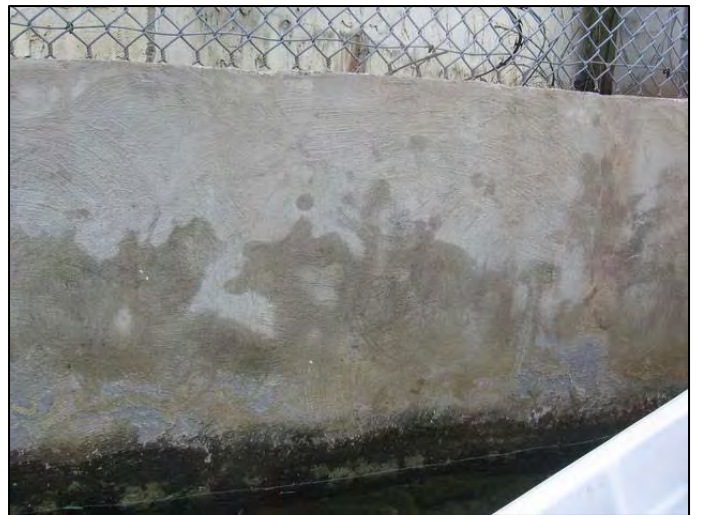
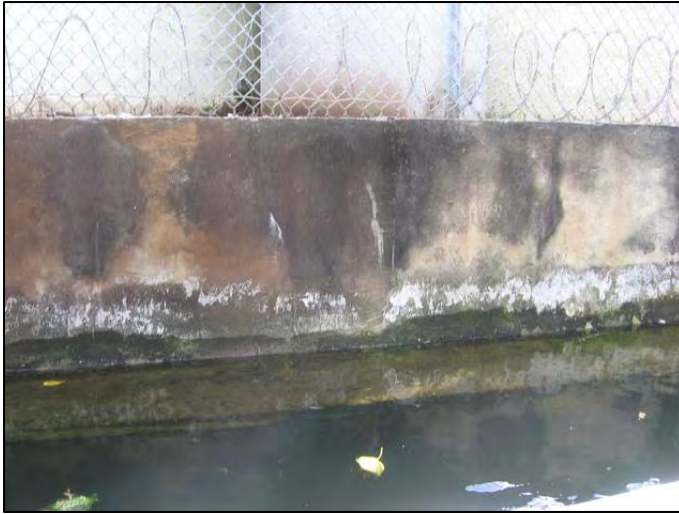
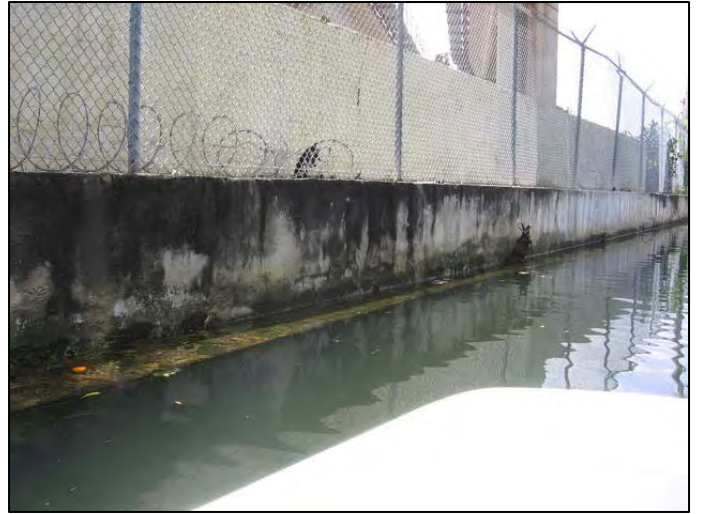
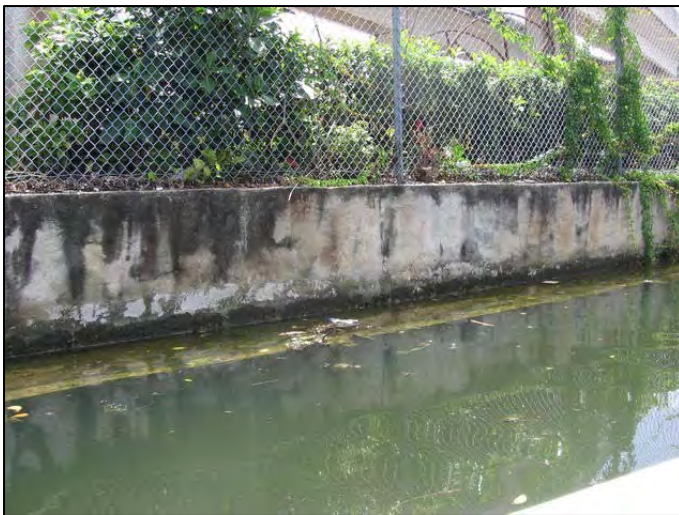
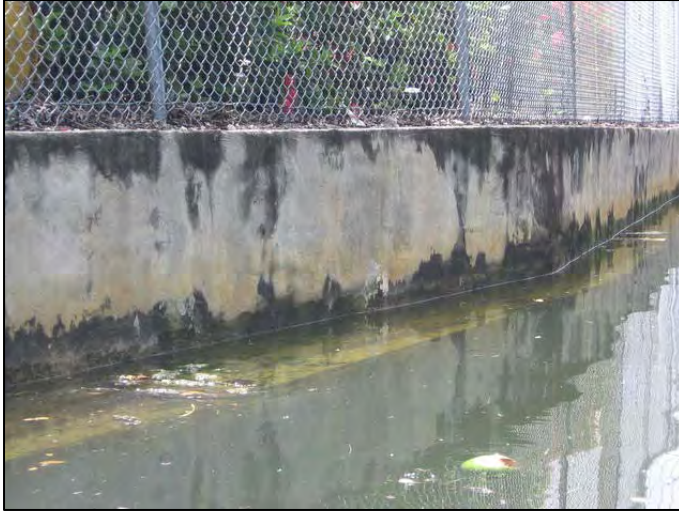
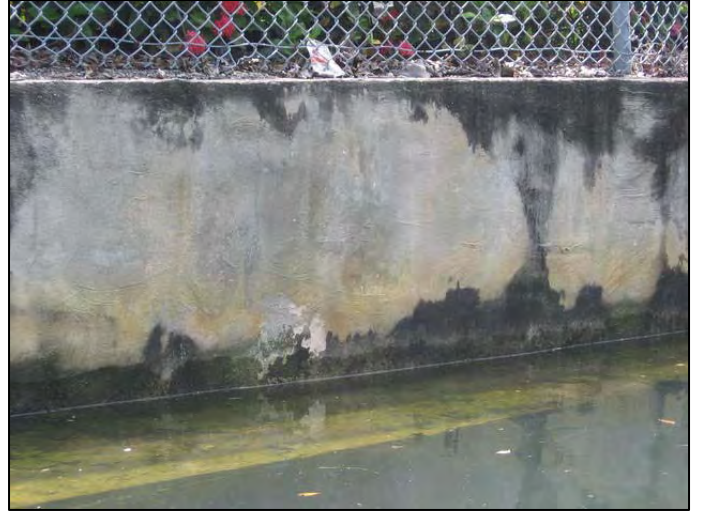
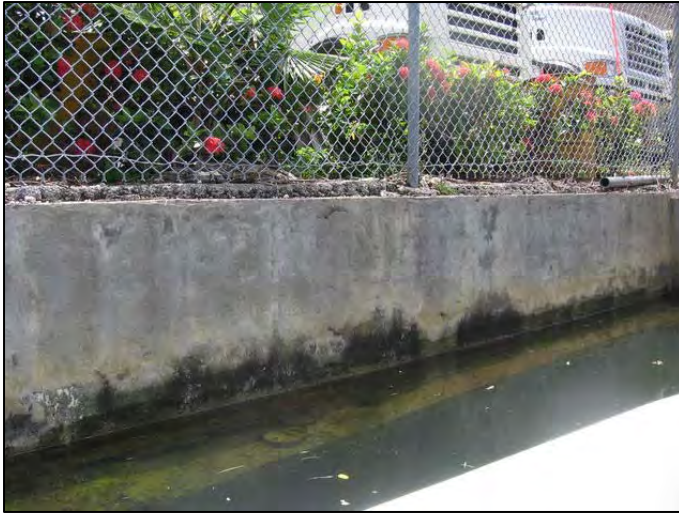
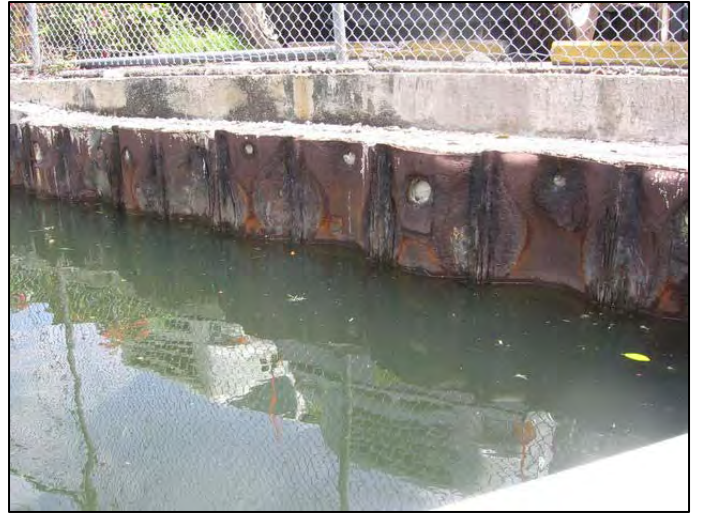
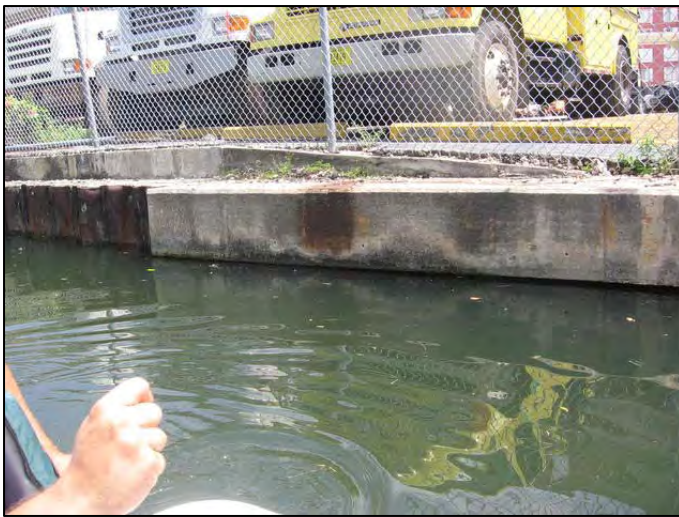
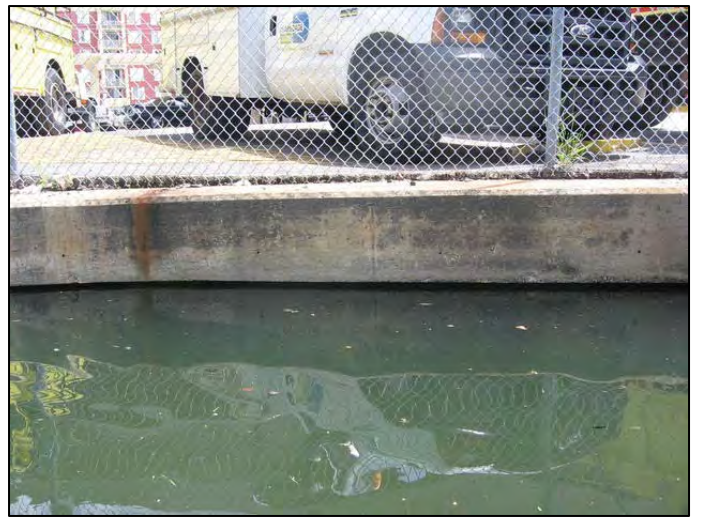
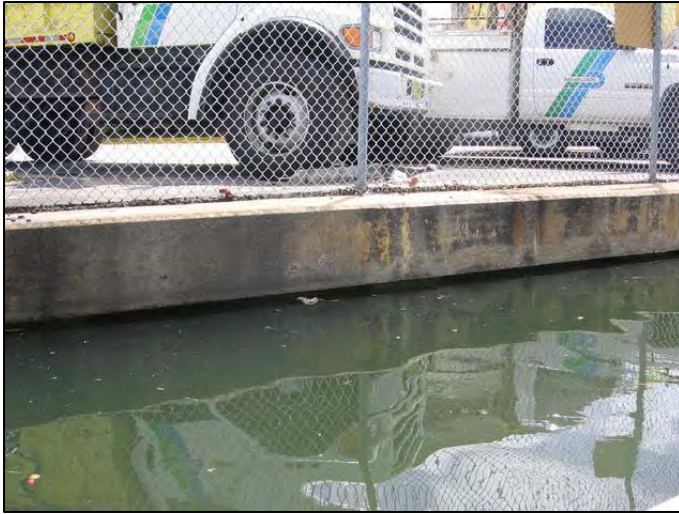
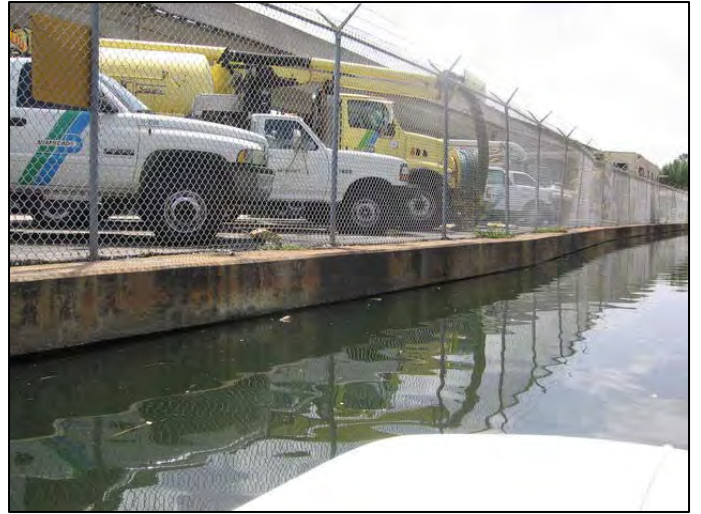
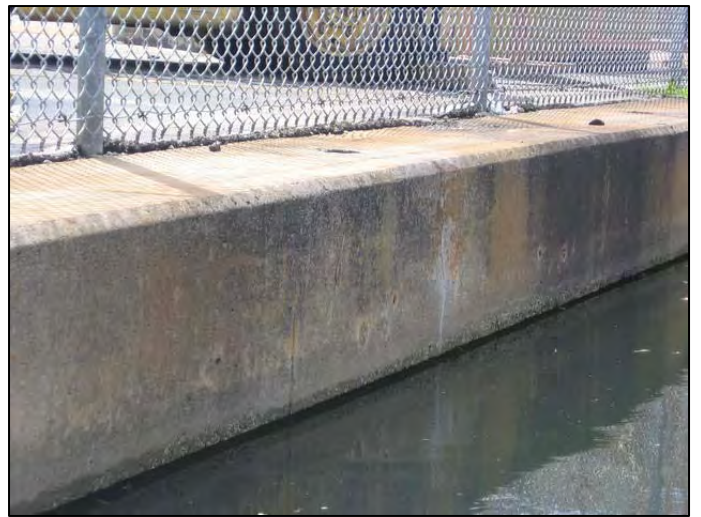
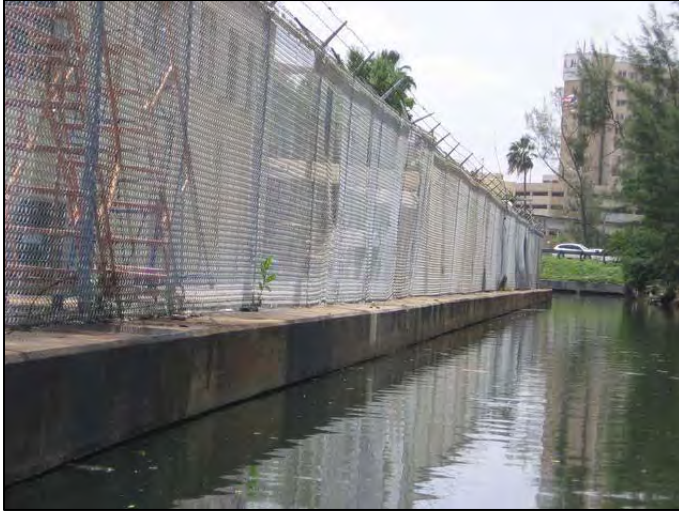
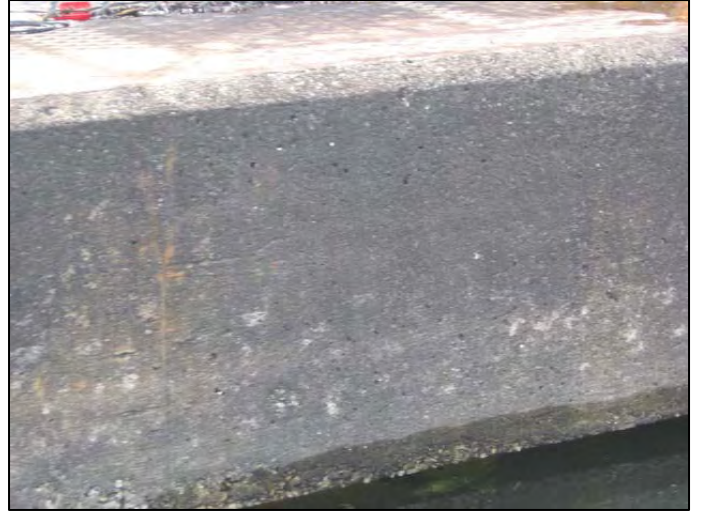
Address	1001 NW 11 <sup>th</sup> St.
Folio #	0131350000190
Access Agreement	
Description	Concrete seawall
Water Body	Wagner Creek
Operational Section	5
Easting	915956.376
Northing	528044.187
Bank Location	West
Picture #	953-963, 965-988
Condition	Fair
Damage to Structure and Picture #'s	C-1, 972; C-2, 978; C-3, 980; C-4, 983
End of Structure	S-81
End of Structure Picture #	988

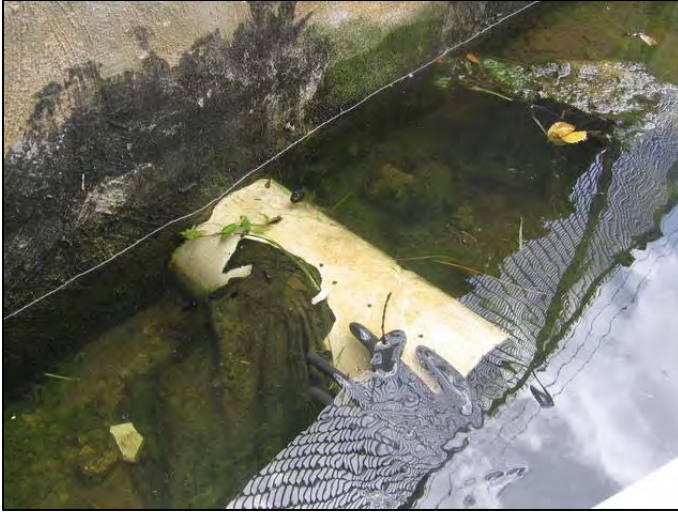
IMG\_0964

Address	1001 NW 11 <sup>th</sup> St.
Folio #	0131350000190
Access Agreement	
Description	12" PVC pipe
Water Body	Wagner Creek
Operational Section	5
Easting	915792.960
Northing	528186.170
Bank Location	West
Picture #	964
Condition	Fair
Damage to Structure and Picture #'s	N/A
End of Structure	N/A
End of Structure Picture #	N/A

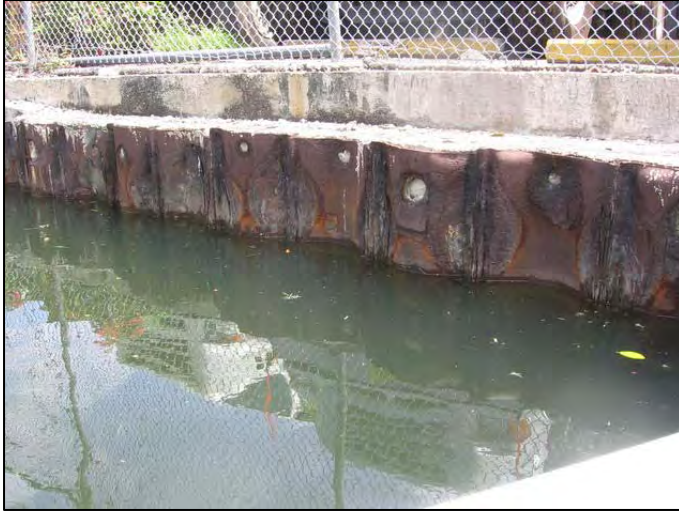
IMG\_0967

Address	1001 NW 11 <sup>th</sup> St.
Folio #	0131350000190
Access Agreement	
Description	Metal seawall, part of structure S-78.
Water Body	Wagner Creek
Operational Section	5
Easting	915696.260
Northing	528234.040
Bank Location	West
Picture #	967
Condition	Poor
Damage to Structure and Picture #'s	N/A
End of Structure	N/A
End of Structure Picture #	N/A

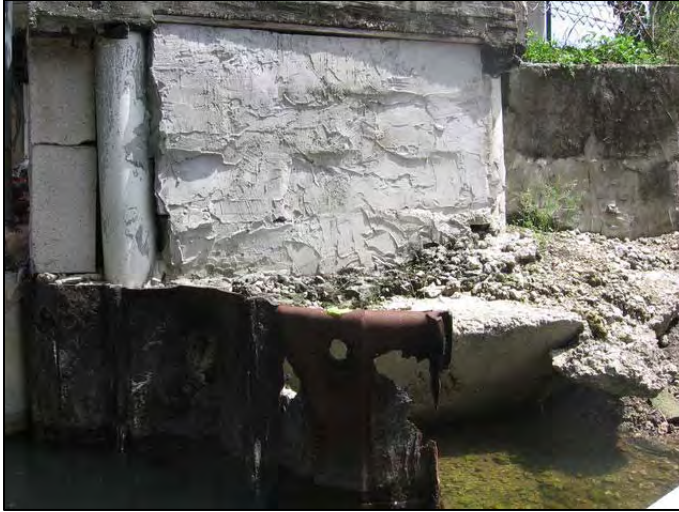
IMG\_0989

Address	1001 NW 11 <sup>th</sup> St.
Folio #	0131350000190
Access Agreement	
Description	Concrete seawall with metal protrusion
Water Body	Wagner Creek
Operational Section	5
Easting	915311.180
Northing	528534.420
Bank Location	West
Picture #	989
Condition	Poor
Damage to Structure and Picture #'s	N/A
End of Structure	N/A
End of Structure Picture #	N/A

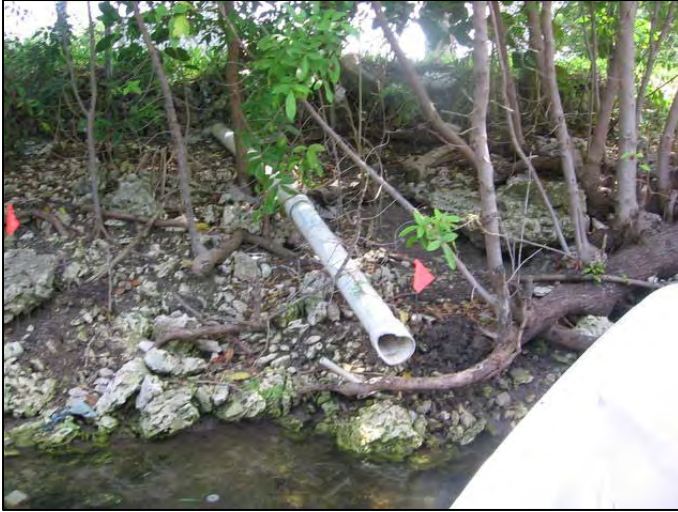
IMG\_0995

Address	1155 NW 11 <sup>th</sup> St.
Folio #	0131350000166
Access Agreement	
Description	6" PVC pipe
Water Body	Wagner Creek
Operational Section	5
Easting	915194.400
Northing	528616.420
Bank Location	West
Picture #	995
Condition	Poor
Damage to Structure and Picture #'s	N/A
End of Structure	N/A
End of Structure Picture #	N/A

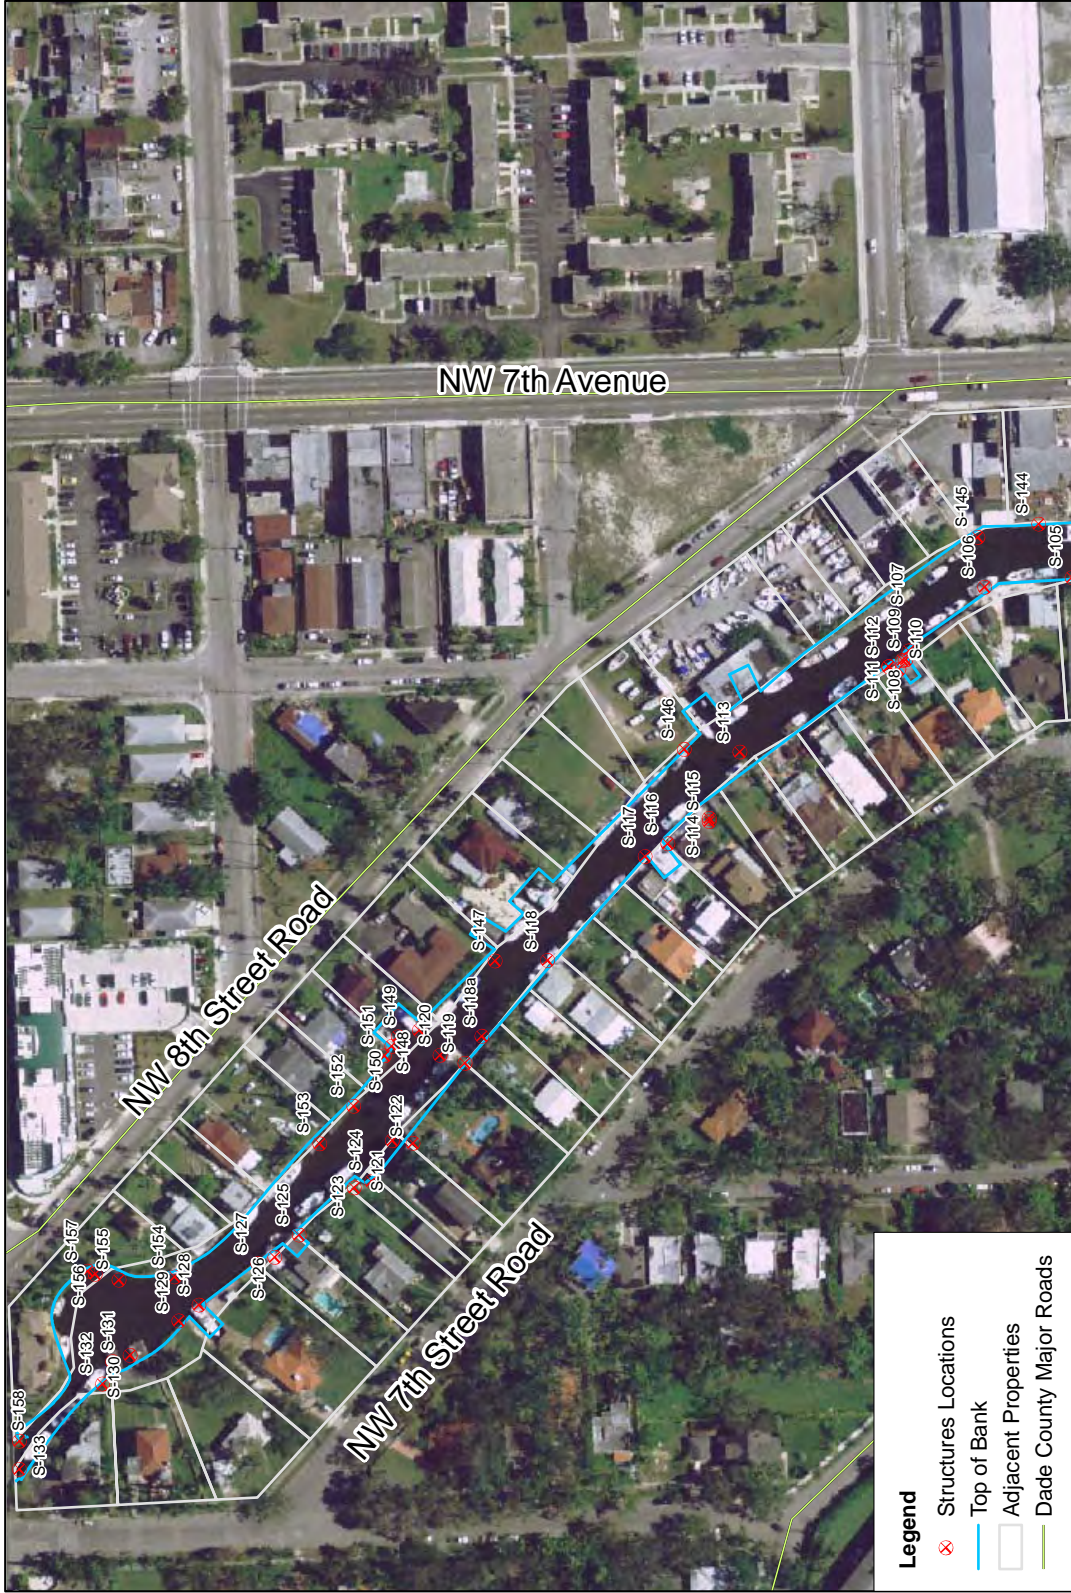
Operational Section 6  
Structure Locations  
Structure Condition Report

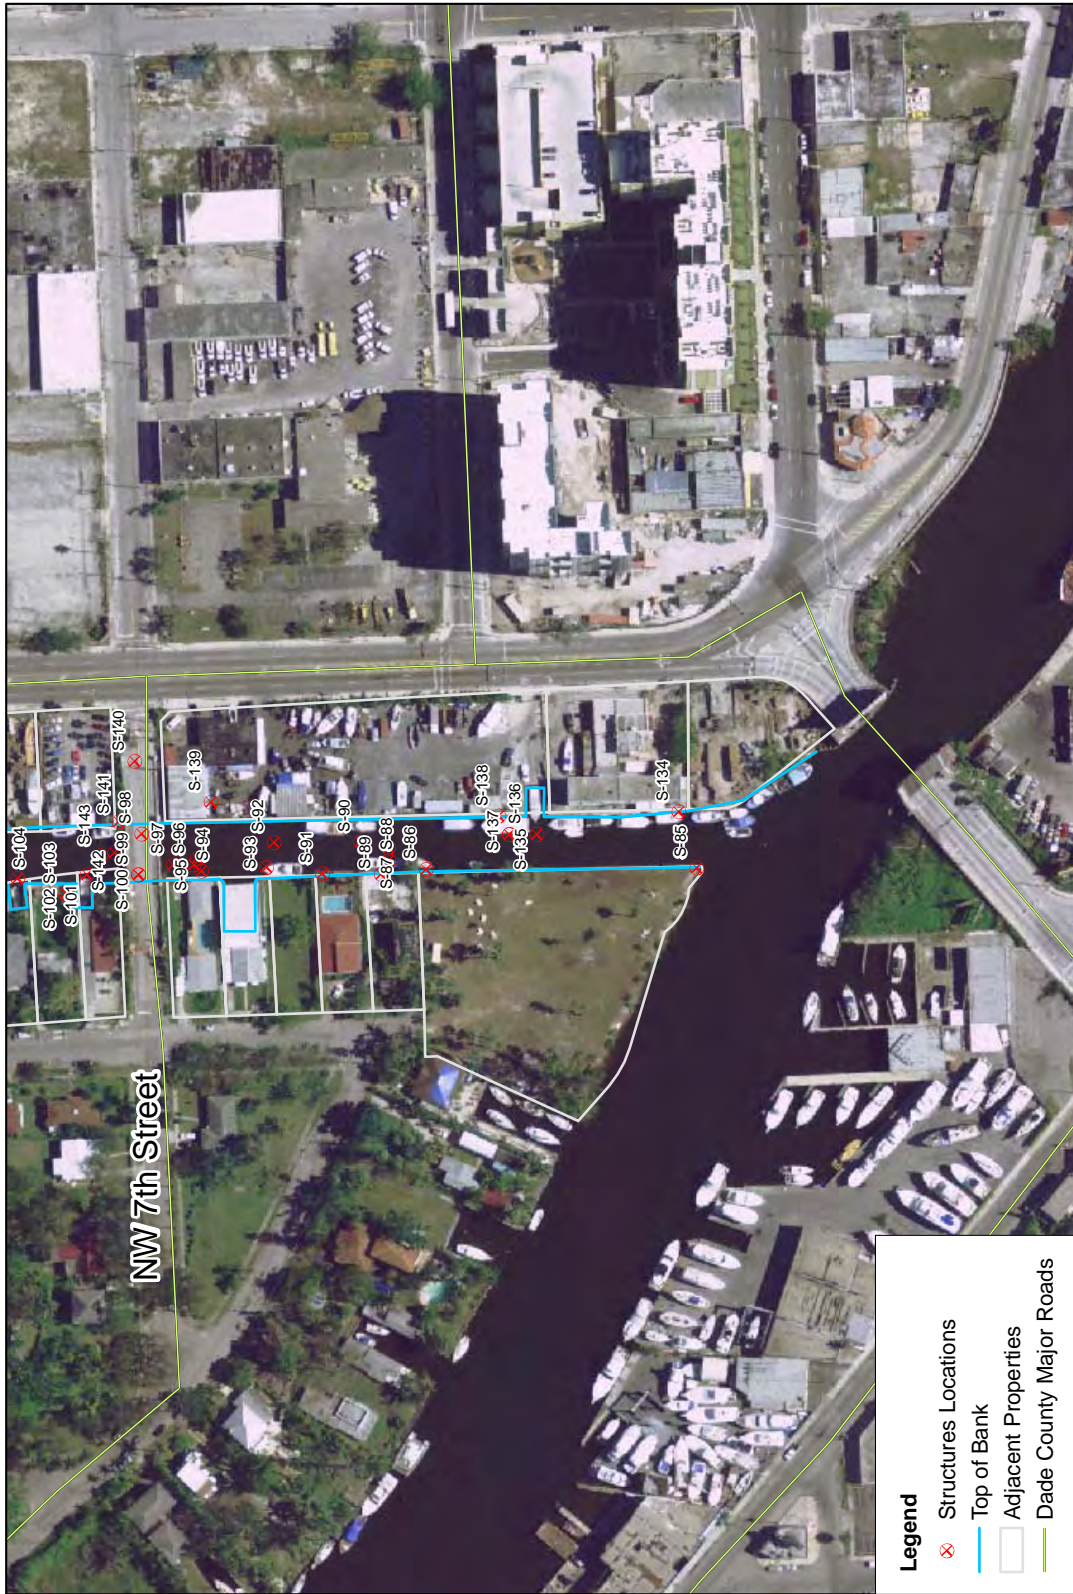
**Operational Section 6**  
 Structure Locations  
 Structure Condition Report

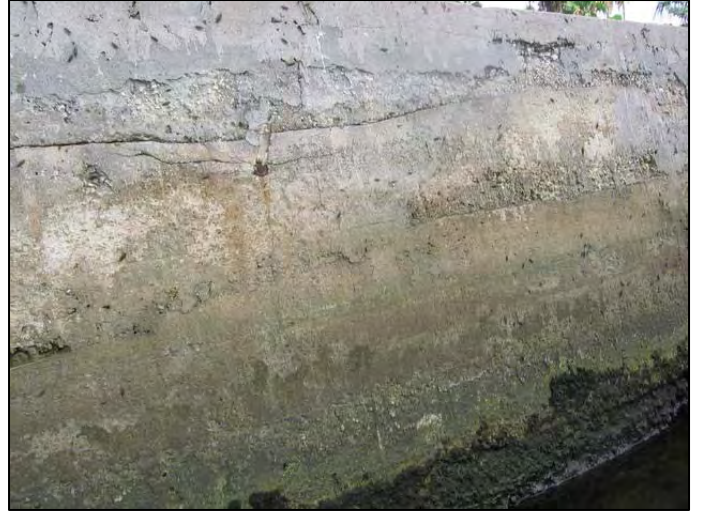
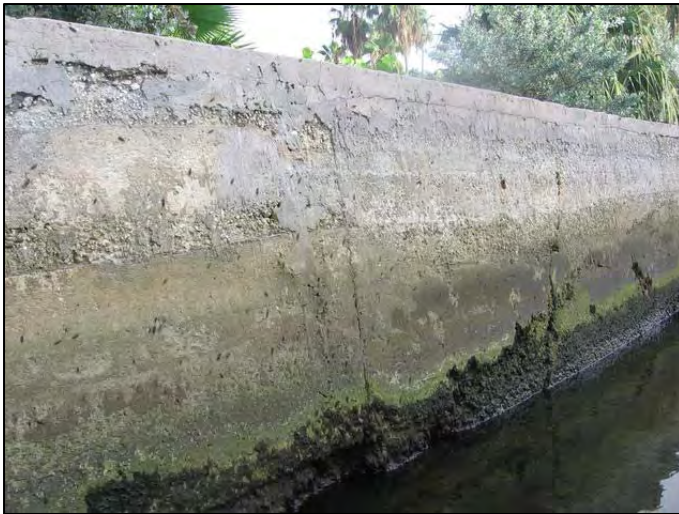
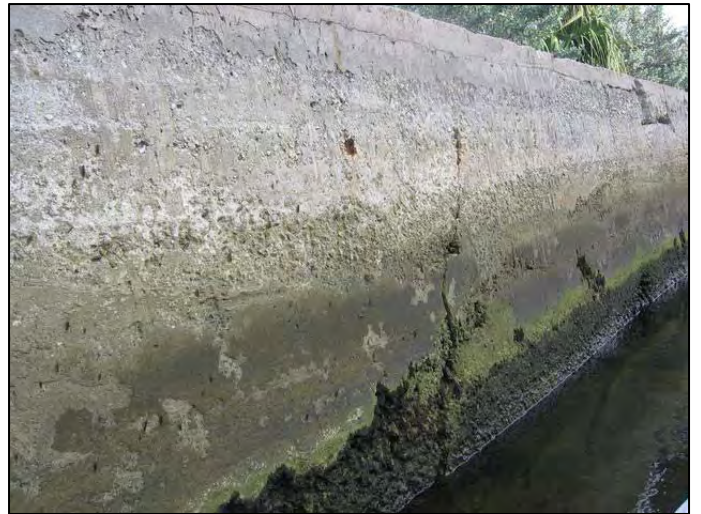
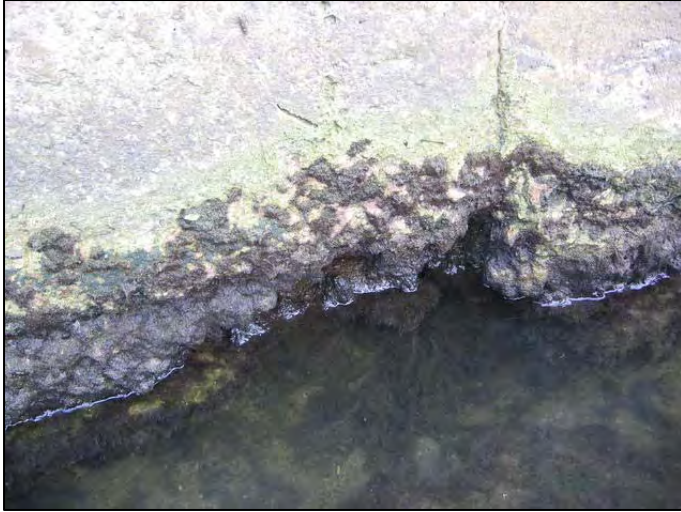
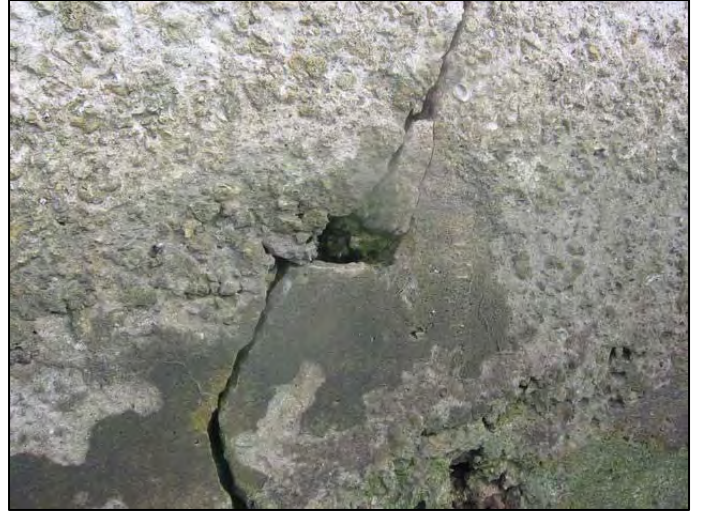
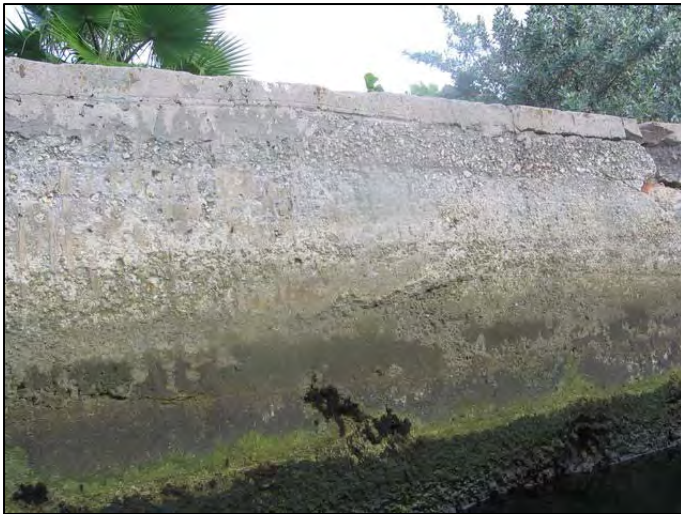
Address	601 NW 7 <sup>th</sup> St. Rd.; 617 NW 7 <sup>th</sup> St. Rd.
Folio #	0131350271330; 0131350271340
Access Agreement	
Description	Seawall beginning at southwest end of Seybold Canal where it meets the Miami River
Water Body	Seybold Canal
Operational Section	6
Latitude (dd.ddddd)*	25.77889
Longitude (dd.ddddd)*	-80.20730
Bank Location	West
Picture #	996, 1004, 1006, 1012-1013, 1017-1018, 1022, 1026-1028, 1033-1037, 1041-1045
Condition	Fair
Damage to Structure and Picture #'s	C-1, 997-998; C-2, 999; C-3, 1000-1003; C-4, 1005; C-5, 1007-1008; C-6, 1009; C-7, 1010-1011; C-8, 1014-1016; C-9, 1019-1020; C-10, 1021; C-11, 1023-1025; C-12, 1029-1030; C-13, 1031; C-14, 1032; C-15, 1038-1040; C-16, 1046-1047
End of Structure	S-87
End of Structure Picture #	1050-1051

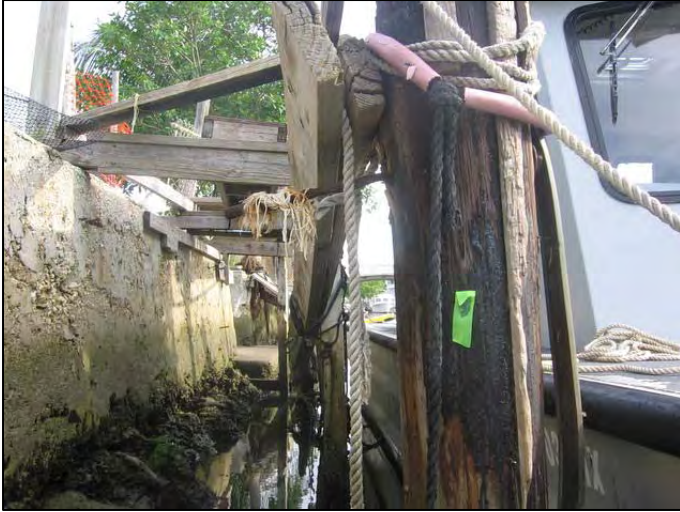
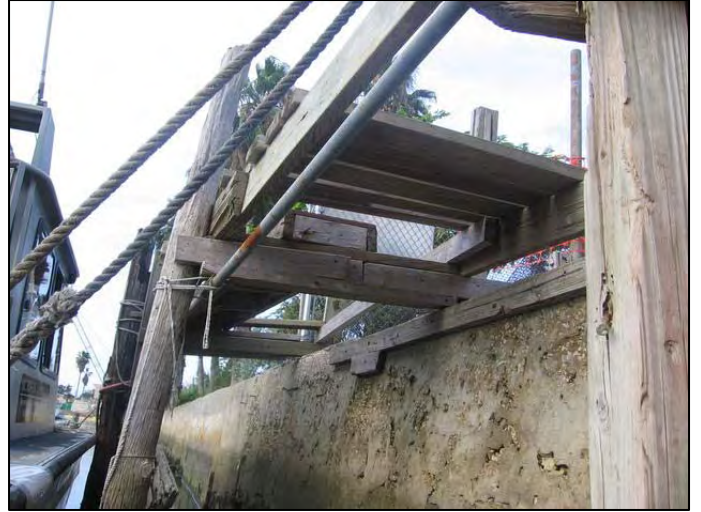
**Structure S-86 Pictures**

Address	617 NW 7 <sup>th</sup> St. Rd.
Folio #	0131350271340
Access Agreement	
Description	Wooden dock
Water Body	Seybold Canal
Operational Section	6
Latitude (dd.ddddd)*	25.77967
Longitude (dd.ddddd)*	-80.20730
Bank Location	West
Picture #	1048-1049
Condition	Poor
Damage to Structure and Picture #'s	N/A
End of Structure	N/A
End of Structure Picture #	N/A

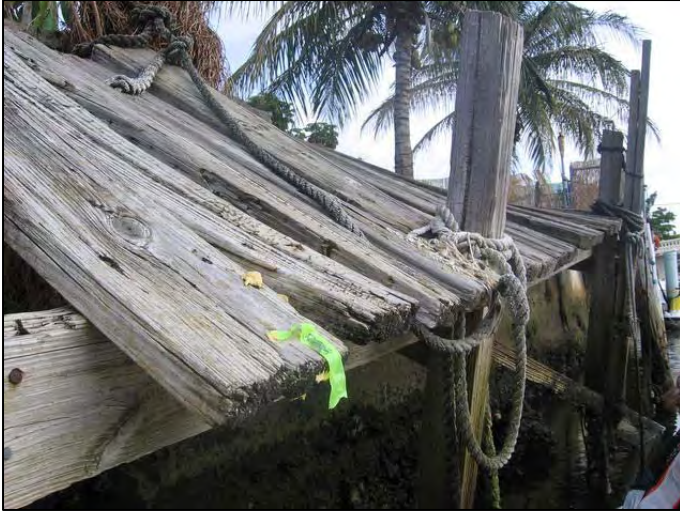
IMG\_1052

Address	617 NW 7 <sup>th</sup> St. Rd.
Folio #	0131350271340
Access Agreement	
Description	Collapsing wooden dock
Water Body	Seybold Canal
Operational Section	6
Latitude (dd.ddddd)*	25.77978
Longitude (dd.ddddd)*	-80.20727
Bank Location	West
Picture #	1052
Condition	Poor
Damage to Structure and Picture #'s	N/A
End of Structure	N/A
End of Structure Picture #	N/A

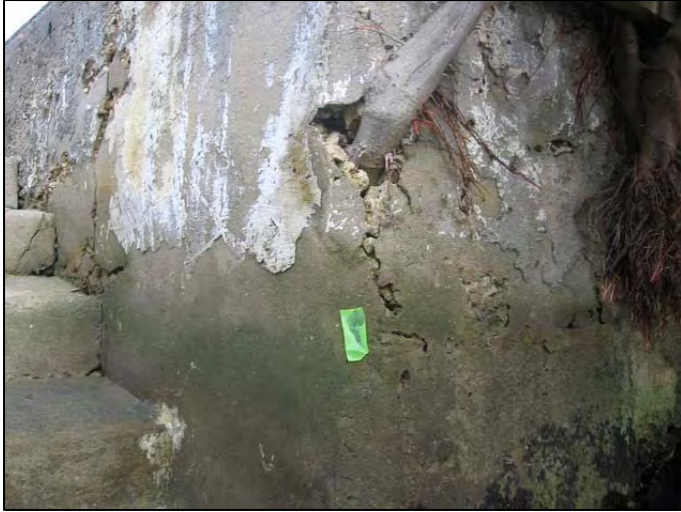
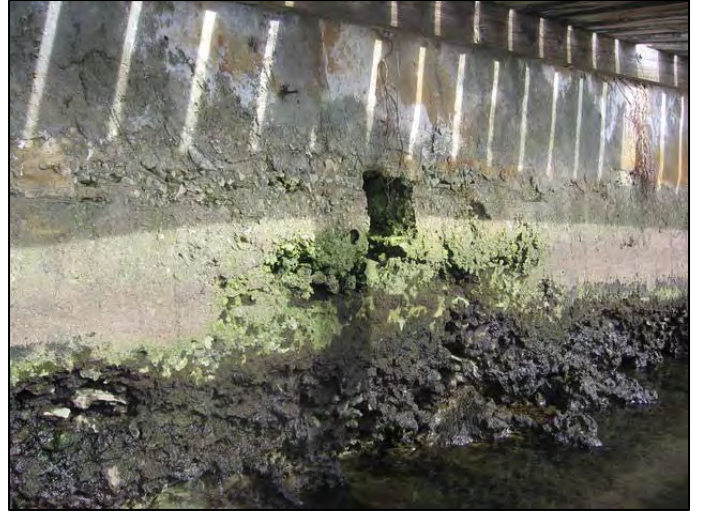
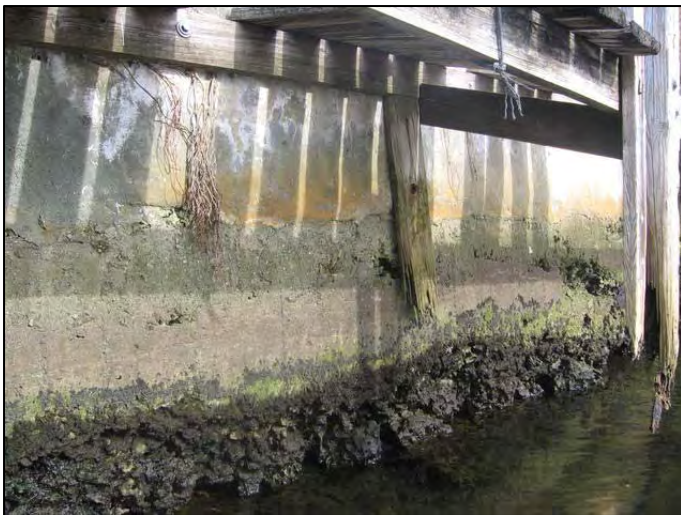
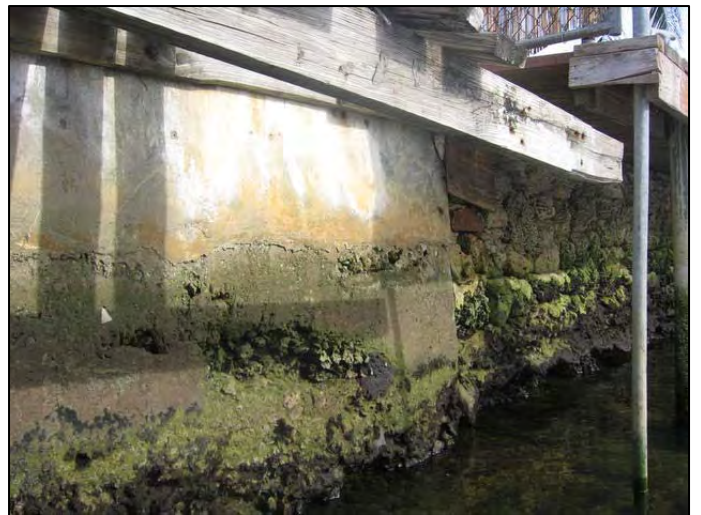
Structure S-89 Pictures

Address	617 NW 7 <sup>th</sup> St. Rd.
Folio #	0131350271340
Access Agreement	
Description	Concrete seawall
Water Body	Seybold Canal
Operational Section	6
Latitude (dd.ddddd)*	25.97979
Longitude (dd.ddddd)*	-80.20722
Bank Location	West
Picture #	1053-1066
Condition	Poor
Damage to Structure and Picture #'s	C-1, 1065-1066
End of Structure	S-93
End of Structure Picture #	1068
