*Corrective Action Plan - Version 2*

# Wagner Creek/Seybold Canal

Volume 2 — Appendices G through I

Submitted to  
City of Miami

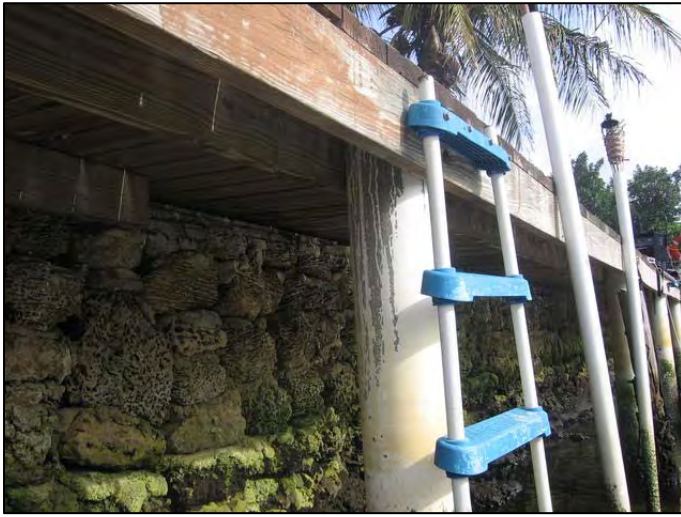
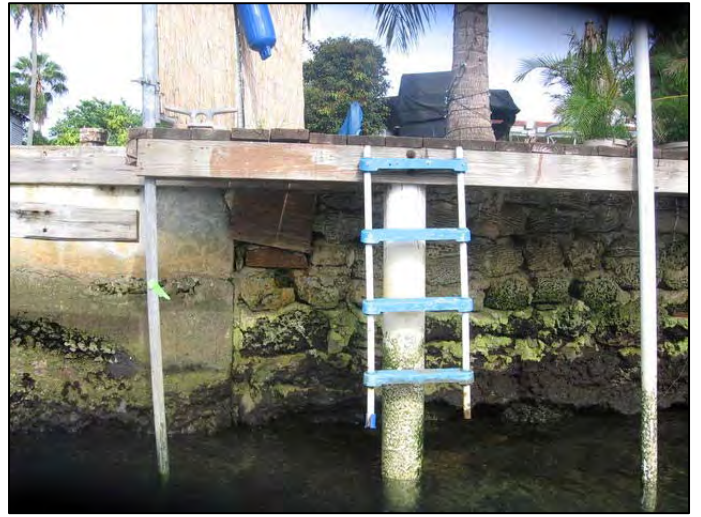
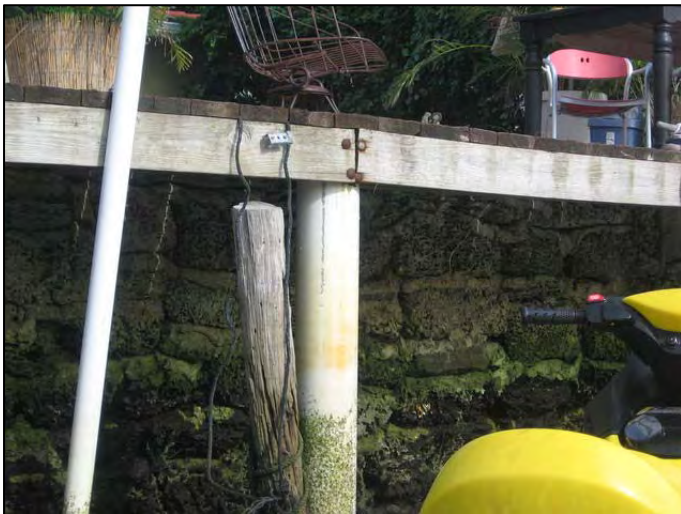
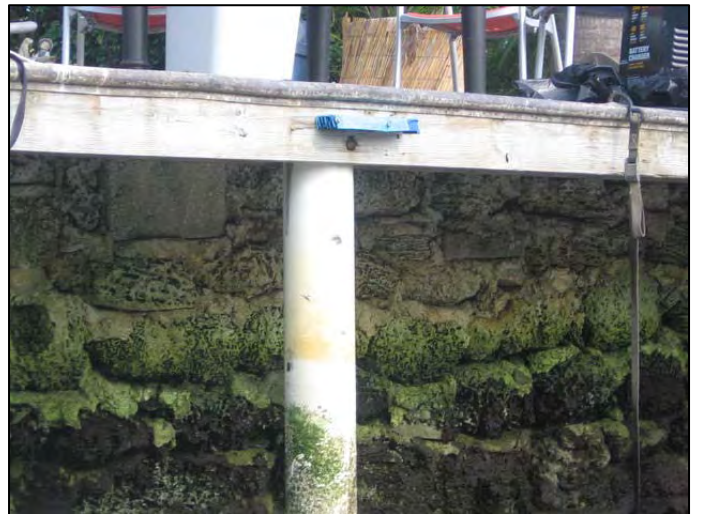
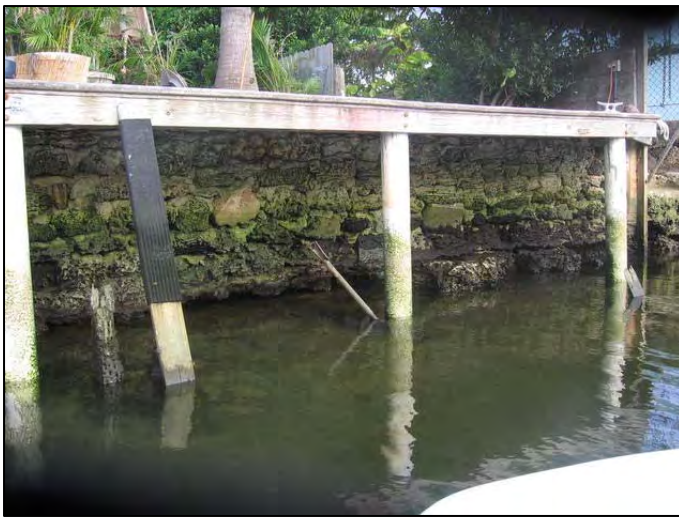
Structure S-90 Pictures

Address	617 NW 7 <sup>th</sup> St. Rd.
Folio #	0131350271340
Access Agreement	
Description	Wooden dock with PVC pilings
Water Body	Seybold Canal
Operational Section	6
Latitude (dd.ddddd)*	25.77986
Longitude (dd.ddddd)*	-80.20721
Bank Location	West
Picture #	1057-1063
Condition	Fair
Damage to Structure and Picture #'s	N/A
End of Structure	N/A
End of Structure Picture #	N/A

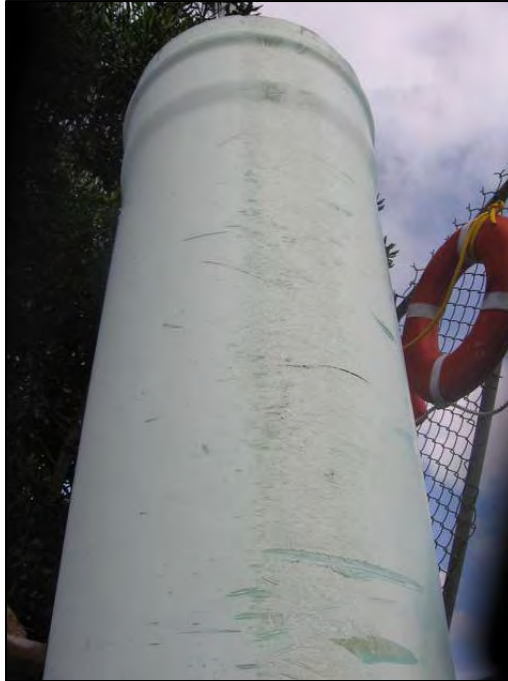
IMG\_1067

Address	617 NW 7 <sup>th</sup> St. Rd.
Folio #	0131350271340
Access Agreement	
Description	PVC pipe protruding from canal
Water Body	Seybold Canal
Operational Section	6
Latitude (dd.ddddd)*	25.77997
Longitude (dd.ddddd)*	-80.20731
Bank Location	West
Picture #	1067
Condition	Good
Damage to Structure and Picture #'s	N/A
End of Structure	N/A
End of Structure Picture #	N/A

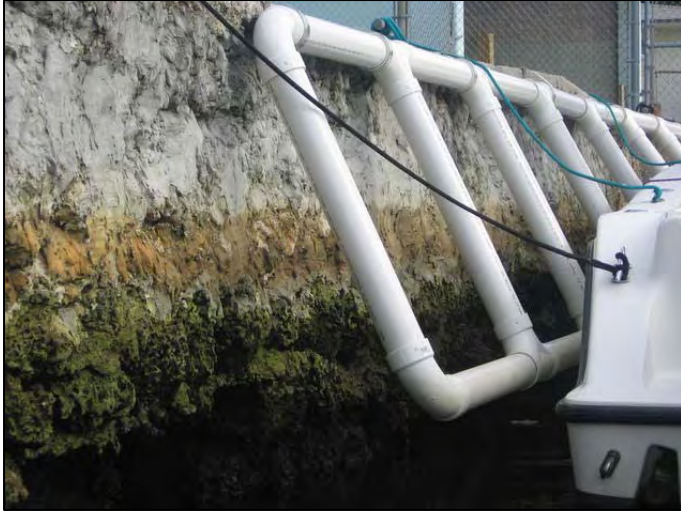
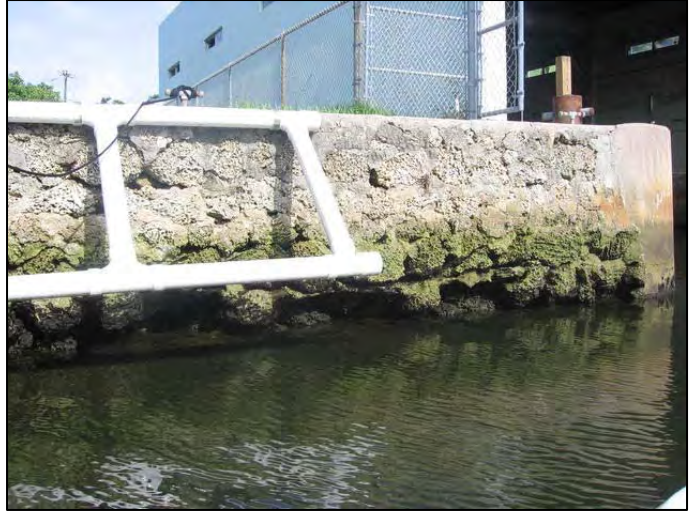
**Structure S-92 Pictures**

Address	691 NW 7 <sup>th</sup> St. Rd.
Folio #	0131350271370
Access Agreement	
Description	PVC boat buffer between seawall and boat
Water Body	Seybold Canal
Operational Section	6
Latitude (dd.ddddd)*	25.78011
Longitude (dd.ddddd)*	-80.20721
Bank Location	West
Picture #	1066, 1068
Condition	Good
Damage to Structure and Picture #'s	N/A
End of Structure	N/A
End of Structure Picture #	N/A

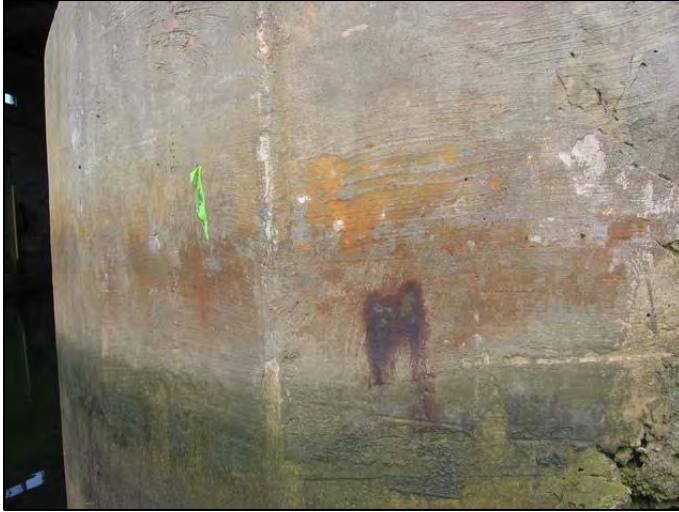
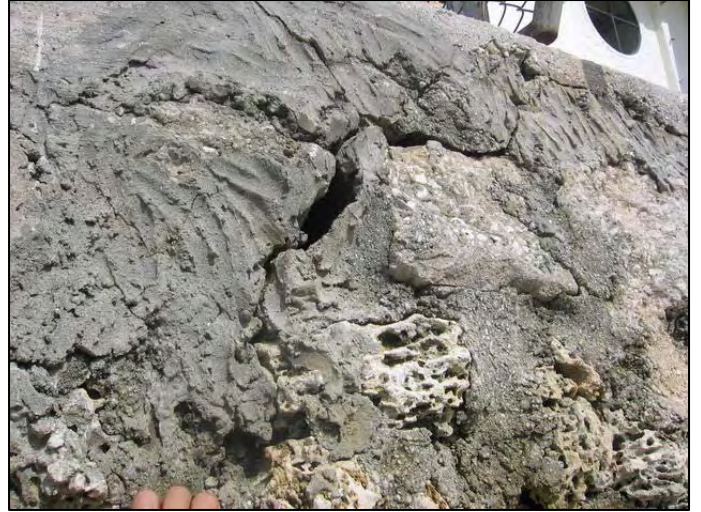
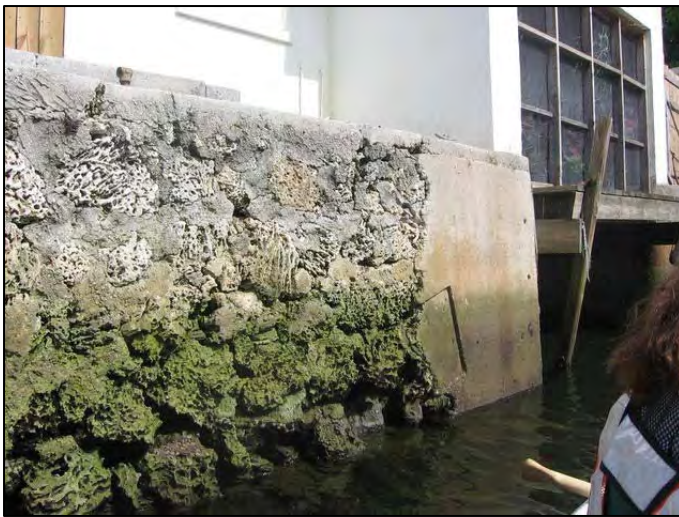
**Structure S-94 Pictures**

Address	631 NW 7 <sup>th</sup> St. Rd.
Folio #	0131350271355
Access Agreement	
Description	Coral rock seawall
Water Body	Seybold Canal
Operational Section	6
Latitude (dd.ddddd)*	25.78032
Longitude (dd.ddddd)*	-80.20730
Bank Location	West
Picture #	1070
Condition	Fair
Damage to Structure and Picture #'s	C-1, 1071; C-2, 1072
End of Structure	S-95
End of Structure Picture #	1072

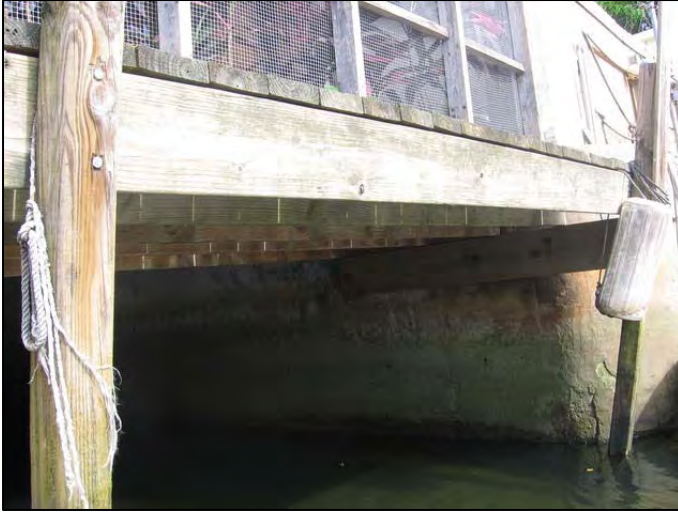
IMG\_1073

Address	631 NW 7 <sup>th</sup> St. Rd.
Folio #	0131350271355
Access Agreement	
Description	Wooden dock
Water Body	Seybold Canal
Operational Section	6
Latitude (dd.ddddd)*	25.78034
Longitude (dd.ddddd)*	-80.20728
Bank Location	West
Picture #	1073
Condition	Good
Damage to Structure and Picture #'s	N/A
End of Structure	N/A
End of Structure Picture #	N/A

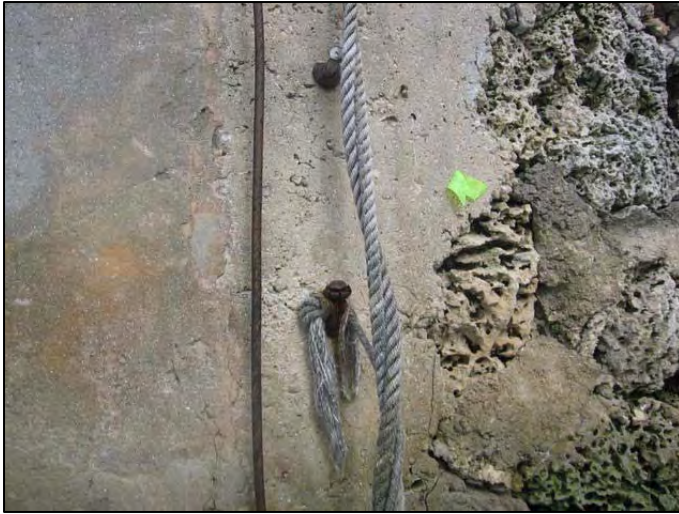
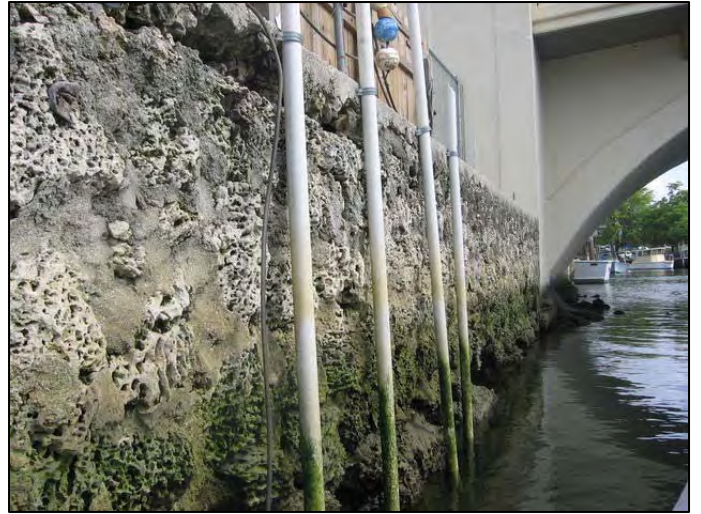
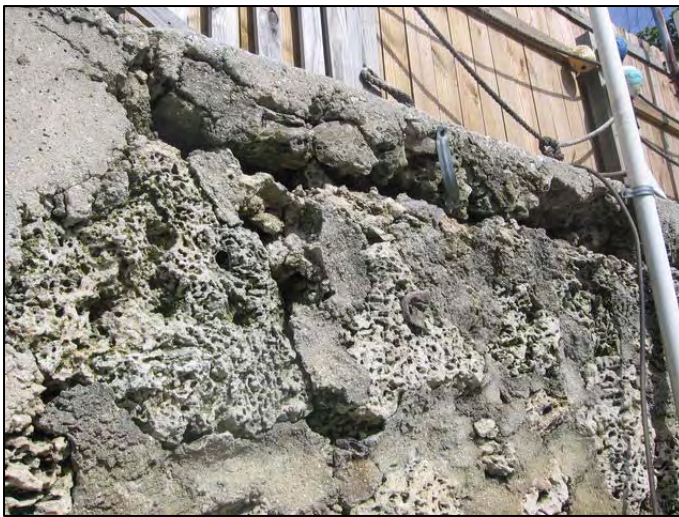
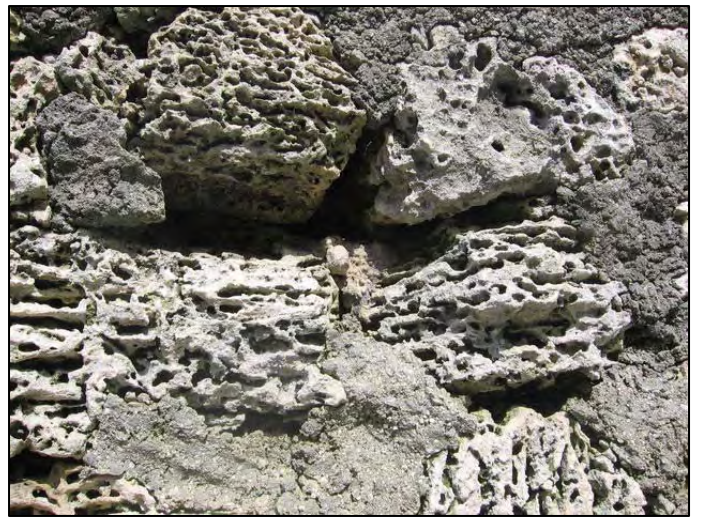
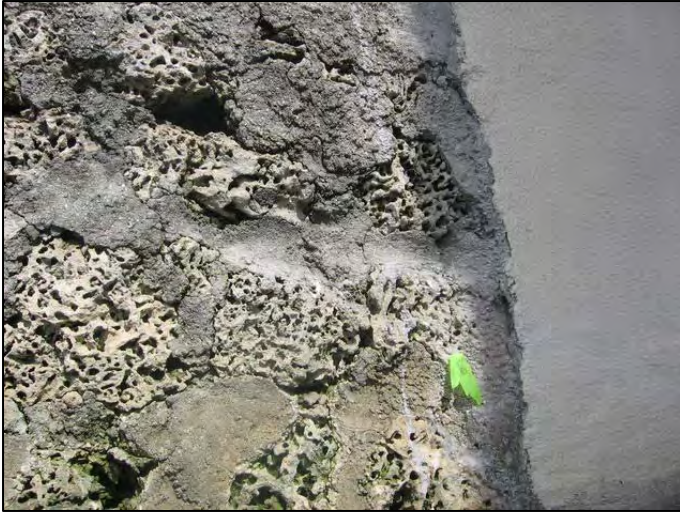
Structure S-97 Pictures

Address	631 NW 7 <sup>th</sup> St. Rd.
Folio #	0131350271355
Access Agreement	
Description	Concrete and coral rock seawall
Water Body	Seybold Canal
Operational Section	6
Latitude (dd.ddddd)*	25.78040
Longitude (dd.ddddd)*	-80.20728
Bank Location	West
Picture #	1074-1075
Condition	Fair
Damage to Structure and Picture #'s	C-1, 1076; C-2, 1077
End of Structure	S-98
End of Structure Picture #	1078

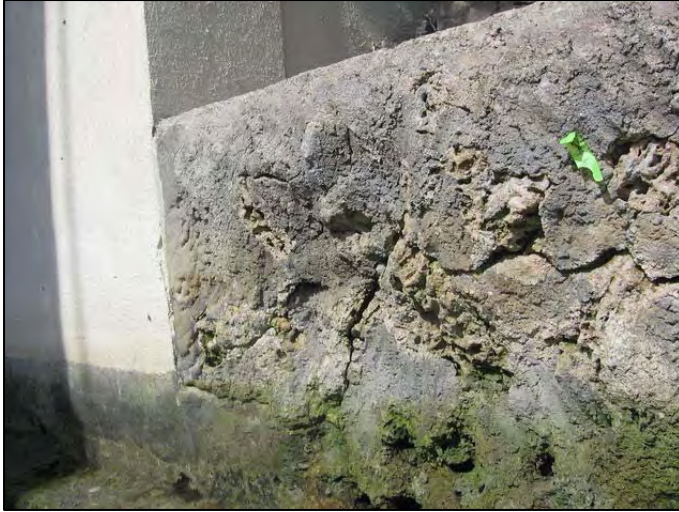
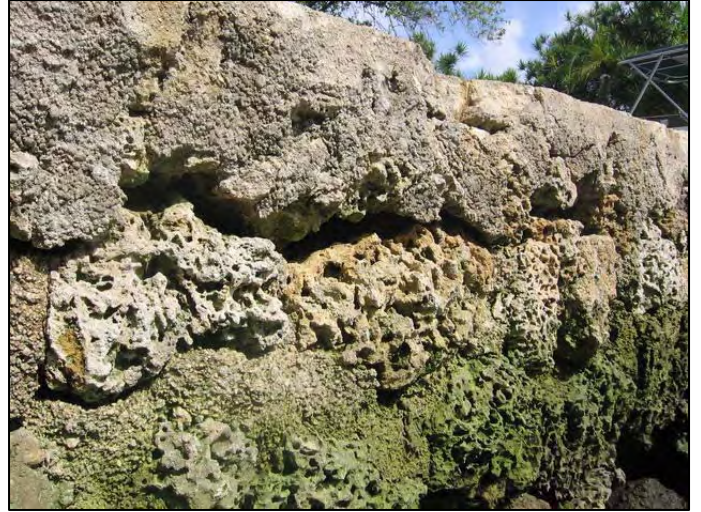
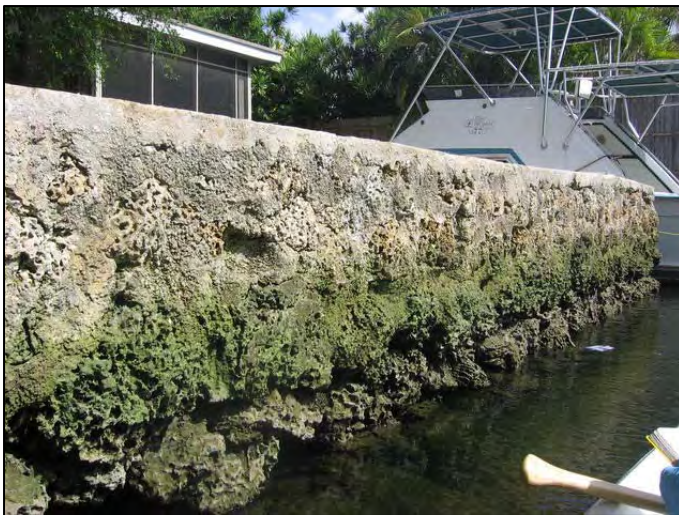
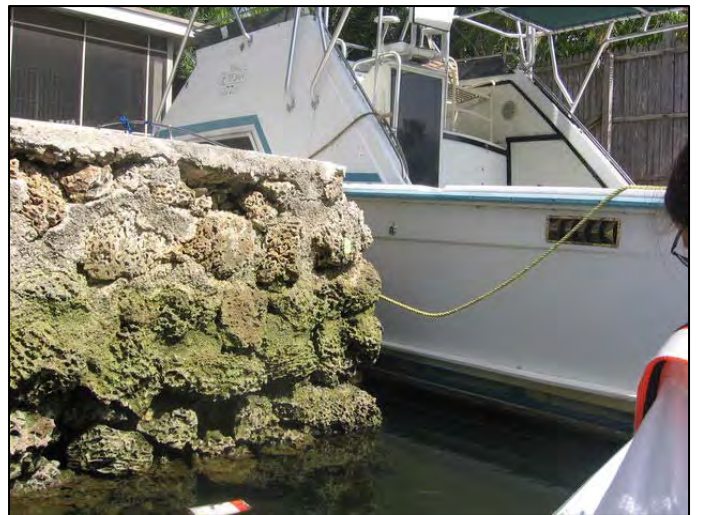
**Structure S-99 Pictures**

Address	701 NW 7 <sup>th</sup> St. Rd.
Folio #	0131350270910
Access Agreement	
Description	Concrete and coral rock seawall
Water Body	Seybold Canal
Operational Section	6
Latitude (dd.ddddd)*	25.78050
Longitude (dd.ddddd)*	-80.20731
Bank Location	West
Picture #	1079, 1081-1083
Condition	Fair
Damage to Structure and Picture #'s	C-1, 1081
End of Structure	S-101
End of Structure Picture #	1083

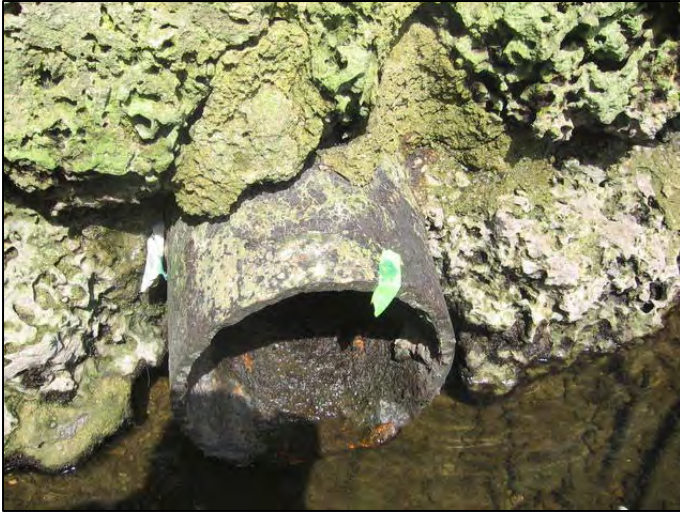
IMG\_1080

Address	701 NW 7 <sup>th</sup> St. Rd.
Folio #	0131350270910
Access Agreement	
Description	18" Metal pipe
Water Body	Seybold Canal
Operational Section	6
Latitude (dd.ddddd)*	25.78050
Longitude (dd.ddddd)*	-80.20731
Bank Location	West
Picture #	1080
Condition	Fair
Damage to Structure and Picture #'s	N/A
End of Structure	N/A
End of Structure Picture #	N/A

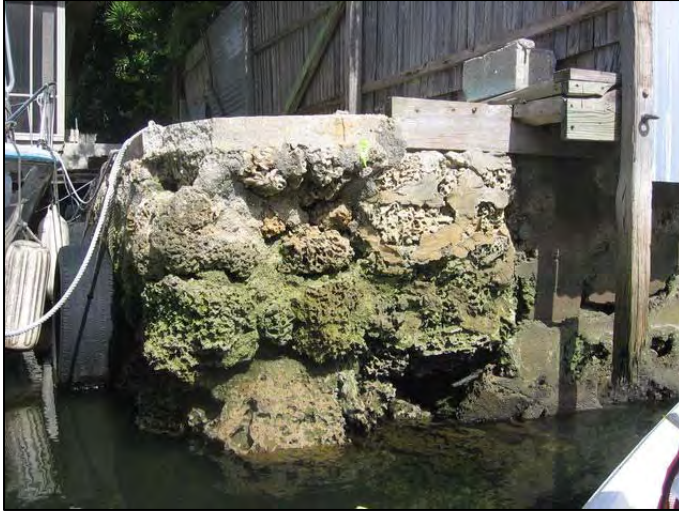
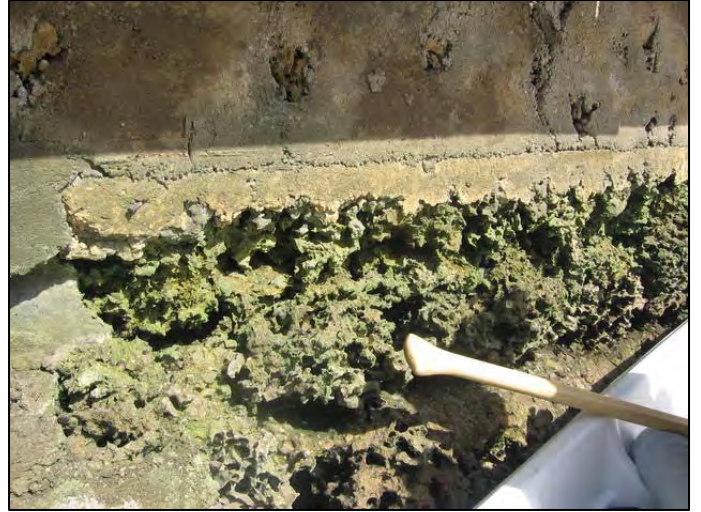
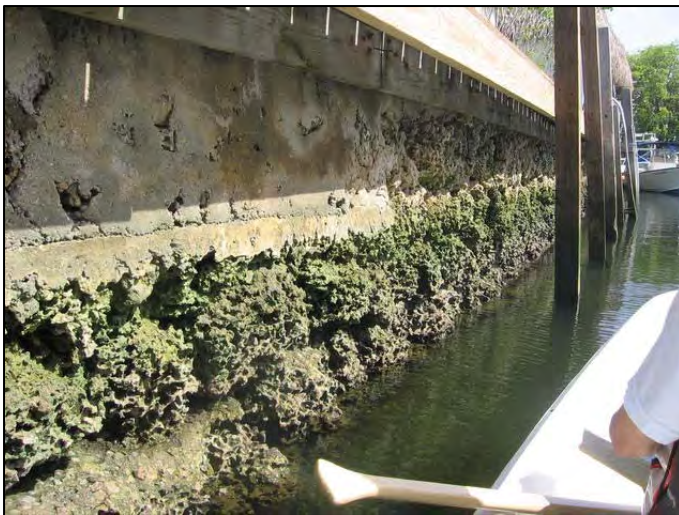
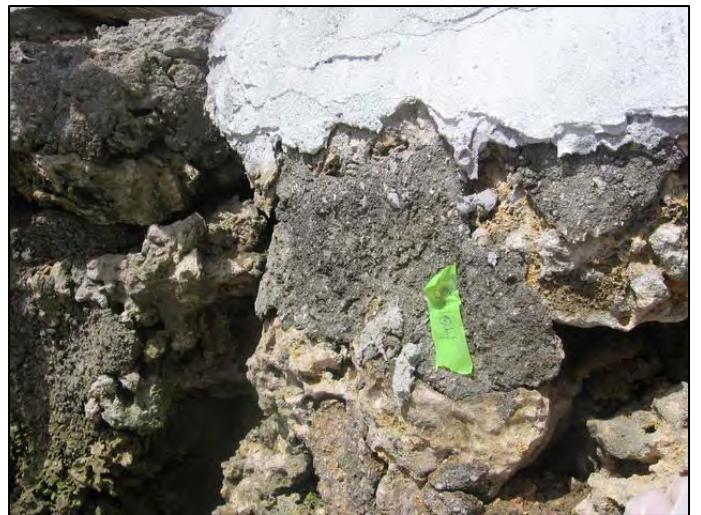
Structure S-102 Pictures

Address	701 NW 7 <sup>th</sup> St. Rd.; 713 NW 7 <sup>th</sup> St. Rd.; 721 NW 7 <sup>th</sup> St. Rd
Folio #	0131350270910; 0131350270900; 0131350270890
Access Agreement	
Description	Concrete and coral rock seawall
Water Body	Seybold Canal
Operational Section	6
Latitude (dd.ddddd)*	25.78071
Longitude (dd.ddddd)*	-80.20737
Bank Location	West
Picture #	1084-1086
Condition	Fair
Damage to Structure and Picture #'s	N/A
End of Structure	S-104
End of Structure Picture #	1088

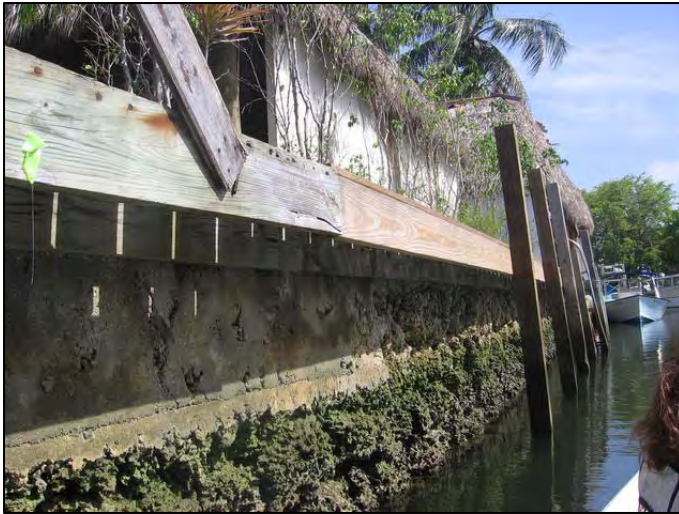
IMG\_1087

Address	713 NW 7 <sup>th</sup> St. Rd.
Folio #	0131350270900
Access Agreement	
Description	Wooden dock
Water Body	Seybold Canal
Operational Section	6
Latitude (dd.ddddd)*	25.78071
Longitude (dd.ddddd)*	-80.20737
Bank Location	West
Picture #	1087
Condition	Fair
Damage to Structure and Picture #'s	N/A
End of Structure	N/A
End of Structure Picture #	N/A

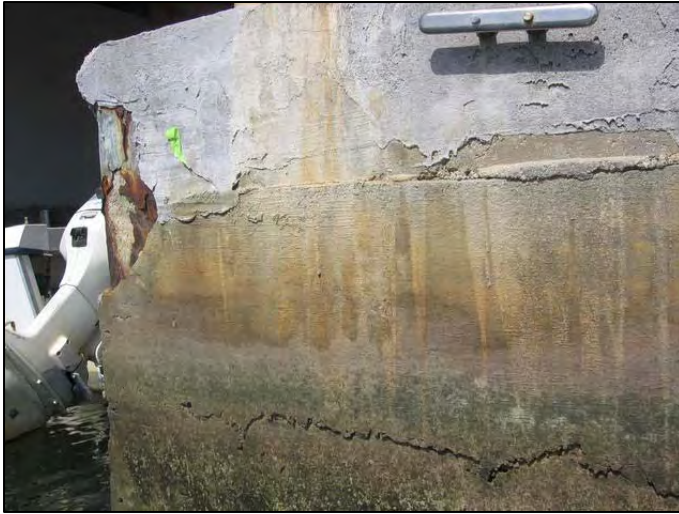
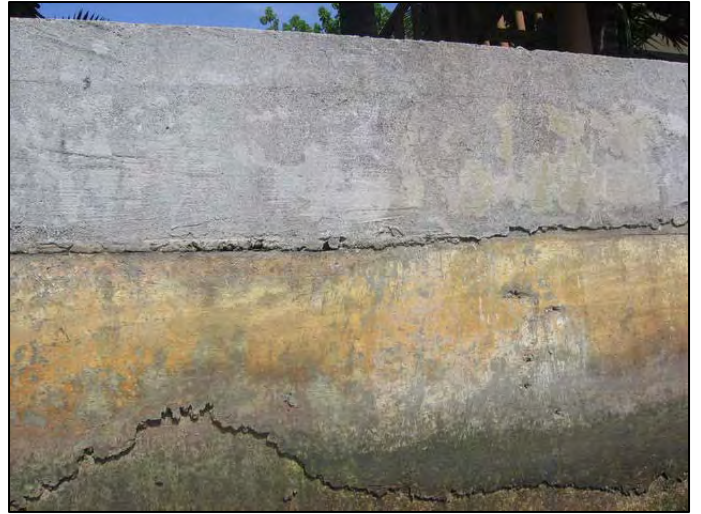
Structure S-105 Pictures

Address	721 NW 7 <sup>th</sup> St. Rd.; 727 NW 7 <sup>th</sup> St. Rd.; 735 NW 7 <sup>th</sup> St. Rd.; 743 NW 7 <sup>th</sup> St. Rd.
Folio #	0131350270890; 0131350270880; 0131350270870; 0131350270860
Access Agreement	
Description	Concrete seawall; turns into coral and concrete at S-105, C-1
Water Body	Seybold Canal
Operational Section	6
Latitude (dd.ddddd)*	25.78094
Longitude (dd.ddddd)*	-80.20734
Bank Location	West
Picture #	1089-1103
Condition	Fair
Damage to Structure and Picture #'s	C-1, 1092; C-2, 1101-1102
End of Structure	S-107
End of Structure Picture #	1103

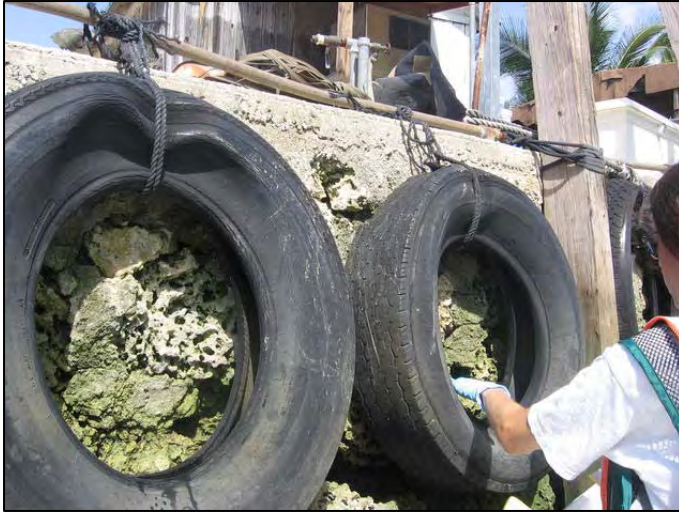
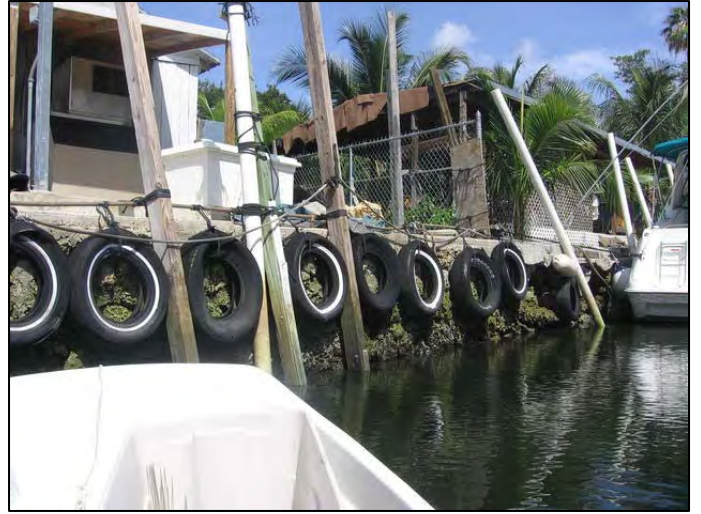
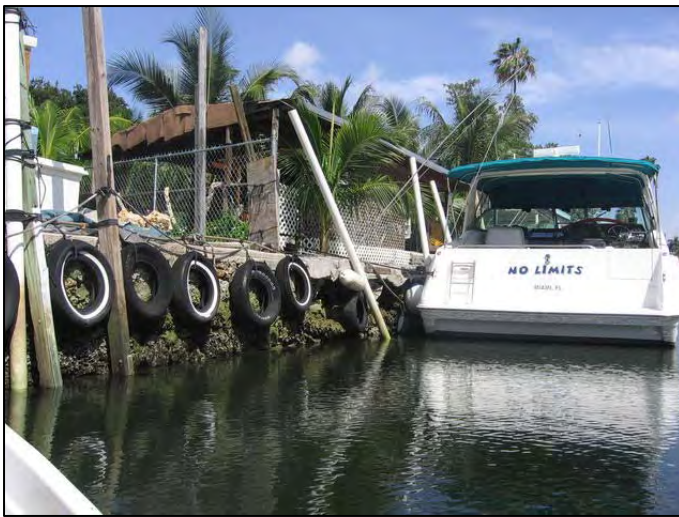
Structure S-106 Pictures

Address	727 NW 7 <sup>th</sup> St. Rd.
Folio #	0131350270880
Access Agreement	
Description	Boat buffer composed of tires, PVC pipes, and wooden poles
Water Body	Seybold Canal
Operational Section	6
Latitude (dd.ddddd)*	25.78119
Longitude (dd.ddddd)*	-80.20737
Bank Location	West
Picture #	1098-1100
Condition	Fair
Damage to Structure and Picture #'s	N/A
End of Structure	N/A
End of Structure Picture #	N/A

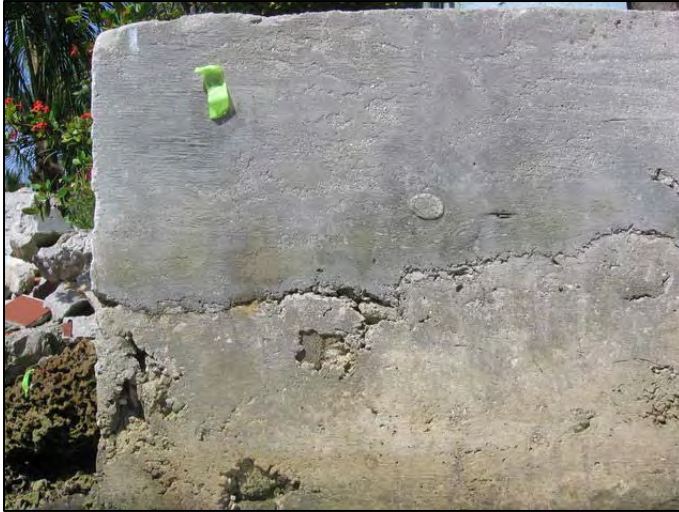
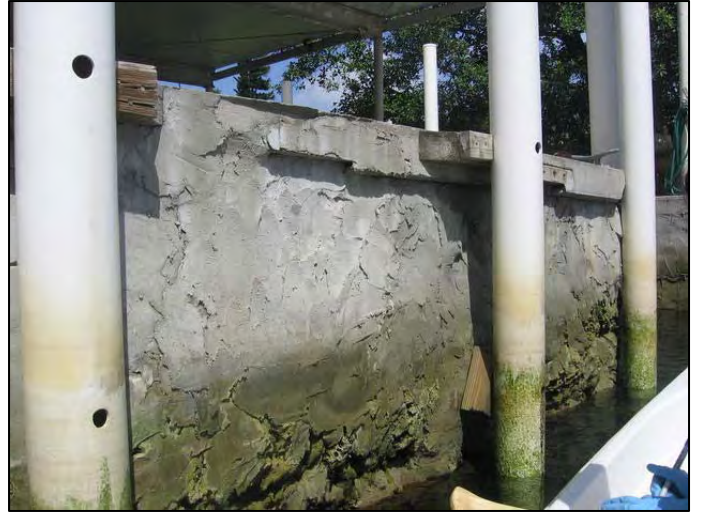
Structure S-108 Pictures

Address	743 NW 7 <sup>th</sup> St. Rd.
Folio #	0131350270860
Access Agreement	
Description	Concrete and coral rock seawall
Water Body	Seybold Canal
Operational Section	6
Latitude (dd.ddddd)*	25.78142
Longitude (dd.ddddd)*	-80.20760
Bank Location	West
Picture #	1104-1106
Condition	Fair
Damage to Structure and Picture #'s	N/A
End of Structure	S-110
End of Structure Picture #	1106

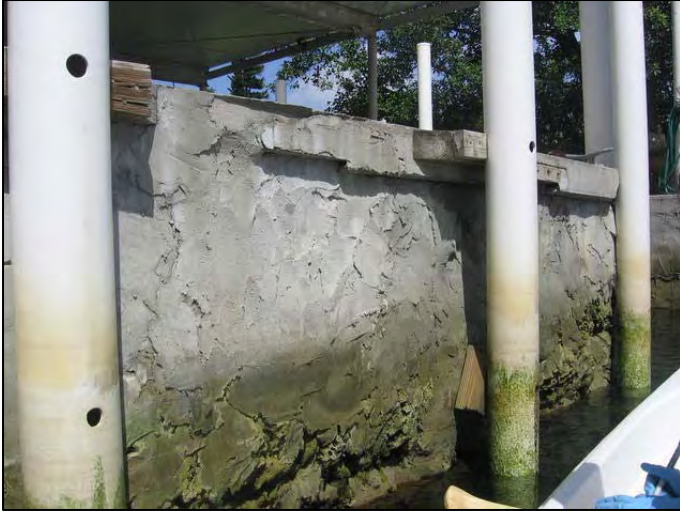
**Structure S-109 Pictures**

Address	743 NW 7 <sup>th</sup> St. Rd.
Folio #	0131350270860
Access Agreement	
Description	Boat buffer
Water Body	Seybold Canal
Operational Section	6
Latitude (dd.ddddd)*	25.78143
Longitude (dd.ddddd)*	-80.20760
Bank Location	West
Picture #	1105
Condition	Good
Damage to Structure and Picture #'s	N/A
End of Structure	N/A
End of Structure Picture #	N/A

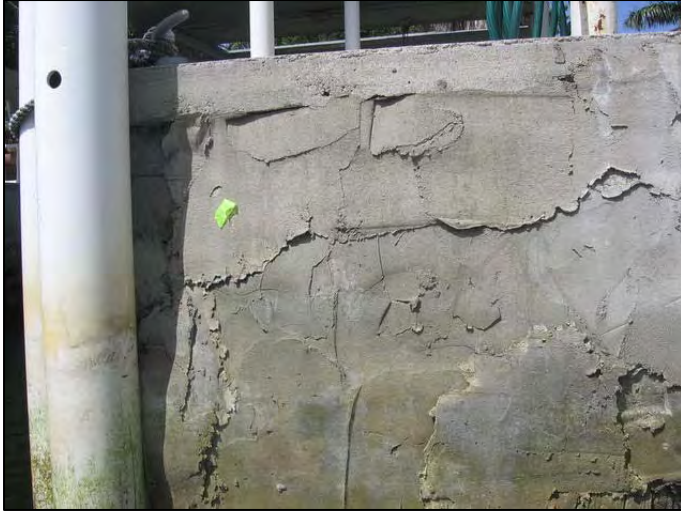
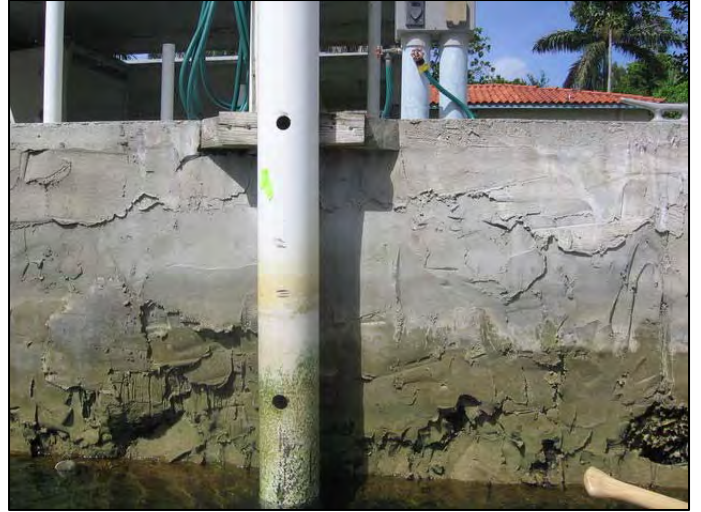
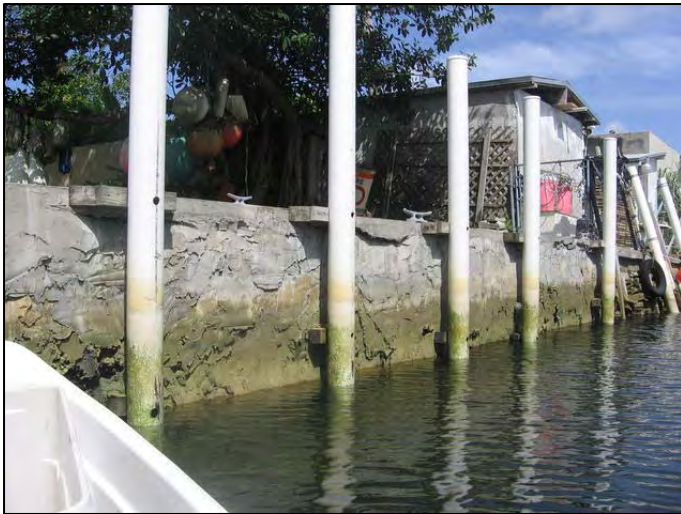
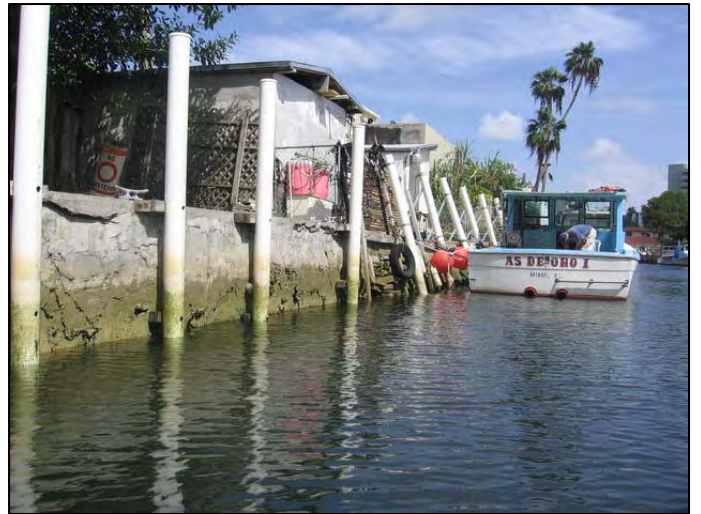
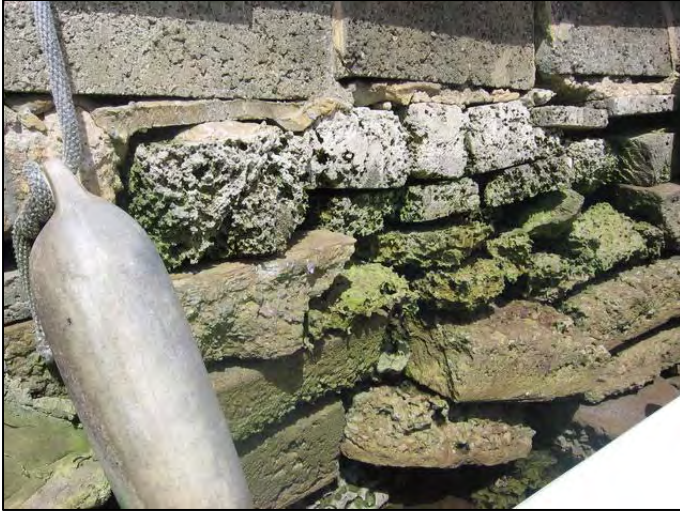
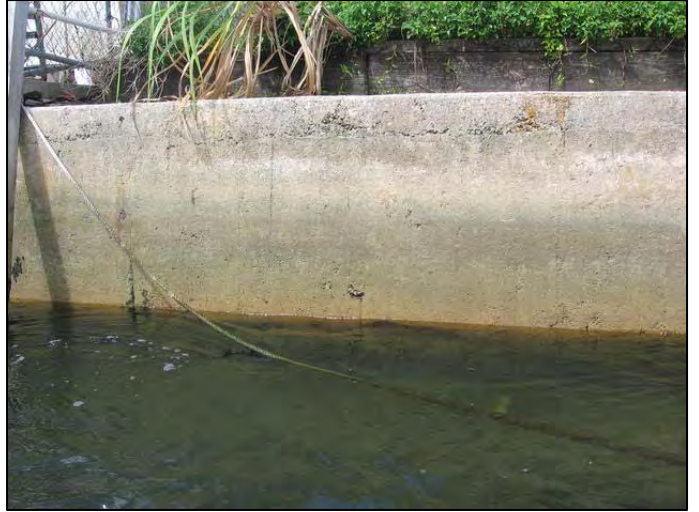
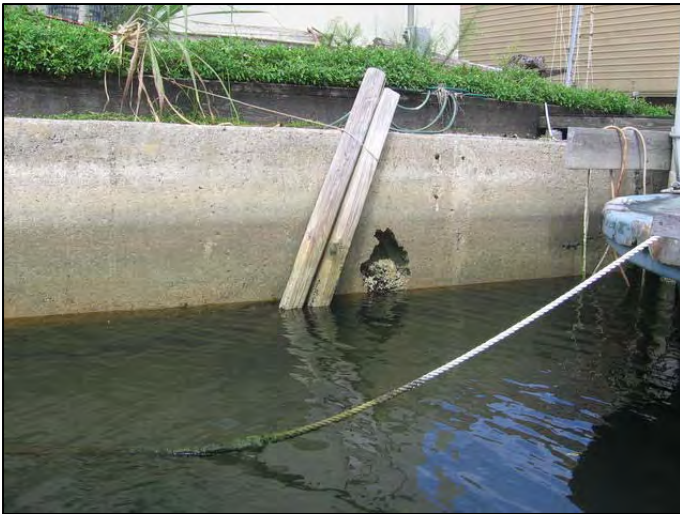
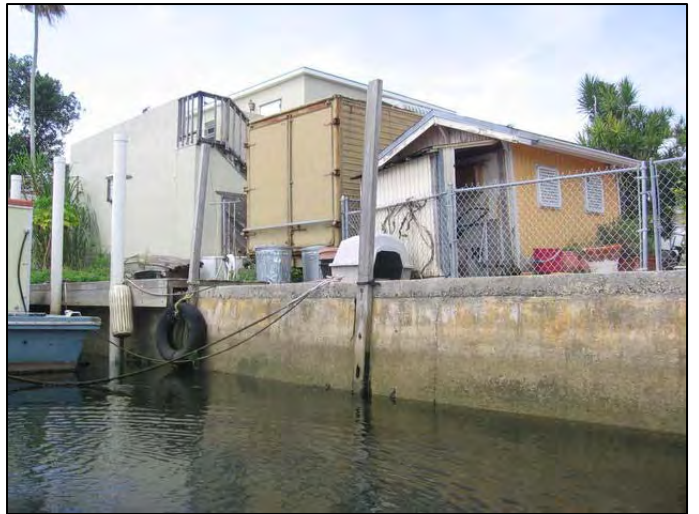
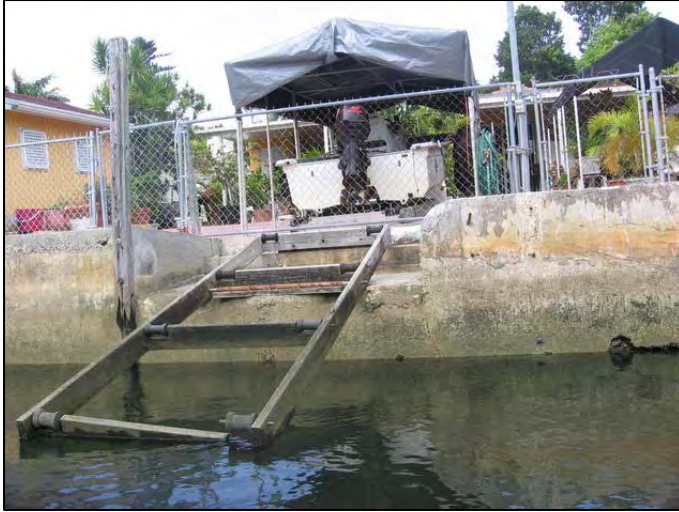
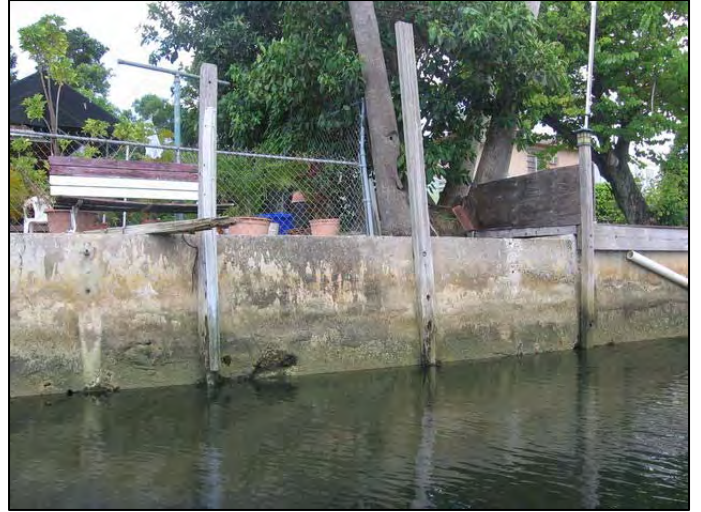
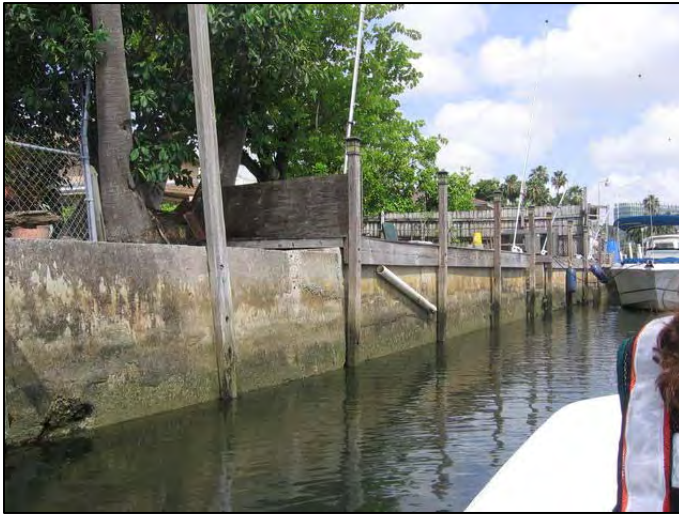
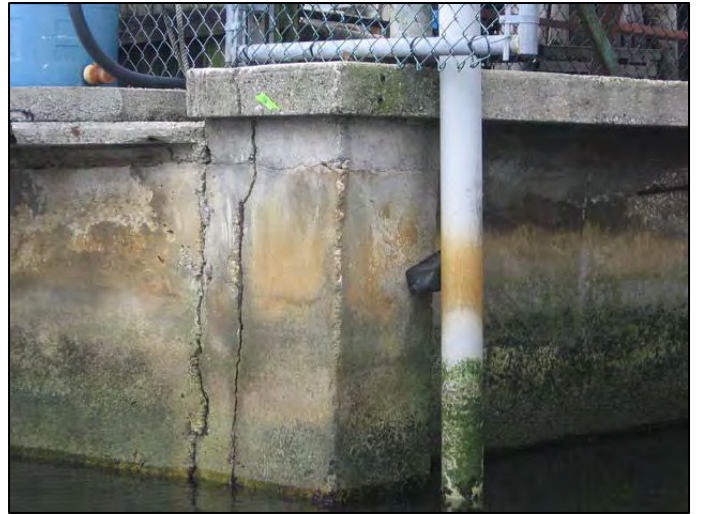
Structure S-111 Pictures

Address	743 NW 7 <sup>th</sup> St. Rd.; 801 NW 7 <sup>th</sup> St. Rd.; 805 NW 7 <sup>th</sup> St. Rd.; 807 NW 7 <sup>th</sup> St. Rd.; 811 NW 7 <sup>th</sup> St. Rd.; 821 NW 7 <sup>th</sup> St. Rd.
Folio #	0131350270860; 0131350270850; 0131350270840; 0131350270830; 0131350270820; 0131350270810
Access Agreement	
Description	Coral rock seawall covered in concrete. North end deteriorating.
Water Body	Seybold Canal
Operational Section	6
Latitude (dd.ddddd)*	25.78179
Longitude (dd.ddddd)*	-80.20789
Bank Location	West
Picture #	1108-1111, 1113-1118
Condition	Fair
Damage to Structure and Picture #'s	C-1, 1112; C, 1114
End of Structure	S-116
End of Structure Picture #	1121

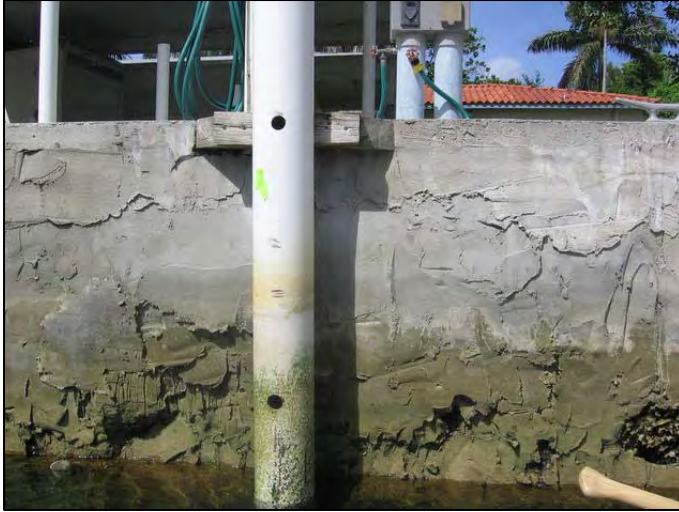
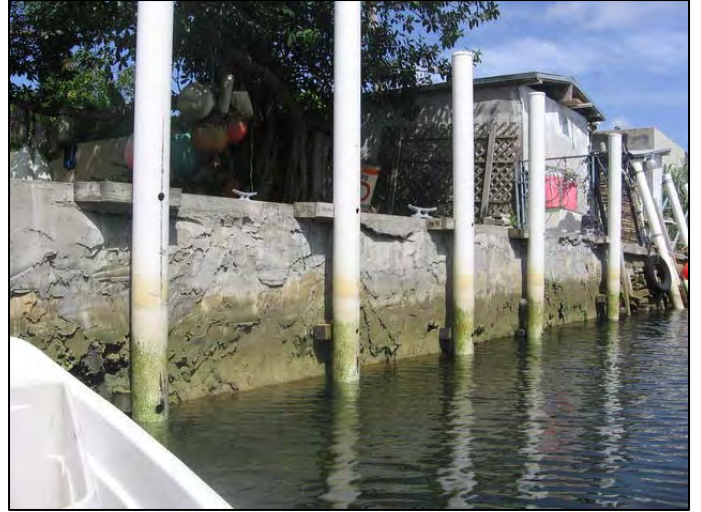
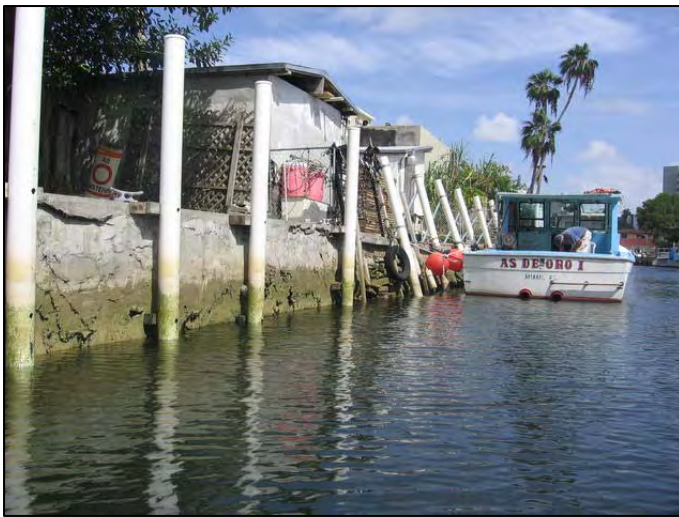
Structure S-112 Pictures

Address	743 NW 7 <sup>th</sup> St. Rd.
Folio #	0131350270860
Access Agreement	
Description	Multiple PVC boat buffers, only one is flagged.
Water Body	Seybold Canal
Operational Section	6
Latitude (dd.ddddd)*	25.78147
Longitude (dd.ddddd)*	-80.20762
Bank Location	West
Picture #	1109-1111
Condition	Fair
Damage to Structure and Picture #'s	N/A
End of Structure	N/A
End of Structure Picture #	N/A

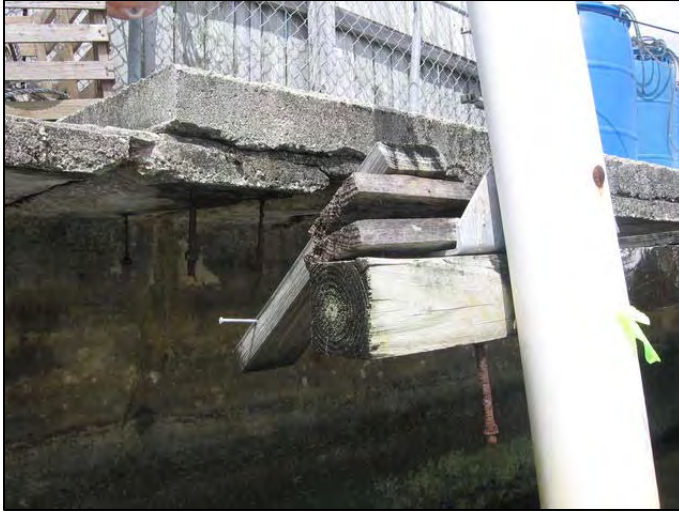
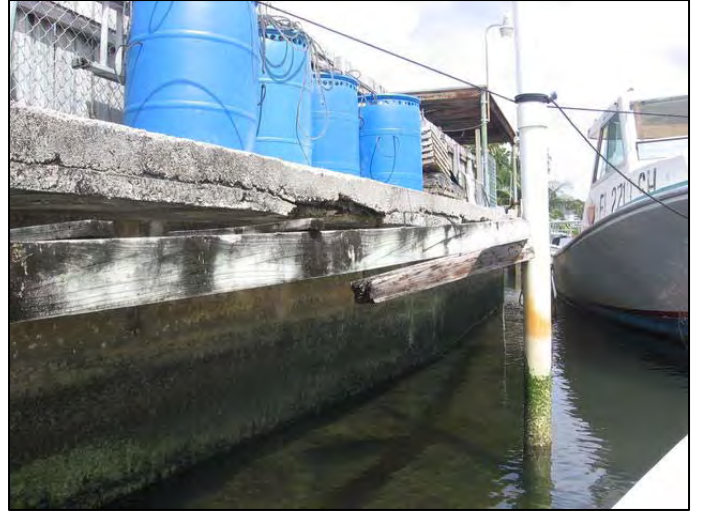
**Structure S-114 Pictures**

Address	821 NW 7 <sup>th</sup> St. Rd.
Folio #	0131350270810
Access Agreement	
Description	Concrete overhang
Water Body	Seybold Canal
Operational Section	6
Latitude (dd.ddddd)*	25.78199
Longitude (dd.ddddd)*	-80.20810
Bank Location	West
Picture #	1119-1120
Condition	Poor
Damage to Structure and Picture #'s	N/A
End of Structure	N/A
End of Structure Picture #	N/A

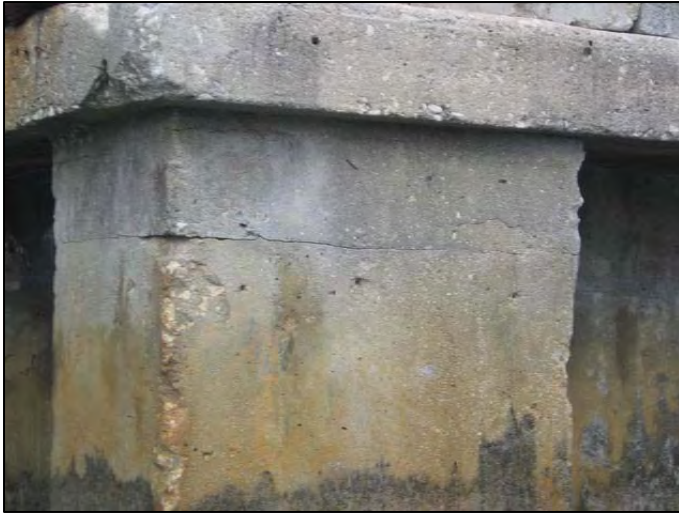
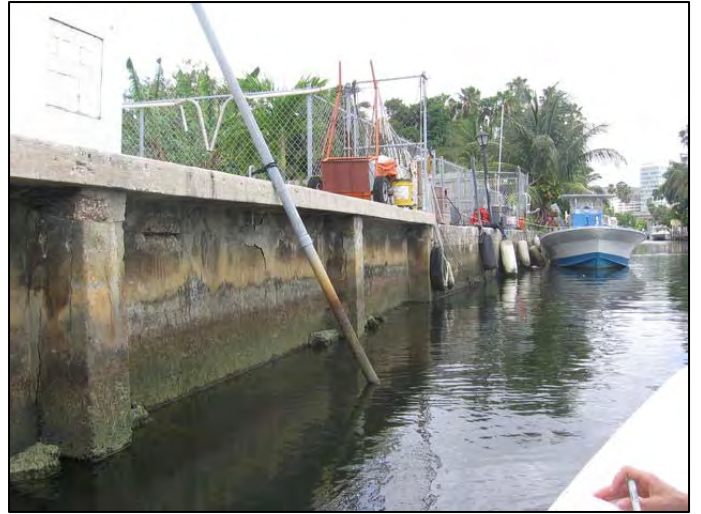
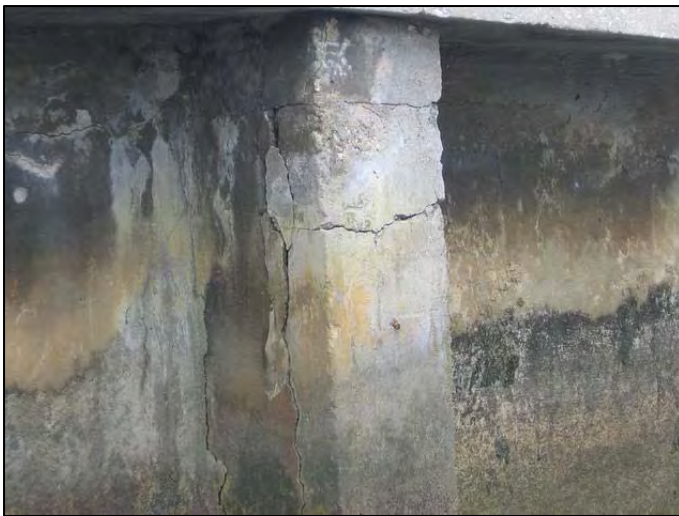
Structure S-117 Pictures

Address	827 NW 7 <sup>th</sup> St. Rd.; 835 NW 7 <sup>th</sup> St. Rd.; 843 NW 7 <sup>th</sup> St. Rd.; 851 NW 7 <sup>th</sup> St. Rd.; 857 NW 7 <sup>th</sup> St. Rd.; 901 NW 7 <sup>th</sup> St. Rd.
Folio #	0131350270800; 0131350270790; 0131350270780; 0131350270770; 0131350270760; 0131350270750
Access Agreement	
Description	Concrete seawall, bottom deteriorating.
Water Body	Seybold Canal
Operational Section	6
Latitude (dd.ddddd)*	25.78220
Longitude (dd.ddddd)*	-80.20817
Bank Location	West
Picture #	1123-1135
Condition	Fair
Damage to Structure and Picture #'s	C-1, 1125; C-2, 1130; C-3, 1133
End of Structure	S-119
End of Structure Picture #	1135

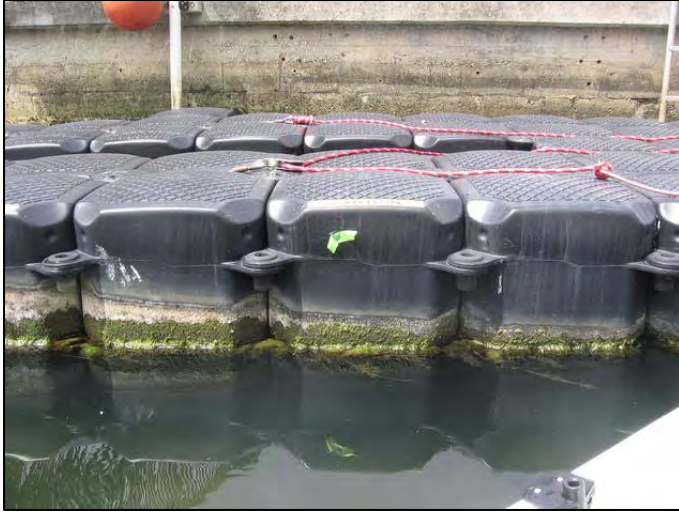
IMG\_1129

Address	851 NW 7 <sup>th</sup> St. Rd.
Folio #	0131350270770
Access Agreement	
Description	Floating dock
Water Body	Seybold Canal
Operational Section	6
Latitude (dd.ddddd)*	25.78246
Longitude (dd.ddddd)*	-80.20855
Bank Location	West
Picture #	1129
Condition	Good
Damage to Structure and Picture #'s	N/A
End of Structure	N/A
End of Structure Picture #	N/A

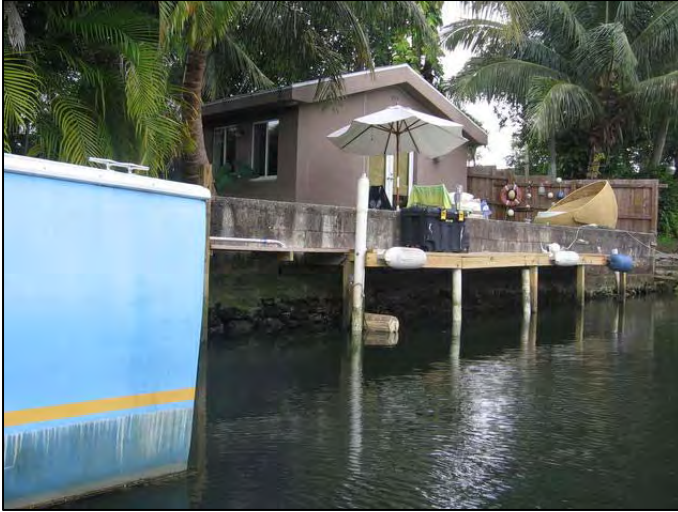
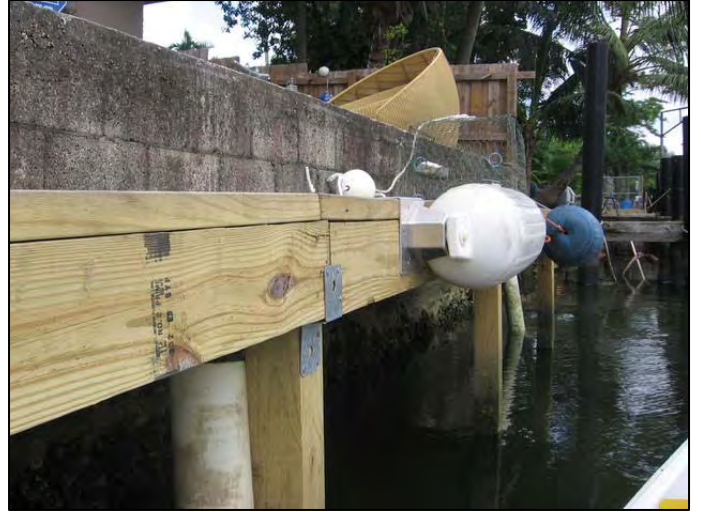
Address	901 NW 7 <sup>th</sup> St. Rd.
Folio #	0131350270750
Access Agreement	
Description	Wooden dock
Water Body	Seybold Canal
Operational Section	6
Latitude (dd.ddddd)*	25.78265
Longitude (dd.ddddd)*	-80.20879
Bank Location	West
Picture #	1132, 1134
Condition	Fair
Damage to Structure and Picture #'s	N/A
End of Structure	N/A
End of Structure Picture #	N/A
