*Corrective Action Plan - Version 2*

# Wagner Creek/Seybold Canal

Volume 2 — Appendices G through I

Submitted to  
City of Miami

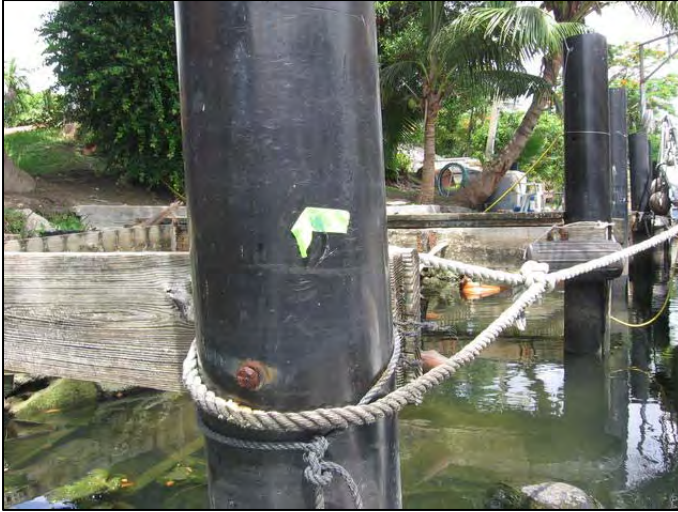
IMG\_1136

Address	911 NW 7 <sup>th</sup> St. Rd.
Folio #	0131350270740
Access Agreement	
Description	Wooden dock
Water Body	Seybold Canal
Operational Section	6
Latitude (dd.ddddd)*	25.78277
Longitude (dd.ddddd)*	-80.20885
Bank Location	West
Picture #	1136
Condition	Poor
Damage to Structure and Picture #'s	N/A
End of Structure	N/A
End of Structure Picture #	N/A

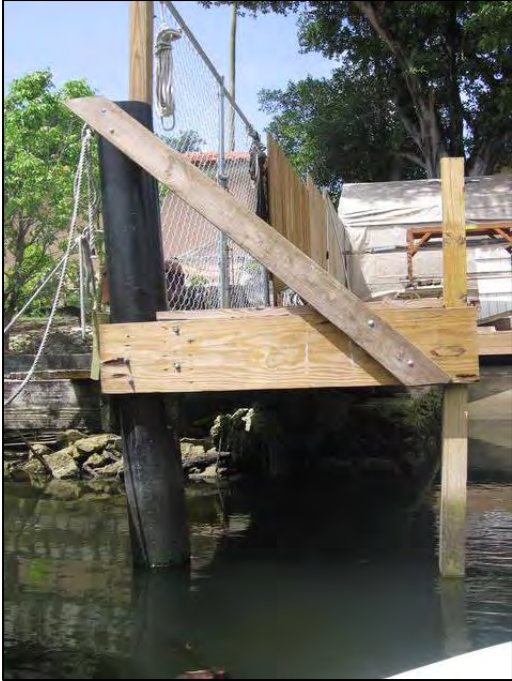
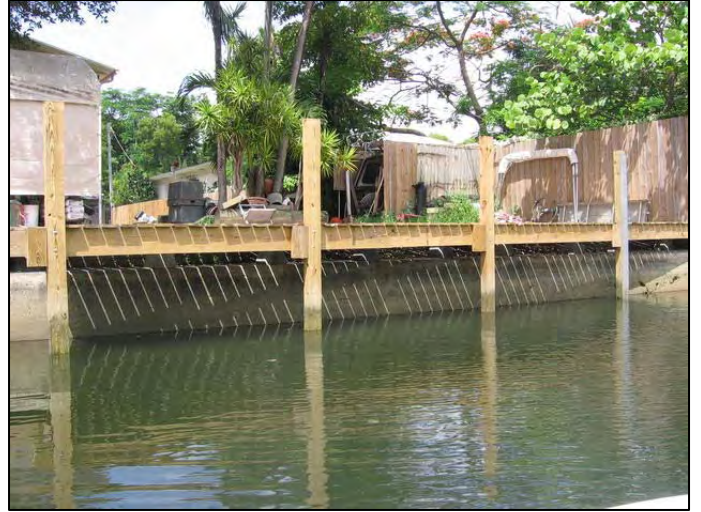
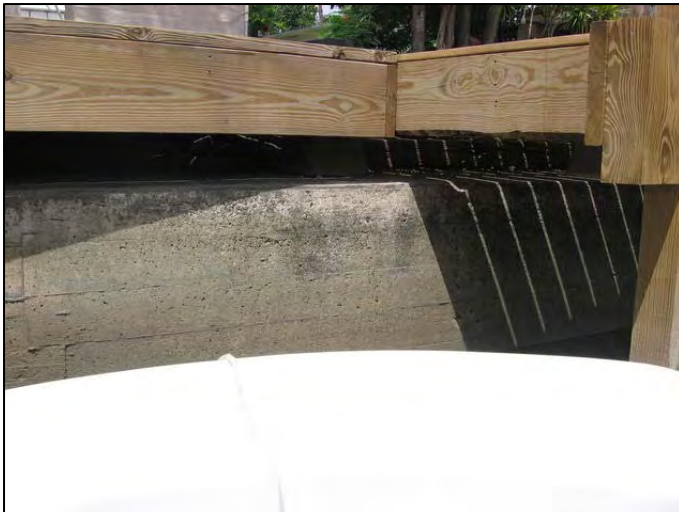
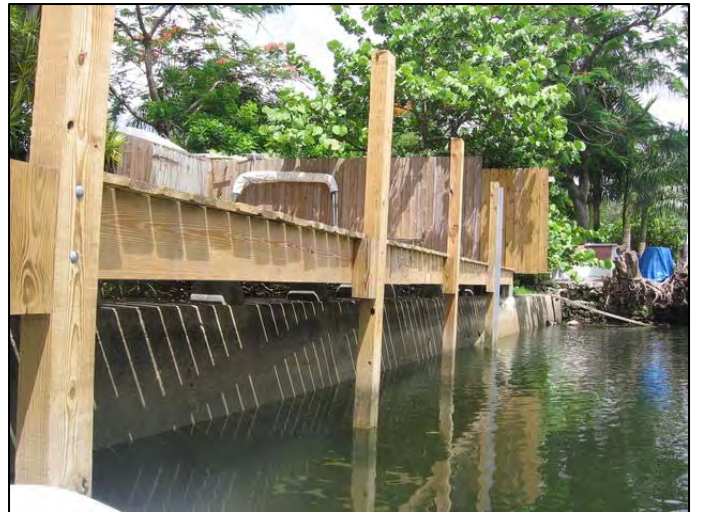
Address	925 NW 7 <sup>th</sup> St. Rd.
Folio #	0131350270730
Access Agreement	
Description	Wooden dock
Water Body	Seybold Canal
Operational Section	6
Latitude (dd.ddddd)*	25.78291
Longitude (dd.ddddd)*	-80.20912
Bank Location	West
Picture #	1139-1140, 1144-1145
Condition	Good
Damage to Structure and Picture #'s	N/A
End of Structure	N/A
End of Structure Picture #	N/A

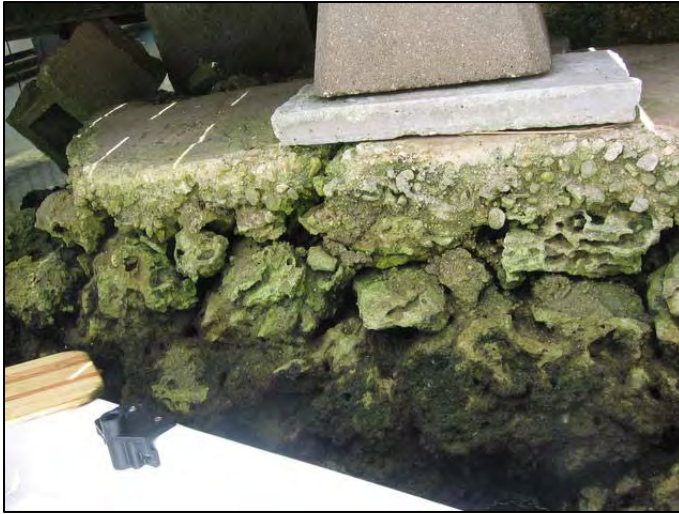
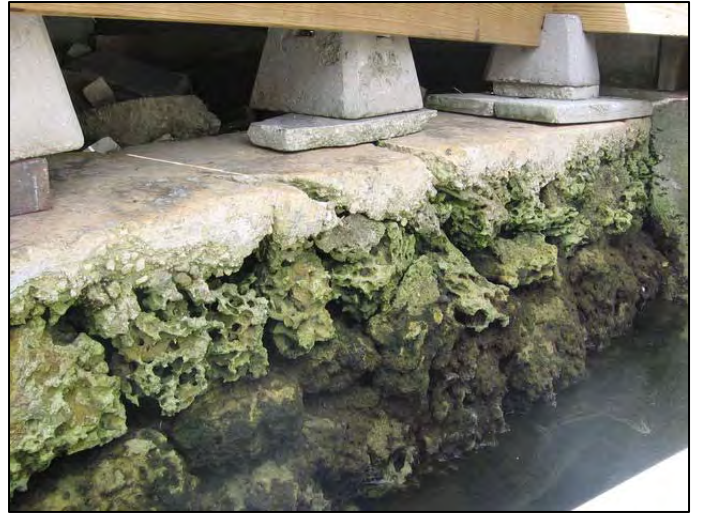
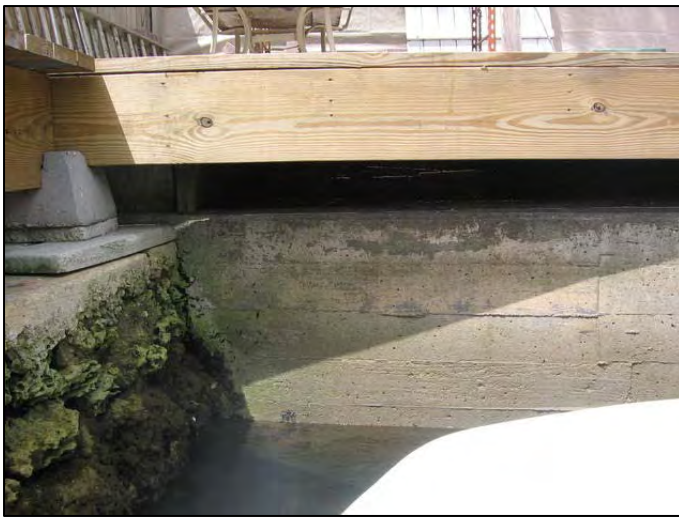
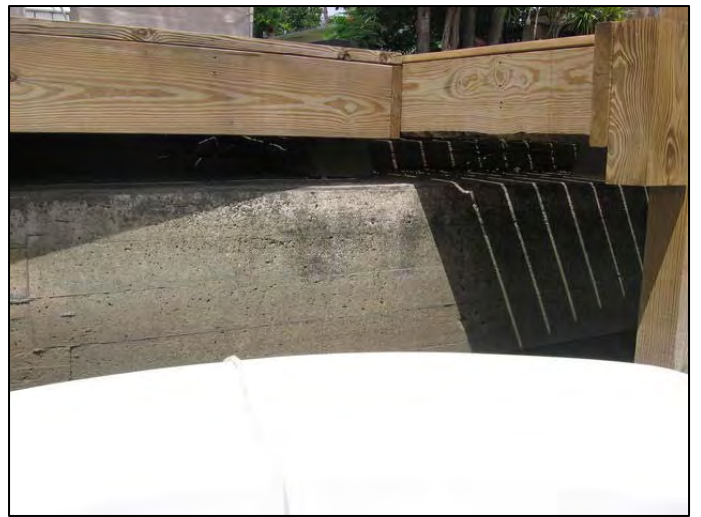
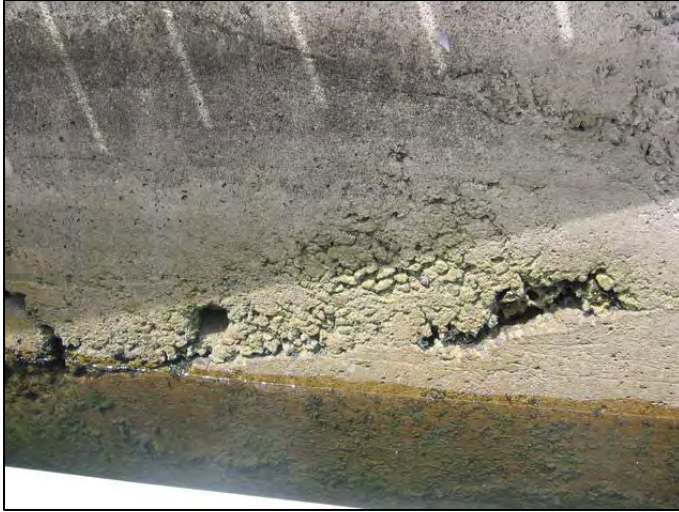
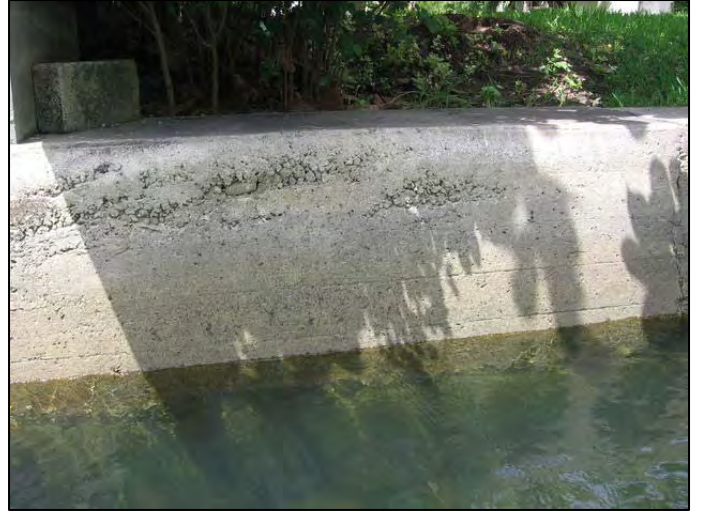
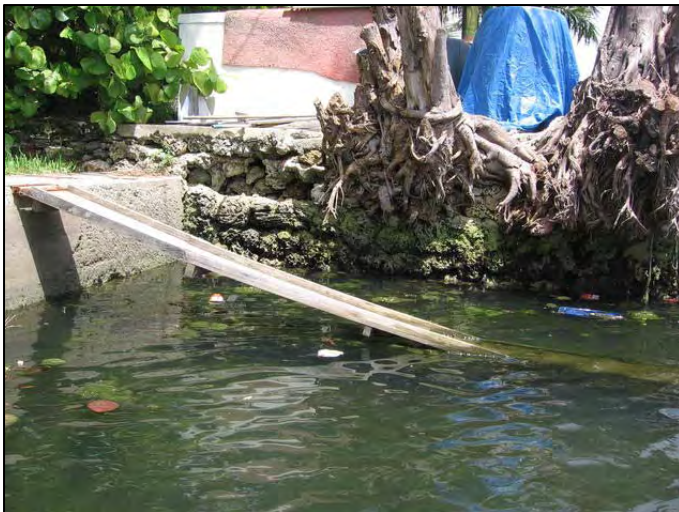
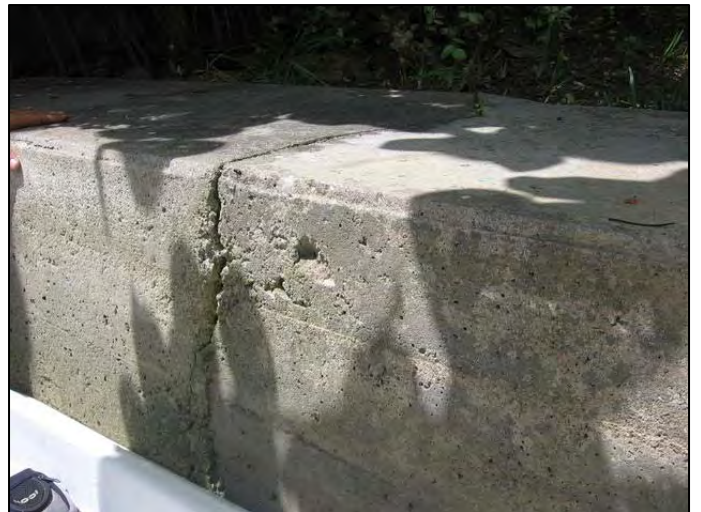
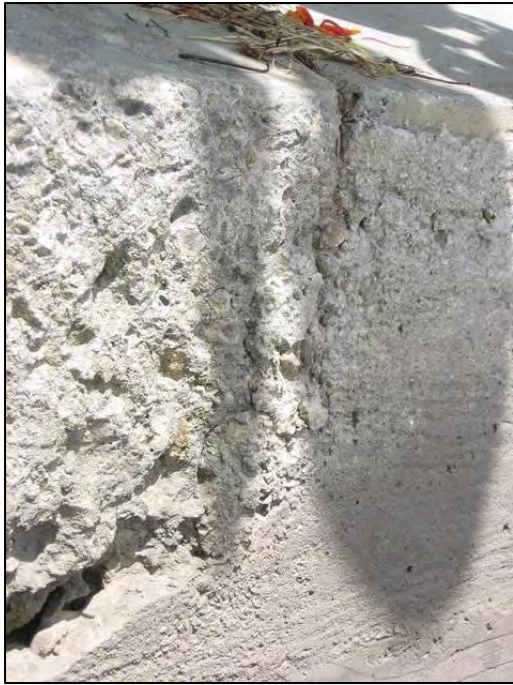
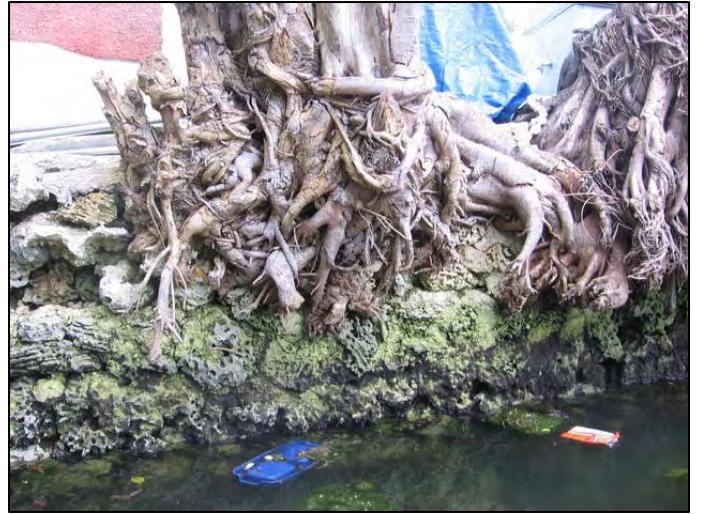
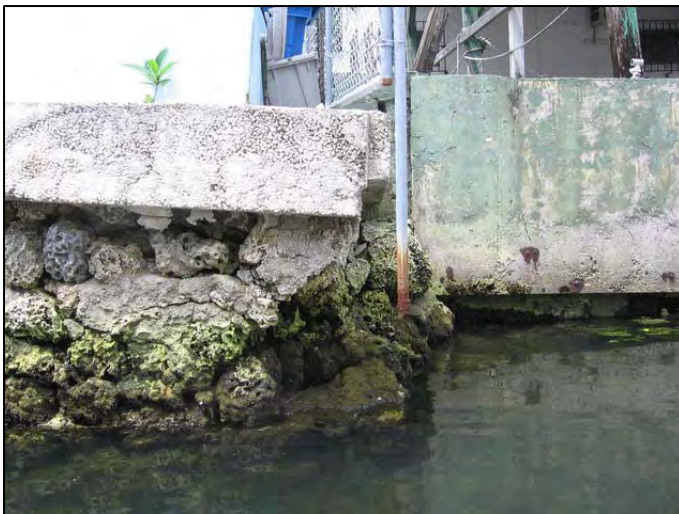
Address	925 NW 7 <sup>th</sup> St. Rd.; 935 NW 7 <sup>th</sup> St. Rd.; 945 NW 7 <sup>th</sup> St. Rd.
Folio #	0131350270730; 0131350270720; 0131350270710
Access Agreement	
Description	Coral rock and concrete seawall. Bottom of end is deteriorating.
Water Body	Seybold Canal
Operational Section	6
Latitude (dd.ddddd)*	25.78285
Longitude (dd.ddddd)*	-80.20913
Bank Location	West
Picture #	1141-1144, 1147-1148, 1151
Condition	Fair, end is Poor
Damage to Structure and Picture #'s	C-1, 1146; C-2, 1149; C-3, 1150
End of Structure	S-122
End of Structure Picture #	1155

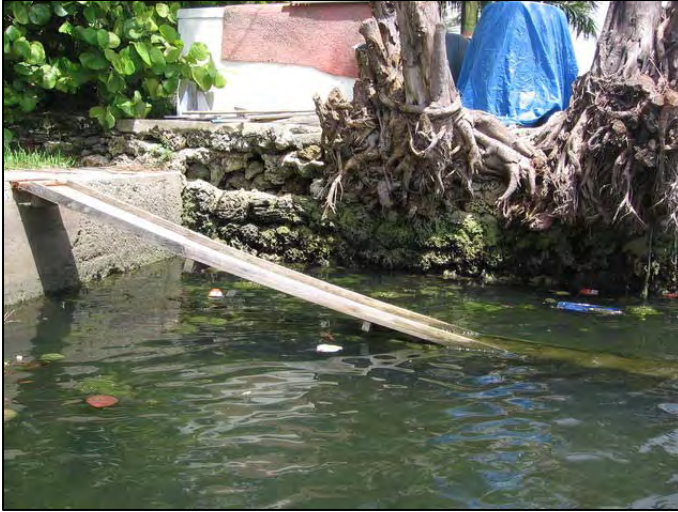
IMG\_1148

Address	935 NW 7 <sup>th</sup> St. Rd.
Folio #	0131350270720
Access Agreement	
Description	Wooden loading ramp
Water Body	Seybold Canal
Operational Section	6
Latitude (dd.ddddd)*	25.78302
Longitude (dd.ddddd)*	-80.20927
Bank Location	West
Picture #	1148
Condition	Fair
Damage to Structure and Picture #'s	N/A
End of Structure	N/A
End of Structure Picture #	N/A

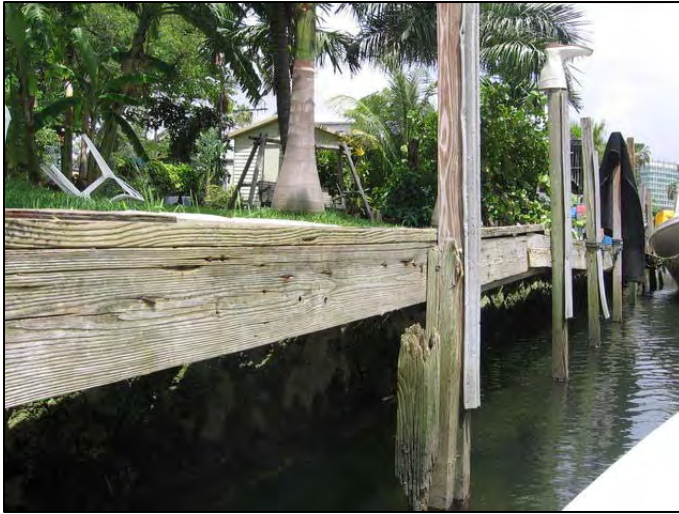
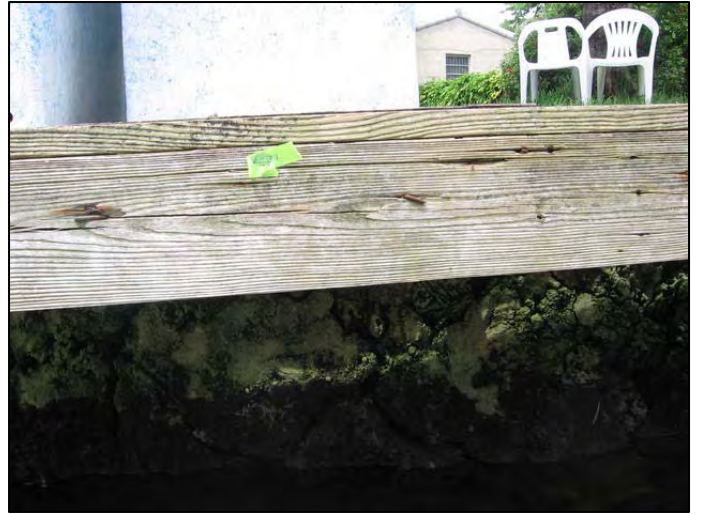
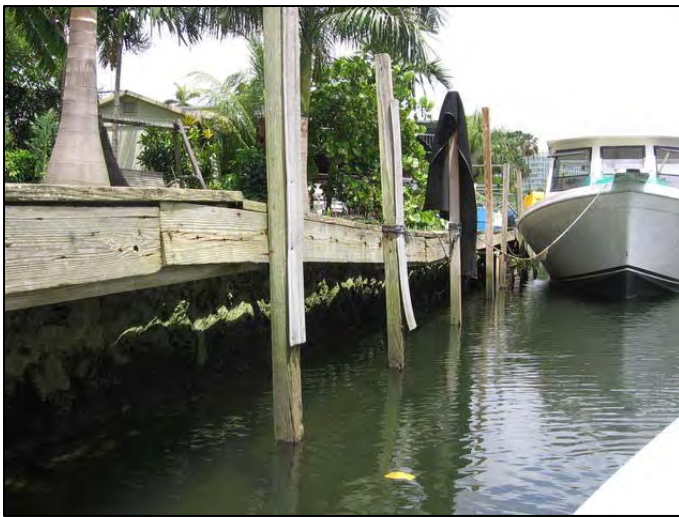
Address	945 NW 7 <sup>th</sup> St. Rd.
Folio #	0131350270710
Access Agreement	
Description	Wooden dock
Water Body	Seybold Canal
Operational Section	6
Latitude (dd.ddddd)*	25.78297
Longitude (dd.ddddd)*	-80.20925
Bank Location	West
Picture #	1152-1154
Condition	Poor
Damage to Structure and Picture #'s	N/A
End of Structure	N/A
End of Structure Picture #	N/A

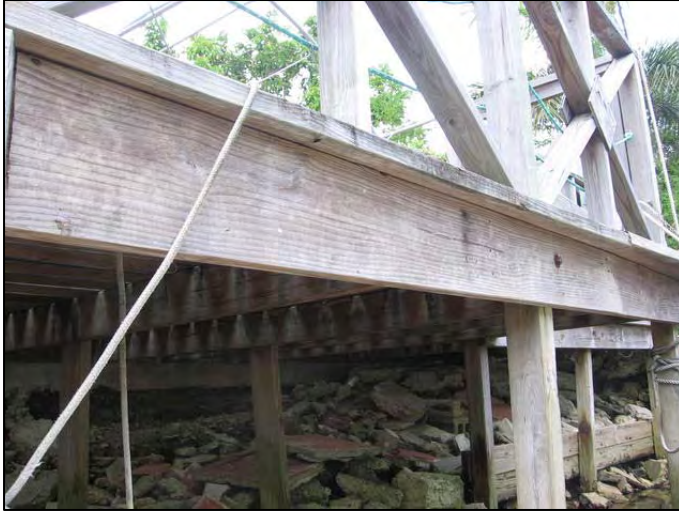
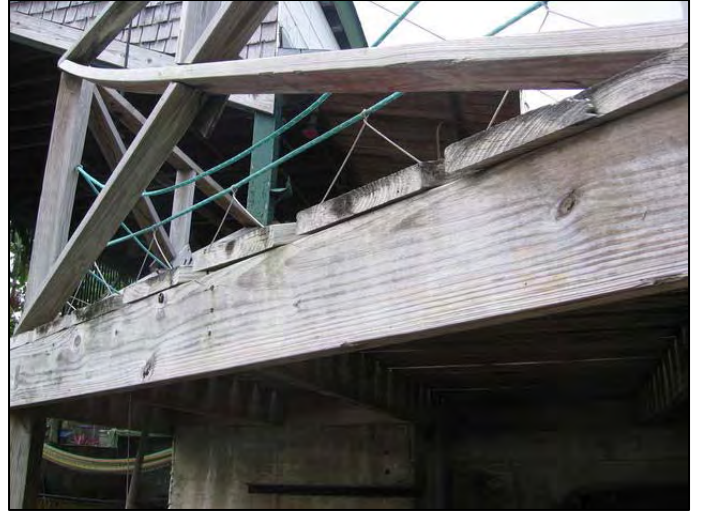
Address	951 NW 7 <sup>th</sup> St. Rd.
Folio #	0131350270700
Access Agreement	
Description	Wooden dock
Water Body	Seybold Canal
Operational Section	6
Latitude (dd.ddddd)*	25.78325
Longitude (dd.ddddd)*	-80.20949
Bank Location	West
Picture #	1157-1158
Condition	Fair
Damage to Structure and Picture #'s	N/A
End of Structure	N/A
End of Structure Picture #	N/A

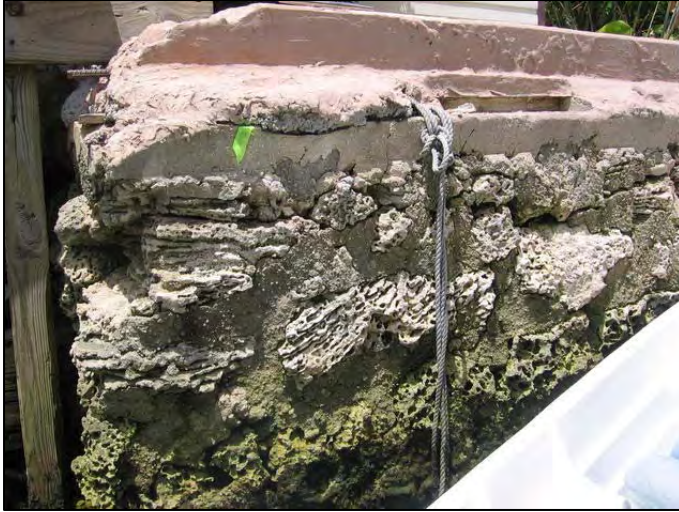
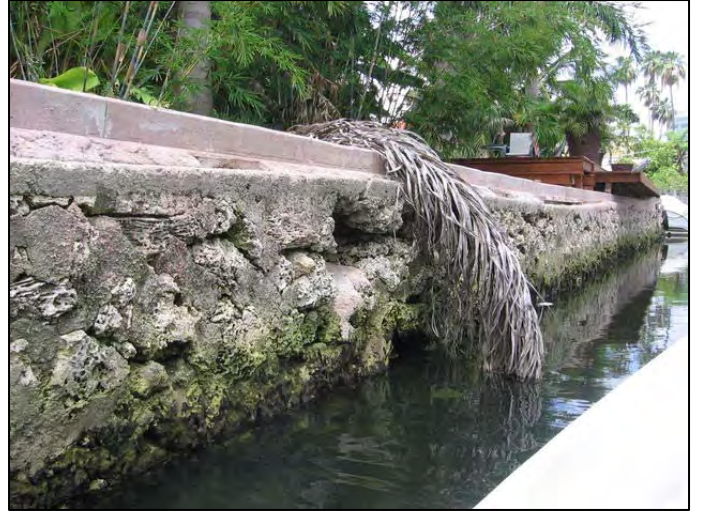
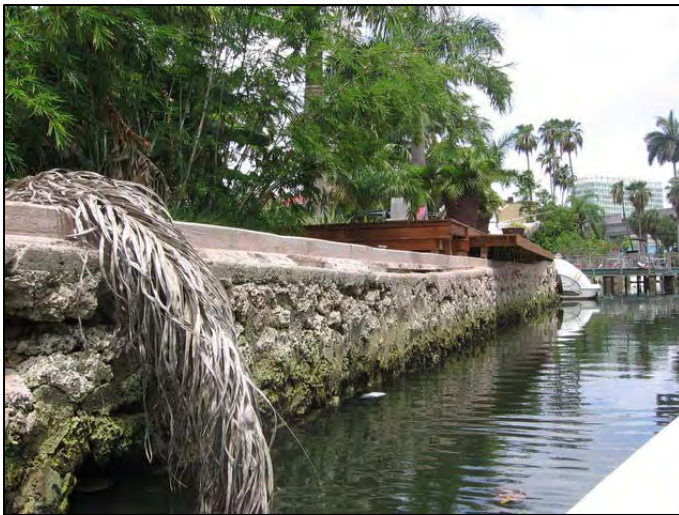
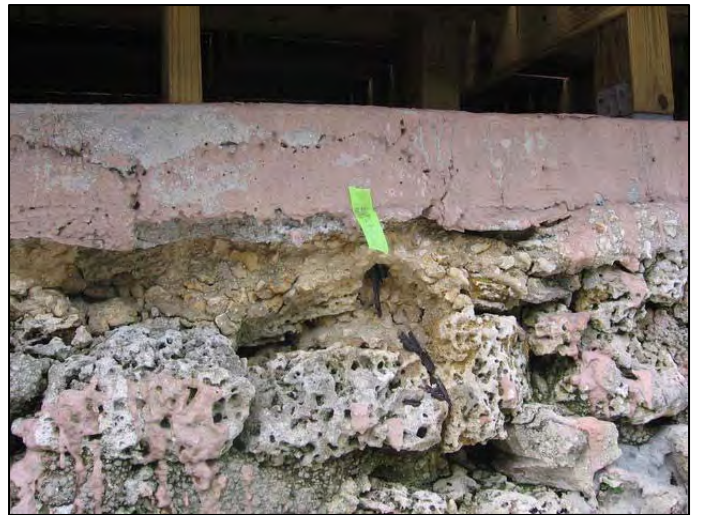
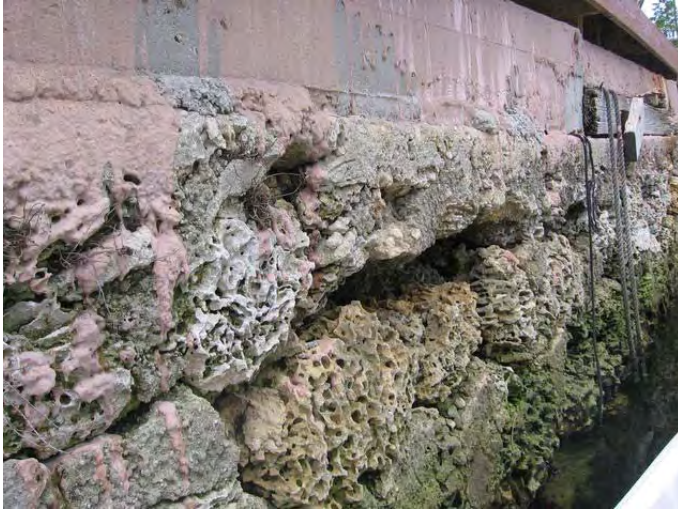
Address	951 NW 7 <sup>th</sup> St. Rd.; 965 NW 7 <sup>th</sup> St. Rd.
Folio #	0131350270700; 0131350270690
Access Agreement	
Description	Coral rock seawall with a painted concrete cap. End is highly damaged
Water Body	Seybold Canal
Operational Section	6
Latitude (dd.ddddd)*	25.78330
Longitude (dd.ddddd)*	-80.20951
Bank Location	West
Picture #	1160, 1162-1165
Condition	Fair/Poor
Damage to Structure and Picture #'s	C-1, 1161; C-2, 1163; C-3, 1164
End of Structure	S-128
End of Structure Picture #	1165

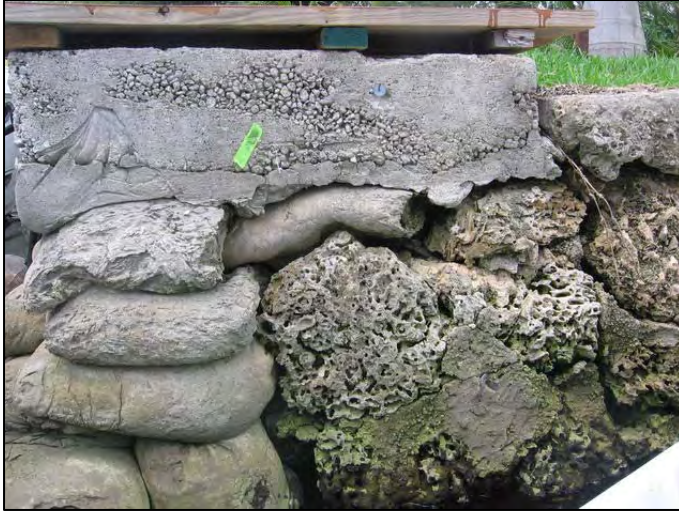
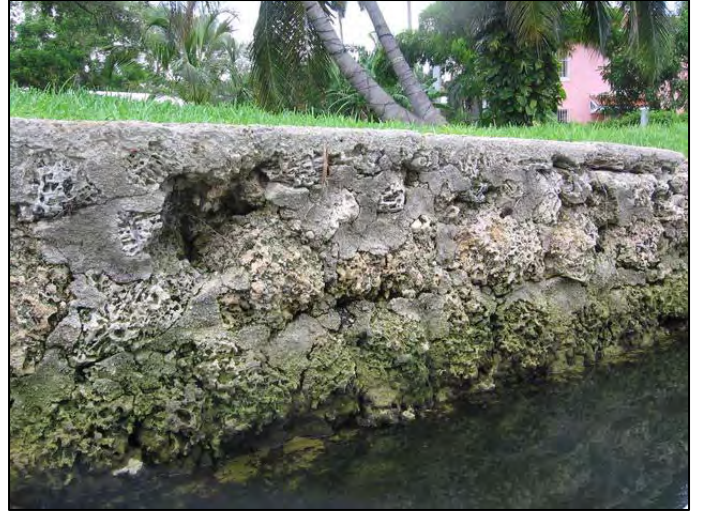
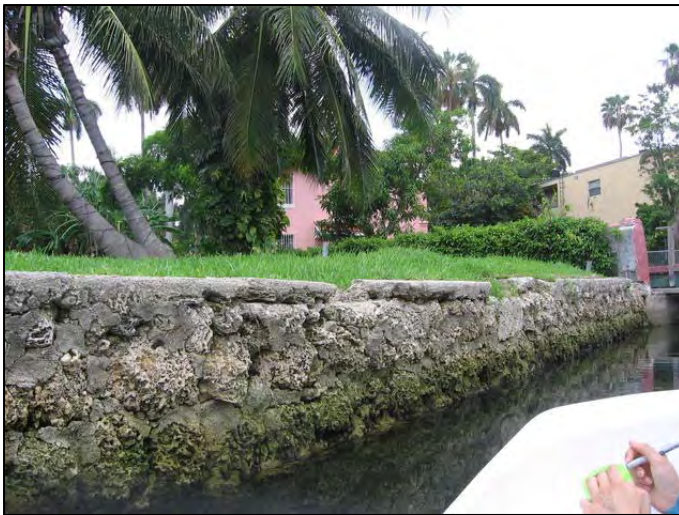
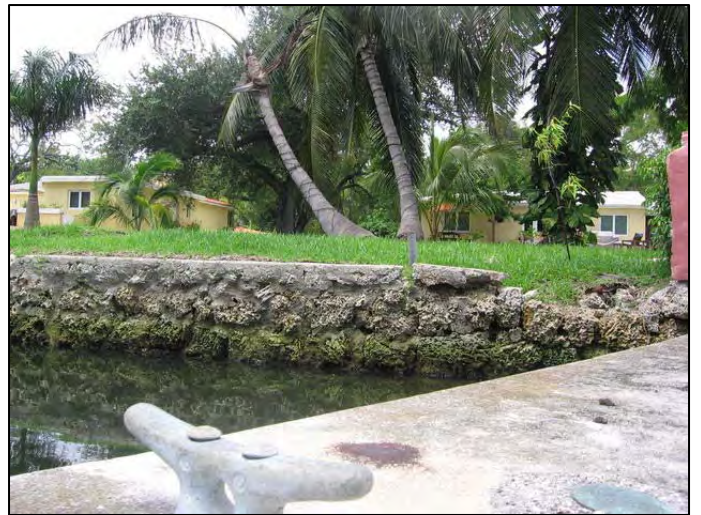
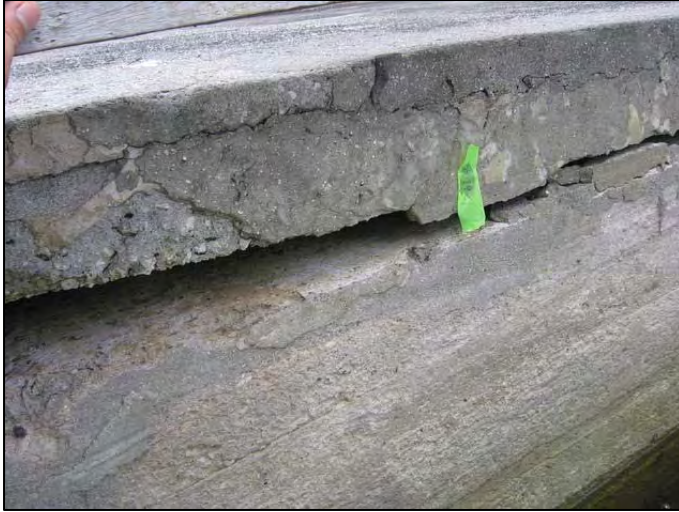
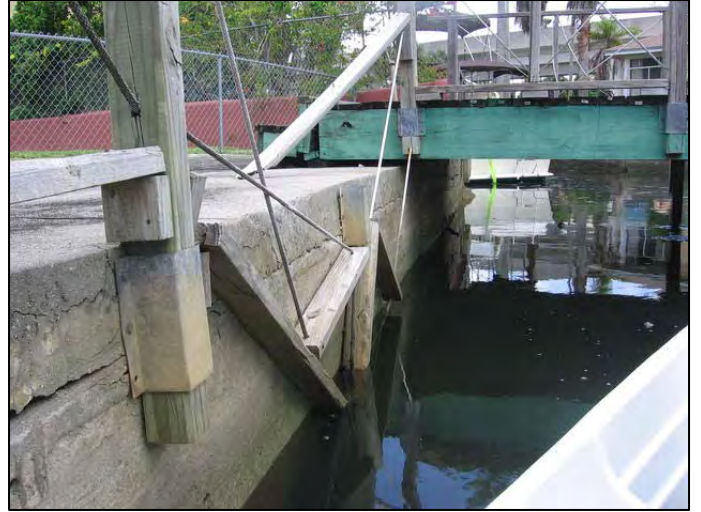
Structure S-129 Pictures

Address	965 NW 7 <sup>th</sup> St. Rd.; 975 NW 7 <sup>th</sup> St. Rd.; 1017 NW 9 <sup>th</sup> Ct.; 1099 NW 9 <sup>th</sup> Ct.
Folio #	0131350270690; 0131350270680; 0131350270670; 0131350270660
Access Agreement	
Description	Coral rock with concrete cap/concrete block seawall
Water Body	Seybold Canal
Operational Section	6
Latitude (dd.ddddd)*	25.78353
Longitude (dd.ddddd)*	-80.20969
Bank Location	West
Picture #	1167-1170, 1178-1185
Condition	Poor
Damage to Structure and Picture #'s	C-1, 1172-1173; C-2, 1175; C-3, 1176; C- 4, 1186
End of Structure	S-133
End of Structure Picture #	1185

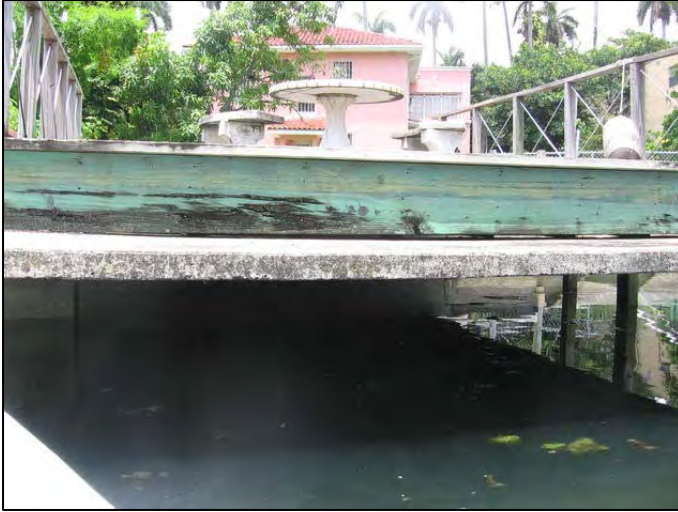
IMG\_1171

Address	1017 NW 9 <sup>th</sup> Ct.
Folio #	0131350270670
Access Agreement	
Description	Concrete dock with concrete pilings
Water Body	Seybold Canal
Operational Section	6
Latitude (dd.ddddd)*	25.78367
Longitude (dd.ddddd)*	-80.20980
Bank Location	West
Picture #	1171
Condition	Fair
Damage to Structure and Picture #'s	N/A
End of Structure	N/A
End of Structure Picture #	N/A

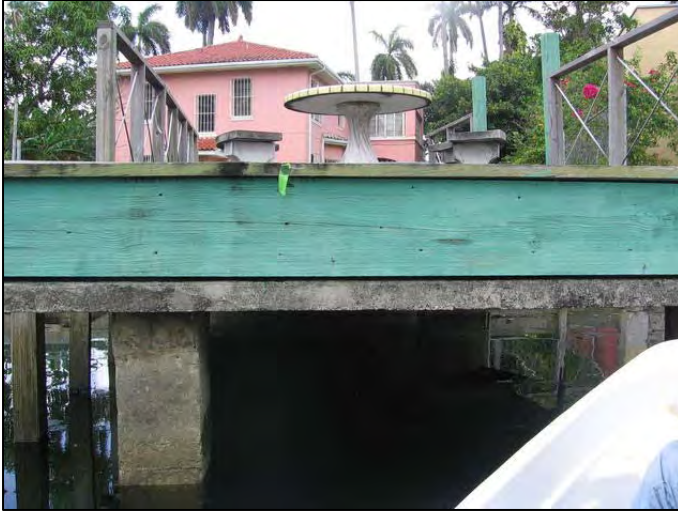
IMG\_1174

Address	1017 NW 9 <sup>th</sup> Ct.
Folio #	0131350270670
Access Agreement	
Description	Wooden dock with concrete platform and pilings.
Water Body	Seybold Canal
Operational Section	6
Latitude (dd.ddddd)*	25.78372
Longitude (dd.ddddd)*	-80.20982
Bank Location	West
Picture #	1174
Condition	Fair
Damage to Structure and Picture #'s	N/A
End of Structure	N/A
End of Structure Picture #	N/A

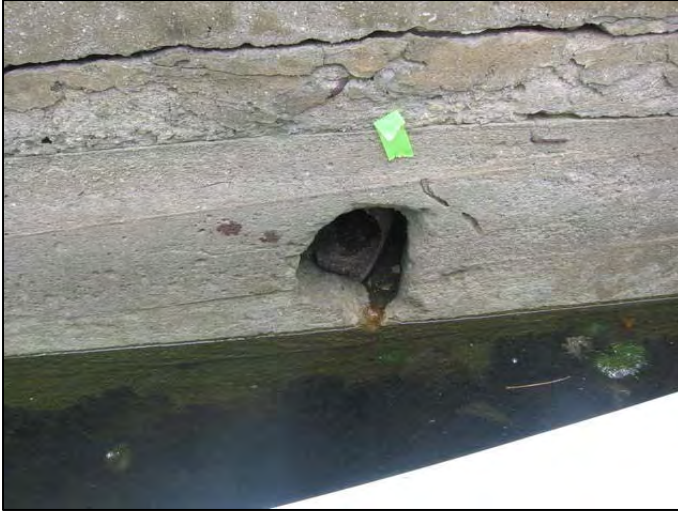
IMG\_1177

Address	1099 NW 9 <sup>th</sup> Ct.
Folio #	0131350270660
Access Agreement	
Description	6" Metal pipe
Water Body	Seybold Canal
Operational Section	6
Latitude (dd.ddddd)*	25.78375
Longitude (dd.ddddd)*	-80.20989
Bank Location	West
Picture #	1177
Condition	Poor
Damage to Structure and Picture #'s	N/A
End of Structure	N/A
End of Structure Picture #	N/A

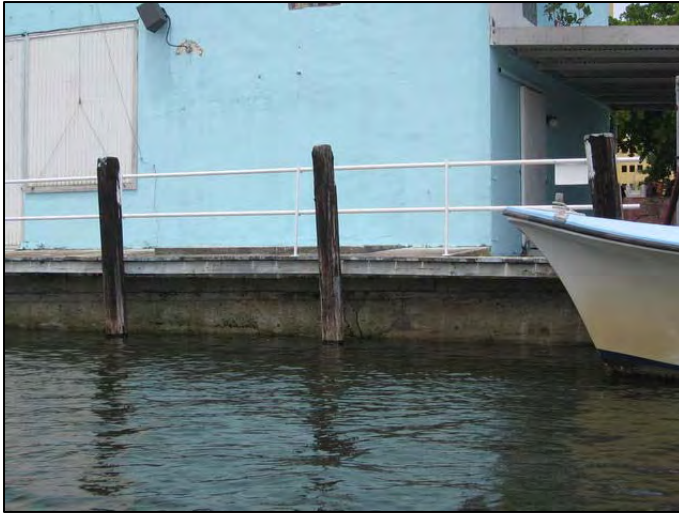
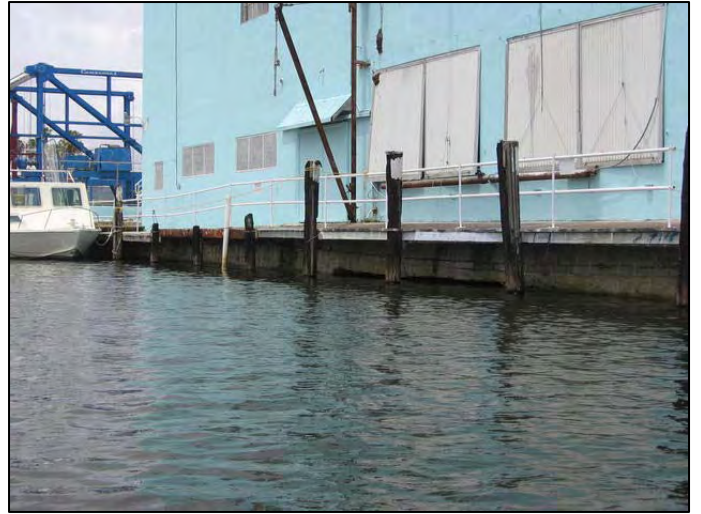
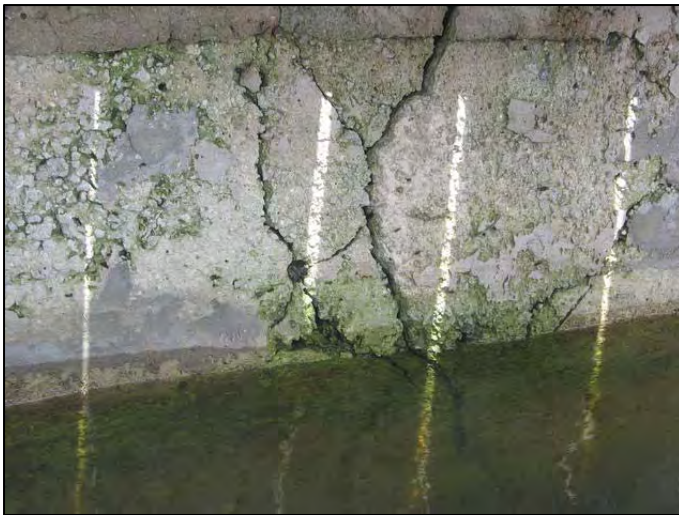
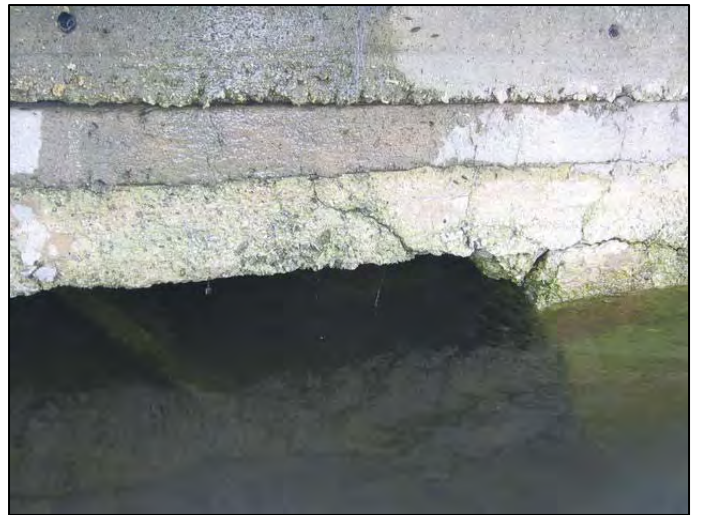
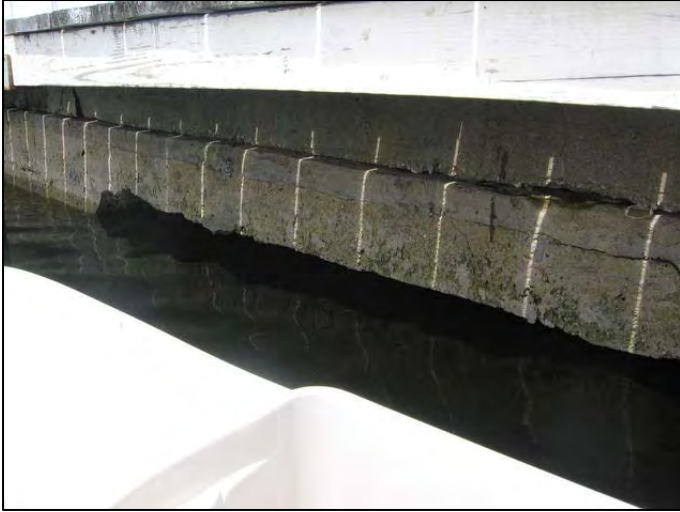
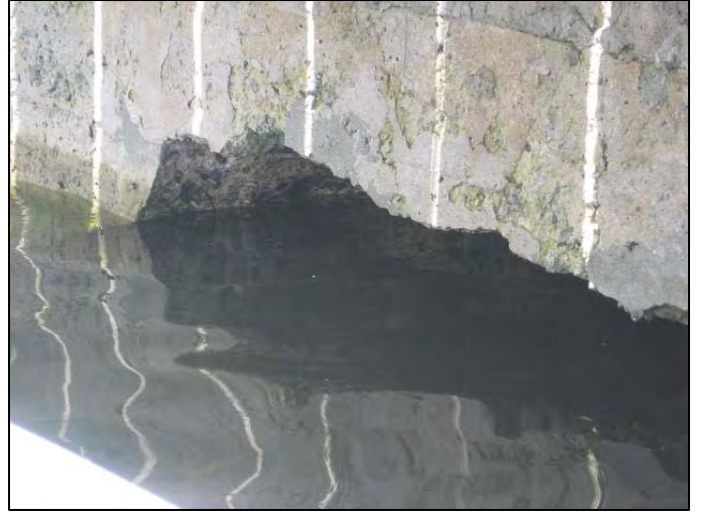
Structure S-134 Pictures

Address	528 NW 7 <sup>th</sup> Ave.; 600 NW 7 <sup>th</sup> Ave.
Folio #	0131350271410; 0131350271400
Access Agreement	
Description	Concrete seawall, with wood pilings and dock. Bottom of seawall is deteriorating.
Water Body	Seybold Canal
Operational Section	6
Latitude (dd.ddddd)*	25.77894
Longitude (dd.ddddd)*	-80.20712
Bank Location	East
Picture #	1188-1189, 1197-1201, 1203-1204
Condition	Fair
Damage to Structure and Picture #'s	C-1, 1190; C-2, 1191-1193; C-3, 1194-1196; C-4, 1202; C-5, 1205
End of Structure	S-135
End of Structure Picture #	1206
