*Corrective Action Plan - Version 2*

# Wagner Creek/Seybold Canal

Volume 2 — Appendices G through I

Submitted to  
City of Miami

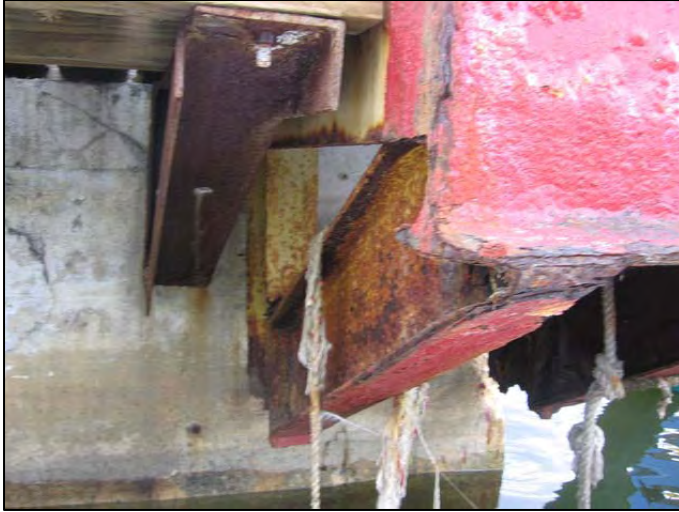
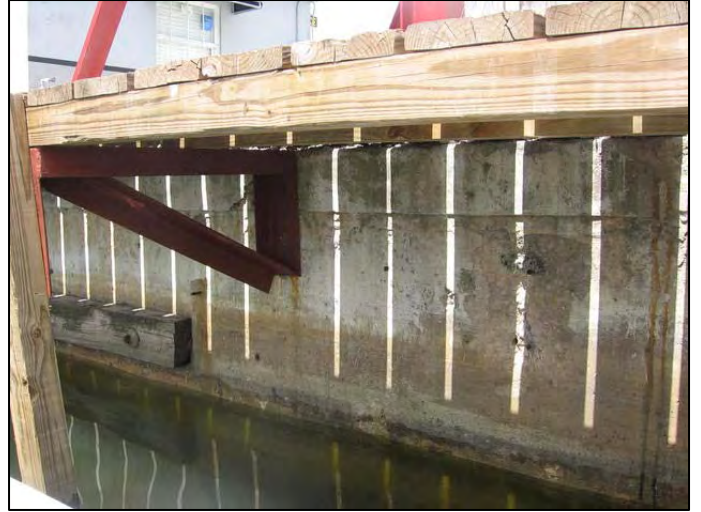
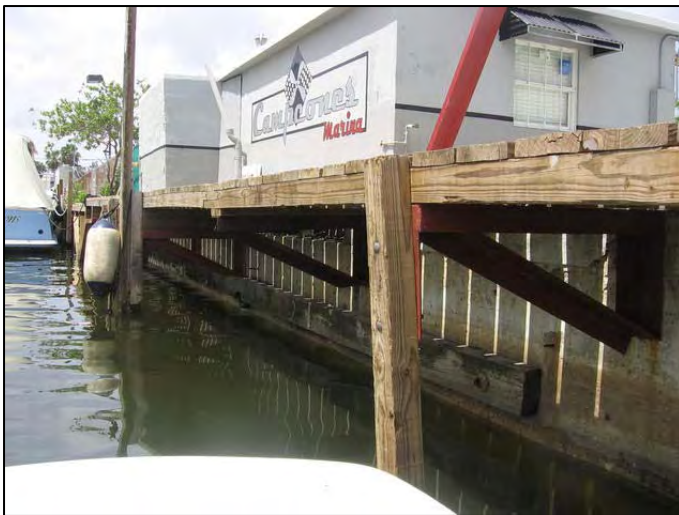
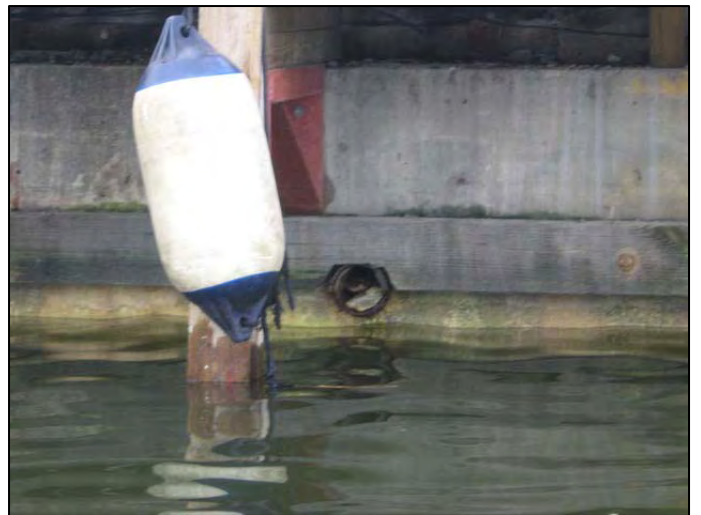
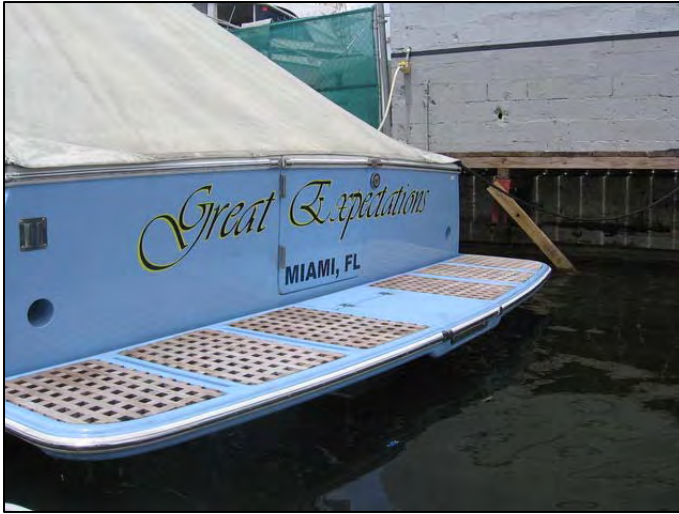
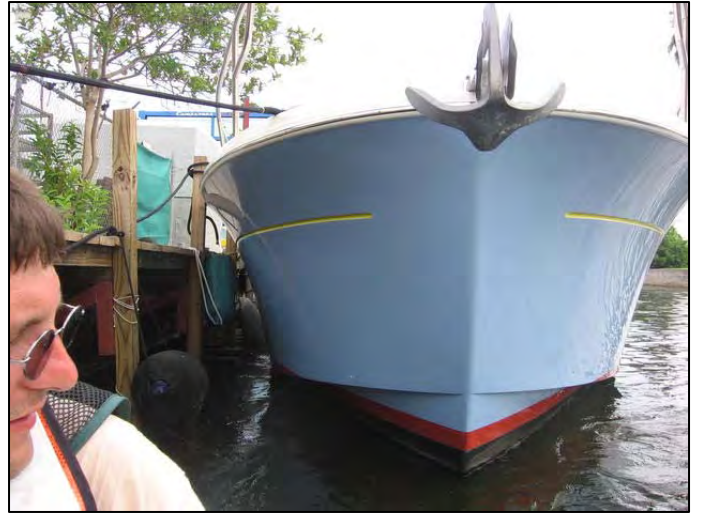
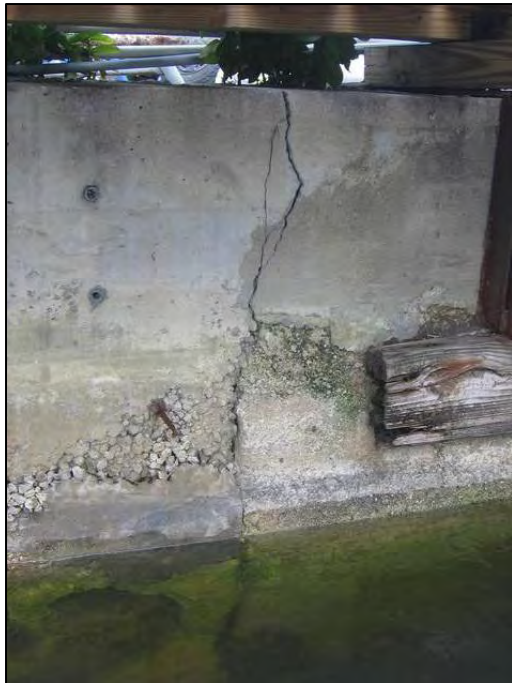
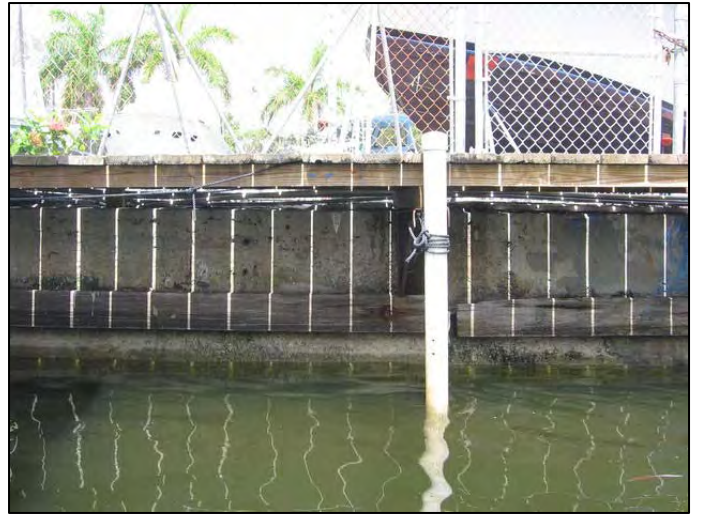
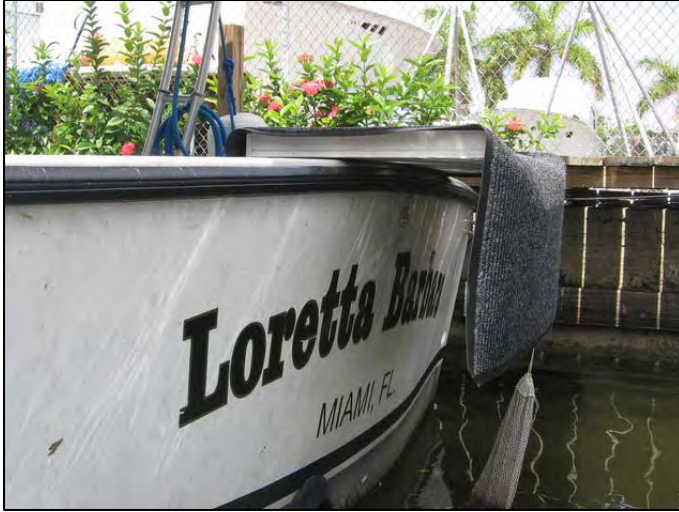
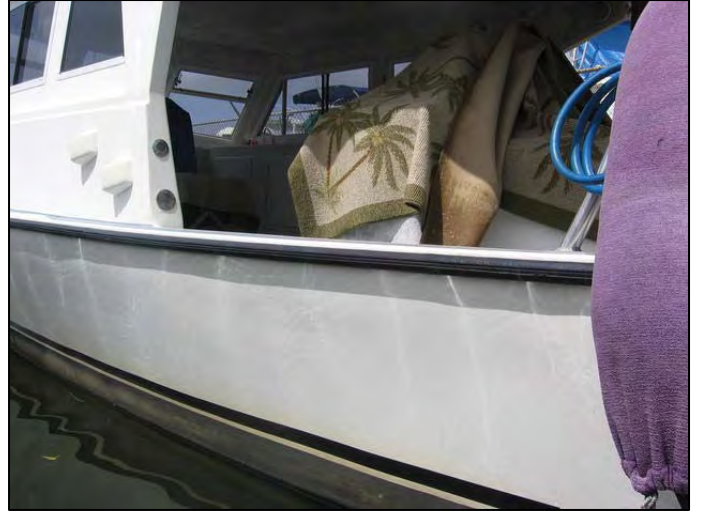
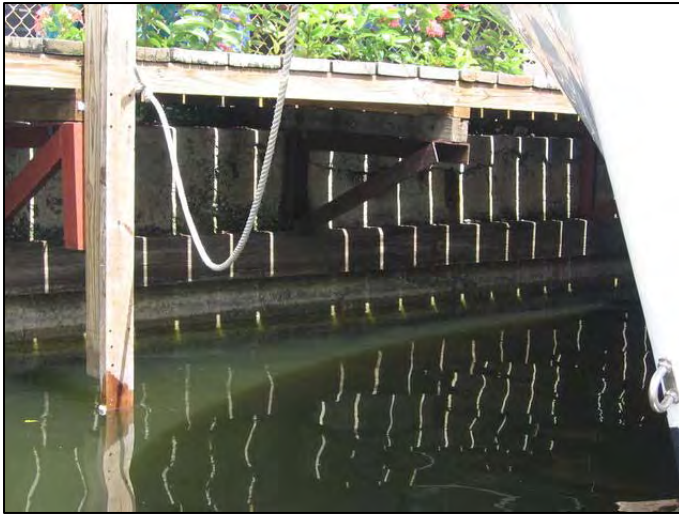
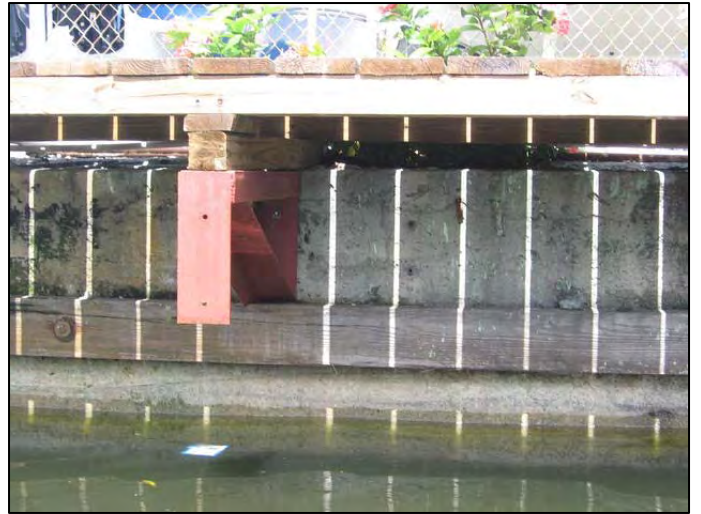
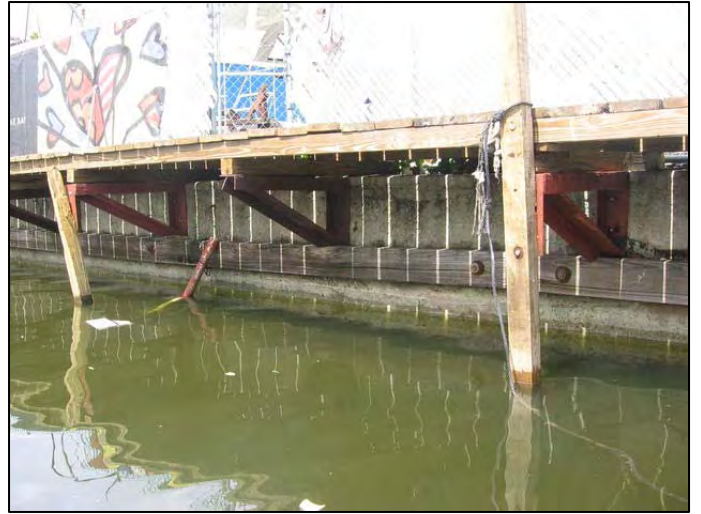
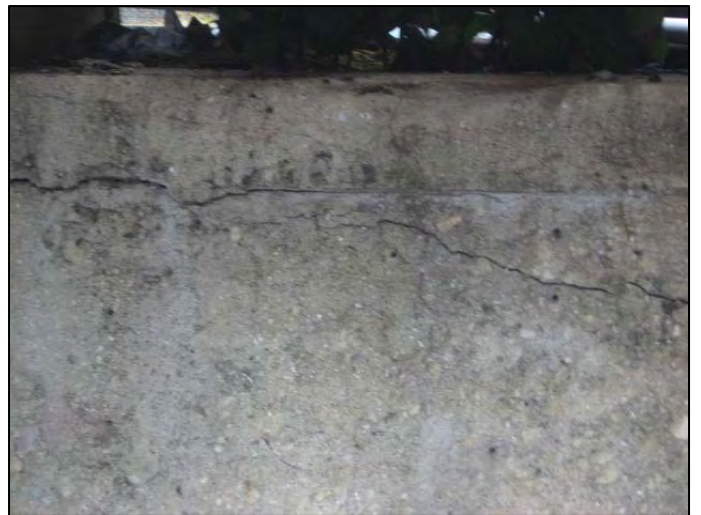
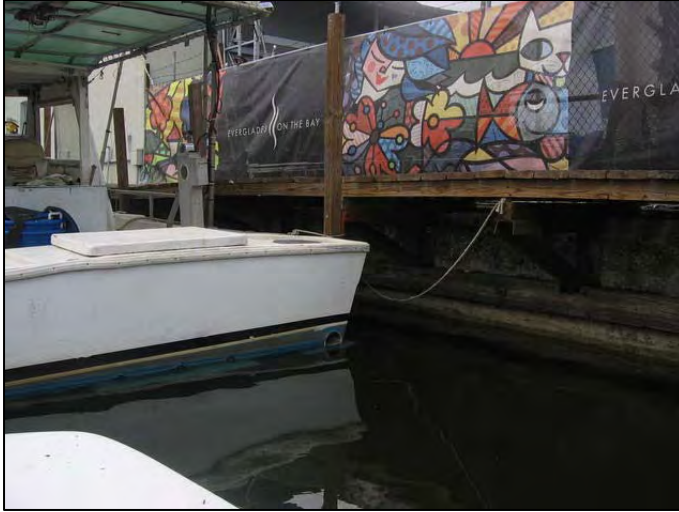
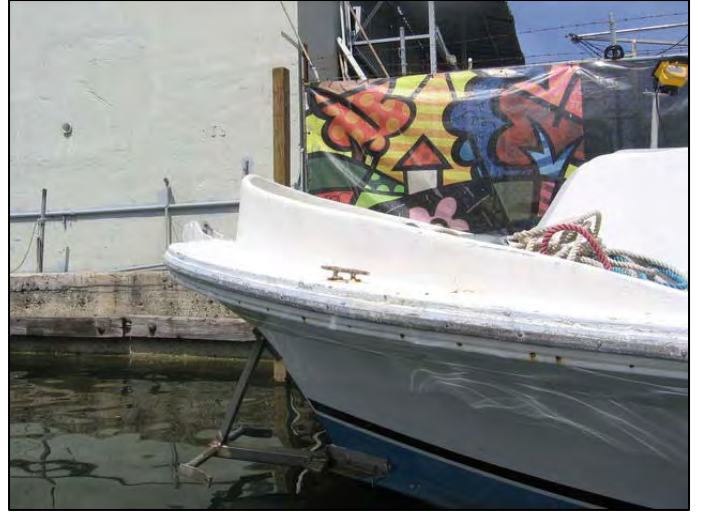
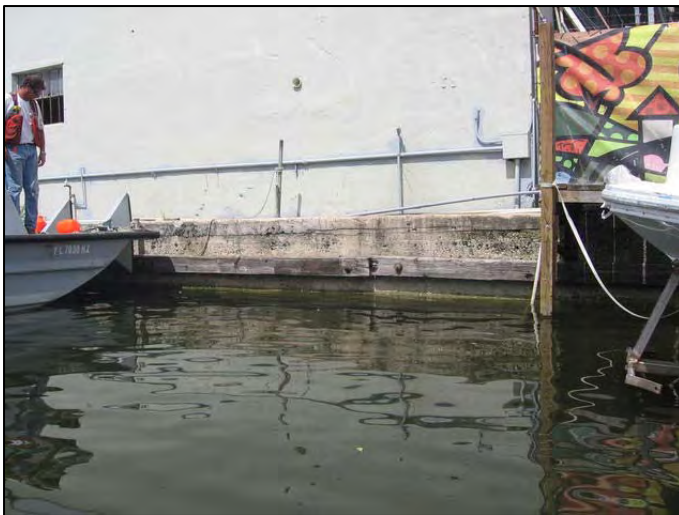
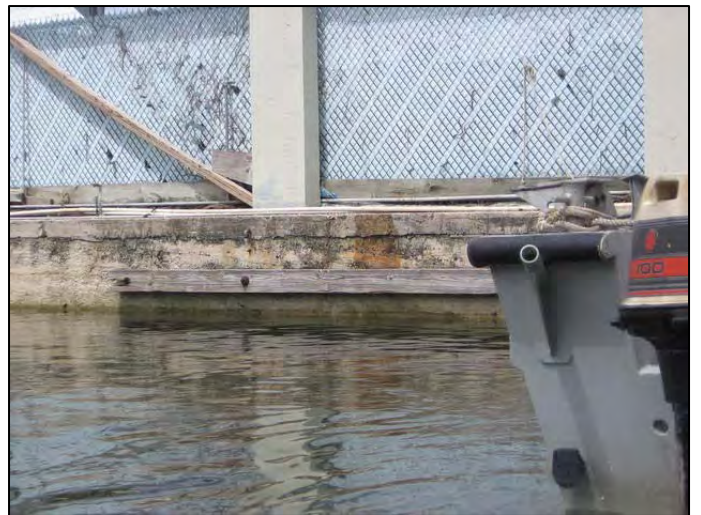
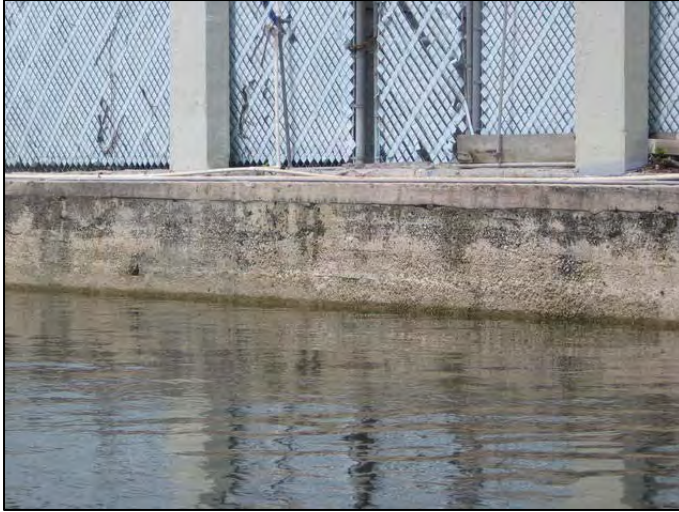
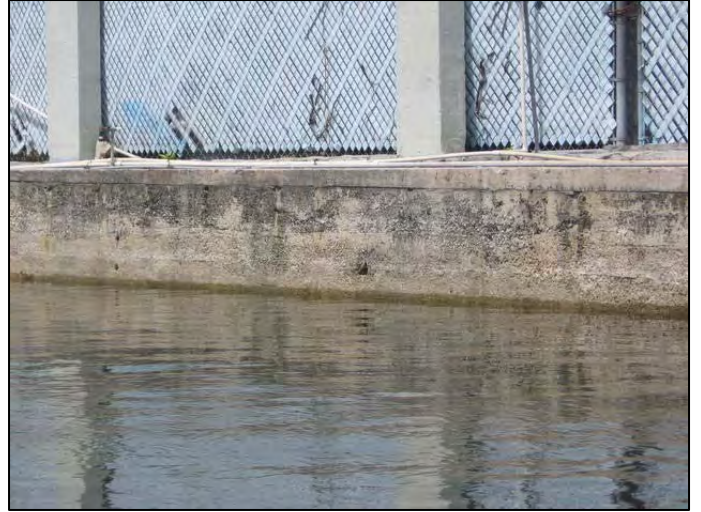
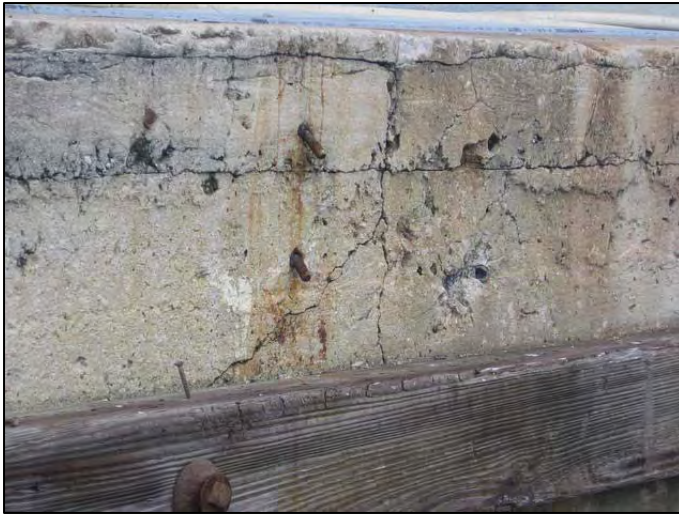
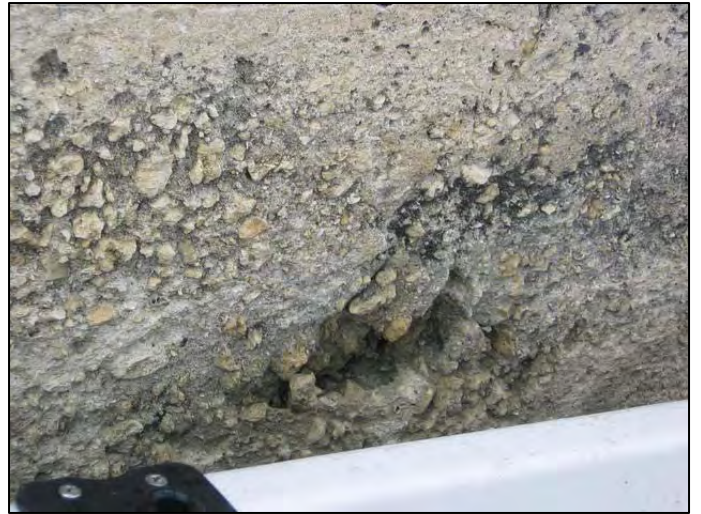
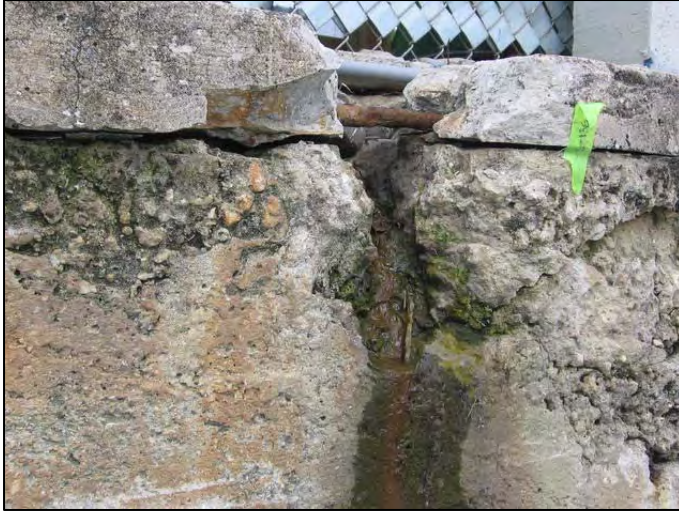
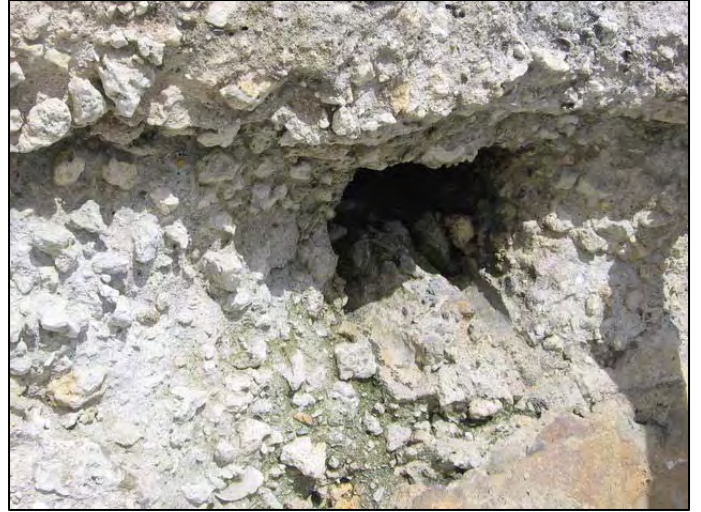
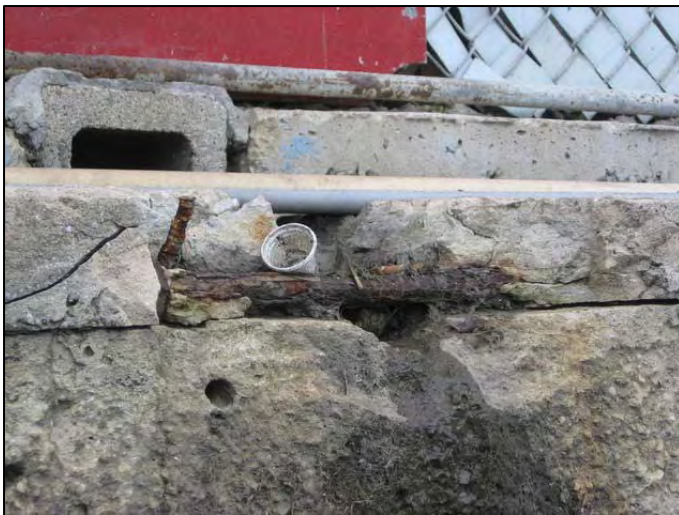
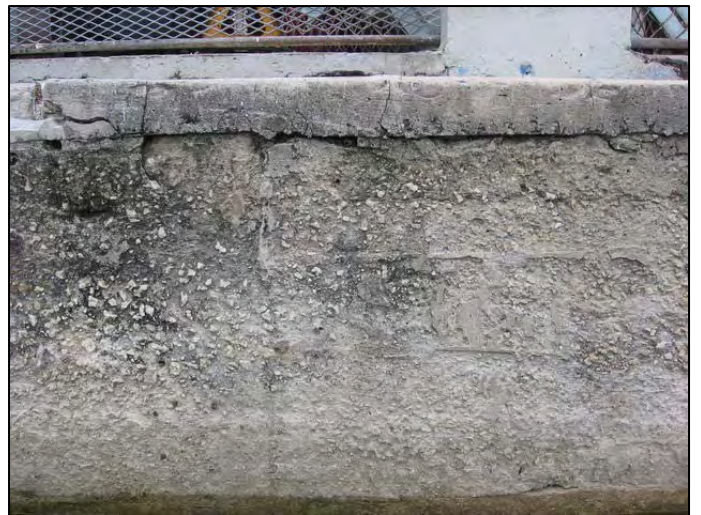
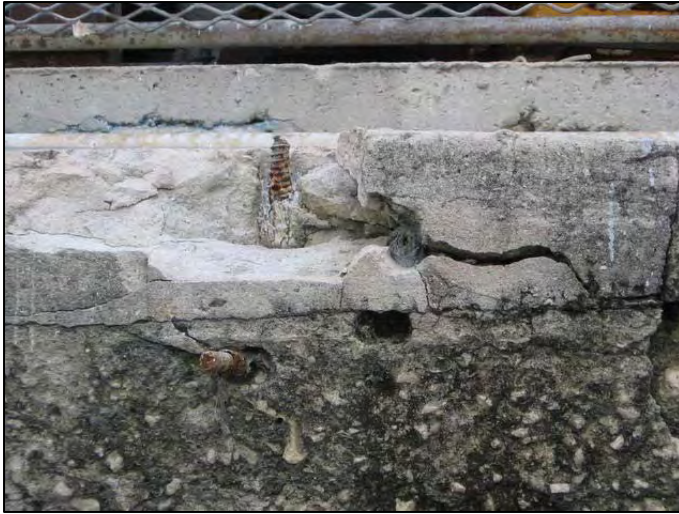
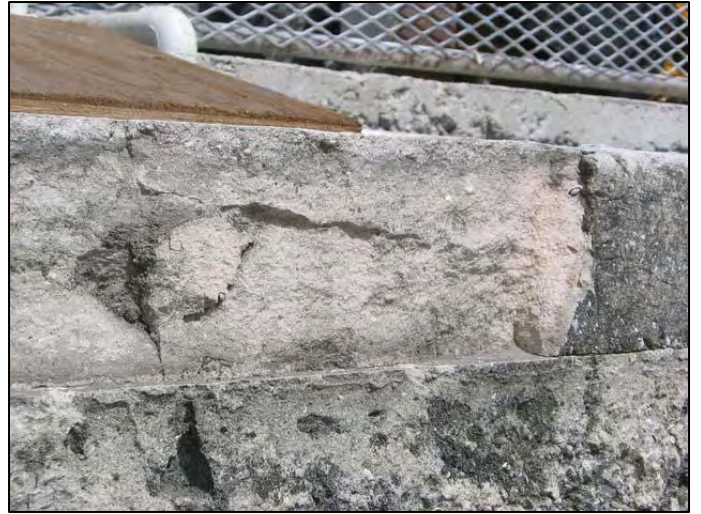
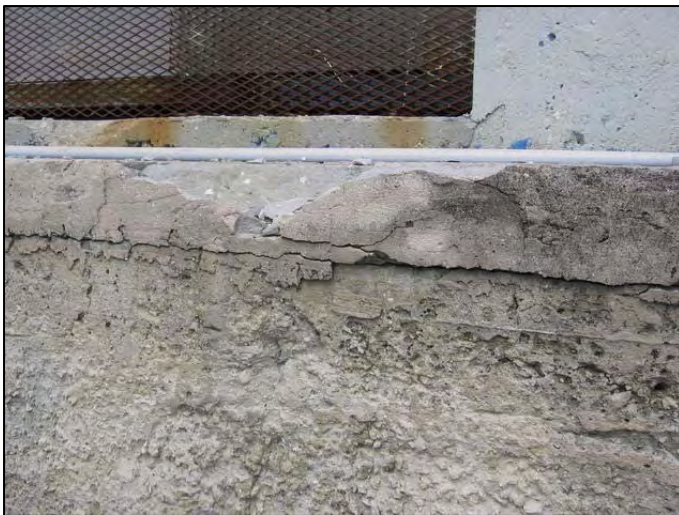
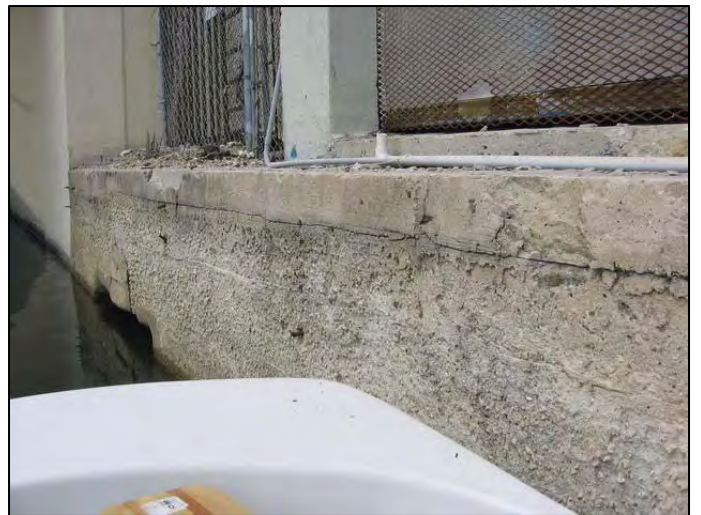
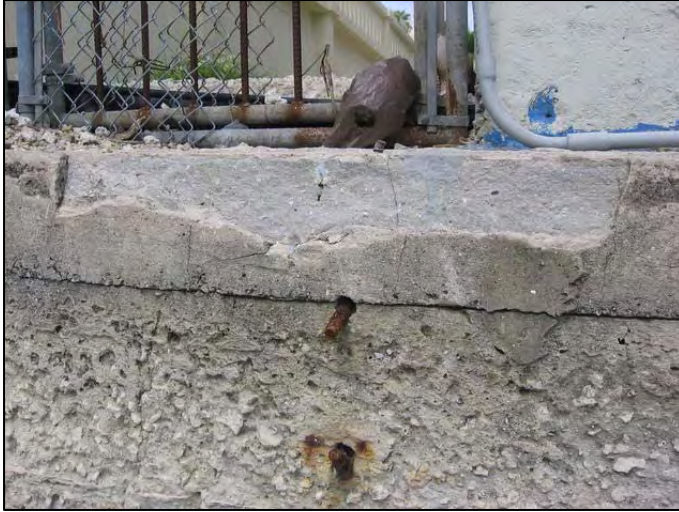
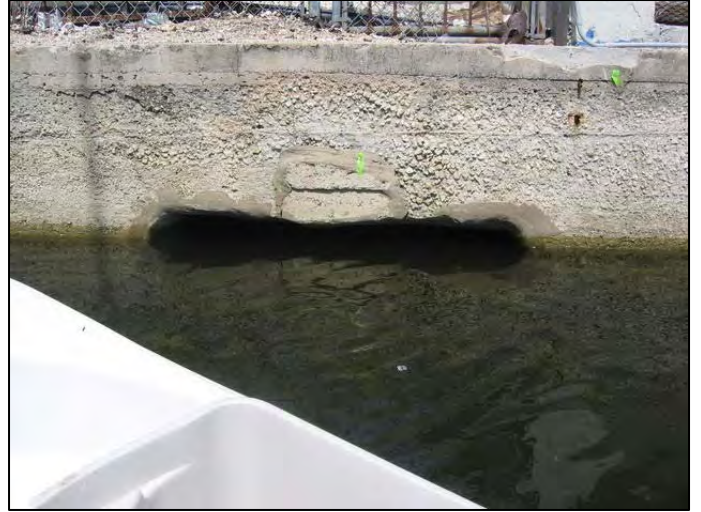
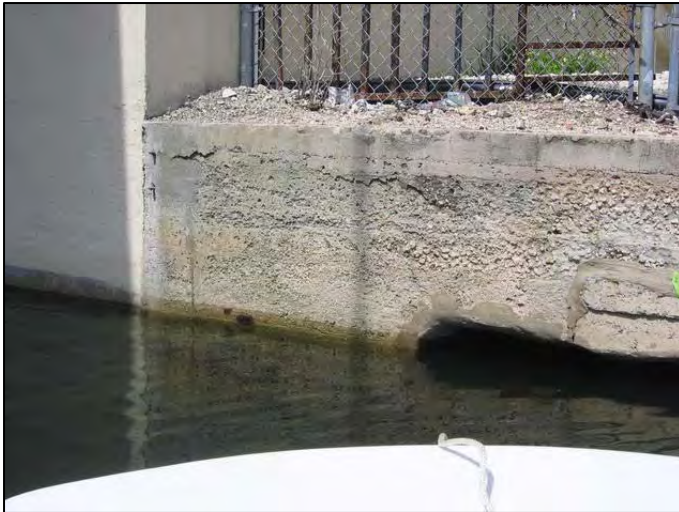
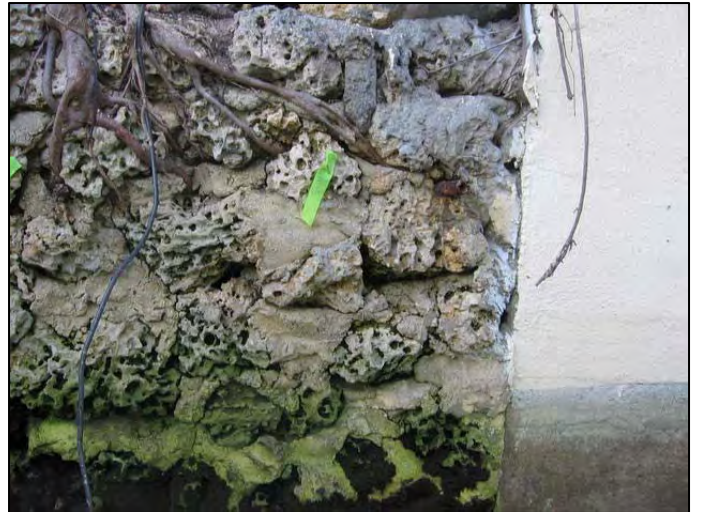
Structure S-136 Pictures

Address	600 NW 7 <sup>th</sup> Ave.
Folio #	0131350271400
Access Agreement	
Description	Concrete seawall
Water Body	Seybold Canal
Operational Section	6
Latitude (dd.ddddd)*	25.77943
Longitude (dd.ddddd)*	-80.20719
Bank Location	East
Picture #	1208, 1210-1214, 1216-1223, 1225-1230, 1237, 1241
Condition	Fair
Damage to Structure and Picture #'s	C-1, 1215; C-2, 1224; C-3, 1231; C-4, 1232; C-5, 1233; C-6, 1234; C-7, 1236; C-8, 1238; C-9, 1239; C-10, 1240; C-11, 1242; C-12, 1243
End of Structure	S-140
End of Structure Picture #	1244

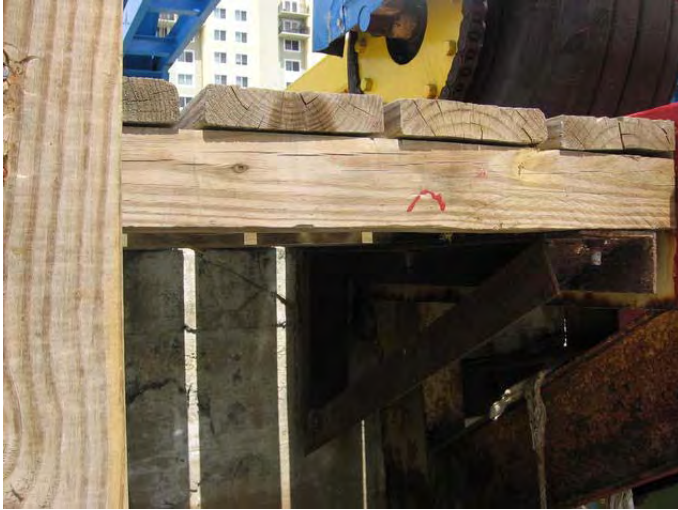
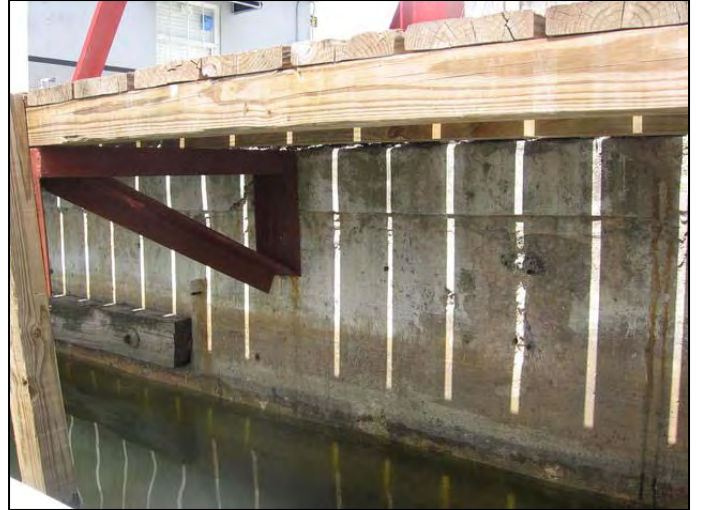
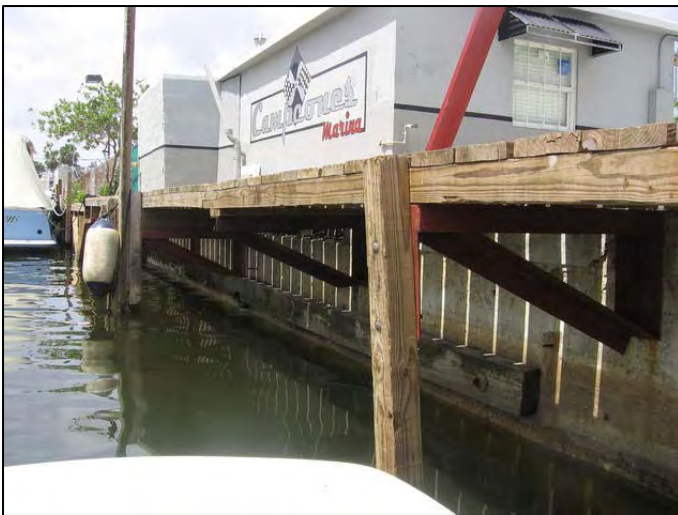
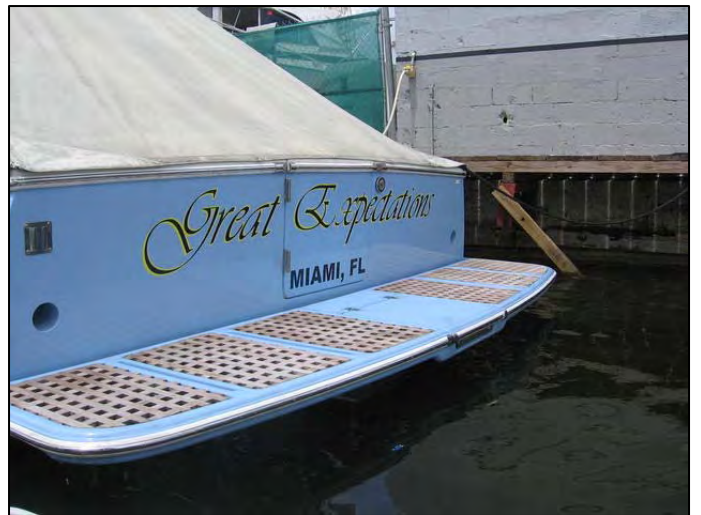
Structure S-137 Pictures

Address	600 NW 7 <sup>th</sup> Ave.
Folio #	0131350271400
Access Agreement	
Description	Wooden dock
Water Body	Seybold Canal
Operational Section	6
Latitude (dd.ddddd)*	25.77943
Longitude (dd.ddddd)*	-80.20719
Bank Location	East
Picture #	1209-1211, 1213-1214, 1216-1217, 1219-1223, 1225-1226
Condition	Fair
Damage to Structure and Picture #'s	N/A
End of Structure	N/A
End of Structure Picture #	N/A

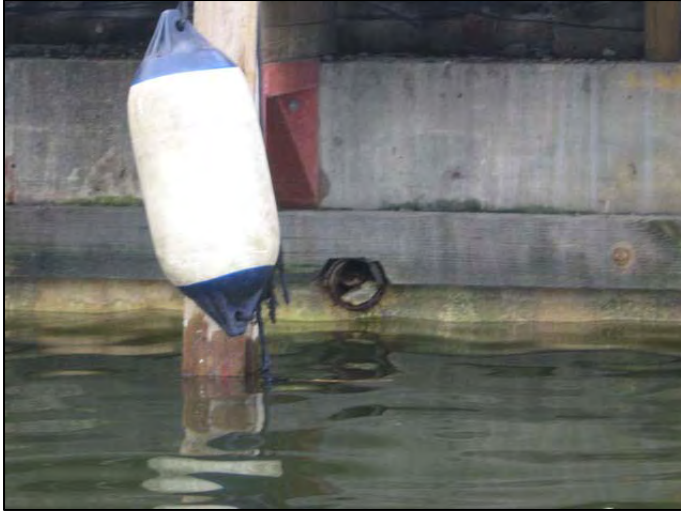
IMG\_1212

Address	600 NW 7 <sup>th</sup> Ave.
Folio #	0131350271400
Access Agreement	
Description	Metal pipe
Water Body	Seybold Canal
Operational Section	6
Latitude (dd.ddddd)*	25.77946
Longitude (dd.ddddd)*	-80.20713
Bank Location	East
Picture #	1212
Condition	Poor
Damage to Structure and Picture #'s	N/A
End of Structure	N/A
End of Structure Picture #	N/A

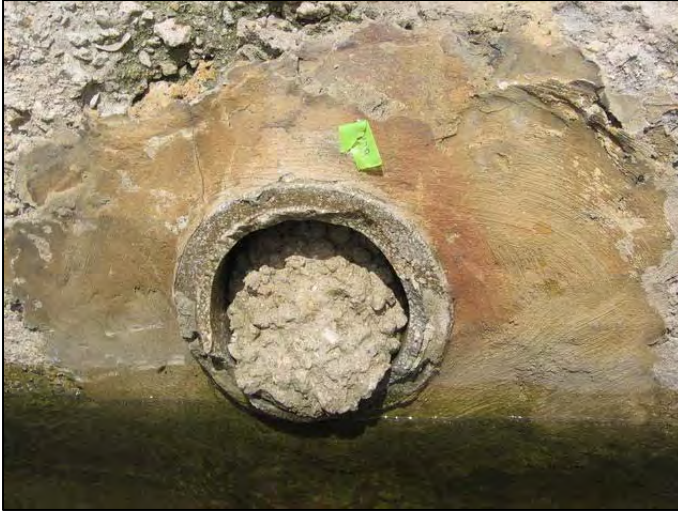
IMG\_1235

Address	600 NW 7 <sup>th</sup> Ave.
Folio #	0131350271400
Access Agreement	
Description	Sealed 12" concrete pipe
Water Body	Seybold Canal
Operational Section	6
Latitude (dd.ddddd)*	25.78029
Longitude (dd.ddddd)*	-80.20708
Bank Location	East
Picture #	1235
Condition	Fair
Damage to Structure and Picture #'s	N/A
End of Structure	N/A
End of Structure Picture #	N/A

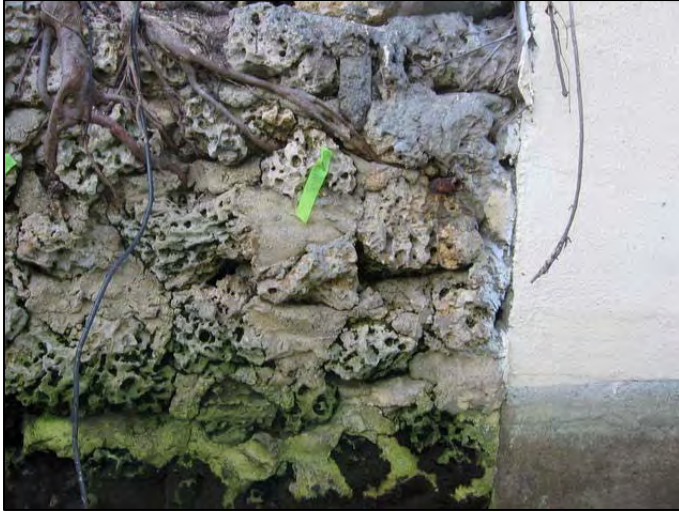
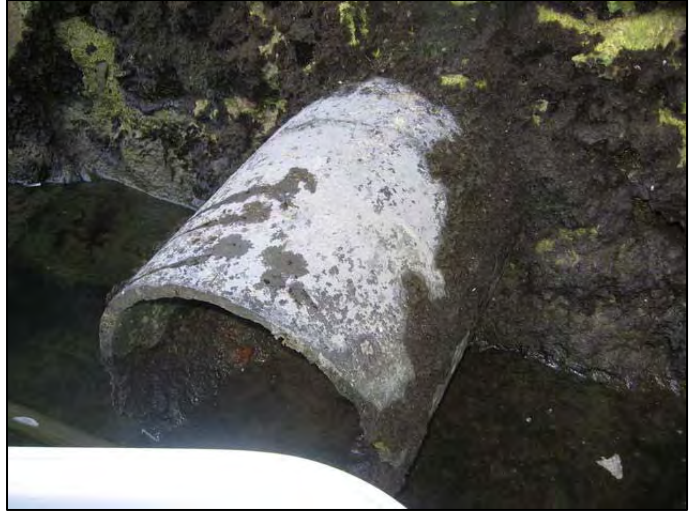
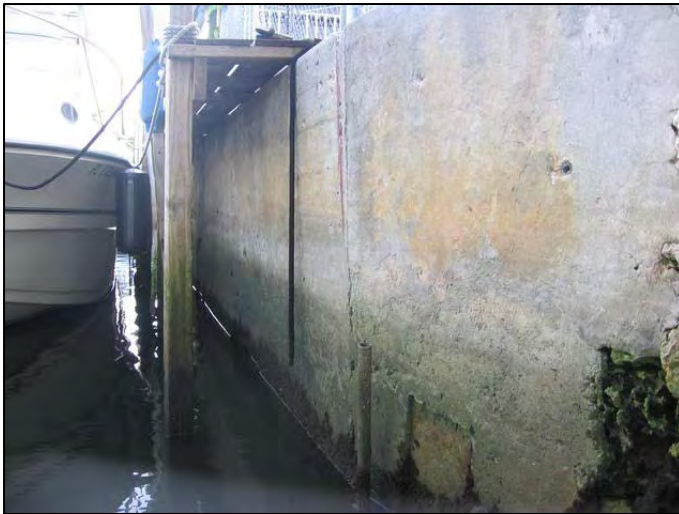
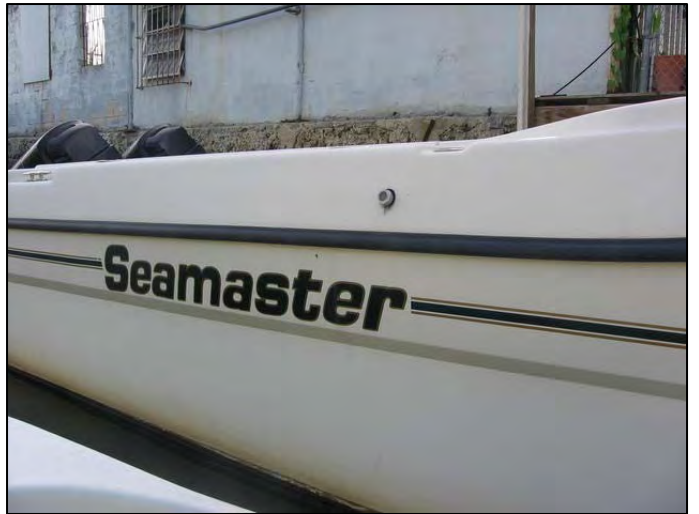
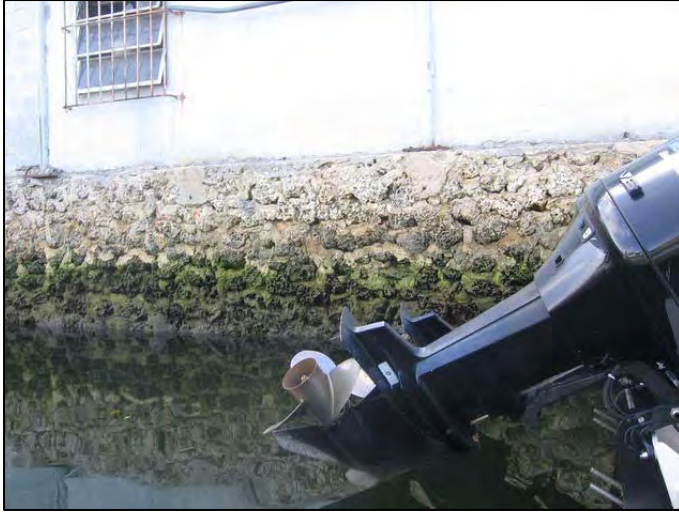
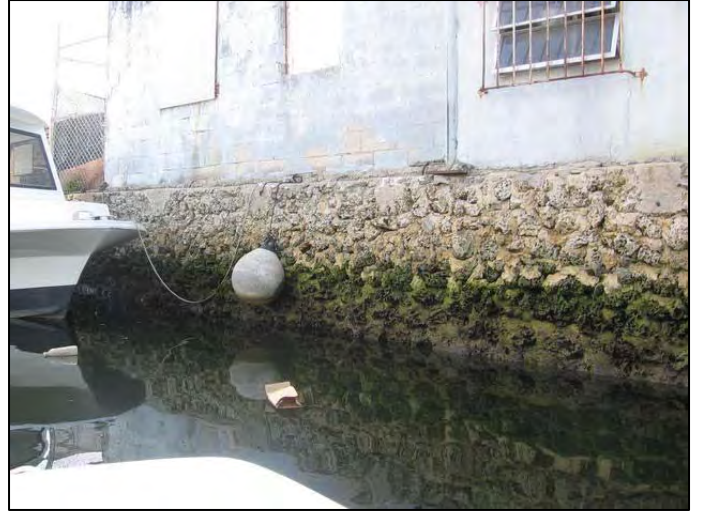
Structure S-141 Pictures

Address	700 NW 7 <sup>th</sup> Ave.; 710 NW 7 <sup>th</sup> Ave.; 722 NW 7 <sup>th</sup> Ave.
Folio #	0131350271160; 0131350271140; 0131350271130
Access Agreement	
Description	Coral rock seawall
Water Body	Seybold Canal
Operational Section	6
Latitude (dd.ddddd)*	25.78070
Longitude (dd.ddddd)*	-80.20745
Bank Location	East
Picture #	1245-1259
Condition	Fair
Damage to Structure and Picture #'s	N/A
End of Structure	End could not be flagged due to blockage by boats.
End of Structure Picture #	N/A

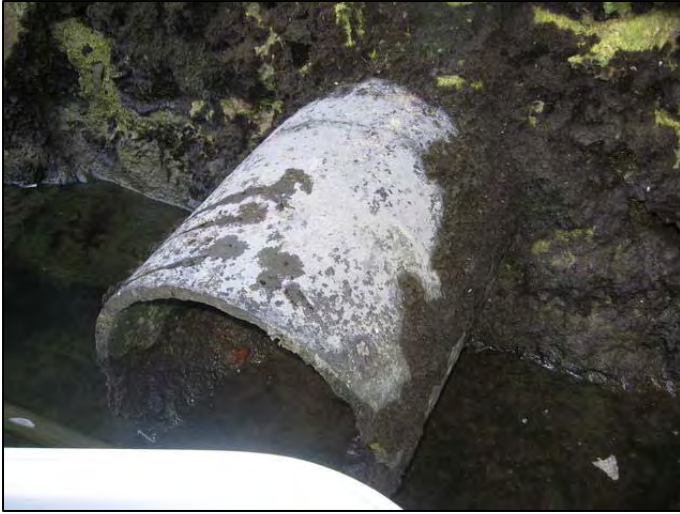
IMG\_1246

Address	700 NW 7 <sup>th</sup> Ave.
Folio #	0131350271160
Access Agreement	
Description	18" Metal pipe
Water Body	Seybold Canal
Operational Section	6
Latitude (dd.ddddd)*	25.78057
Longitude (dd.ddddd)*	-80.20724
Bank Location	East
Picture #	1246
Condition	Fair
Damage to Structure and Picture #'s	N/A
End of Structure	N/A
End of Structure Picture #	N/A

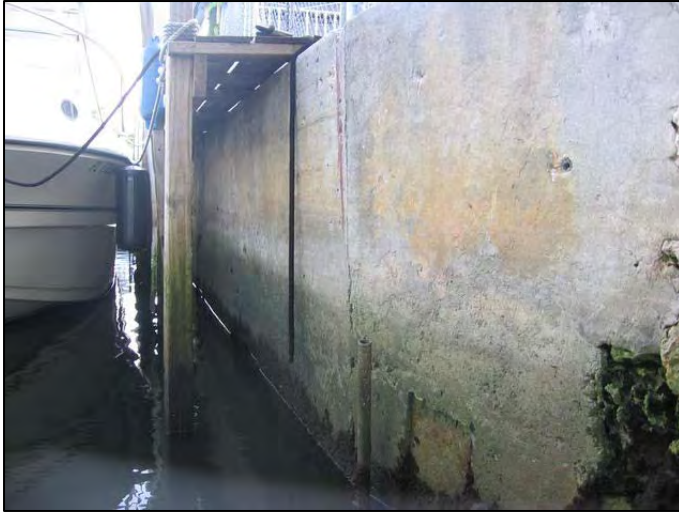
IMG\_1247

Address	700 NW 7 <sup>th</sup> Ave.
Folio #	0131350271160
Access Agreement	
Description	Wooden dock
Water Body	Seybold Canal
Operational Section	6
Latitude (dd.ddddd)*	25.78061
Longitude (dd.ddddd)*	-80.20725
Bank Location	East
Picture #	1247
Condition	Fair
Damage to Structure and Picture #'s	N/A
End of Structure	N/A
End of Structure Picture #	N/A

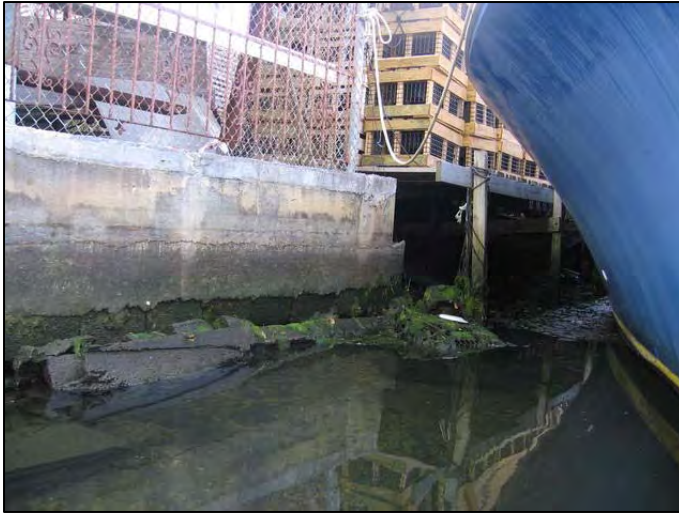
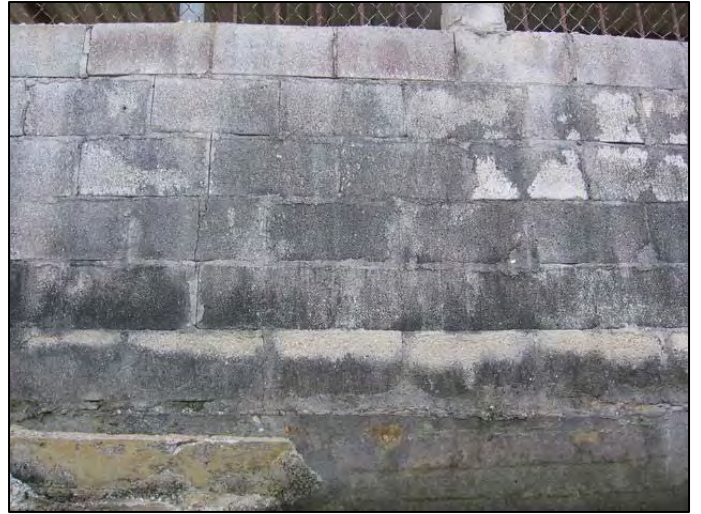
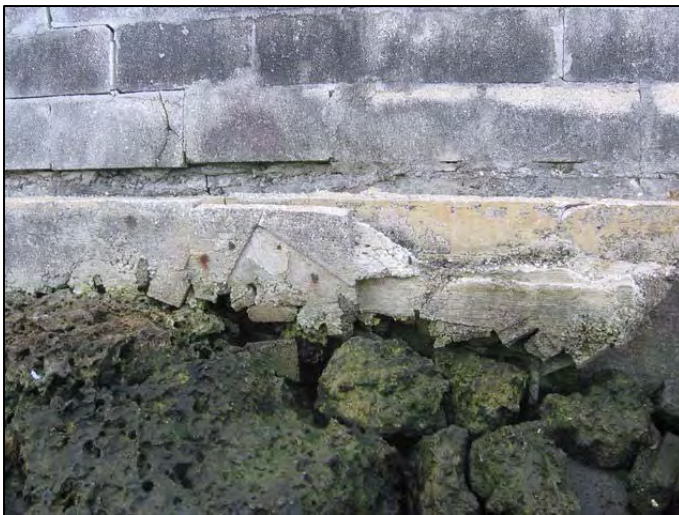
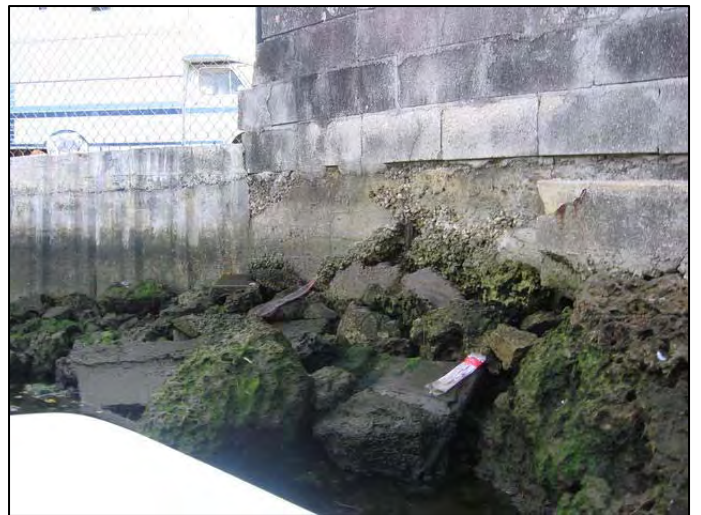
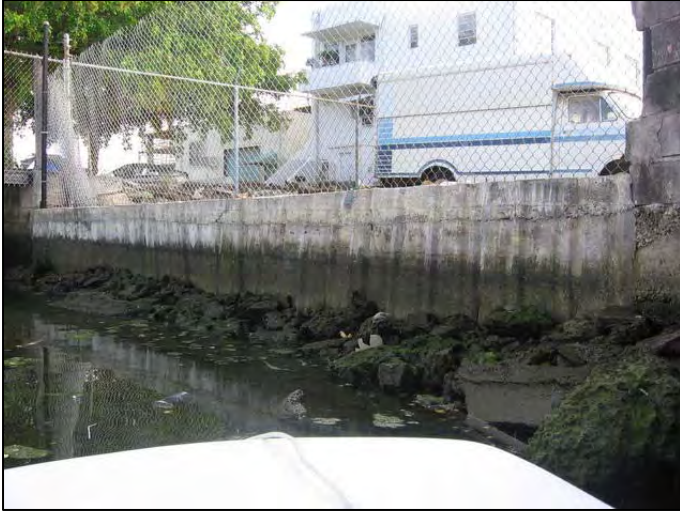
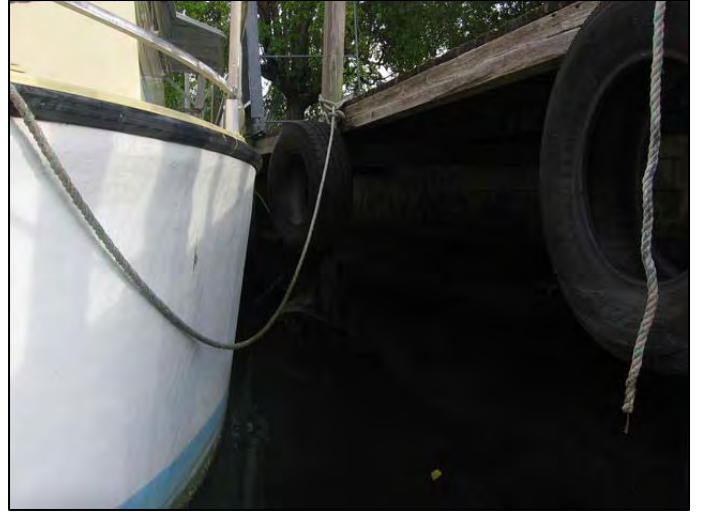
Structure S-144 Pictures

Address	722 NW 7 <sup>th</sup> Ave.; 732 NW 7 <sup>th</sup> Ave.; 800 NW 7 <sup>th</sup> Ave.; 808 NW 8 <sup>th</sup> St. Rd.; 810 NW 8 <sup>th</sup> St. Rd.; 812 NW 8 <sup>th</sup> St. Rd.; 830 NW 8 <sup>th</sup> St. Rd.
Folio #	0131350271130; 0131350271120; 0131350271110; 0131350271100; 0131350271090; 0131350271080; 0131350271070
Access Agreement	
Description	Concrete seawall with wooden docks
Water Body	Seybold Canal
Operational Section	6
Latitude (dd.ddddd)*	25.78122
Longitude (dd.ddddd)*	-80.20724
Bank Location	East
Picture #	1260-1264, 1266-1275, 1277-1285, 1288, 1290-1292
Condition	Unknown
Damage to Structure and Picture #'s	C, 1286-1287
End of Structure	End could not be flagged due to blockage by boats
End of Structure Picture #	N/A

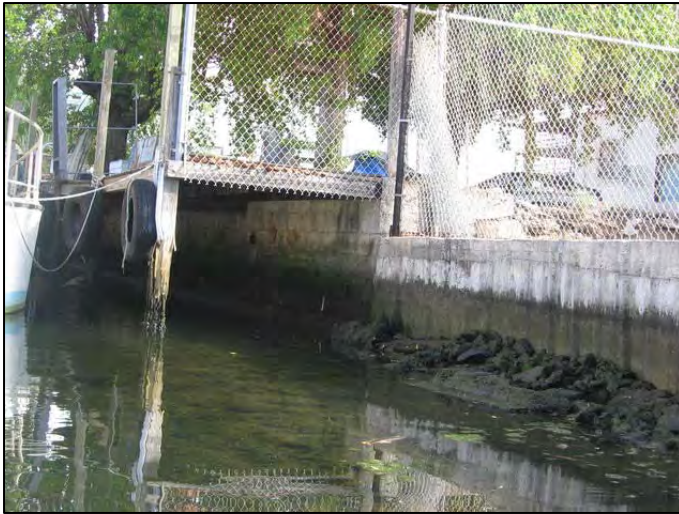
IMG\_1265

Address	800 NW 7 <sup>th</sup> Ave
Folio #	0131350271110
Access Agreement	
Description	Wooden dock
Water Body	Seybold Canal
Operational Section	6
Latitude (dd.ddddd)*	25.78121
Longitude (dd.ddddd)*	-80.20721
Bank Location	East
Picture #	1265
Condition	Fair/Poor
Damage to Structure and Picture #'s	N/A
End of Structure	N/A
End of Structure Picture #	N/A
