*Corrective Action Plan - Version 2*

# Wagner Creek/Seybold Canal

Volume 2 — Appendices G through I

Submitted to  
City of Miami

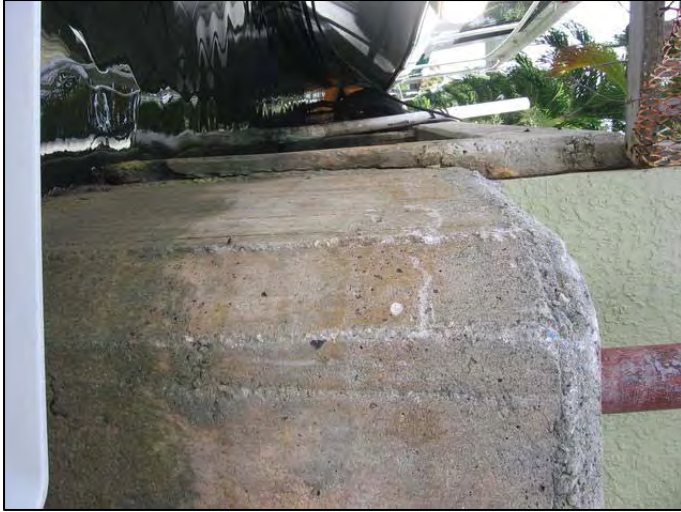
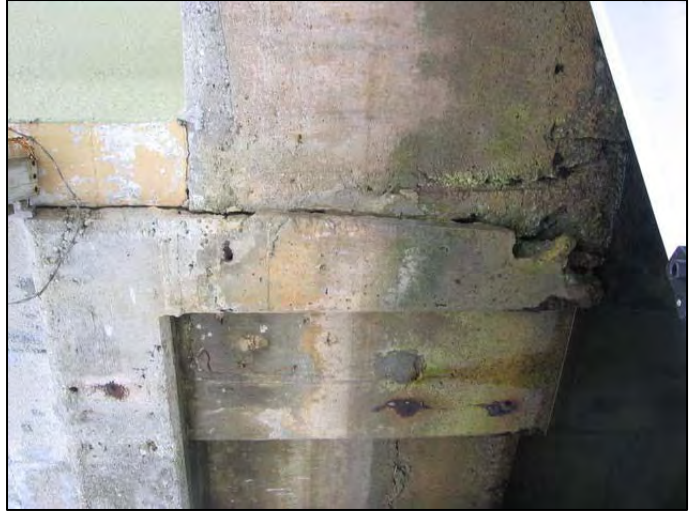
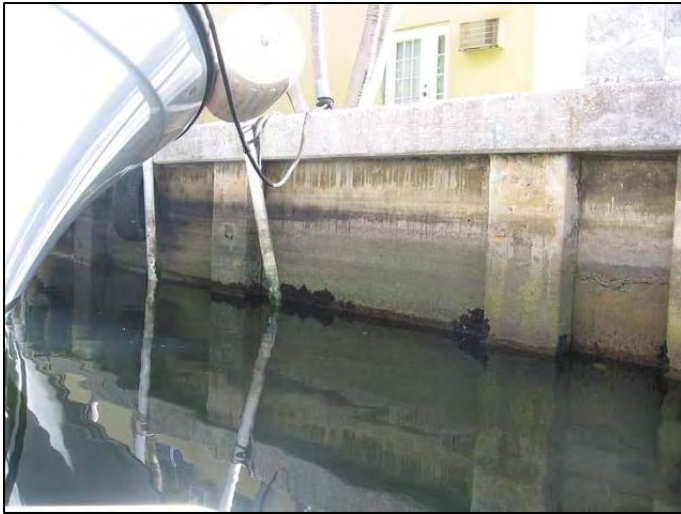
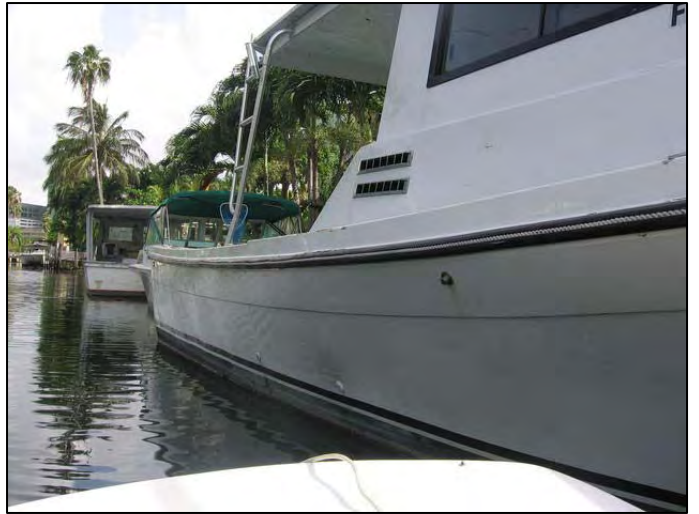
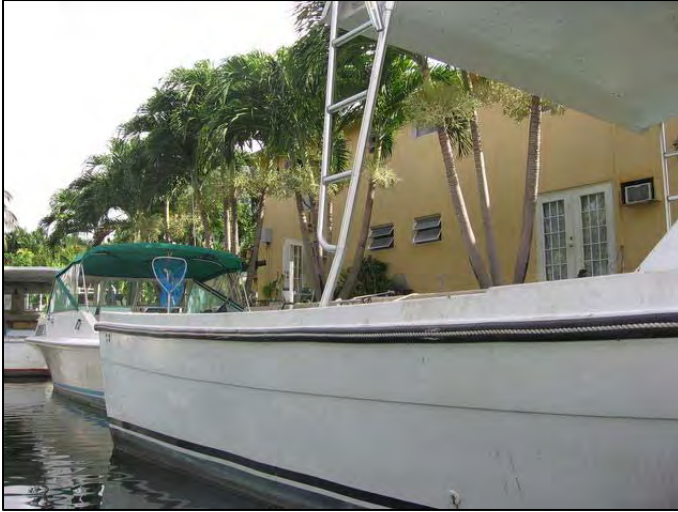
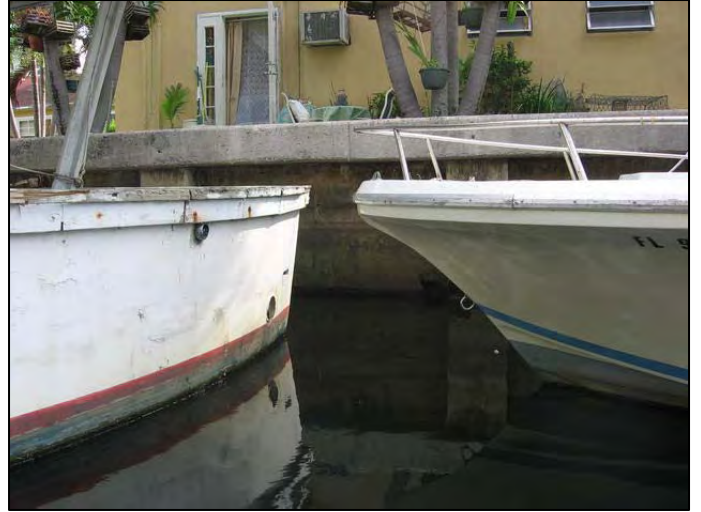
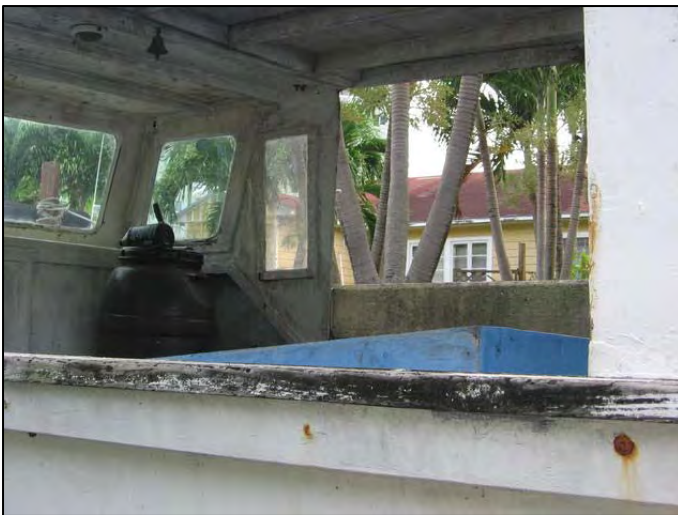
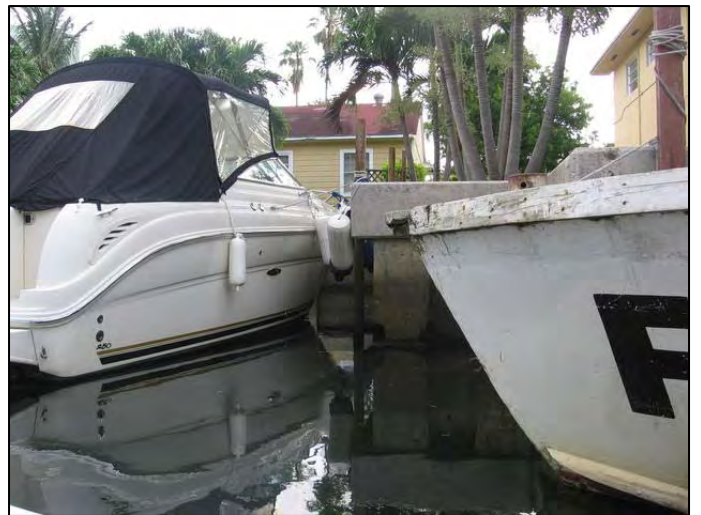
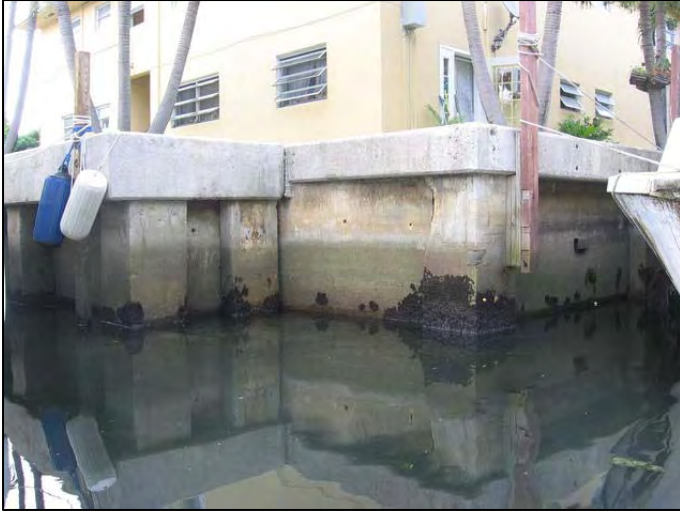
Structure S-147 Pictures

Address	938-940 NW 8 <sup>th</sup> St. Rd.; 942 NW 8 <sup>th</sup> St. Rd.
Folio #	0131350271000; 0131350270990
Access Agreement	
Description	Concrete seawall
Water Body	Seybold Canal
Operational Section	6
Latitude (dd.ddddd)*	25.78261
Longitude (dd.ddddd)*	-80.20855
Bank Location	East
Picture #	1318, 1320-1325
Condition	Fair
Damage to Structure and Picture #'s	C-1, 1319
End of Structure	S-148
End of Structure Picture #	1326

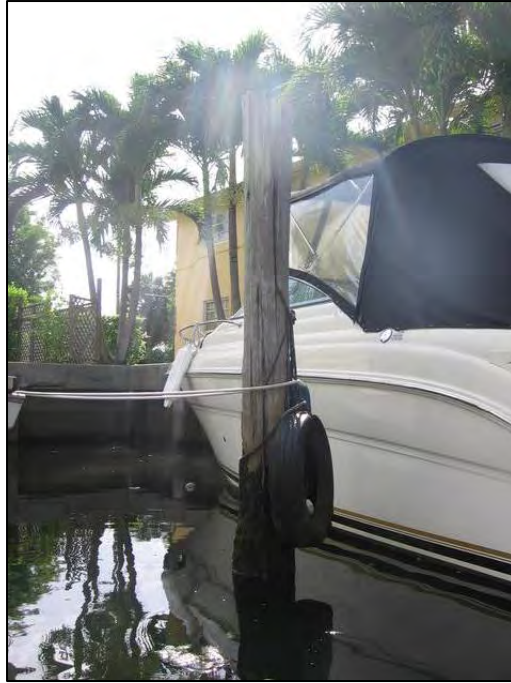
IMG\_1329

Address	942 NW 8 <sup>th</sup> St. Rd.
Folio #	0131350270990
Access Agreement	
Description	Wooden piling
Water Body	Seybold Canal
Operational Section	6
Latitude (dd.ddddd)*	25.78289
Longitude (dd.ddddd)*	-80.20879
Bank Location	East
Picture #	1329
Condition	Fair/Poor
Damage to Structure and Picture #'s	N/A
End of Structure	N/A
End of Structure Picture #	N/A

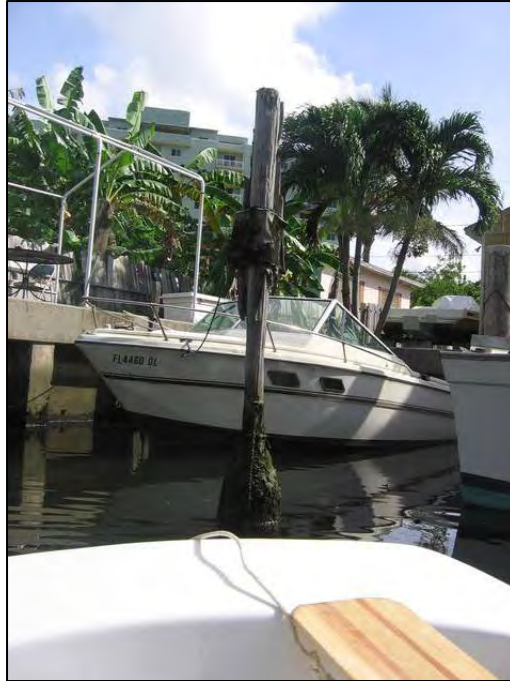
IMG\_1328

Address	942 NW 8 <sup>th</sup> St. Rd.
Folio #	0131350270990
Access Agreement	
Description	Wooden piling
Water Body	Seybold Canal
Operational Section	6
Latitude (dd.ddddd)*	25.78291
Longitude (dd.ddddd)*	-80.20882
Bank Location	East
Picture #	1328
Condition	Fair
Damage to Structure and Picture #'s	N/A
End of Structure	N/A
End of Structure Picture #	N/A

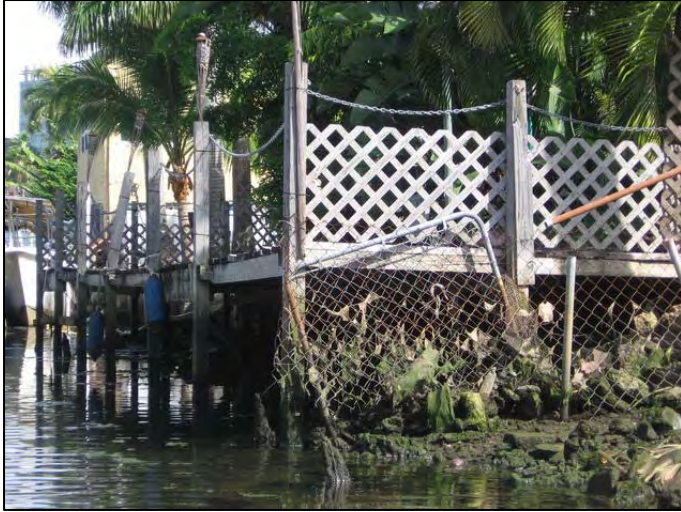
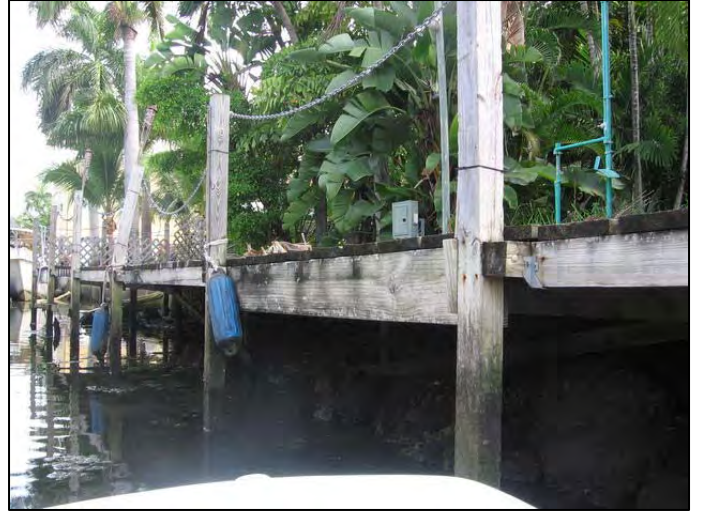
**Structure S-152 Pictures**

Address	962 NW 8 <sup>th</sup> St. Rd.
Folio #	0131350270970
Access Agreement	
Description	Wooden dock
Water Body	Seybold Canal
Operational Section	6
Latitude (dd.ddddd)*	25.78302
Longitude (dd.ddddd)*	-80.20901
Bank Location	East
Picture #	1333-1334
Condition	Fair/Poor
Damage to Structure and Picture #'s	N/A
End of Structure	N/A
End of Structure Picture #	N/A

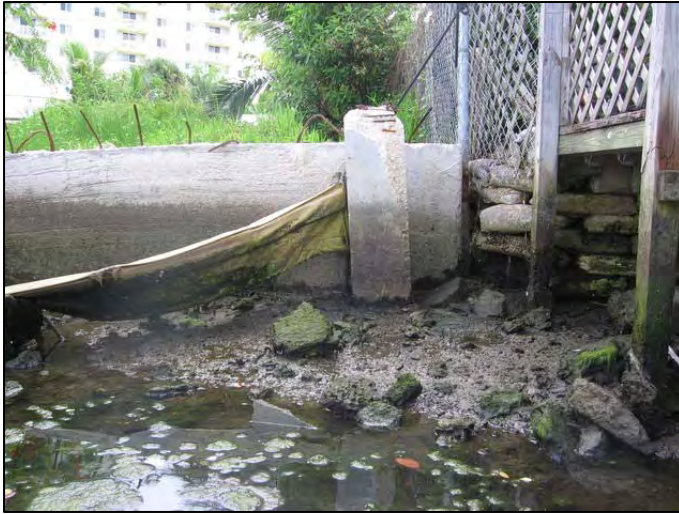
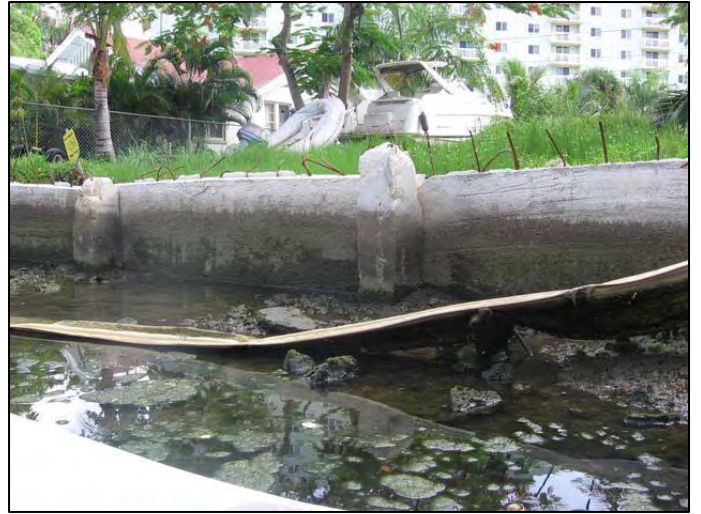
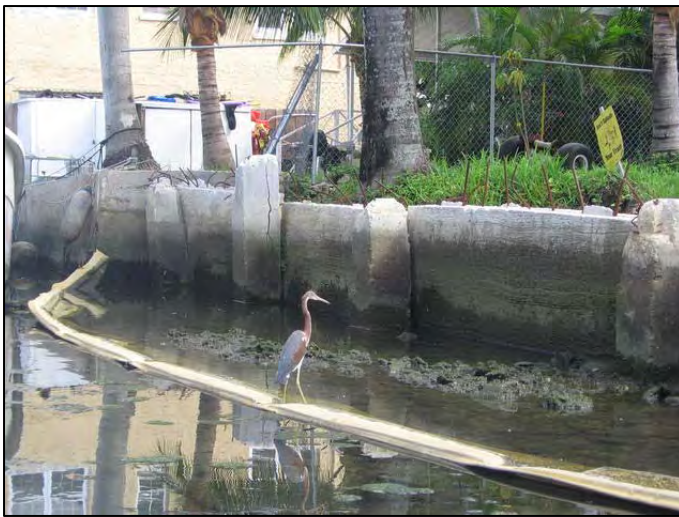
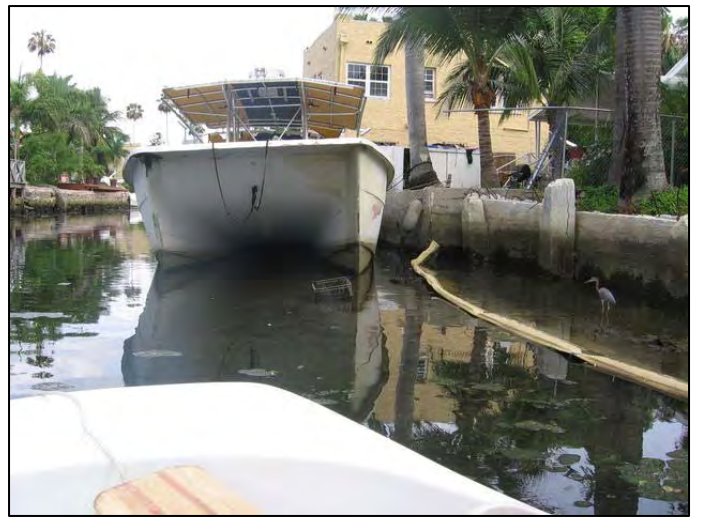
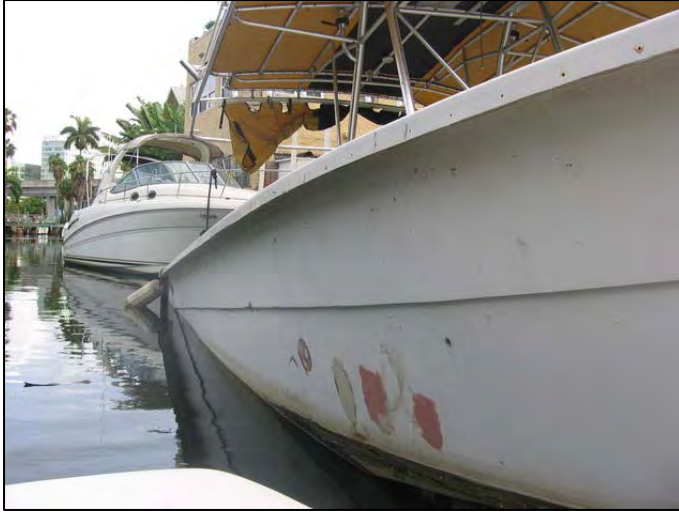
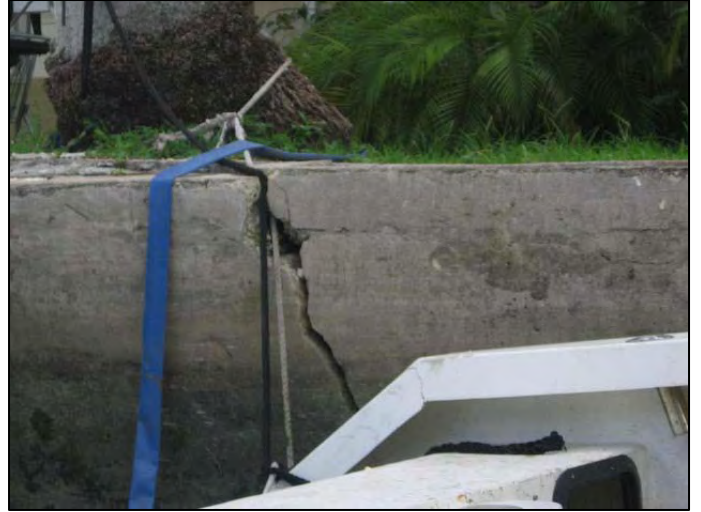
Structure S-153 Pictures

Address	1008 NW 8 <sup>th</sup> St. Rd.; 1014 NW 8 <sup>th</sup> St. Rd.; 1022 NW 8 <sup>th</sup> St. Rd.; 870 NW 11 <sup>th</sup> St.
Folio #	0131350270950; 0131350270940; 0131350270930; 0131350270920
Access Agreement	
Description	Concrete seawall
Water Body	Seybold Canal
Operational Section	6
Latitude (dd.ddddd)*	25.78312
Longitude (dd.ddddd)*	-80.20913
Bank Location	East
Picture #	1335-1339, 1343-1344, 1346-1347, 1349- 1350
Condition	Poor
Damage to Structure and Picture #'s	C, 1340, 1345, 1348; C-1, 1341; C-2, 1342
End of Structure	S-154
End of Structure Picture #	1351

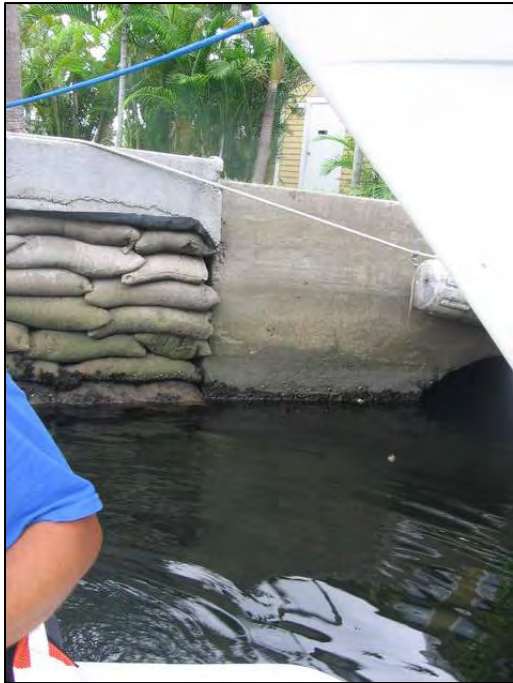
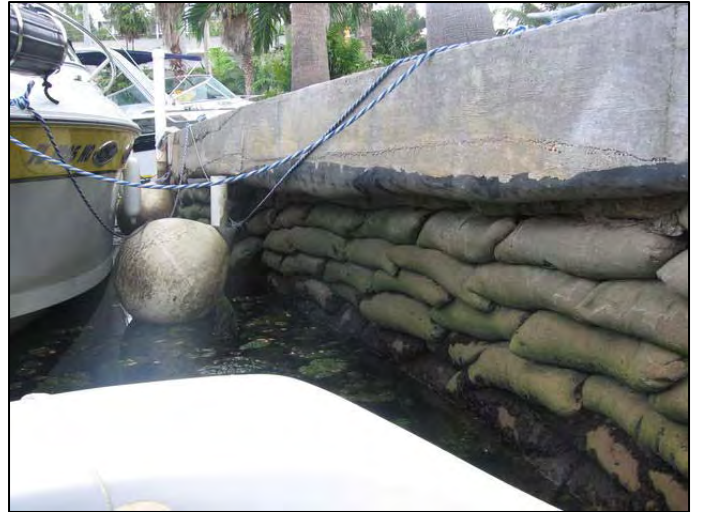
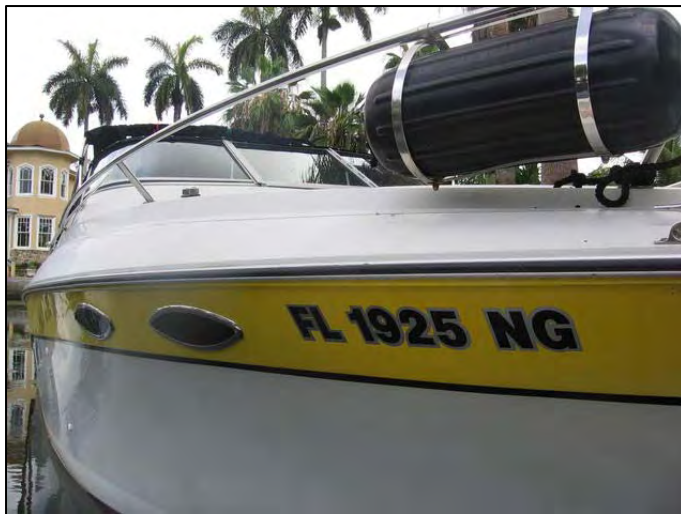
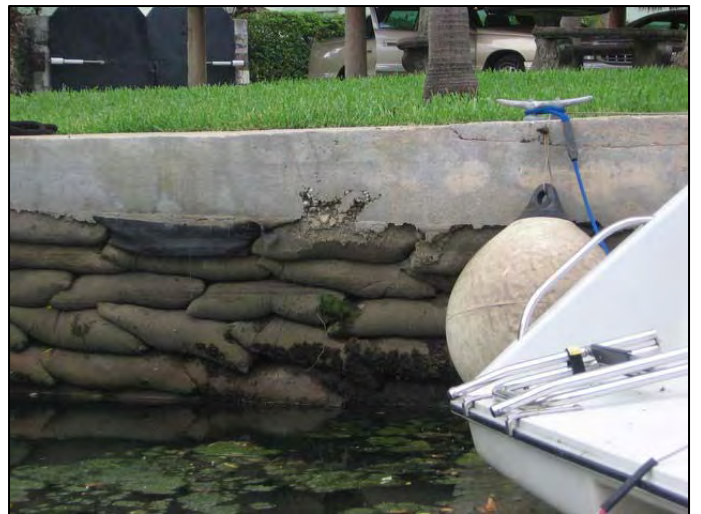
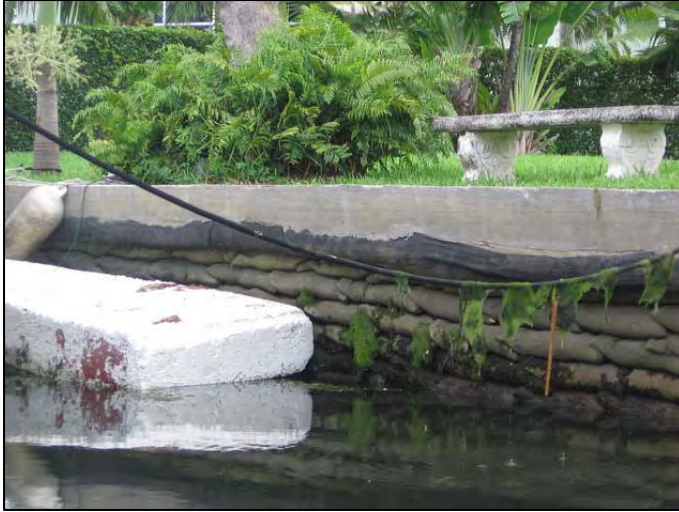
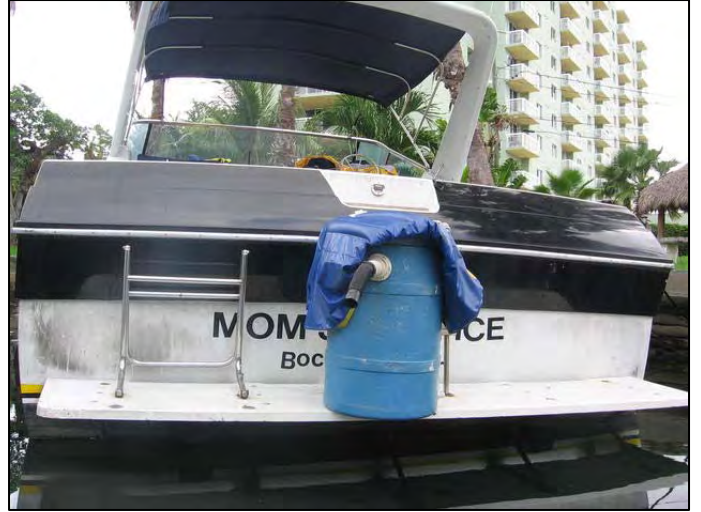
Structure S-155 Pictures

Address	870 NW 11 <sup>th</sup> St.
Folio #	0131350270920
Access Agreement	
Description	Concrete sandbag seawall
Water Body	Seybold Canal
Operational Section	6
Latitude (dd.ddddd)*	25.78370
Longitude (dd.ddddd)*	-80.20956
Bank Location	East
Picture #	1351-1356
Condition	Fair
Damage to Structure and Picture #'s	N/A
End of Structure	S-156
End of Structure Picture #	1357

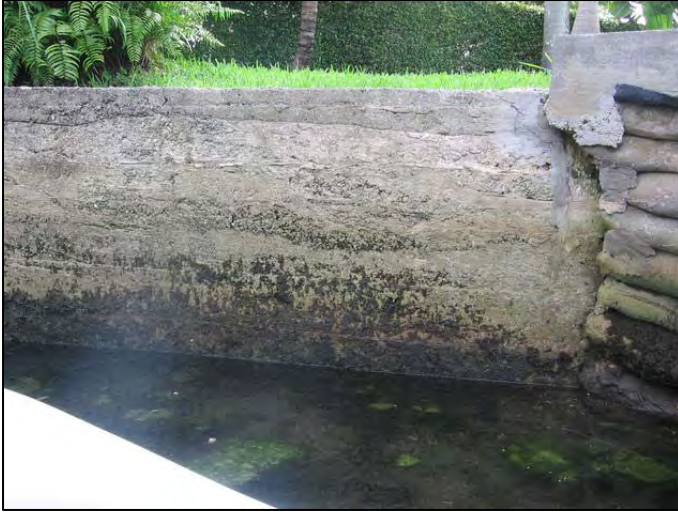
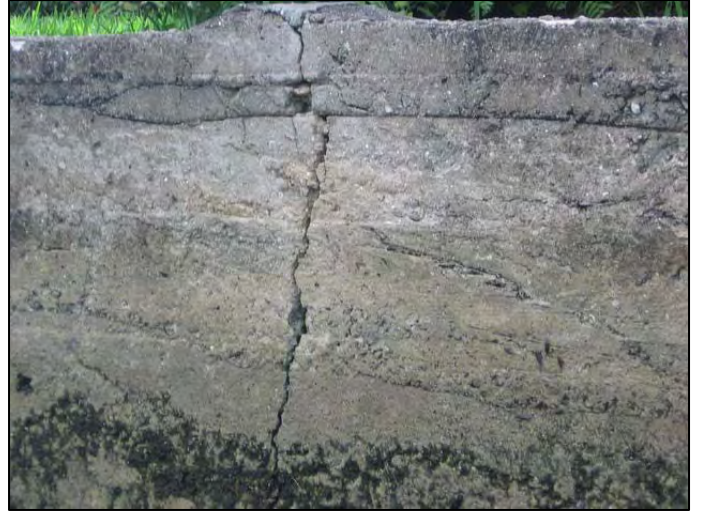
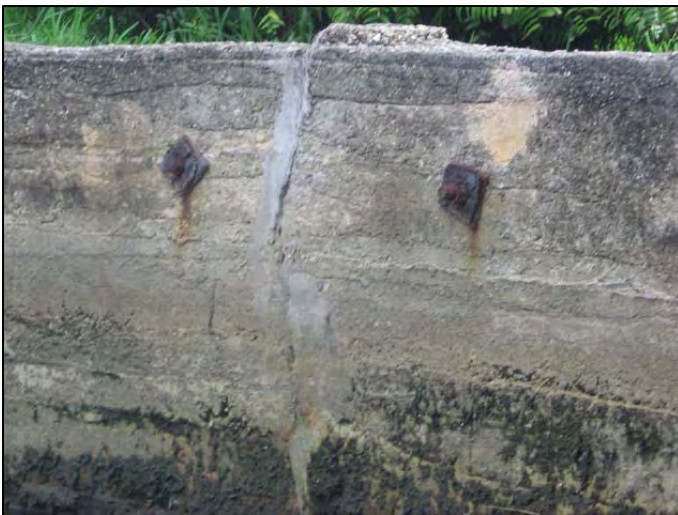
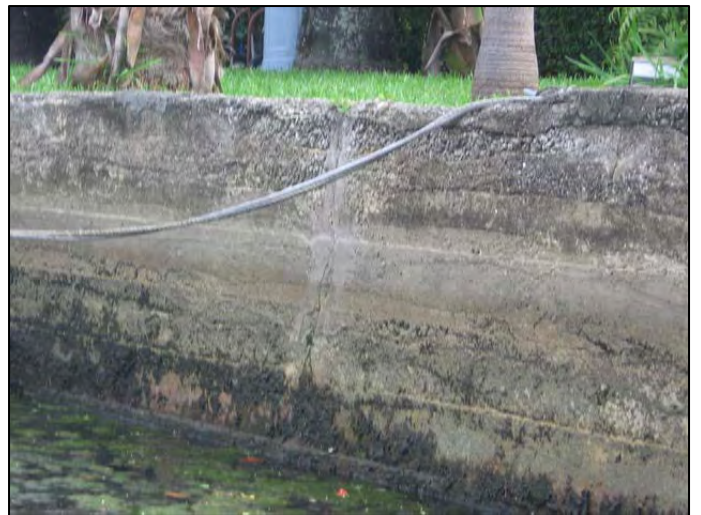
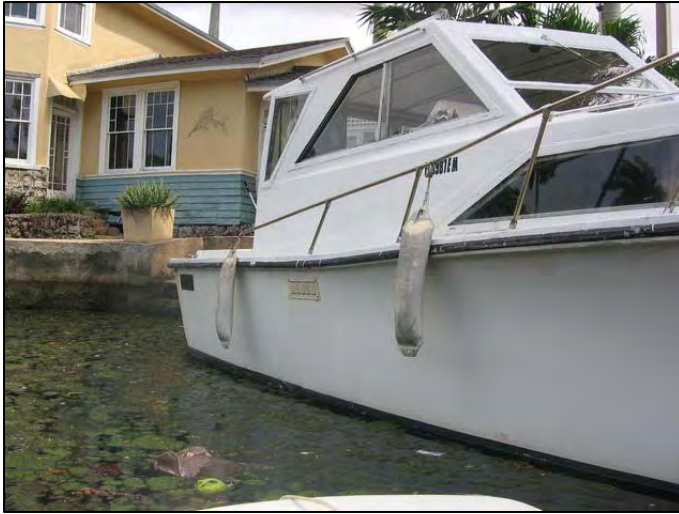
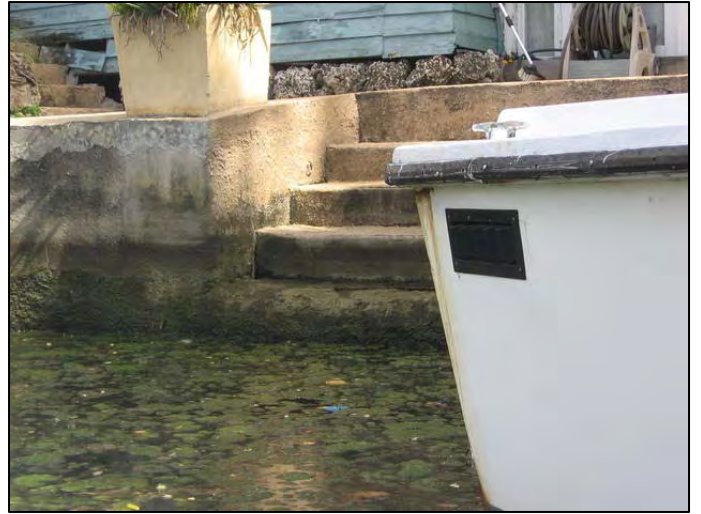
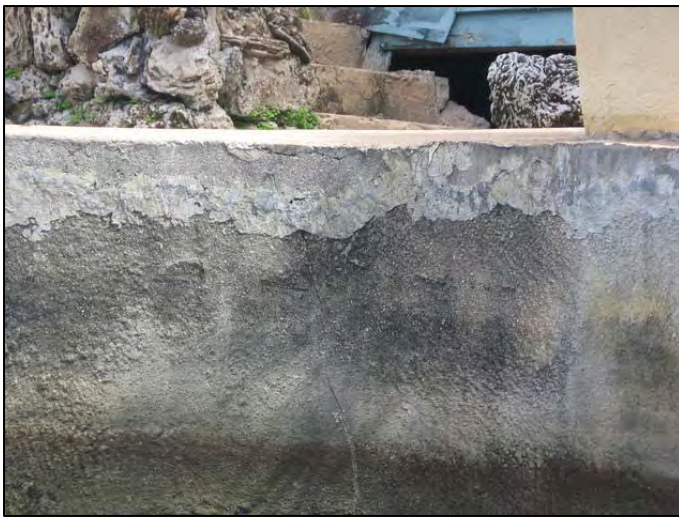
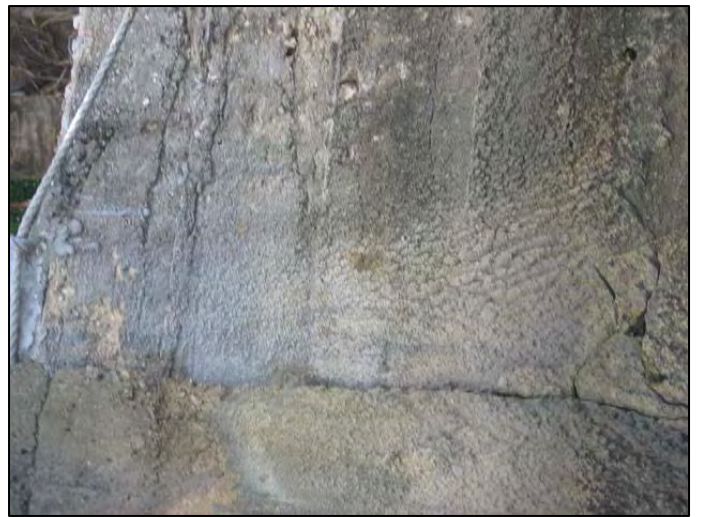
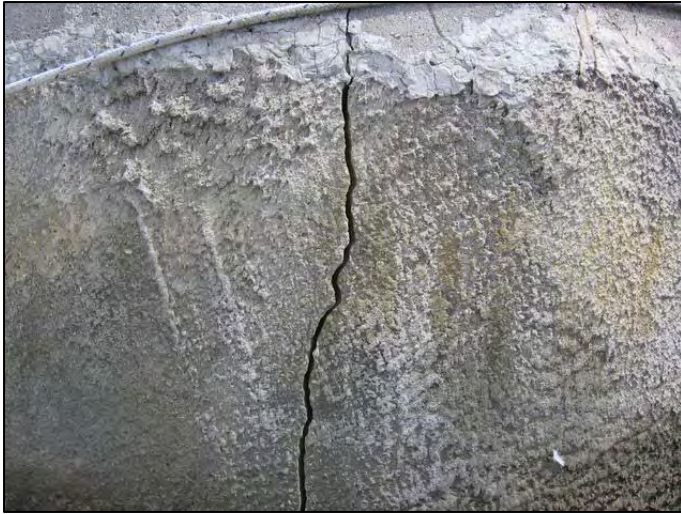
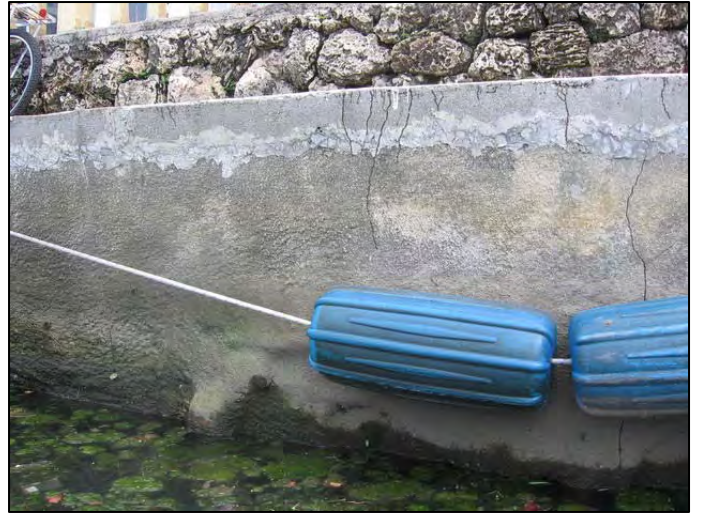
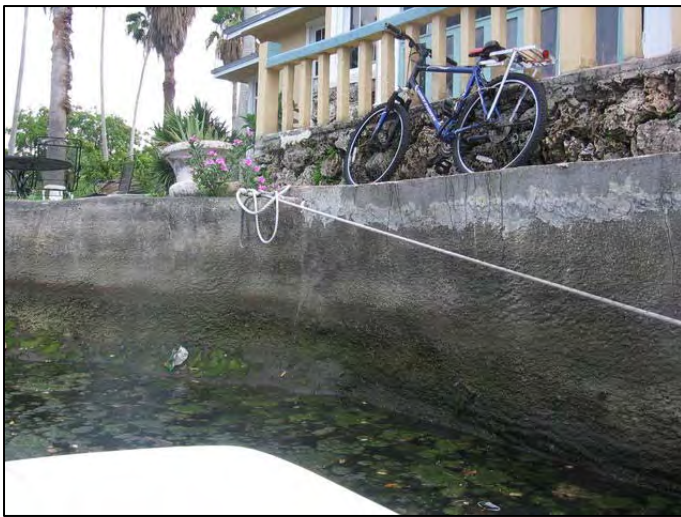
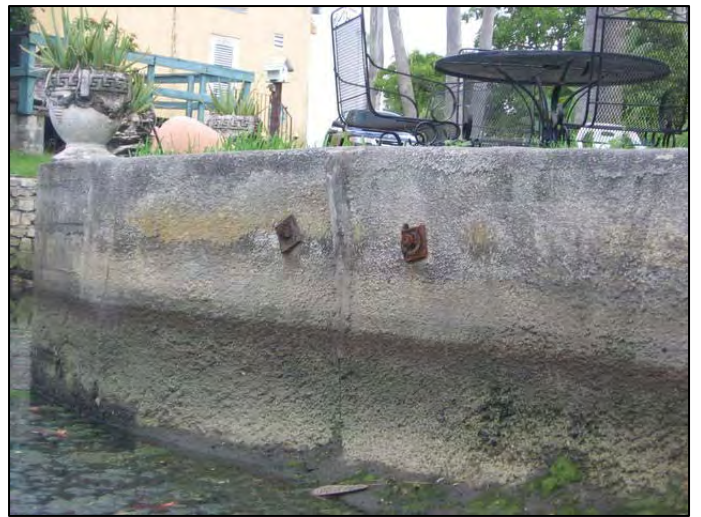
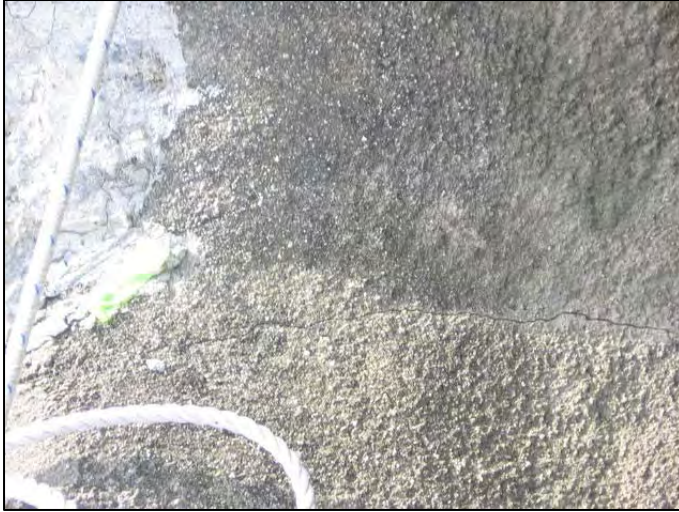
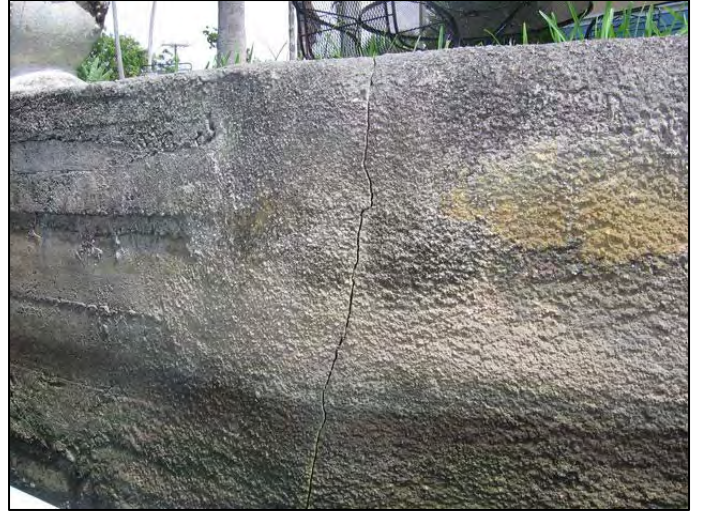
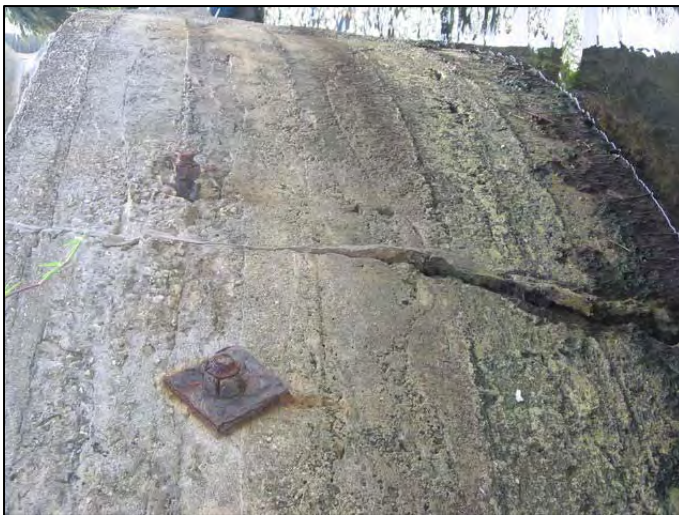
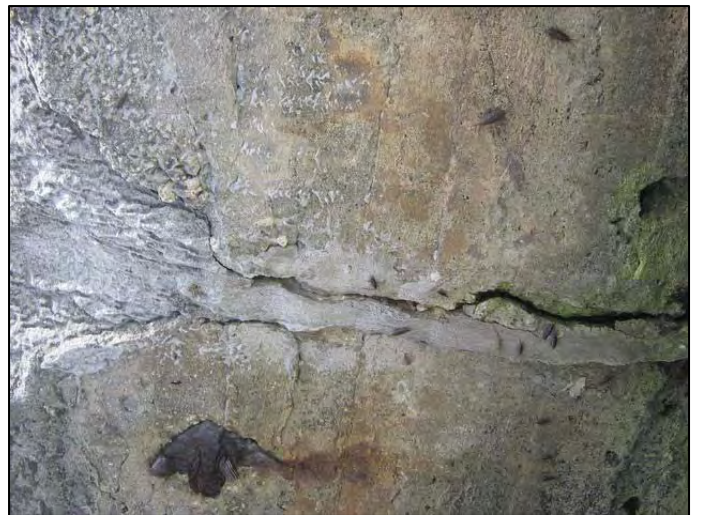
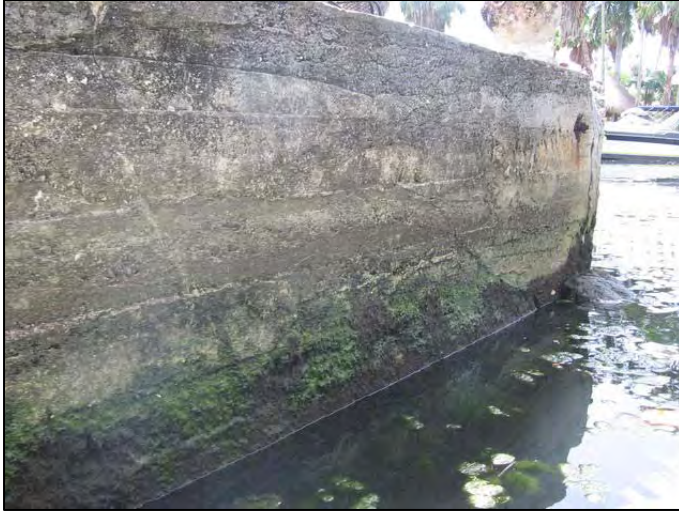
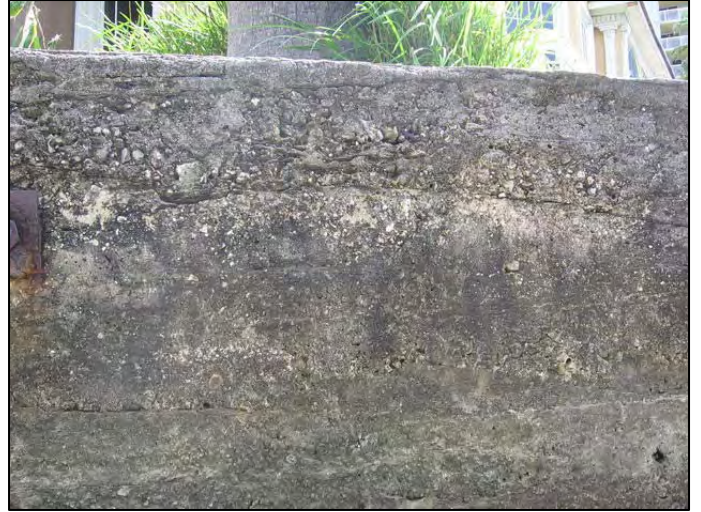
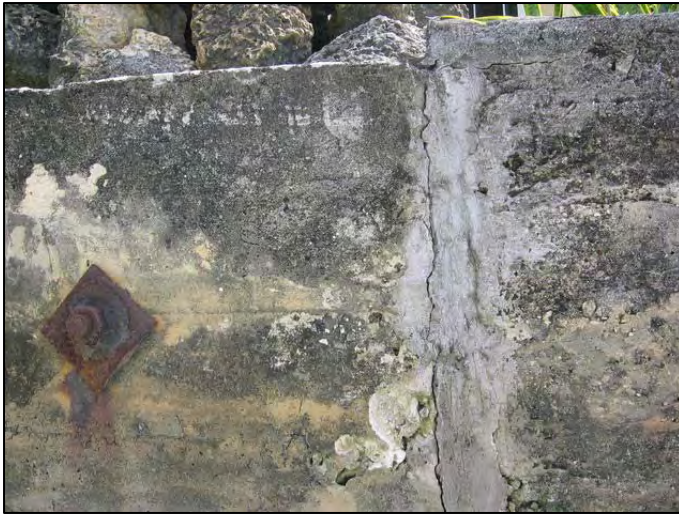
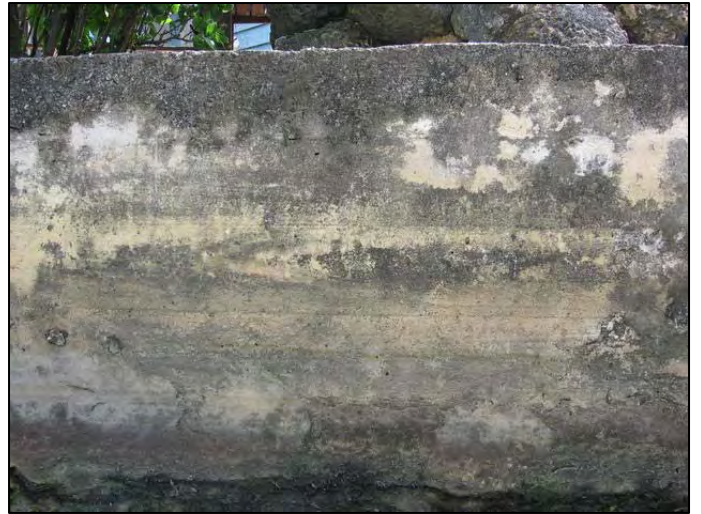
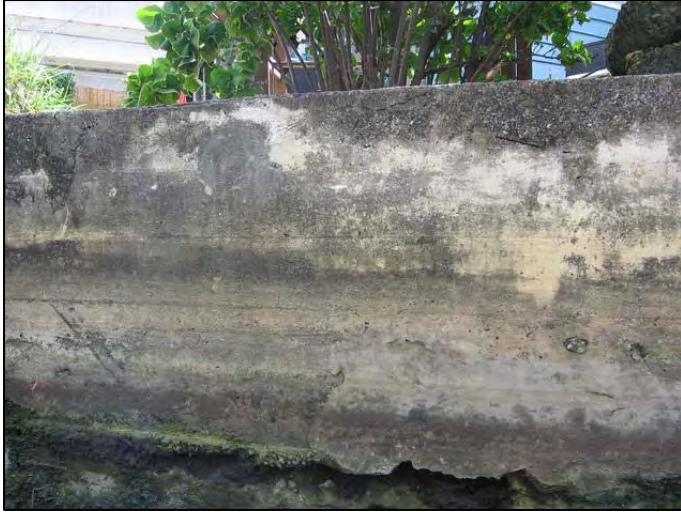
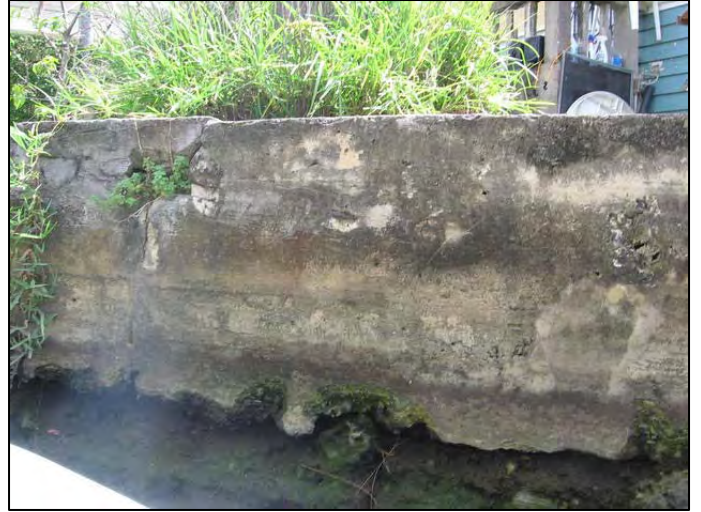
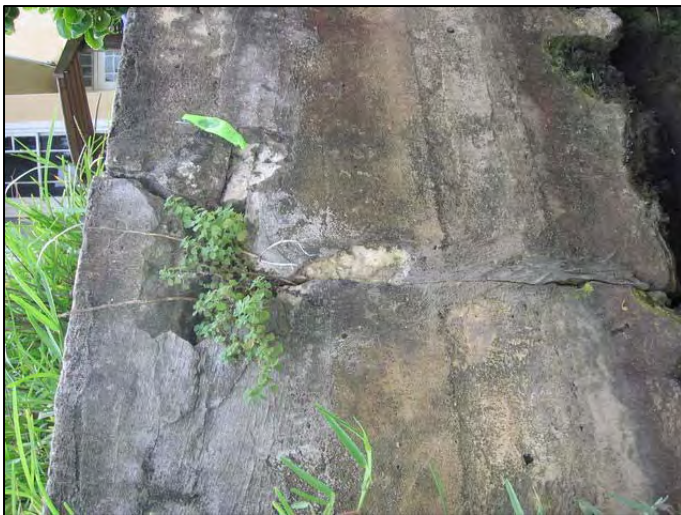
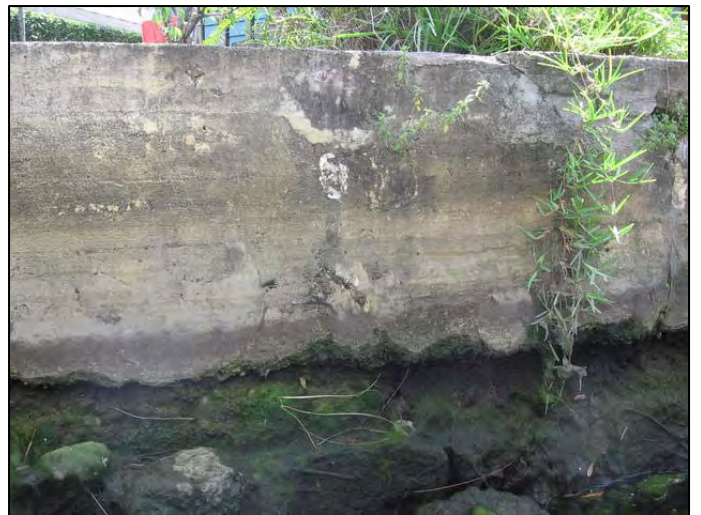
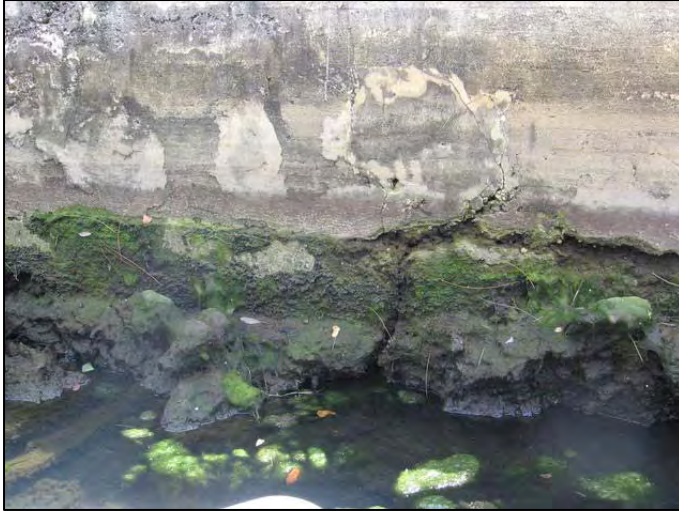
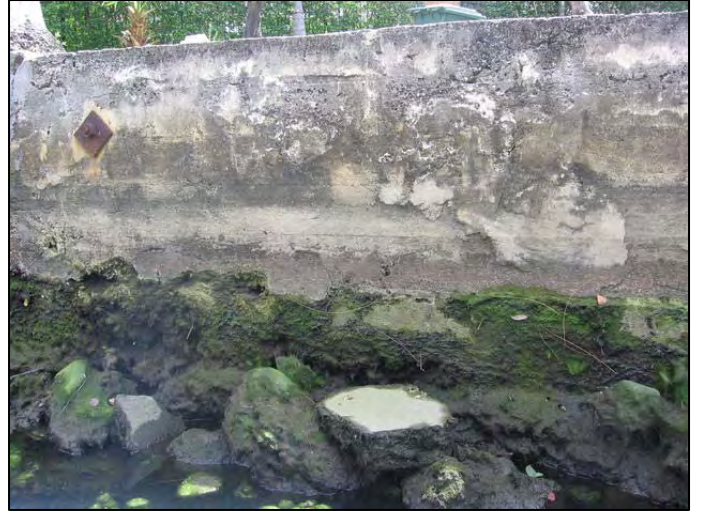
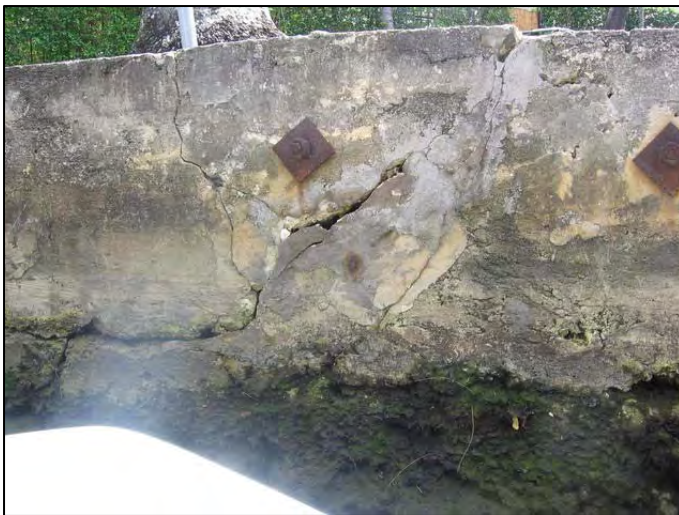
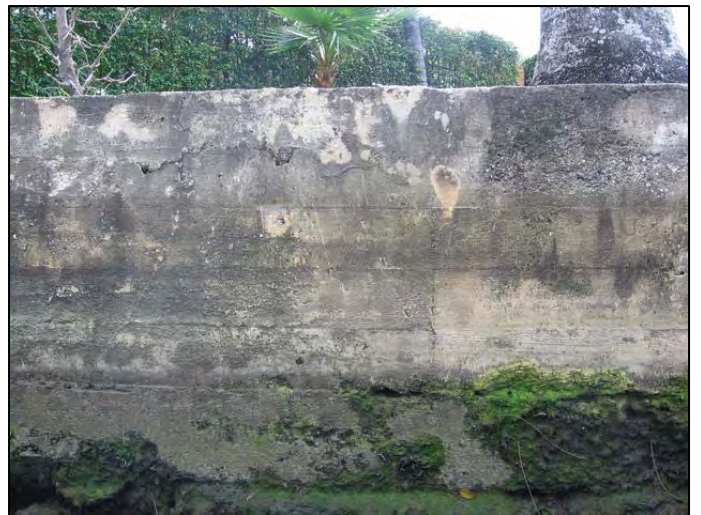
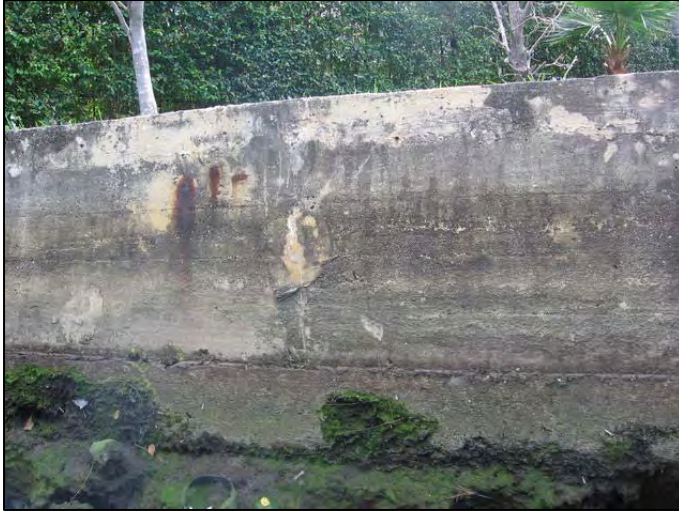
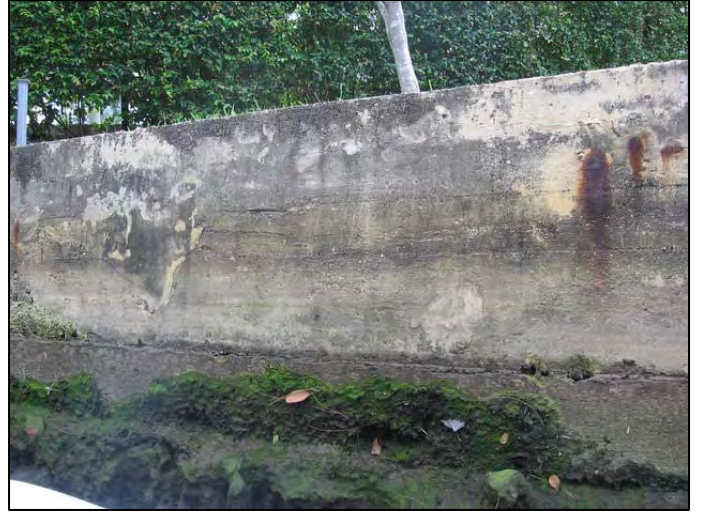
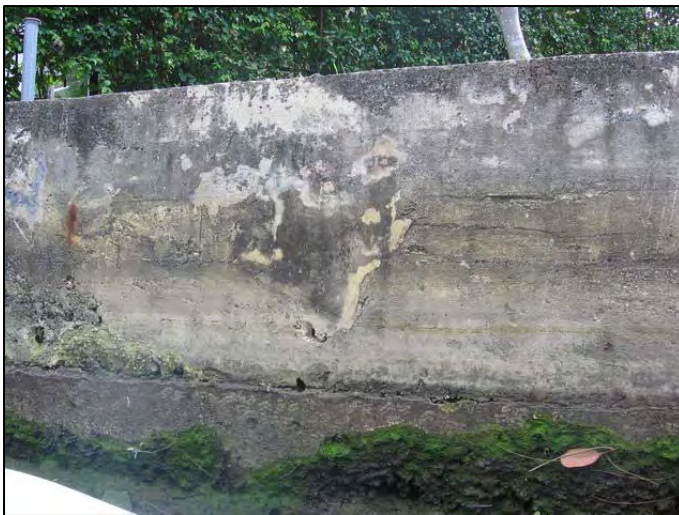
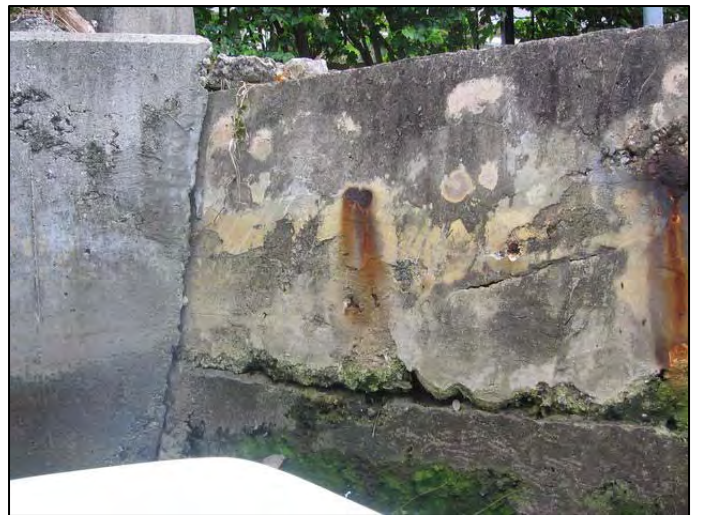
Structure S-157 Pictures

Address	870 NW 11 <sup>th</sup> St.
Folio #	0131350270920
Access Agreement	
Description	Concrete seawall. Bottom is deteriorating.
Water Body	Seybold Canal
Operational Section	6
Latitude (dd.ddddd)*	25.78379
Longitude (dd.ddddd)*	-80.20953
Bank Location	East
Picture #	1358, 1362-1364, 1367, 1369, 1374-1379, 1381-1383, 1385-1388
Condition	Fair
Damage to Structure and Picture #'s	C-1, 1359; C-2, 1360; C-3, 1361; C-4, 1365; C-5, 1366; C-6, 1368; C-7, 1370; C- 8, 1371; C-9, 1372; C-10, 1373; C-11, 1380; C-12, 1384
End of Structure	S-158
End of Structure Picture #	1389
